X-33 LH₂ Tank Failure Investigation Findings

Presented by
Mindy Niedermeyer
MSFC

International Conference on Composites Engineering

July 23, 2003

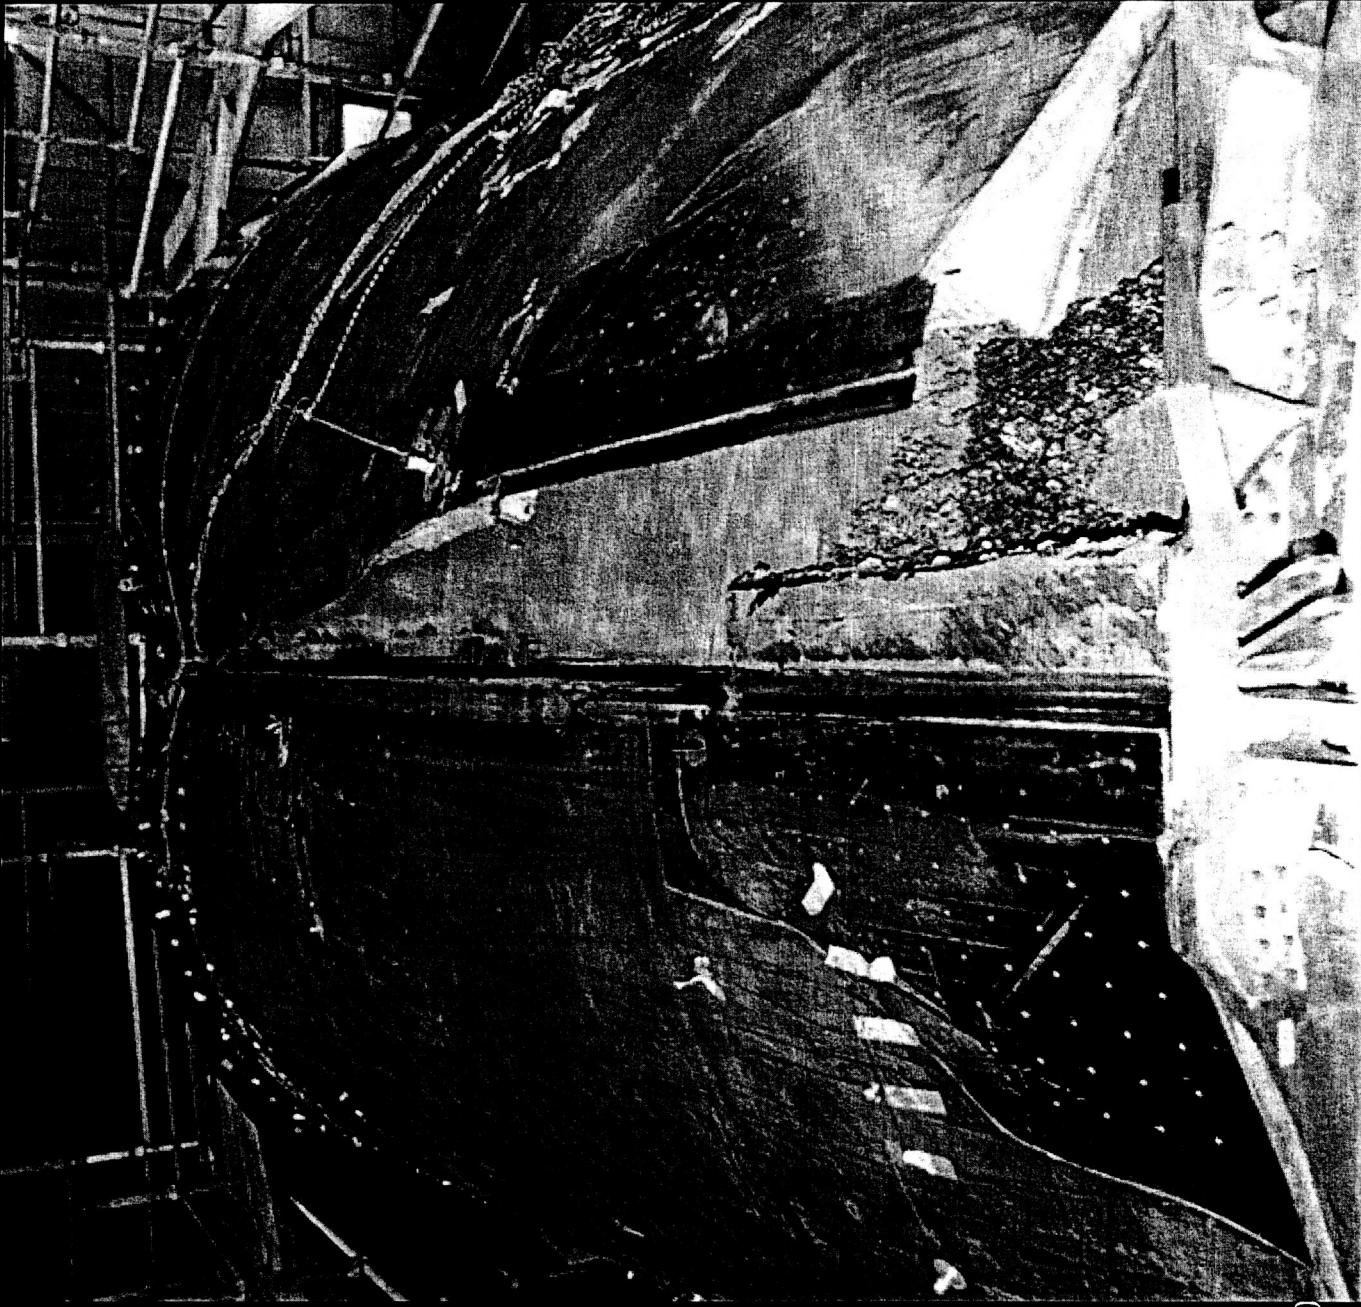
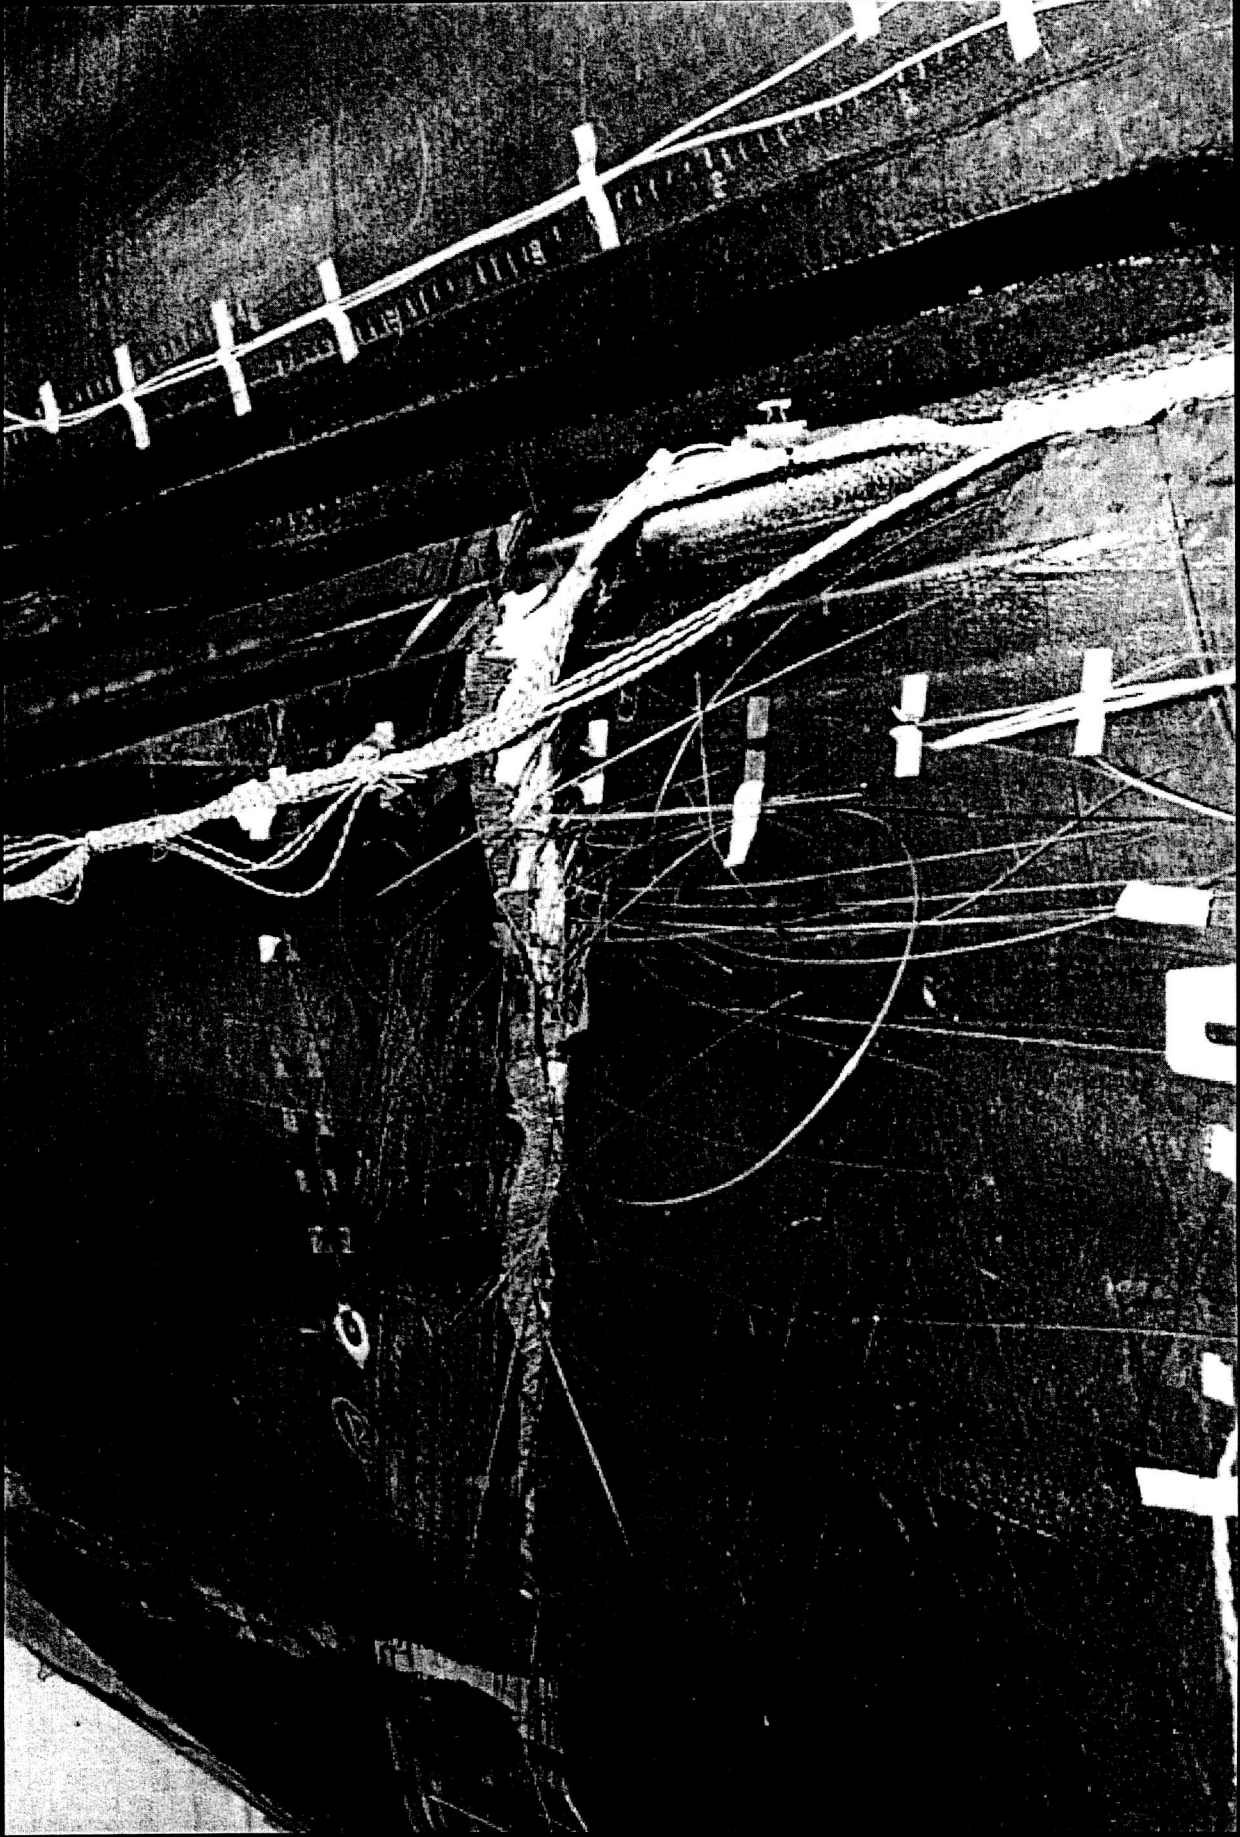
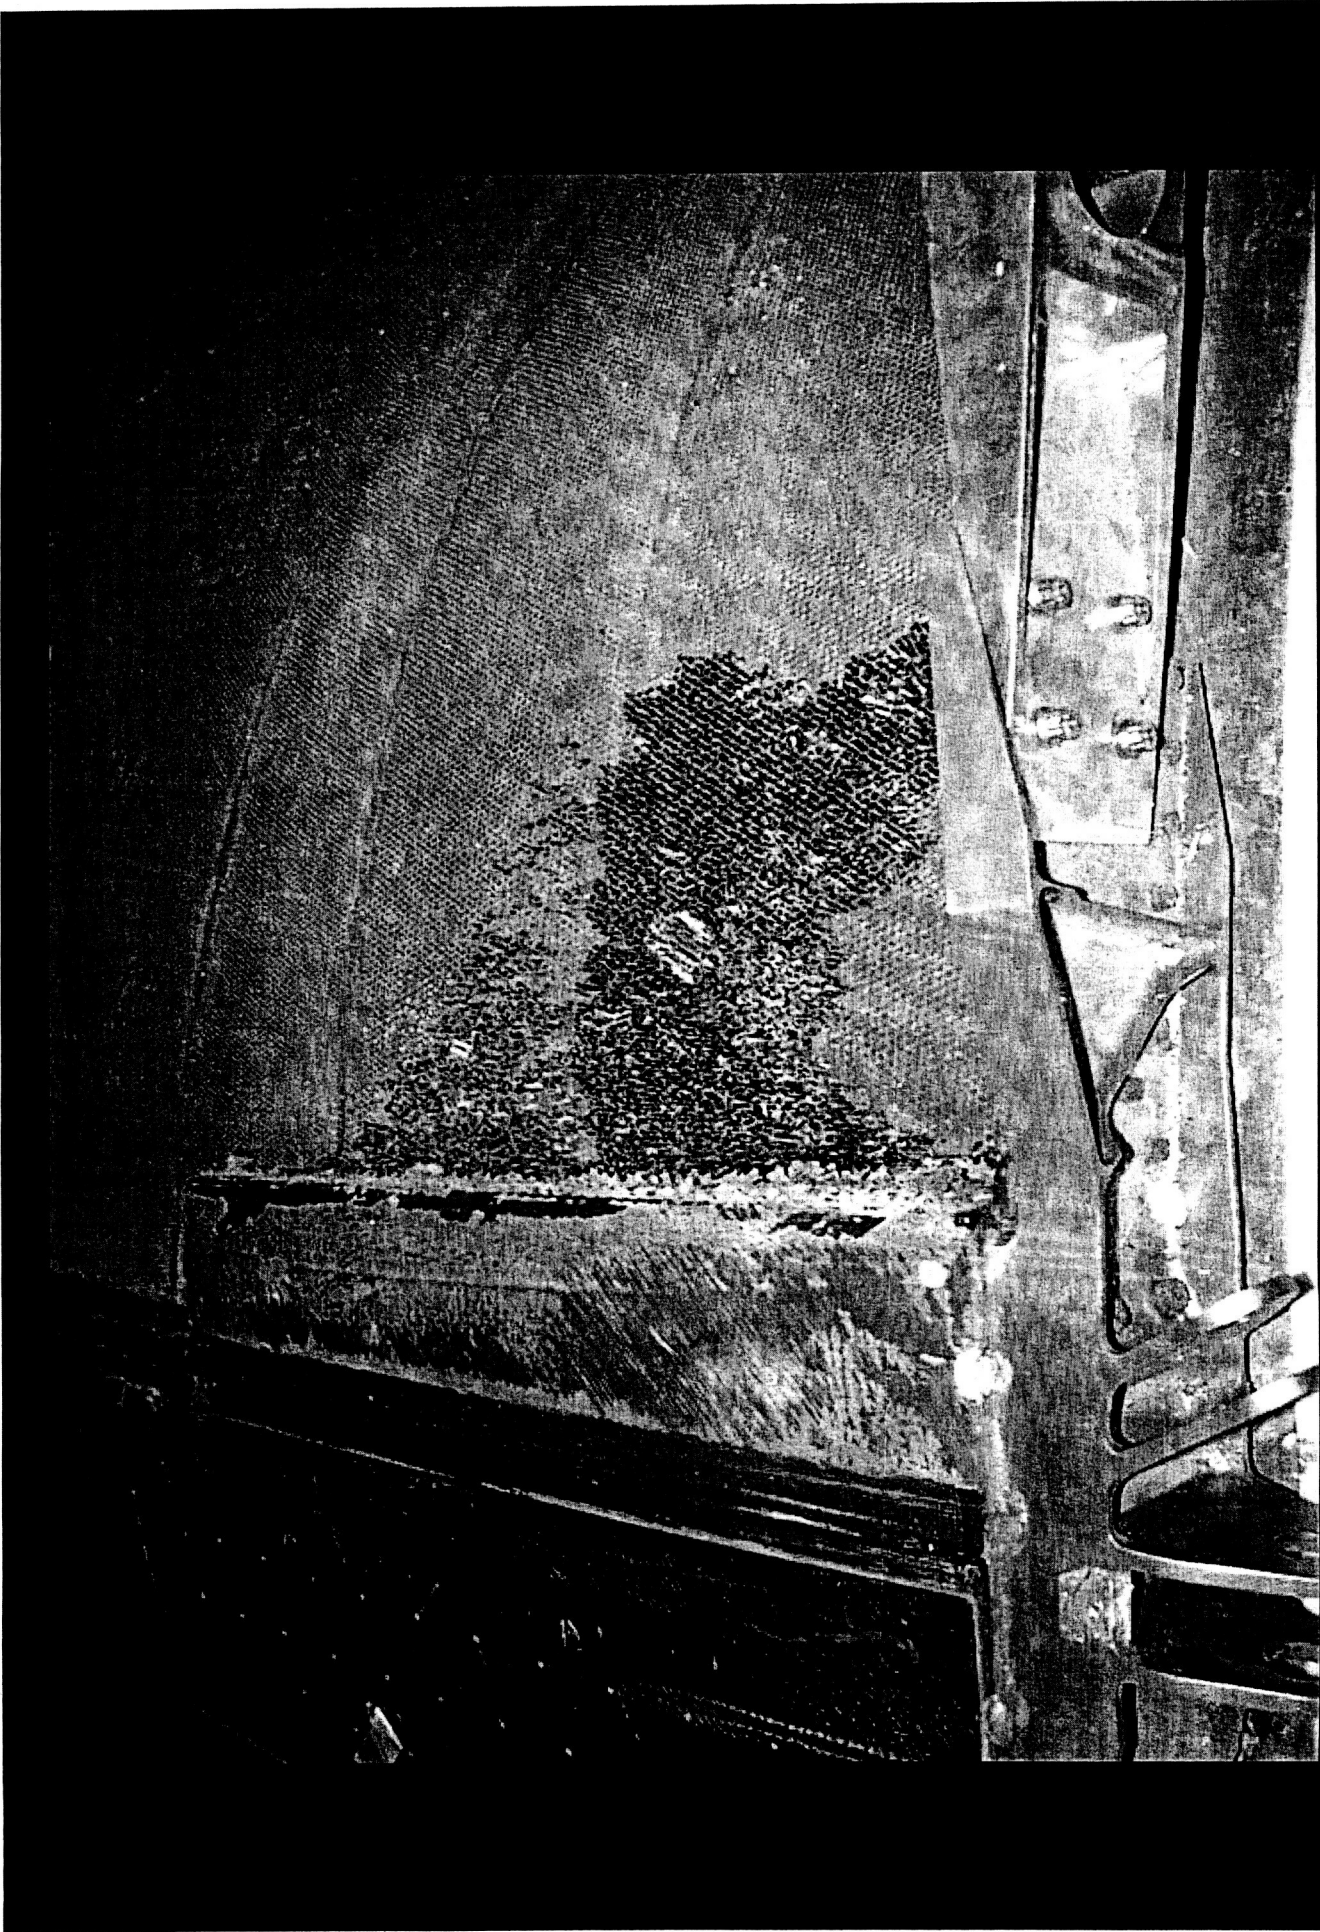
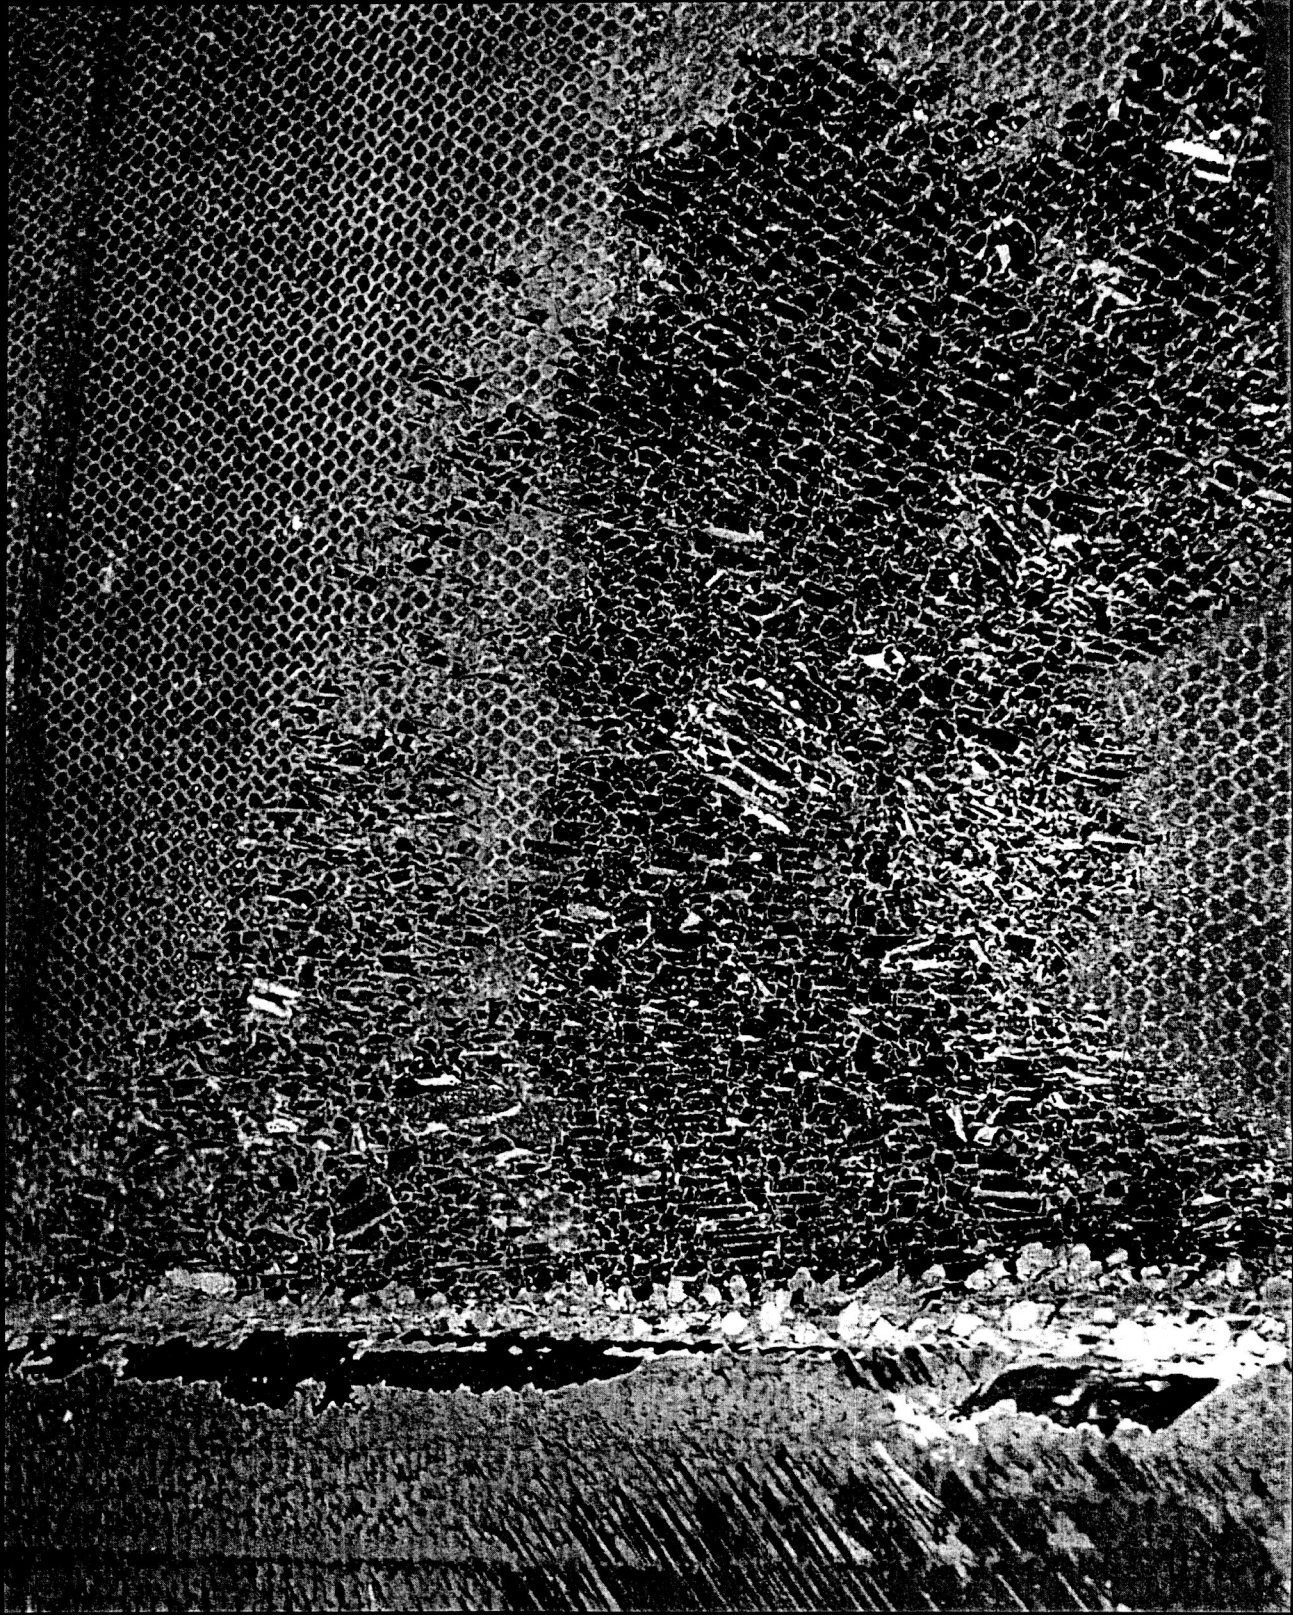
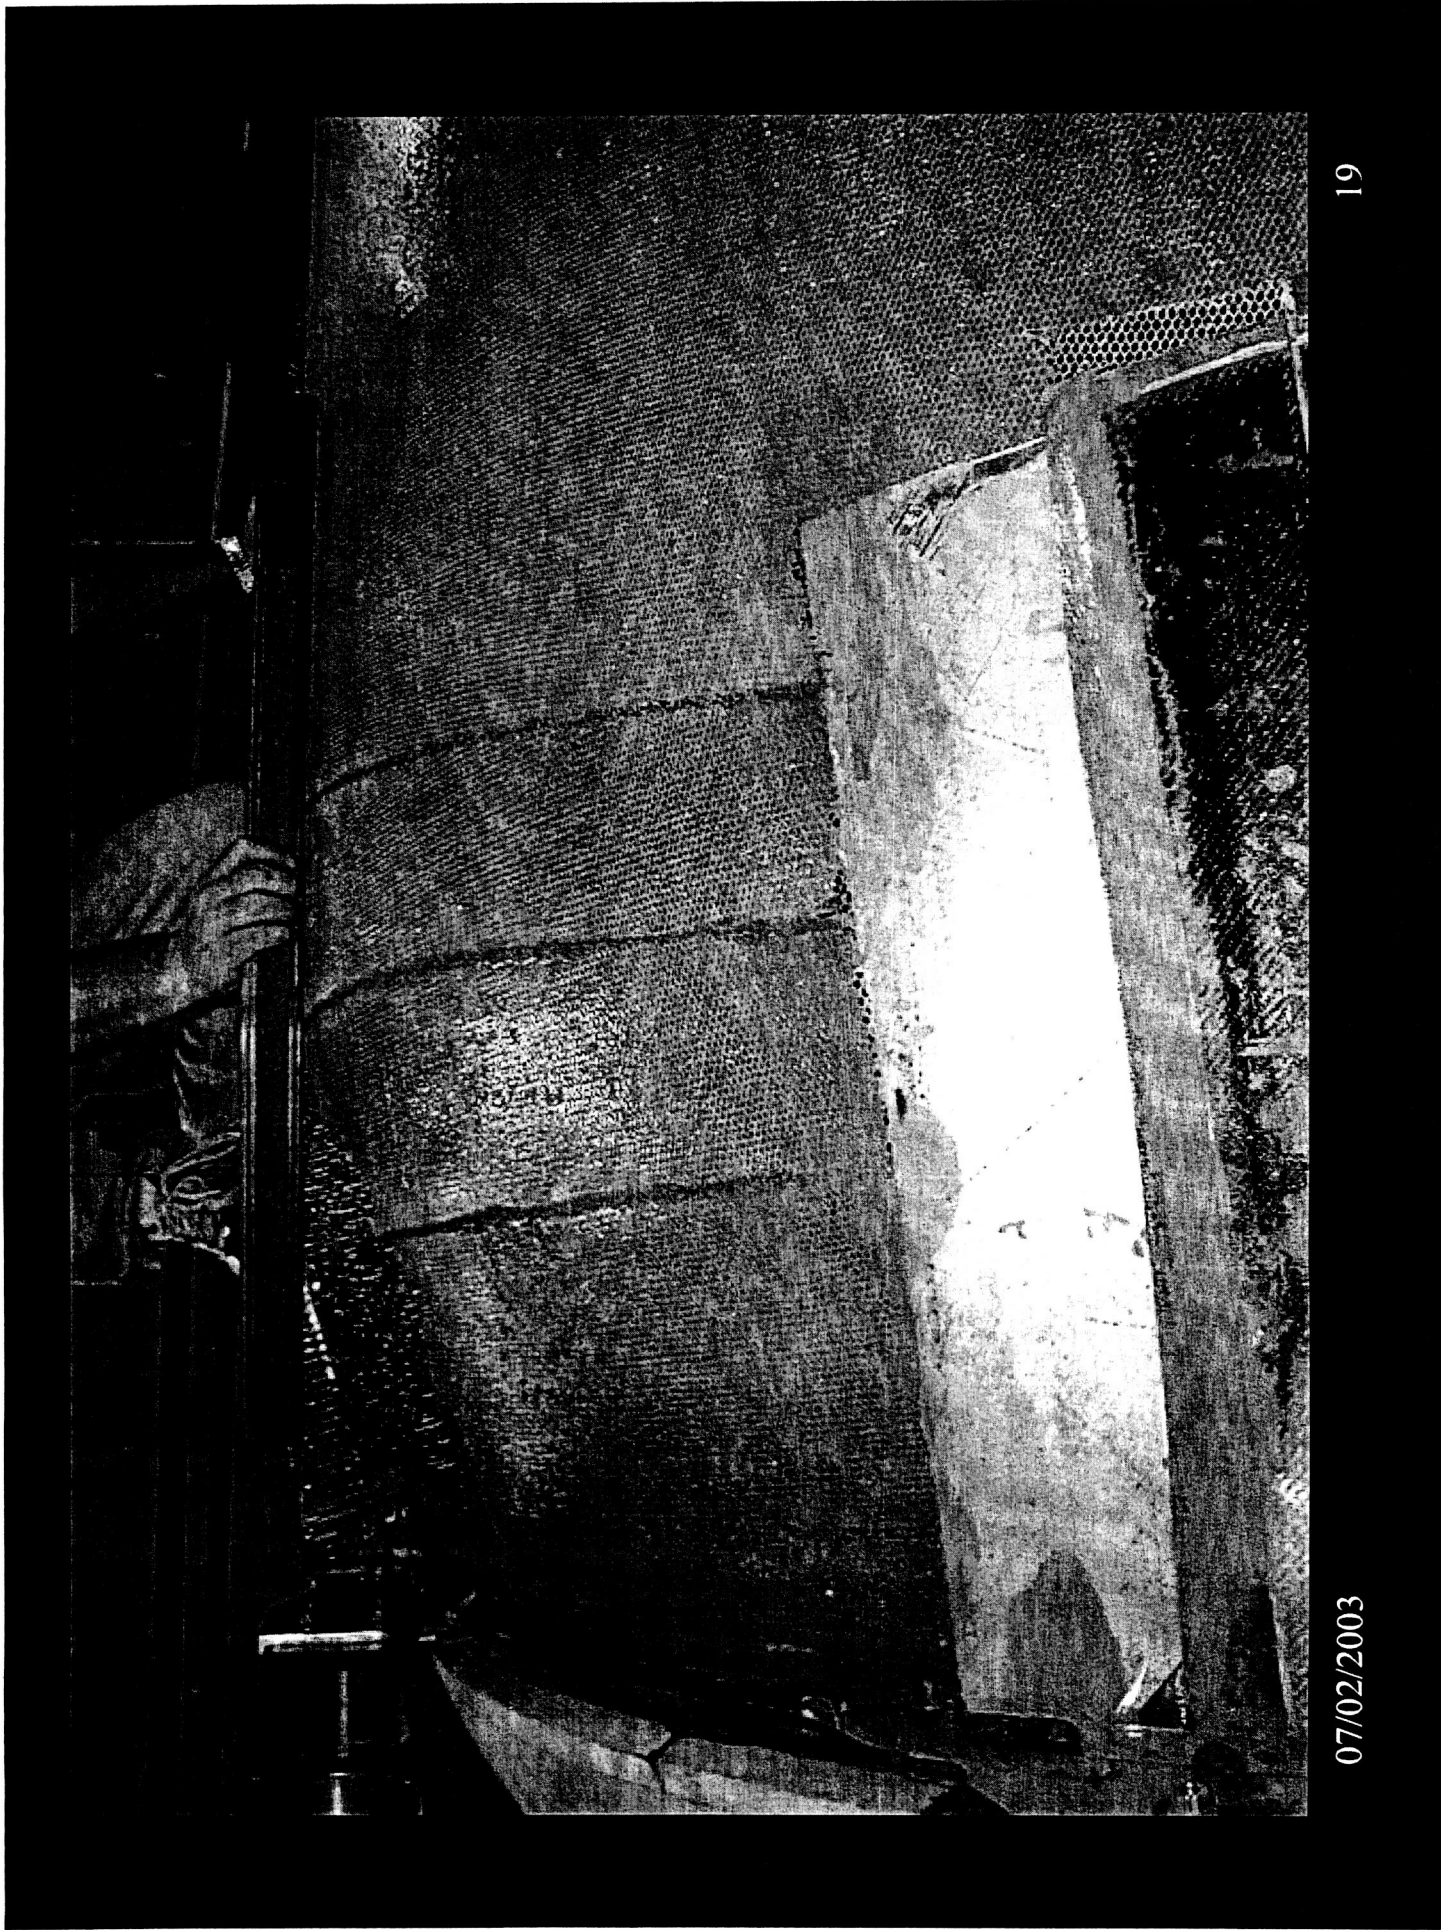
- **Peel Failure**
- **Outer skin and core peeled away from inner skin**
- **Core Failure**
 - **Core is 'mangled'**
- **Hydraulic fluid on test article**
- **Foreign Object Debris (FOD)**
- **Poor bondlines**
- **Pressure in core above ambient 13 hours after failure**

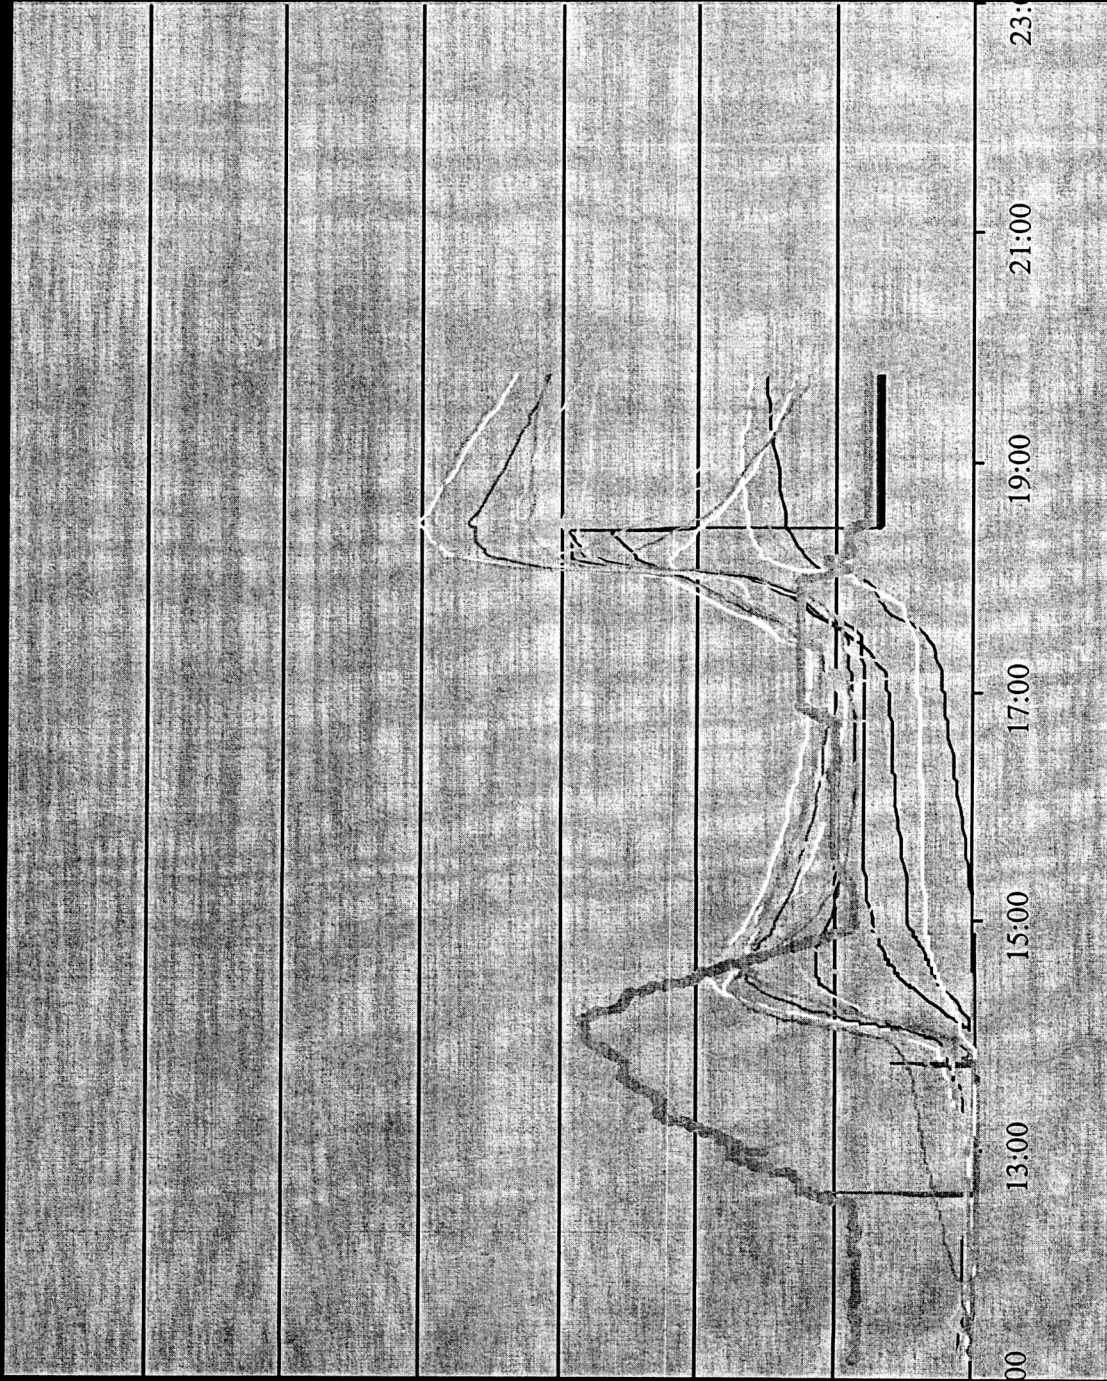
Core Pressure vs Time

- Core pressures behaved unexpectedly
- Microcracking

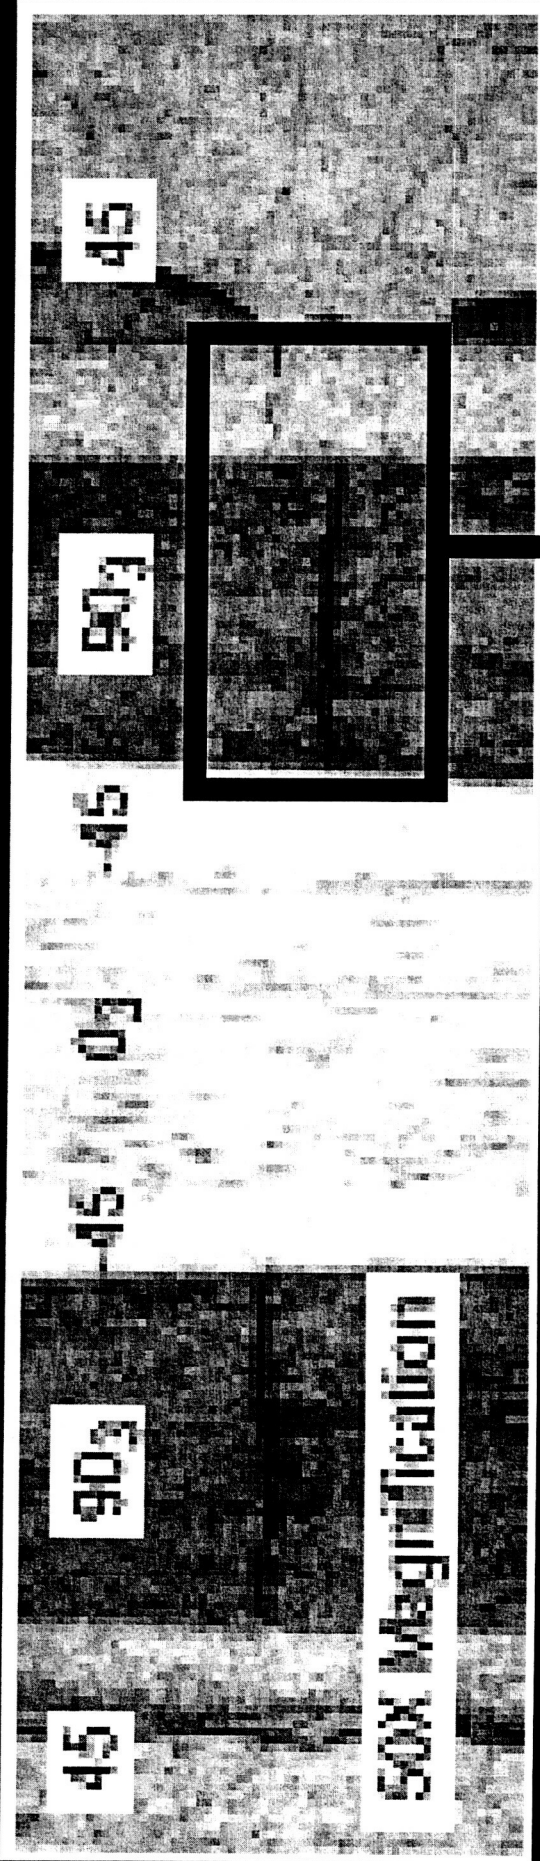
200X Magnification

- The inner skin microcracked and hydrogen infiltrated
- The cracks grew larger under pressure
- When pressure was removed cracks closed slightly
- When tank was drained and warmed, cracks closed and blocked leak path
- FOD and debond areas provided an opportunity for a leak path
- There is still hydrogen in the other 3 lobes today
