# COLUMBIA

## ACCIDENT INVESTIGATION BOARD

REPORT VOLUME IV  
OCTOBER 2003

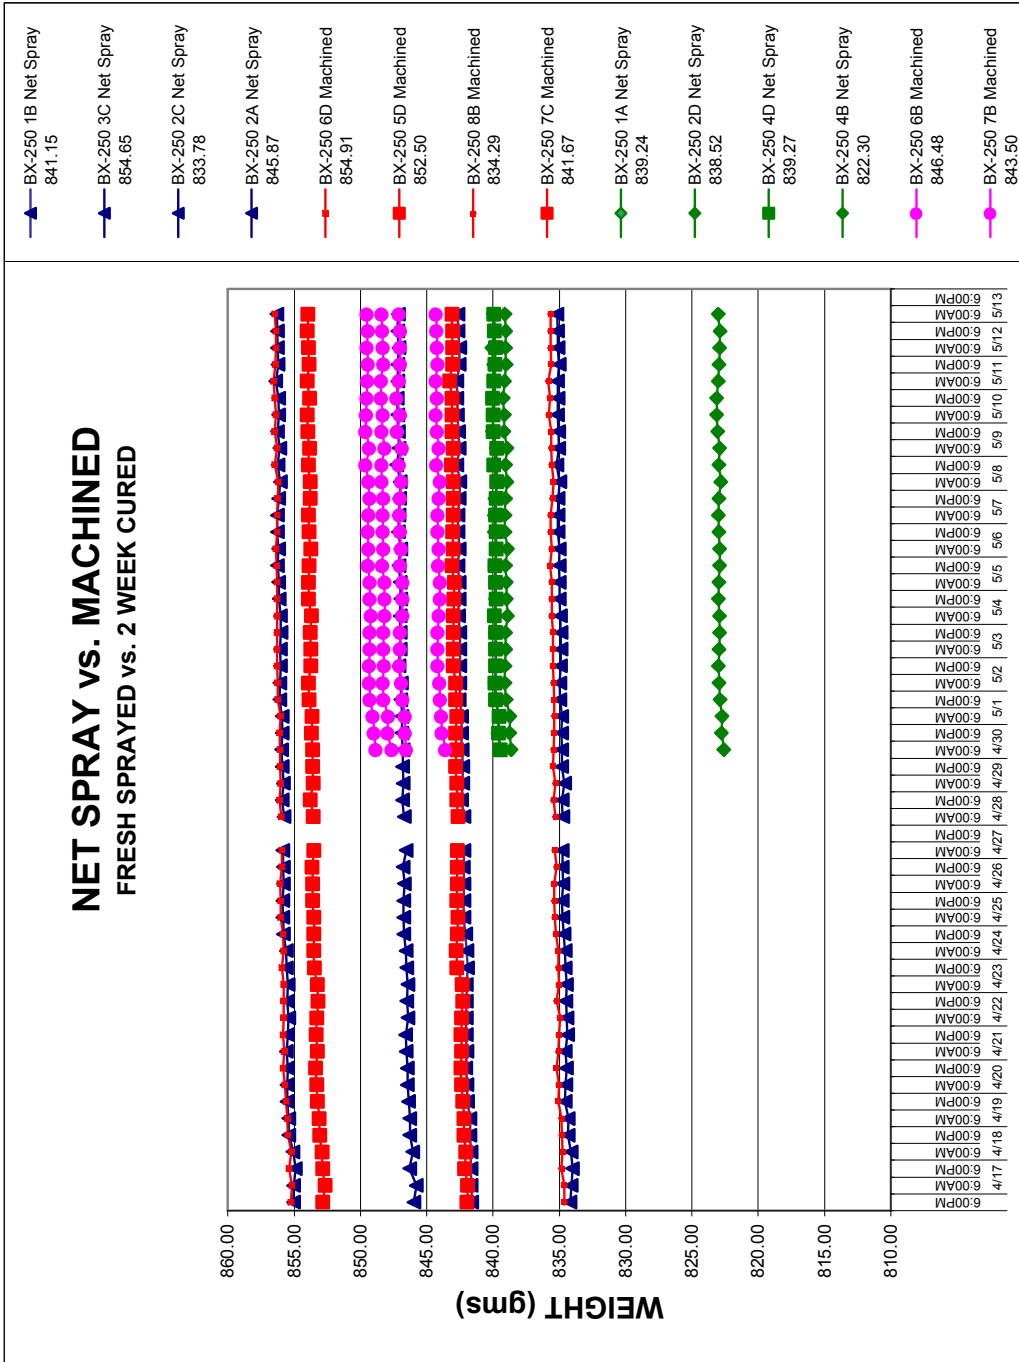
Figure 4. Accelerated Moisture Conditioning (32 °F/76% RH)

- Conclusions:
    - Data confounded by the measurement of combined mass of aluminum substrate and foam
    - Approximately no absorption observed in 32 °F/76% RH conditioning for both just-sprayed and two-week cured materials. See [Figure 4](#).

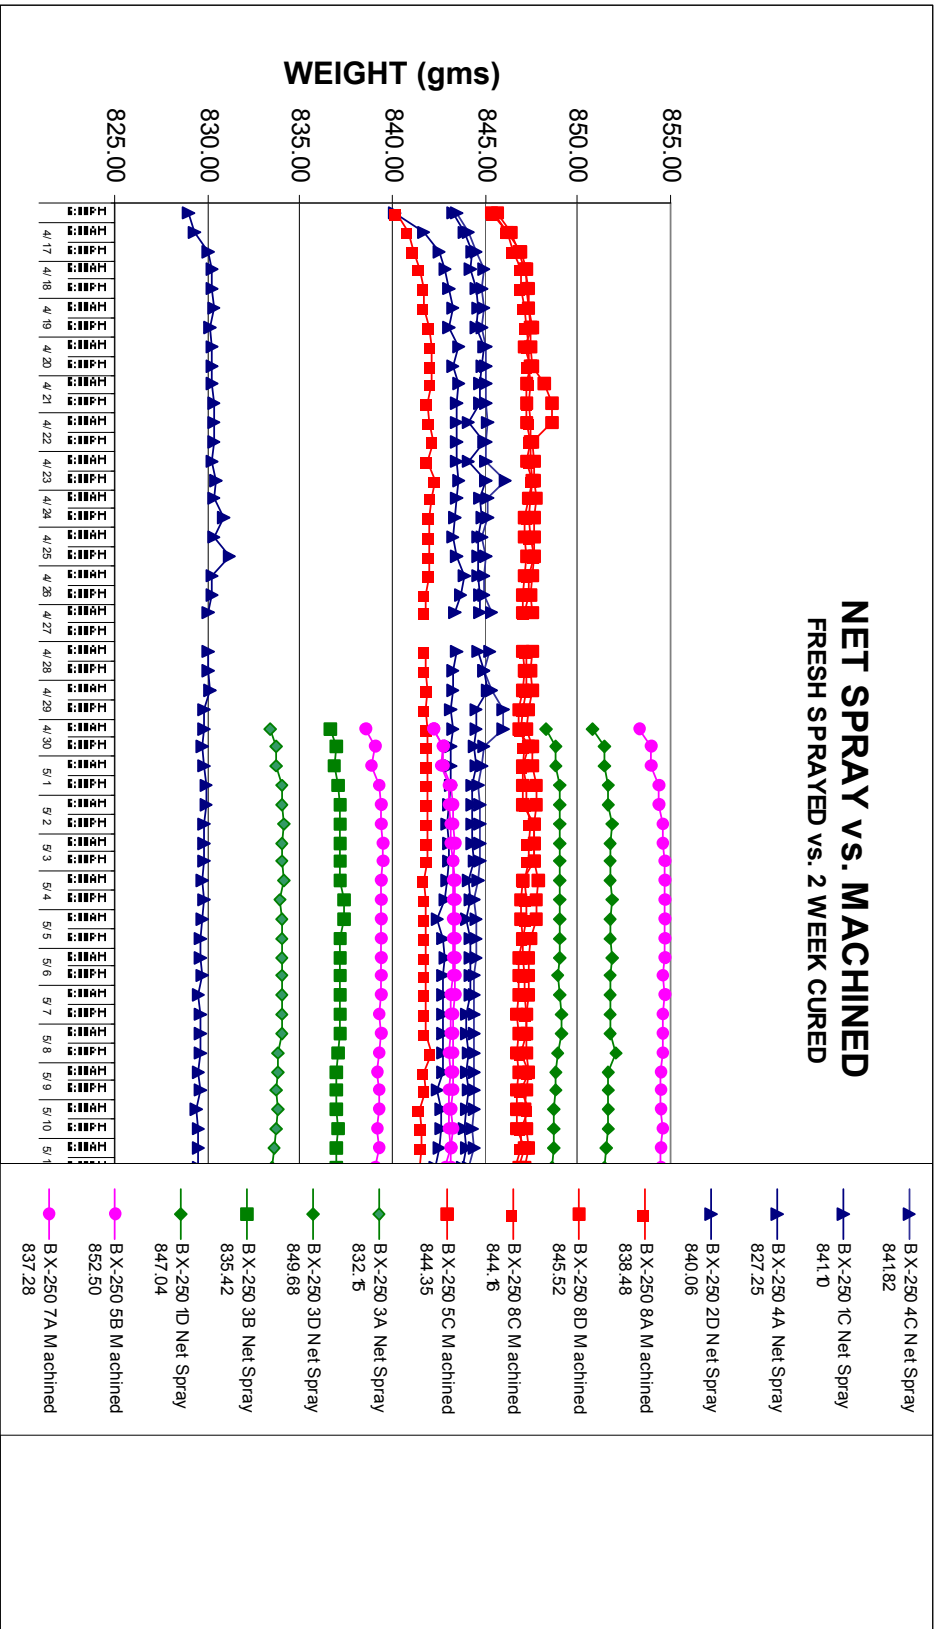
Figure 5. Accelerated Moisture Conditioning (120 °F/98% RH)

- Just-sprayed material arrived to maximum moisture absorption in 48 hours in 120 °F/93% RH conditioning. See [Figure 5](#).
    - Two-week cured material absorbed very little moisture at 120 °F/93% RH conditioning

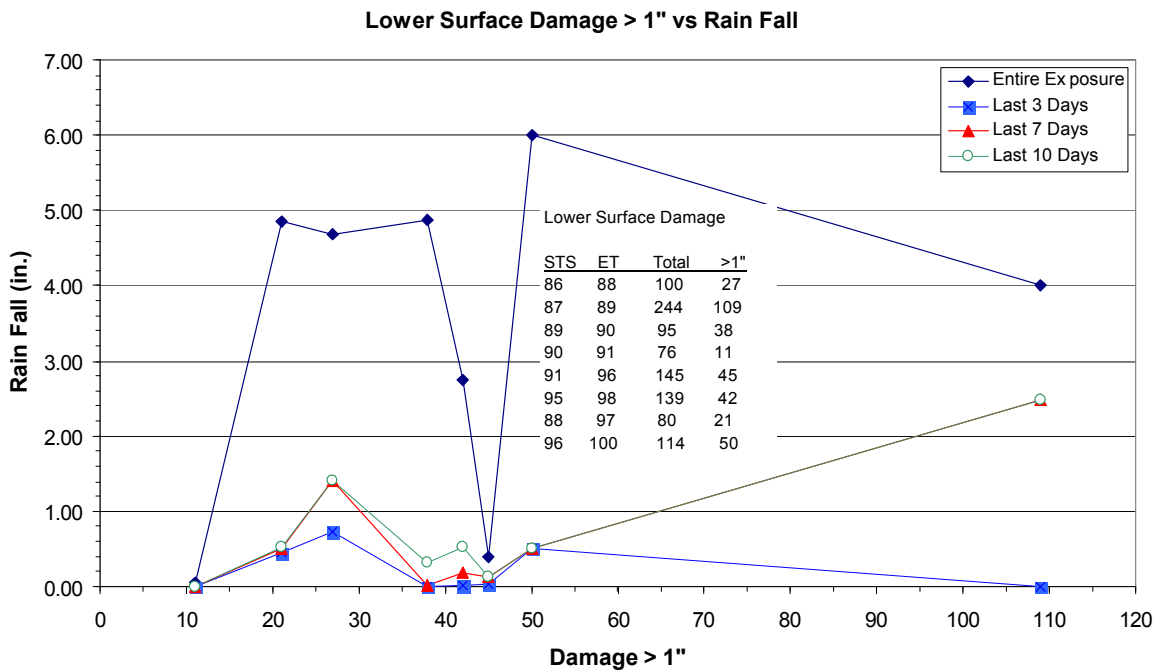
Figure 6. Correlation of On-Pad Rainfall to Orbiter Lower Surface Tile Damage.

- Date: April 1999
- Test Conductor: Chris Bourgeois/LMC
- Scope: Analyze the correlation of on-pad rainfall to orbiter hit count to support investigation and corrective action of IFA-87.
- Conclusions:
  - Limited positive correlation between KSC Prelaunch Dew Point and Bipod foam loss from STS-108 to STS-107 (7 flights spanning 12/01 to 1/03). See [Table 2](#).
  - Limited absence of correlation between on-pad rainfall and orbiter lower-surface tile damage (>1”) from STS-86 to STS-96 (8 flights spanning 9/97 to 5/99). See [Figure 6](#).
- Reference:
  - “ET Weather Report 11”, Jeff Kolodziejczak, February 2003.
  - “KSC ET Exposure Environments”, Chris Bourgeois, April 1999.

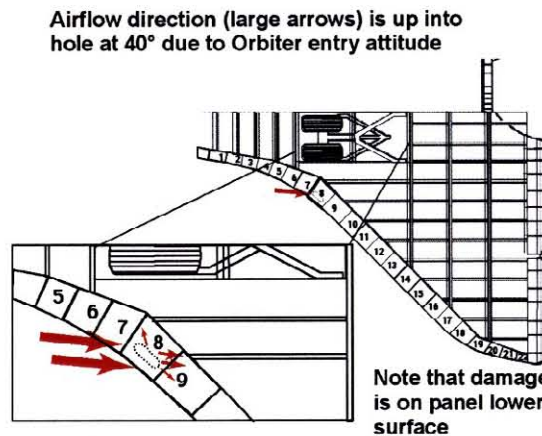
Figure 6: Hypothesized Entry Damage and Initial Entry Heating at Entry Interface.

Testing at Southwest Research Institute and associated analysis has shown (Reference 3) that a strike of debris on the RCC from the ET bipod (briefcase-sized, weighing about 1.7 lbs) striking the WLSS at speeds of 770 ft/sec can cause severe damage. Damage observed included RCC panel cracking, cracking of T-Seals, displacements of both panels and seals and the formation of holes as large as 16 inches by 16 inches.

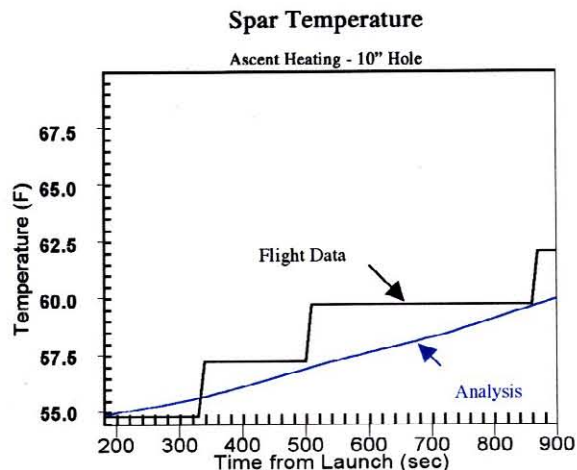
Figure 7: Data from OEX Thermocouple VO 9T9895 and Thermal Analysis by NASA (Reference 12).

One piece of evidence that corroborates that there was a breach in the wing at EI comes from the MADS/OEX thermocouple located behind the spar at the Panel 9 location. As discussed in References 4 and 12, there was “out-of-family” heating at this location during the STS 107 ascent. Figure 7 shows the time history of the measured thermocouple signal and the comparison of NASA’s thermal analysis (Reference 12) of the ascent event. As indicated on the figure, the “stepped” curve is the flight data while the blue-colored, smooth curve is the result of the NASA analysis. Note that the temperature readings are not large, owing to the facts that ascent heating is small, relative to that for entry, and that the thermocouple is behind the spar and the spar insulation. Detail of thermocouple locations will be discussed later.

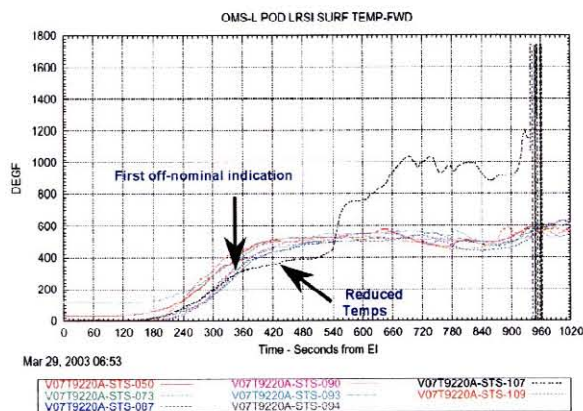
Figure 13: Off-nominal OMS Pod Temps.

Figure 13 shows temperature histories from the left-hand Orbital Maneuvering Systems (OMS) Pod. Again, data from other, similar flights is shown. As can be seen, below nominal temperatures were recorded, starting at about 340 seconds after EI. The following figure explains that this is likely due to a modification to the normal flow field by damage in the wing leading edge. Note also from this figure that at about 540 seconds from EI, the temperature abruptly increases, to values well beyond that for a normal entry.

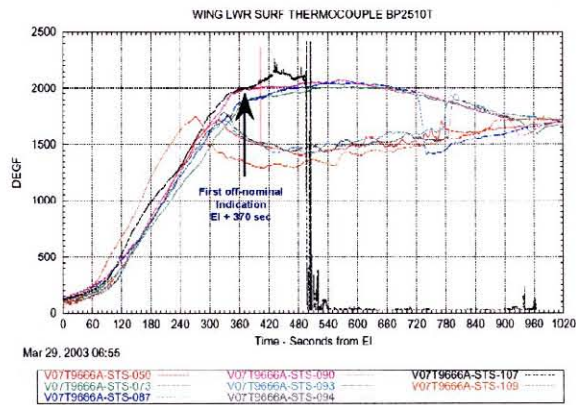
Figure 18: OEX/MADS STS-107 Flight Data.

Figure 18 displays the temperature recording from the thermocouple V07T9666A located in a lower wing tile, near the wing leading edge, behind Panel 9. This sensor location was shown above in Figures 9 and 10. As can be seen, there is an off-nominal heating trend in this thermocouple starting at EI + 370 seconds (GMT 13:50:19).

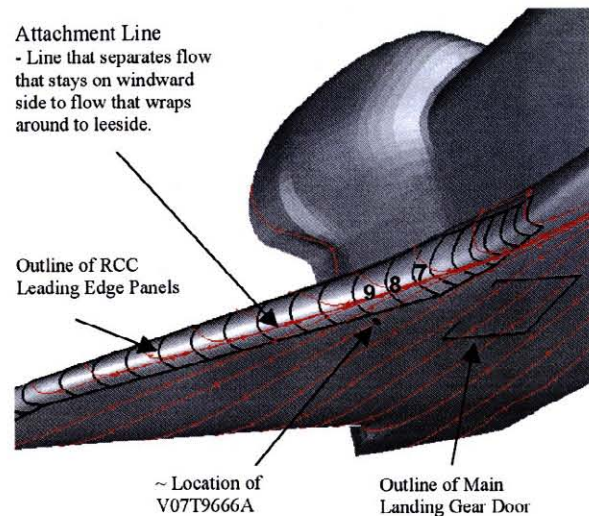
Figure 19: Orbiter Surface Streamlines. 13:50:53 (EI + 404), Mach: 24.9, Altitude: 243 k ft and Location of Thermocouple in Tile. CFD Solution from NASA (Reference 18).

As shown in Figure 19, thermocouple V07T9666A is in the flow area affected by Panel 8 (Reference 18). Specifically, as shown in the figure, the streamline, which passes over the junction of the lower Panel 8/9, also intersects the approximate location of this thermocouple. As will be discussed below, the forensic analysis shows compelling evidence that there was an outflow from the aforementioned 8/9 RCC lower panel junction that probably caused the above nominal readings of V07T9666A that started at EI + 370 seconds and continued till the spar breach occurred. This CFD solution by Gnoffo, Alter and Thompson (Reference 18), was the starting point of studies of flow into the breach, as will be discussed below.

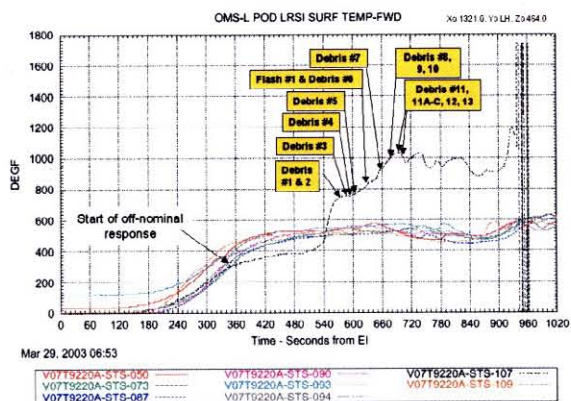
Figure 24: Left OMS Surface Temp Response Indicating the Progression of Damage.

Figure 24 displays the time history of thermocouple V07T9220A located on the OMS Pod. The observation made by NASA (Reference 16) is that from 13:53:29 -> 13:55:29 (EI + 560 -> 680 seconds), there are continual off-nominal increases in OMS Pod temperatures that correlates with the timing of debris sightings 1-13 during the flight. This correlation clearly suggests increasing damage is occurring to the left wing, specifically to the TPS and its substructure.

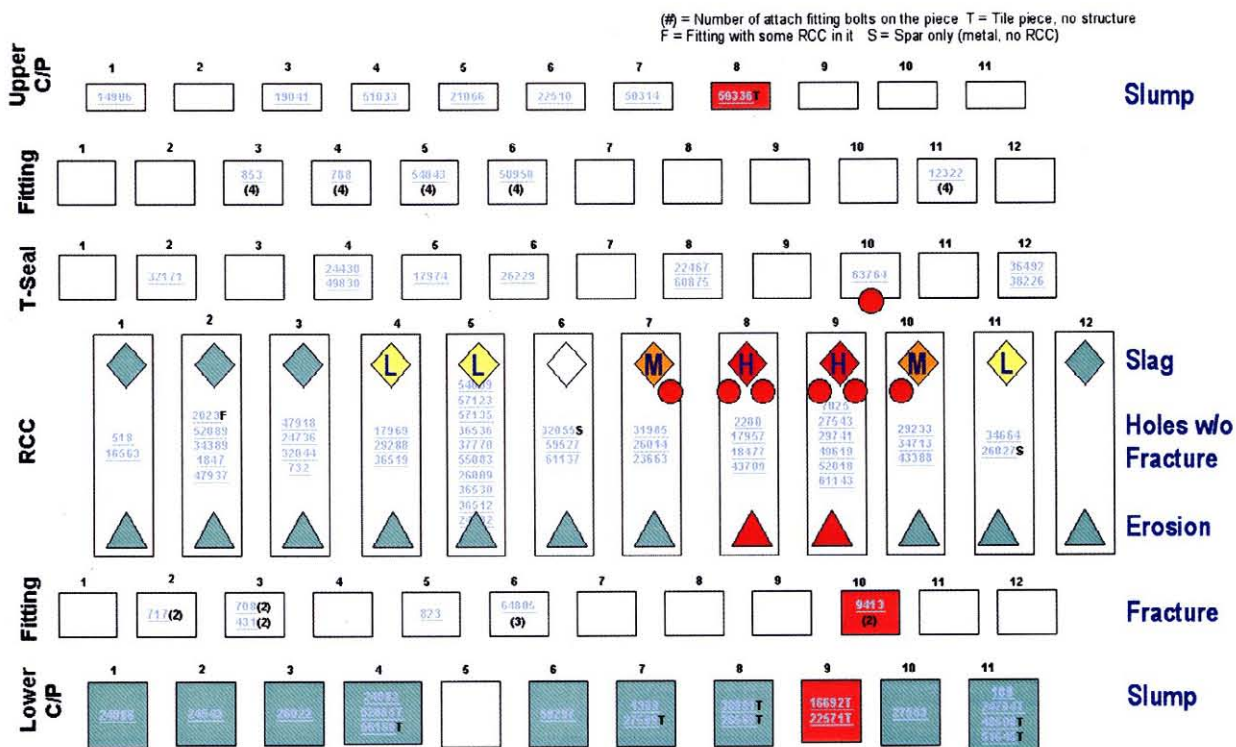
For "Slag" the diamond symbol was used: Red (H) means heavy slag, Orange (M) means medium slag, Yellow (L) means light slag, Green (no letter) means none or very light slag. "Holes without fractures" refers to the unbroken holes in the RCC, interpreted as evidence that the Inconel fasteners melted out. Here, red circles indicate that prolonged heating occurred. Red triangles depict significant RCC erosion. Green triangles indicate no RCC erosion. "Fractures" indicate the possible evidence of hot-shortcracking of the A286 carrier panel attach bolts (as evidenced by intergranular fracture) as an indicator of prolonged high temperature exposure (Reference 20/Appendix, by L. Korb). The red square represents the only such finding among these debris.

Figure 27: Left Hand Wing Debris Points to Breach in RCC Panel 8/9 Area (Reference 20).

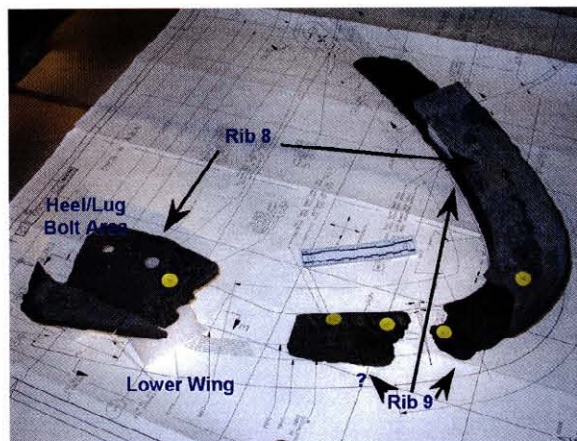
Figure 28: RCC Panel 8/9 Ribs (Outboard View).

The photograph in Figure 28 is an outboard view of recovered parts of RCC ribs from Panels 8 and 9. For perspective, four recovered parts of the outboard rib of Panel 8 are shown sitting on white foam blocks: one upper part of rib 8, and three parts from the lower part of the rib 8 heel/lug bolt area. Two recovered parts from the inboard, upper rib of Panel 9 are shown laying on their full-scale drawing. A third part, placed on the drawing, not identifiable, is likely also from the inboard rib 9 in the location shown. Lack of positive identification of this part is indicated by the ? mark written on the yellow tag. These parts show heavy ablation, and the RCC LW LESS Panel 8/9 area is the only location found with this feature. Ablation features are labeled using yellow tags with the letter "A." The ablation patterns facing the camera on this side of the rib parts strongly suggests that superheated air had been flowing inside the wing, in a generally outboard direction. This indicates significant and prolonged flow from the Panel 8 area into the Panel 9 and outboard regions of the wing inside the RCC-LESS channel. Edges of the ribs are sharpened to a near "knife-edge" (0.05 inches compared to undamaged thickness of 0.365 inches), with a flat side away from the flow direction. Because of the durability of RCC and the extent of the ablation, this flow probably was sustained inside the RCC-LESS cavity area for hundreds of seconds. This type of damage is the result of oxidation (ablation) of the RCC carbon substrate. The following figure shows the same parts from an inboard view.

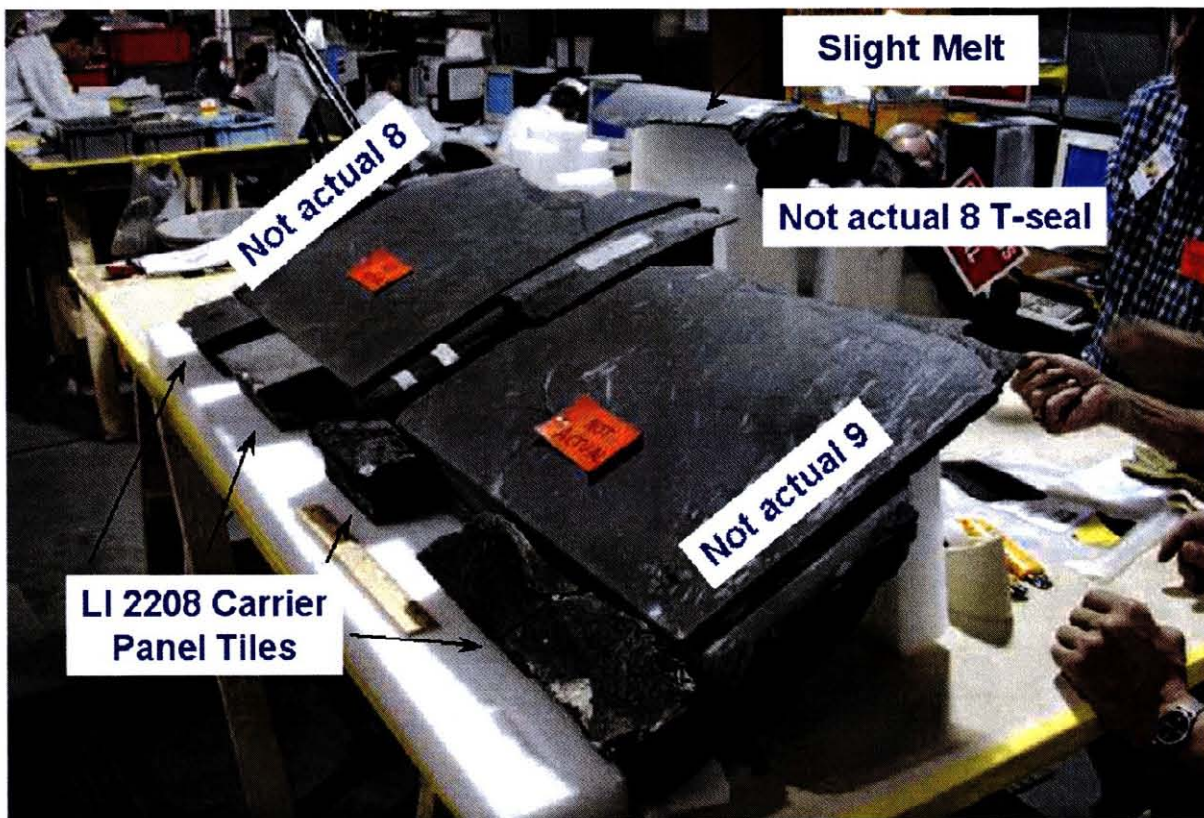
Figure 30: Reconstructed RCC Panel 8/9 Area.

As discussed earlier in describing Figure 19, streamline patterns determined by CFD show that flow out of this lower RCC Panel 8/9 juncture area directly affect the thermocouple V07T9666A, located in the lower tile field, close behind RCC Panel 9. This flow relationship, strongly suggests the above nominal temperatures recorded by this thermocouple were caused by the flow out of the lower Panel 8/9 juncture, which also eroded the lower Panel 9 carrier panel tiles. The flow out of this slot, into a relatively high-pressure area (but below the pressure at the inlet breach) was probably the only outlet available to the large volume of ingested gases once the flow-through of the RCC vent slots was choked. The traces in Figure 18 suggest that this started at EI + 370 seconds and persisted until spar burn-through at approximately EI + 487 seconds.

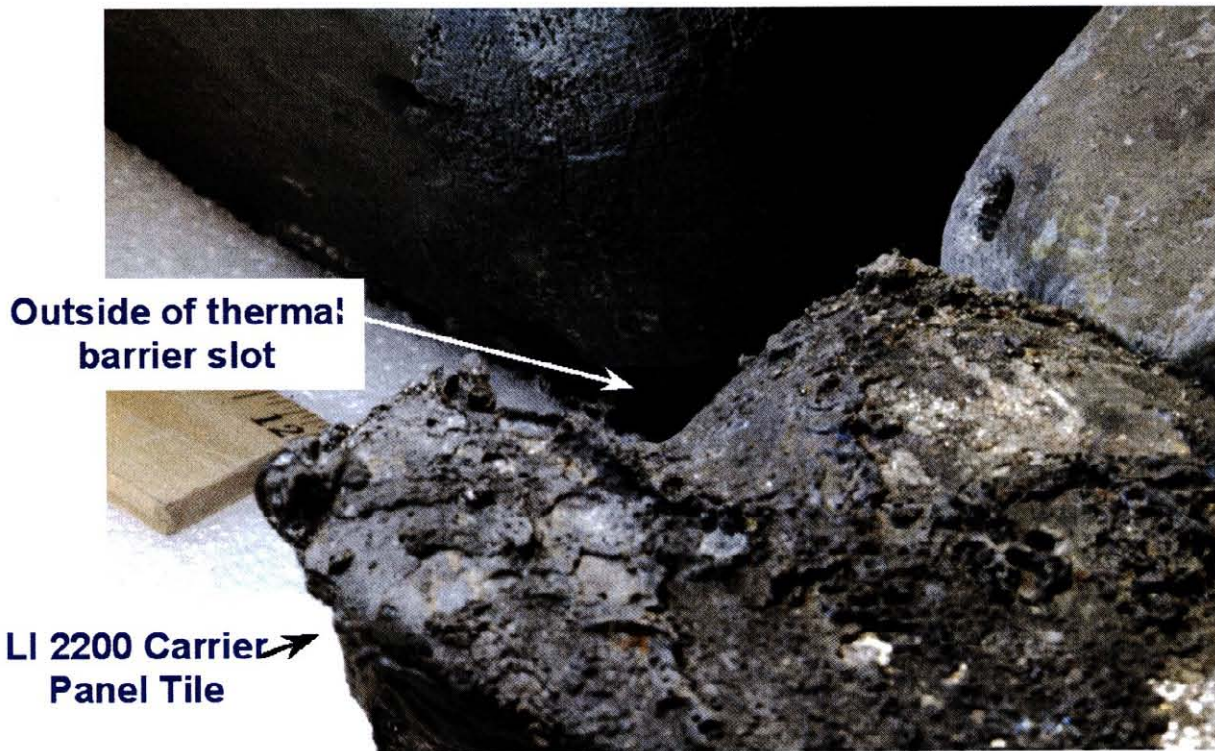
Figure 31: Close-up of Flow Location Affecting Panel 9 Carrier Panel Tiles

The authors believe that in addition to a breach in Panel 8, the upper part of the T-seal between Panels 8 and 9 must have been missing or severely misaligned for a major part of the entry. This is required to account for the severe erosion of the upper RCC Panel 8 outboard and Panel 9 inboard ribs shown in Figures 28 and 29 and discussed above. Flow patterns of the recovered upper Panel 8, suggest this happened as discussed in Reference 20.

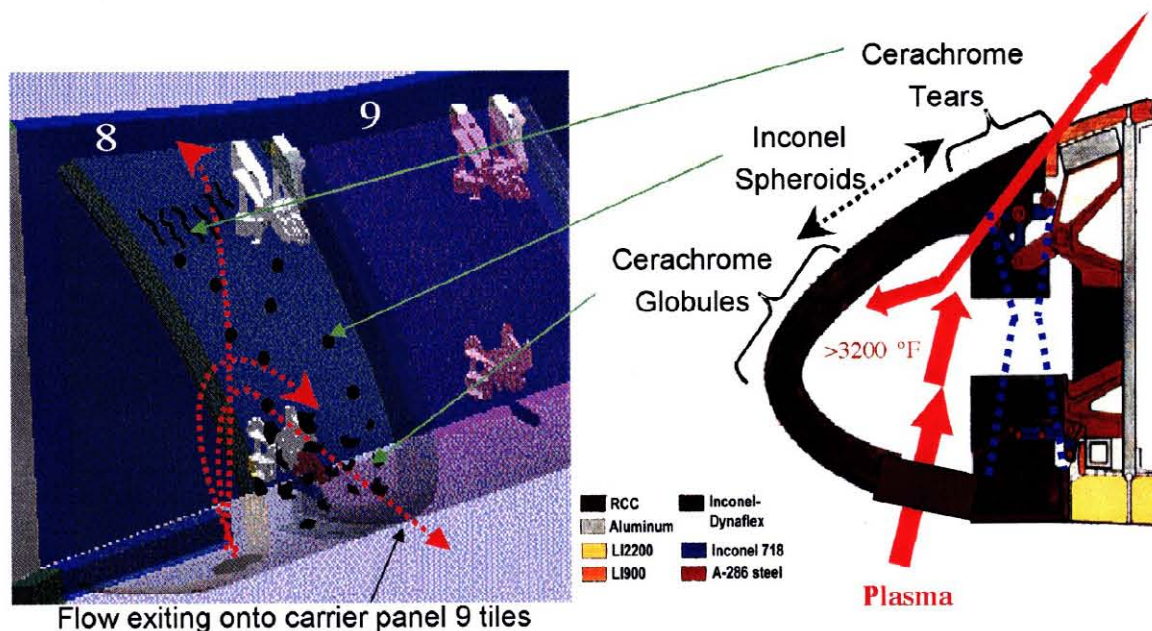
Figure 34: Wing Leading Edge Chemical Analysis of Panel 8 (Reference 20).

Finally, it is noted in Reference 13 that all other recovered RCC panels on both wings have a generally uniform and thin slag layer. All analyzed slag layers show a uniform mix of aluminum, Inconel and cerachrome suggesting short exposure to superheated air and uniform melting of WLESS components.

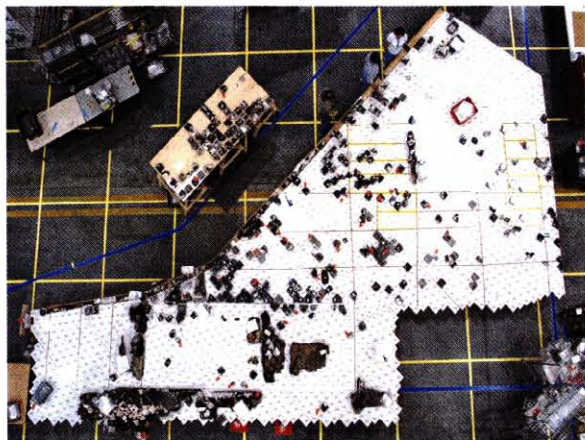
Figure 35: Overview of Tile Table. Left Wing, Lower Surface Tiles.

There is a distinct pattern of RCG coated tiles, in the general X-direction downstream of Panels 8 and 9, outboard of the wheel well where the tiles appear to have little of the dark metal deposit (aluminum - rich) generally seen on the recovered tiles. These normal-appearing tiles all have been identified to have failure at the tile/Koropon bond line and departed from the wing surface prior to a major outflow of molten aluminum. This is indicative of extreme heat, inside the wing behind Panel 8. It then seems probable from this observation that the breach in the wing spar occurred at the Panel 8 location, and this is consistent with the observations discussed above. Ballistic analyses of the trajectories and the geographic location of the recovered tiles (both those detached owing to bond failure and those that did not) suggest they came off from about 100 nautical miles west of their recovery location in Texas.

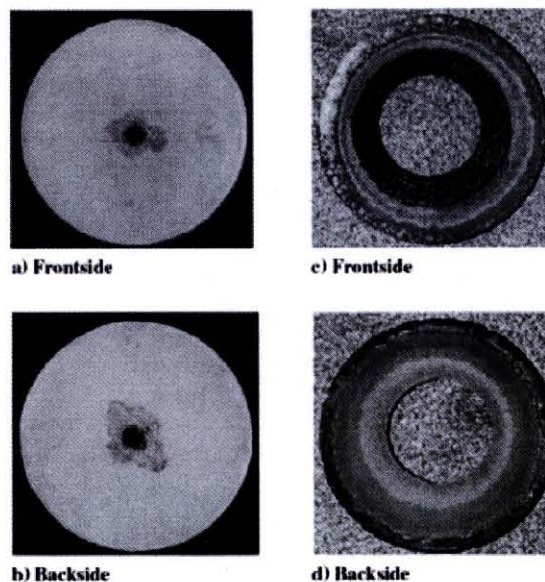
Figure 41: NASA/JSC Model Number 1151, Pre and Post Arc Jet Exposure at 2800 °F and 100 psf, 450 Second Exposure. (Reference 5).

Figure 41 displays photographs of test article number 1151, pre and post test. The temperature of exposed carbon at the SiC edge reached 3,250 °F +. For this test condition (2800 °F and 100 psf), there was significant front face SiC coating erosion as shown in Figures 41 c) and d). Curry, et. al., noted that in general, the front face of the damaged region grew faster than the backside of the specimen, resulting in a conical, or “sharpened shape,” typical of all of their testing at a nominal temperature of 2800 °F.

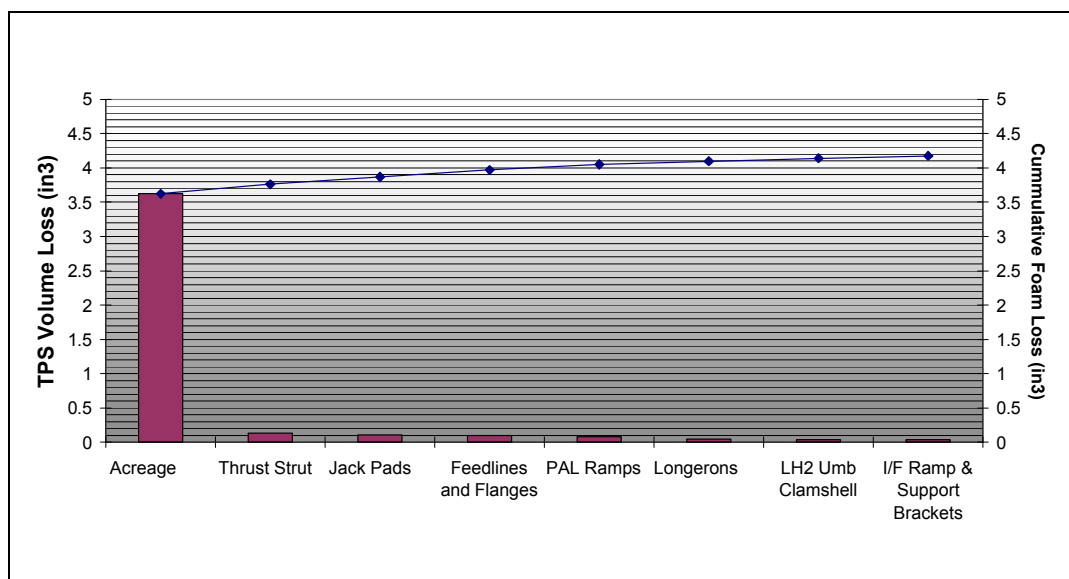
*Figure 5.3.2.2-1. Areas of Observed Loss*

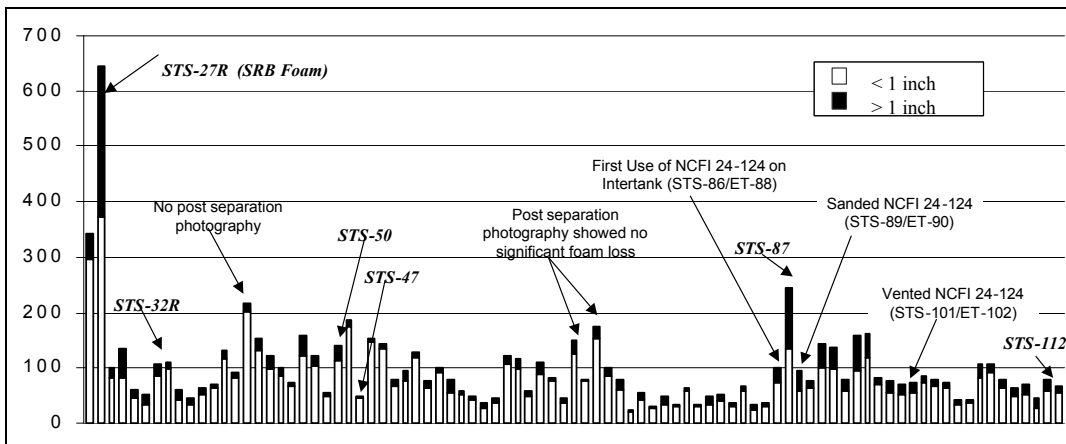
*Figure 5.3.2.2-3.a. Orbiter Tile Damage*
