Restoring Redundancy to the Wilkinson Microwave Anisotropy Probe Propulsion System

NASA Goddard Space Flight Center, Greenbelt, Maryland 20771

Abstract

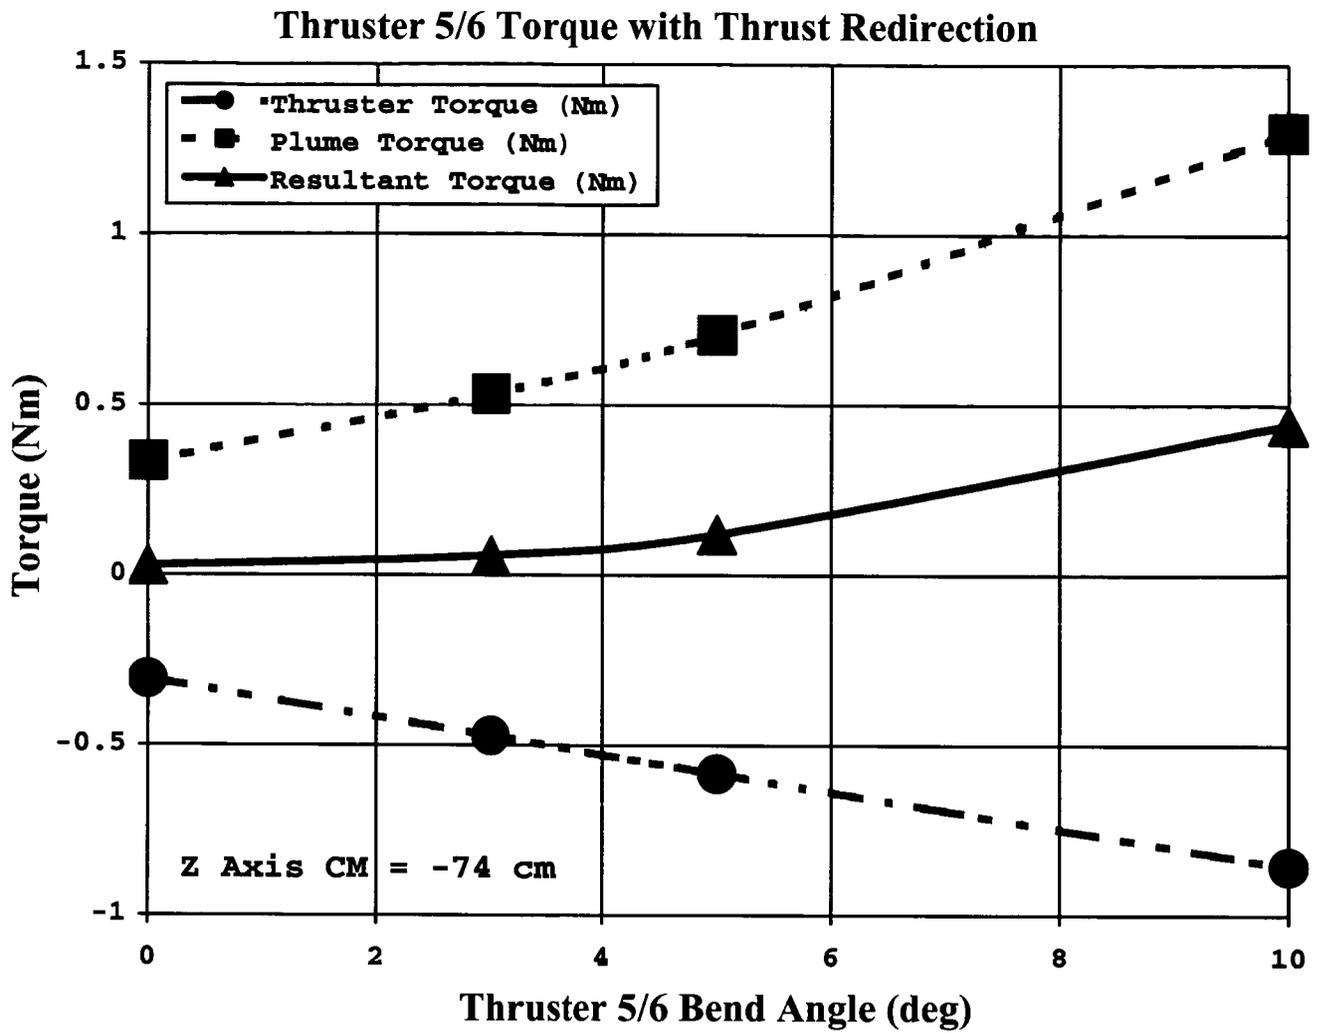
Figure 4: Results of Thruster 5/6 Bend Option

Two groups of thrusters were considered for redesign: thrusters 5–8 or thrusters 1 and 2. Because thrusters 5 and 7 share a mounting bracket, as do thrusters 6 and 8, redirecting the thrust axis of thrusters 5 and 6 might also change the thrust direction for thrusters 7 and 8. The team considered the possibility of moving or changing the cant of thrusters 5 and 6 but eliminated this option for two reasons. First, the proposed change to both thruster brackets interfered with spacecraft structural members, making the modifications nearly impossible. More importantly,

any redirection of the thrust direction for thrusters 5 and 6 in order to create a larger torque in the $-Y$ axis would also create a larger plume impingement torque in the $+Y$ axis. As shown in Fig. 4, the plume impingement torque increased faster than the torque from the redirection, eliminating any torque benefits gained by the increased moment arm relative to the CM.

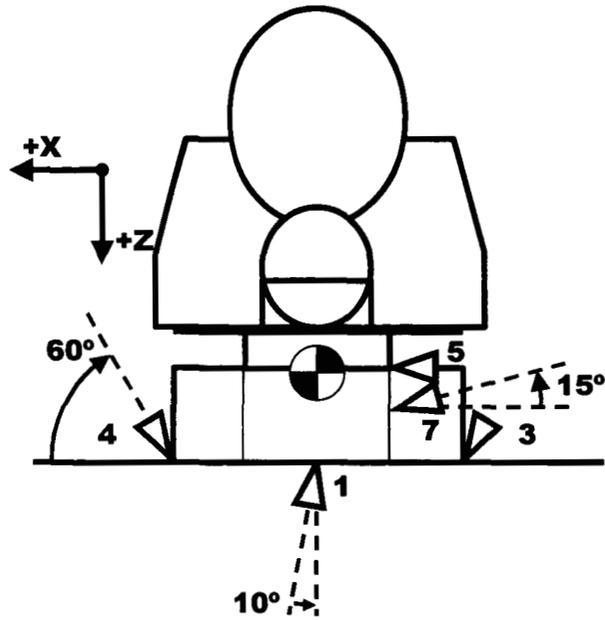
Figure 5: Thruster Layout with Thruster 1/2 Cant

With the 10 deg cant added to thrusters 1 and 2, WMAP's propulsion system had backups for any single thruster failure. Table 4 shows the primary and backup thrusters and beginning of life torques for each direction. The torque authority for each backup mode represented from 18% to 97% that of the primary, all viable and stable modes.

The final question was how to accomplish the thrust redirection. Plume-deflection shields represented the simplest, but also the least deterministic, method among the options. Bending the thruster nozzles would have introduced significant reliability and performance risks. Instead, the team opted to bend the propellant tubing upstream of the thruster. Fig. 5 shows the final thruster flight configuration.

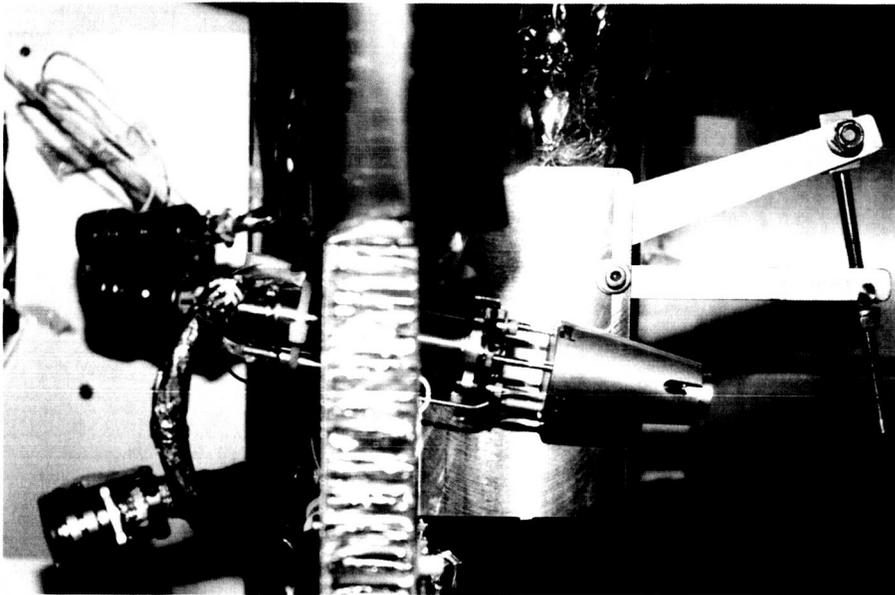
Figure 9: Thruster and Bend Tool After Bending

The new thruster brackets incorporating the 10 deg thruster orientation were then installed. The thruster orientations were re-verified with the alignment mirrors. No additional adjustments were needed. Fig. 8 and Fig. 9 show thruster photographs before and after the bend (the pictures were taken from slightly different angles, but the bend is clearly shown.)

Mirrors were installed on the thruster nozzles and optical theodolite measurements taken while the flight bends were performed. The theodolites measured the orientation of the nozzles before the bend and at several points during the bend until the desired angular change was met. Since the tool was reversible to accommodate thruster 1 or 2, four engineers verified that the thruster was going to be bent in the correct direction before the bending commenced. Thruster 1 was bent in four steps; the desired angular change from its starting orientation was 9.074 ± 0.5 deg and its actual change was 9.605 deg (slightly out of the desired tolerance, but acceptable). Thruster 2 was bent in 5 steps; the desired angular change was 10.0 ± 0.5 deg and its actual change was 9.557 deg.
