BEHAVIOR OF COMPRESSION-LOADED COMPOSITE PANELS WITH STRINGER TERMINATIONS AND IMPACT DAMAGE

Dawn C. Jegley
NASA Langley Research Center
Hampton, VA

AIAA Paper No. 98-1785-CP
Long Beach, California

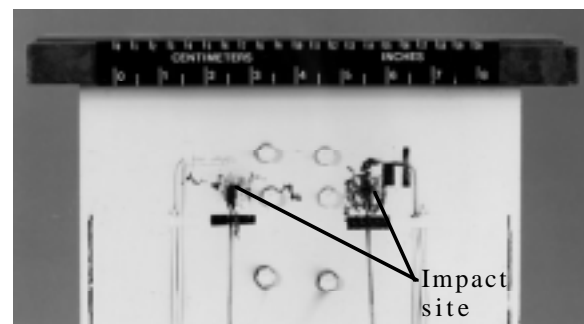
(a) Panel U-2

Panel U-2 was initially loaded to 83,000 lb. The panel was not damaged during the initial loading. The panel was unloaded and subjected to a dropped-weight impact and a static indentation which resulted in two damage sites, each with dent depths of approximately 0.15 inches. The resulting damage was clearly visible. Descriptions of the damage are presented in Table 1 and a photograph of the damage is shown in figure 5.

Panel	Method of damage	Damage depth, in.	Damage size, in.
Single-stringer			
U-1	none	-	-
U-2	static indentation	.155	3.8 x 2.2
	dropped weight (multiple impacts)	.155	2.0 x 0.9
Multi-stringer			
L-1	dropped weight (multiple impacts)	.163	5.2 x 3.0
L-2	dropped weight (multiple impacts)	.108	4.0 x 2.1
L-3	dropped weight 100 ft-lb	~0	~0

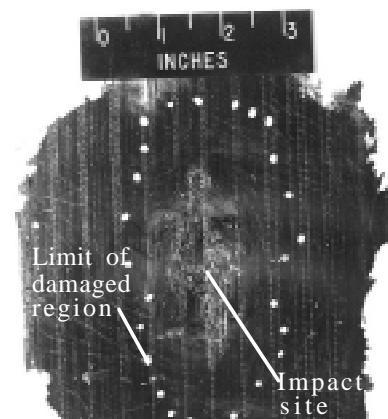
(b) Panel L-1

Panel L-1 was subjected to severe impact damage resulting in an indentation with a depth of 0.16 inches. The criterion of allowable strain at the reference surface of .0053 in/in. and the criterion described in reference 4

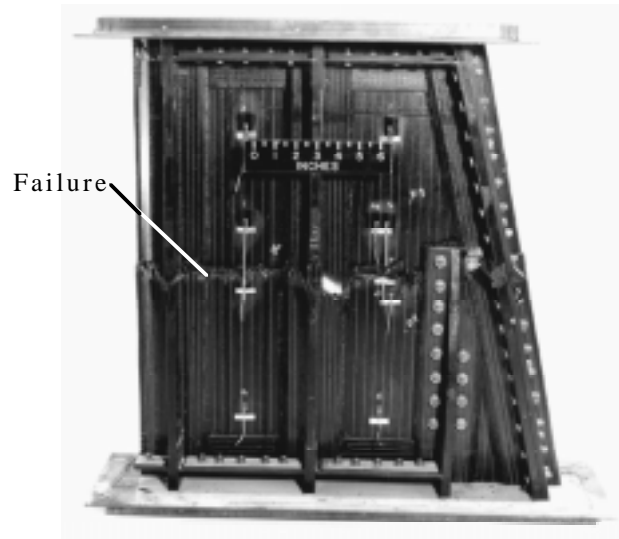
Figure 15. Failed panel L-1.

Panel L-1 failed through the impact site and the point of maximum strain in an undamaged skin with a load of 435,000 lb, and with damage 1.6 times as severe as required by the criterion. The panel failed with a stress at the impact site of 35.2 ksi, which is approximately 89 percent of the design stress. An undamaged panel would have had a strain of approximately .0037 in/in. at the impact site for the load at which the damaged panel failed. The maximum midplane strain (based on the measured surface strains) near the impact site was equal to .0052 in/in. The predicted maximum strain in the panel away from the impact site is equal to .0043 in/in., which is significantly less than the allowable strain in undamaged structure. These results indicate that failure was caused by the strain in the region of the impact site. A photograph of panel L-1 after failure is shown in figure 15.
