GT2004-53970

CERAMIC MATRIX COMPOSITE VANE SUBELEMENT TESTING IN A GAS TURBINE ENVIRONMENT

Michael Verrilli and Anthony Calomino
NASA Glenn Research Center, Cleveland, Ohio, USA

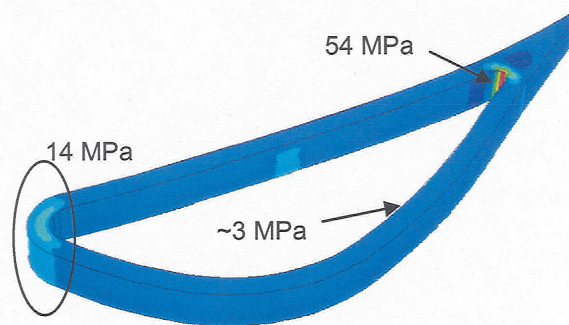
Figure 7 - Interlaminar tensile stresses predicted for the SiC/SiC vane subelement during rig testing.

model including cooling holes is currently being analyzed. The CFD analysis for a cascade of blades was performed using a two-dimensional Euler (i.e., inviscid flow) equation solver. Local pressure and velocity results were used to determine heat transfer coefficients for the vanes exterior surface. Internal cooling of the vane was modeled as constant 93°C air flowing axially through the vane cavity at a rate of 0.15 kg/sec. The convection coefficient was modeled as turbulent flow through a non-circular tube. The predicted maximum temperature (1190 °C) was within the material capabilities based on coupon rupture life (~1300 °C). Calculated in-plane tensile stresses were low (maximum axial stress of 27 MPa and maximum transverse or “hoop” stress of 105 MPa), but the interlaminar tensile (ILT) stresses predicted were found to be high enough to be of concern. ILT values in the leading edge (14 MPa) occur over a rather large area (see Fig. 7) and approach the flat panel measured strength value (17 MPa) for this material. In the

vane's the trailing edge, the ILT values (54 MPa) exceeded the measured strength. Figure 8 shows the approach that was used for modeling the local material orientations within the vane. For purposes of modeling, the trailing edge region was segmented into pressure side and suction side “wedges.” All elements within each wedge were assigned a material orientation aligned with the plane of the segments outer surface. This closely approximates the actual architecture within the Y-cloth region, however it also leads to a material property discontinuity at the inside fillet radius. As a result,

these stresses are artificially inflated in this analysis. Considering this in combination with the facts that the stress is very localized and that the vane's y-cloth architecture provides through thickness fiber reinforcement at the trailing edge, these trailing edge stresses were considered less of a concern than those at the leading edge.

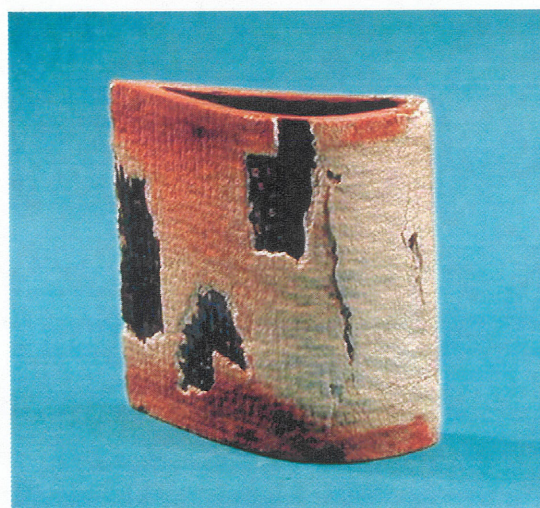
Figure 11 – SiC/SiC vane (number 909) after inadvertent water exposure followed by rig testing for 3.5 hours.

The rig was disassembled to inspect the test section after completion of 50 hours of testing. Water was found in the test section. One of the water-cooled thermocouples downstream of the test section was found to have leaked prior to the beginning of the last 3.5 hours of testing. This led to the accumulation of water in the test section between rig runs. During this period of time, the SiC/SiC vane absorbed some of this water. Upon restarting the test, the absorbed water vaporized, producing spallation damage (Figure 11). About 26% of the total coating surface area had spalled. NDE inspection via computed tomography revealed regions of spalled surface composite ply as well.

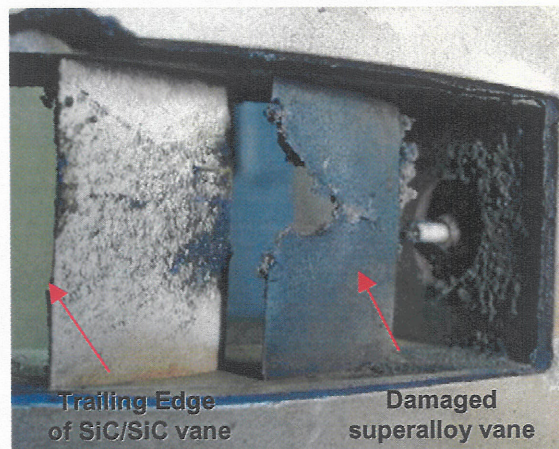
Figure 13 – SiC/SiC (number 910) and superalloy vane subelements after the cyclic testing.

Inspection of the test section after 102 thermal cycles revealed considerable damage of the test section metal hardware. Melting of the superalloy vanes occurred, as well as other test section metal hardware. The SiC/SiC vane subelement was intact but had deposits on the EBC surface (Fig. 13). X-ray diffraction revealed evidence of the Co-based Haynes 188 vane on the suction side of the SiC/SiC vanes, (which can be seen in Fig. 12) and deposits of Ni-based Waspaloy on the pressure side. Note that both these alloys melt above 1400 °C. Using the computed tomography NDE technique, no damage of this SiC/SiC vane was found.

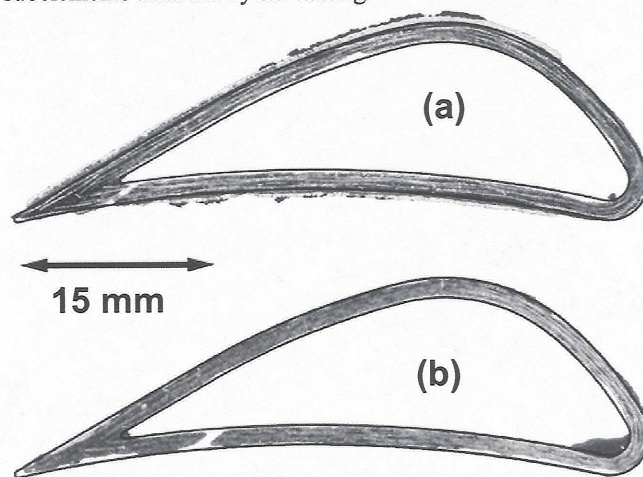
Figure 14 – Cross sections of SiC/SiC vanes after rig testing, (a) vane 910 tested under cyclic conditions, (b) vane 909 tested under steady state conditions.

The cross sections of both vanes are shown in Figure 14. Engineering drawings of the inside and outside vane nominal profile are superimposed over the micrographs of the vanes. Both vanes retained their shape even after exposure to severe test conditions. Cooling holes can be seen near the trailing edges of both vanes, and excess matrix is evident near the leading edge of vane 909, on the inside surface.

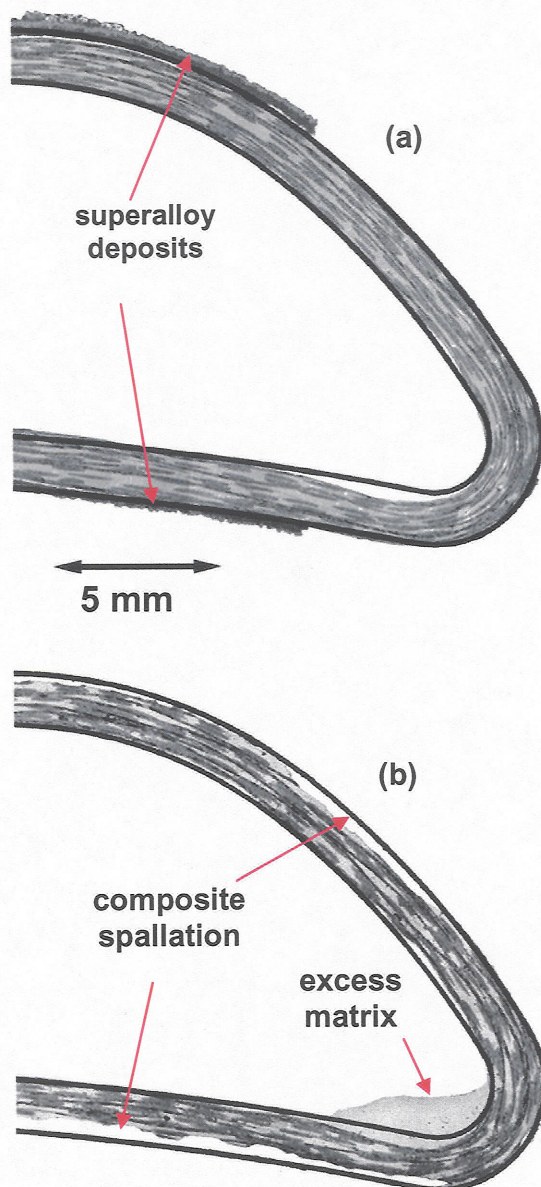
Figure 15 - Microstructure of the leading edge of SiC/SiC vane subelements after rig testing, a) vane 910 tested under cyclic conditions, (b) vane 909 tested under steady state conditions.

Since the finite element analyses predicted the highest stresses to exist in the leading and trailing edges, it is important to examine the microstructure in these regions. In Figure 15, details of the leading edges are shown. A coating of superalloy exists on vane 910 on both the pressure and suction sides. This coating starts in a location that is about 7 mm away from the leading edge (as measured along the bottom surface in the Fig. 15(a) or the pressure side of the vane). Spallation of outer composite plies exists in vane 909 at locations away from the leading edge. However, no cracks exist. In both vanes, the gap on the ID between the actual vane profile and the drawing near the leading edge are the result of the manufacturing process.

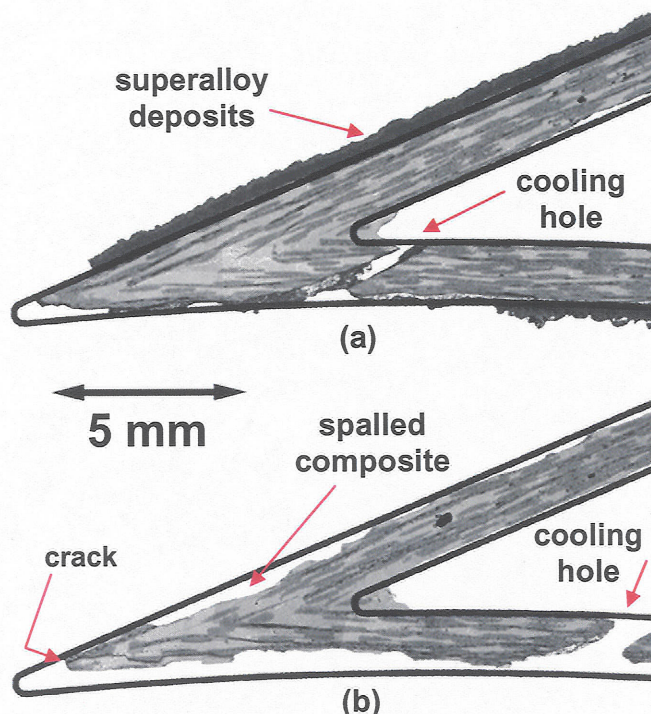
Figure 16 - Microstructure of the trailing edge of SiC/SiC vane subelements after rig testing, a) vane 910 tested under cyclic conditions, (b) vane 909 tested under steady state conditions.

Details of the trailing edge microstructures (Figure 16) revealed features similar to those seen in the leading edge. Superalloy deposits of about 0.4 mm thickness extend toward the trailing edge radius in vane 910. Composite ply spallation and a crack are visible near the trailing edge of vane 909. The outer ply is missing near the cooling hole while three outer plies spalled off in the most damaged regions. It is likely that this spallation, which occurred during rig start up, resulted in higher stresses in the trailing edge of vane 909 during subsequent rig operation, leading to the crack. In spite of this damage, the trailing edge of vane 909 remained intact. Additional microstructural analyses of both SiC/SiC vane subelements are in progress.
