# THE ROSSI X-RAY TIMING EXPLORER (XTE) SOLAR ARRAY ANOMALY

Edward M. Gaddy, Robert Kichak, and Lee Niemeyer  
Goddard Space Flight Center, Greenbelt, MD 20771

## ABSTRACT

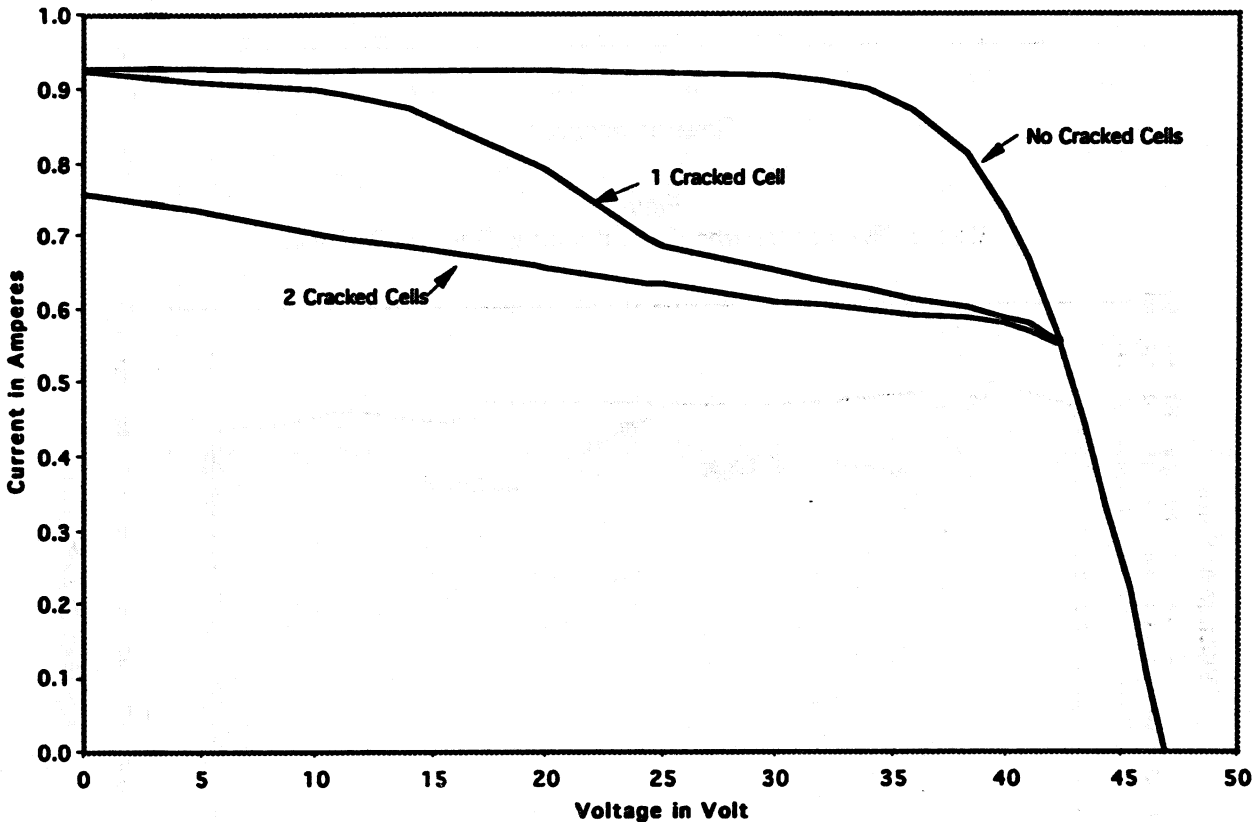
**Figure 5**  
**String Voltage Versus Current at 70C with 0, 1, and 2 Cracked Solar Cells**

Circuit four performance, and the performance of the other malfunctioning circuits, is explained by Figure 5 which shows the I-V curve of one of the circuit's strings with none, one and two cracked solar cells. Each cell is cracked such that the maximum amount of cell that can be lost is lost. The Figure was generated by measuring the reverse bias performance of the XTE solar cells, extrapolating what their current versus voltage characteristics would be with a "maximum" cell crack, and then simulating string performance. A complex example of such a "maximum" crack is shown in Figure 7. If the crack were any further to the "left" both pieces of the cell would be connected into the circuit by the parallel redundant interconnects and the cell would function as if it were in a single piece. Such a crack would have little effect on the overall output. If the crack were any further to the "right", the cell would lose somewhat less than the approximate 1/3 it loses with the worst case crack depicted in the Figure.

The decrease in current observed in circuit 4 is caused by cracks opening in one cell after another in different strings, dropping the current by about 0.3 amperes in a given string each time a cell opens. Furthermore, the effect of the cracks is not observed at short circuit current if only one cracked cell is present in a single string; but is present with two or more cracks in a string. This explains the current recovery in circuit four after it is shorted. Apparently, some of the strings have just one crack. It also explains how the current recovery is not

complete. If any of the strings in circuit four have more than two cracked solar cells, the current will not recover.

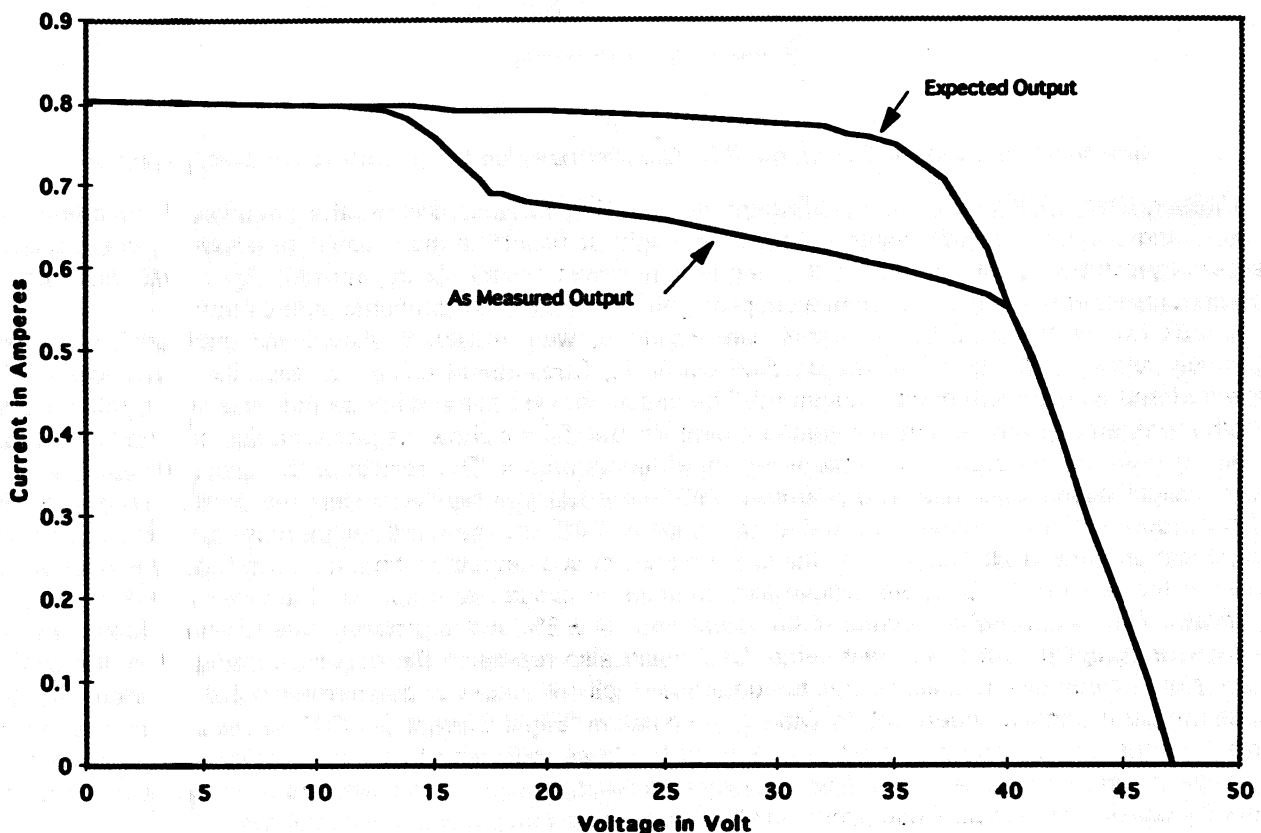
**Figure 6**  
**XTE Qualification Panel Circuit One I-V Curve at 70C**

Because of the array's unexpected performance in space, the XTE qualification panel was used to help determine the cause. Prior to array delivery, the qualification panel underwent extensive testing including exposure to thermal vacuum cycles, thermal cycles at ambient pressure and an acoustic environment. The panel showed no anomalous behavior due to these exposures. However, all the evaluations of the panel were performed at room temperature. When the panel was flash tested at elevated temperatures, subsequent to the XTE's launch, the panel showed an anomalous I-V curve, see Figure 6. At elevated temperature, a crack was clearly seen that could lead to the anomalous performance, see Figure 7.

We recommend that future flight solar panels undergo a visual inspection and an electrical output test at elevated temperatures. The electrical output test need not precisely determine the power output of the array but just the I-V curve shape. This test found the defect on the XTE qualification panel when room temperature tests did not. In addition, a similar test run on a NOAA K qualification panel found failed cell to interconnect connections, when room temperature testing did not. Fortunately the inspection and the test are inexpensive and quickly performed.

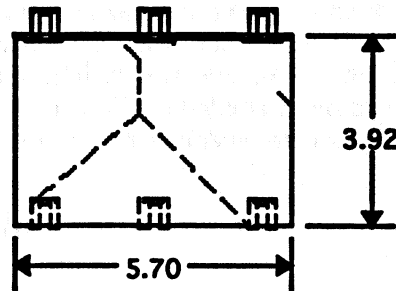
Figure 7

However, the crack in the solar cell was such that only one of its four branches could be seen at room temperature with the usual methods the cell manufacturer, Spectrolab, and GSFC use to inspect for cracks. This suggested the possibility that the XTE array was launched with cracked cells that could not be seen. The plausibility of this was increased because the flight panels were extensively and repeatedly tapped tested to check for delaminated substrates. Further inspections were carried out on the qualification panel to determine the conditions under which the crack could be seen, and also, to further determine if tap testing, bending, or

The panel was reinspected at Goddard using two methods: infrared light and a stereo microscope with normal light. The cracks in the solar cell were not detected using infrared equipment despite several approaches that were tried. Using a stereo microscope, the GSFC located the "vertical" part of the crack at 7X. This vertical crack actually consists of a small series of 45 degree zigzags that on the whole proceed vertically, not unexpected for a silicon solar cell crack as the zigzags follow the crystalline "planes" in the silicon. The other cracks were not visible using this method until the cell was heated to "45 to 50C" with a heat gun at which temperature they were plainly visible.

*Sketch of the Cracked Cell on the XTE Qualification Panel, Dimensions in Centimeters*

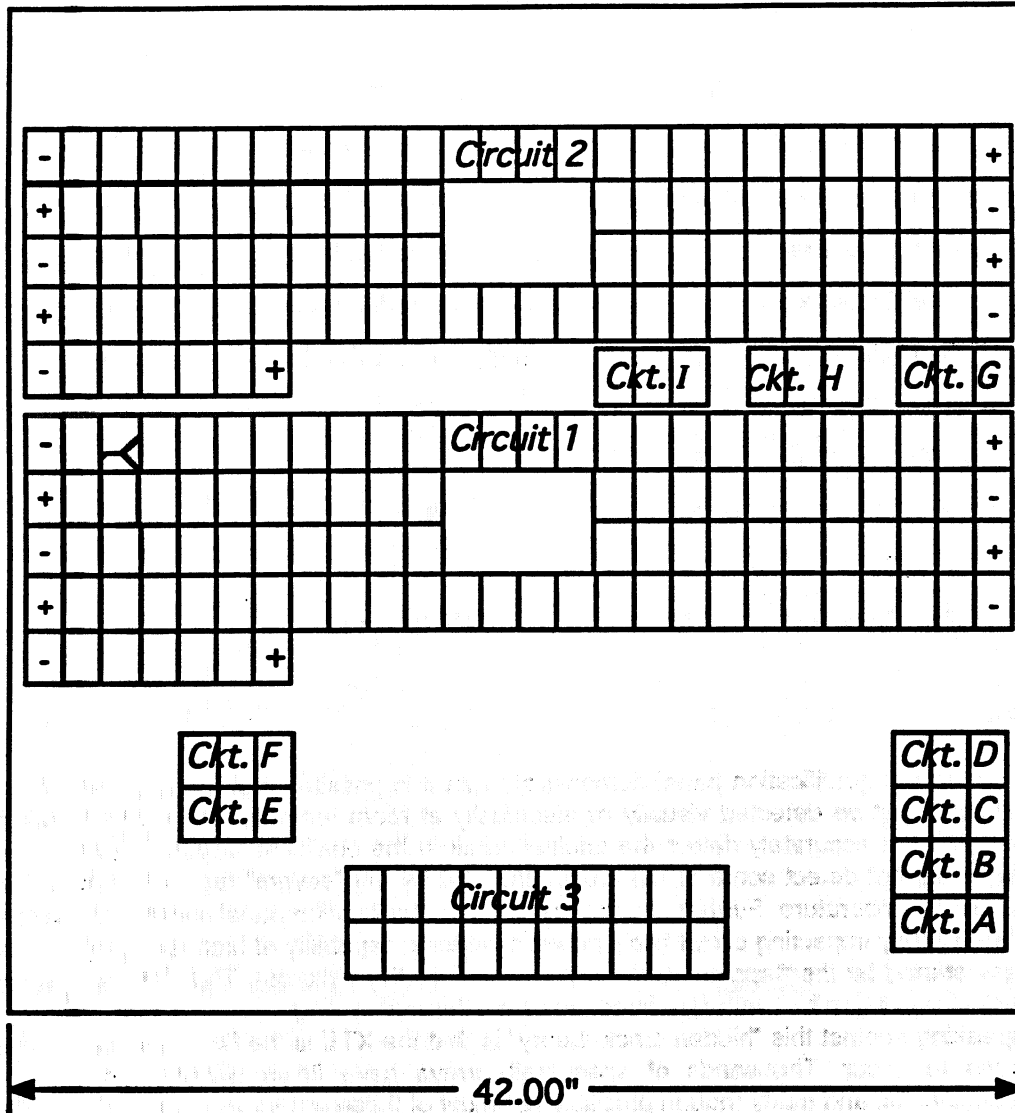
**Figure 8**  
**Sketch of the XTE Qualification Panel**

Circuit two of the qualification panel, see Figure 8, was inspected, electrically measured, and then vigorously tapped. (Circuit 1 had the cracked cell in it.) Subsequent to the tap test, the panel was again inspected and its electrical output measured. The circuit showed some damage that was visually detectable at both room temperature and at elevated temperature, but did not show the phenomenon of a crack that was hidden at room temperature but visible at elevated temperatures. The results of the electrical test, Table I, show a slight power decrease at 28C and at 70C. Note that the results designated as 28C were actually taken at room ambient temperature and extrapolated to 28C, the standard temperature at which solar cells and panels are evaluated. Because of one of the results of subsequent testing, a fairly substantial increase in power at the last test at 28C, we believe that changes in circuit two output on the order of  $\pm 5\%$  are not significant. This is somewhat outside of the usual error of  $\pm 2\%$  and is probably due to an unknown error in the measuring equipment or our test setup. Or it could also represent the actual performance of the circuit which might be somewhat unstable due to numerous small cell cracks or deteriorated solder after the thermal cycles the panel circuits underwent. In Table I, the notation "Slight Current Cut Off" means that the circuit two current versus voltage curve is a bit too sharp at the knee indicating that one or more cells is producing slightly less current than the others. This is a very mild example of the anomalous curve in Figure 5; but is not generally considered a fault. It can occur simply because a low output cell is in circuit two.

Subsequently, circuit two was tapped using a harder tap than previously. It is not conceivable that the Spectrolab technicians would have tapped the flight panels with such force. Numerous cover cracks and several cell cracks were noted both at room temperature and at elevated temperatures, but there was no evidence of cracks that were "hidden" at room temperature but otherwise visible. Table I provides electrical results at 28C and 70C.

In addition, ten cells in circuit two were inspected with a hood and with the naked eye after the thermal cycle test. A large number of cracks that could not be seen prior to the test were visible. An inspection of the ten cells with a stereo microscope at room temperature and at 70C showed a very large proportion of the cracks visible at 70C that were not visible at 28C.

Secondly, we recommend that tap testing solar panels, usually performed to determine whether or not they have a delaminated area, be replaced by other less stressful testing. This testing could include acoustic transmittance through the panel, which is really quite equivalent to a tap test, a suction test where the cells

are pulled with a known force and observed for undue motion, or a pressure test where the cells are gently pushed with known force and observed for undue motion.
