Report of the Seasat Failure Review Board

DECEMBER 21, 1978

REPORT OF THE SEASAT
FAILURE REVIEW BOARD

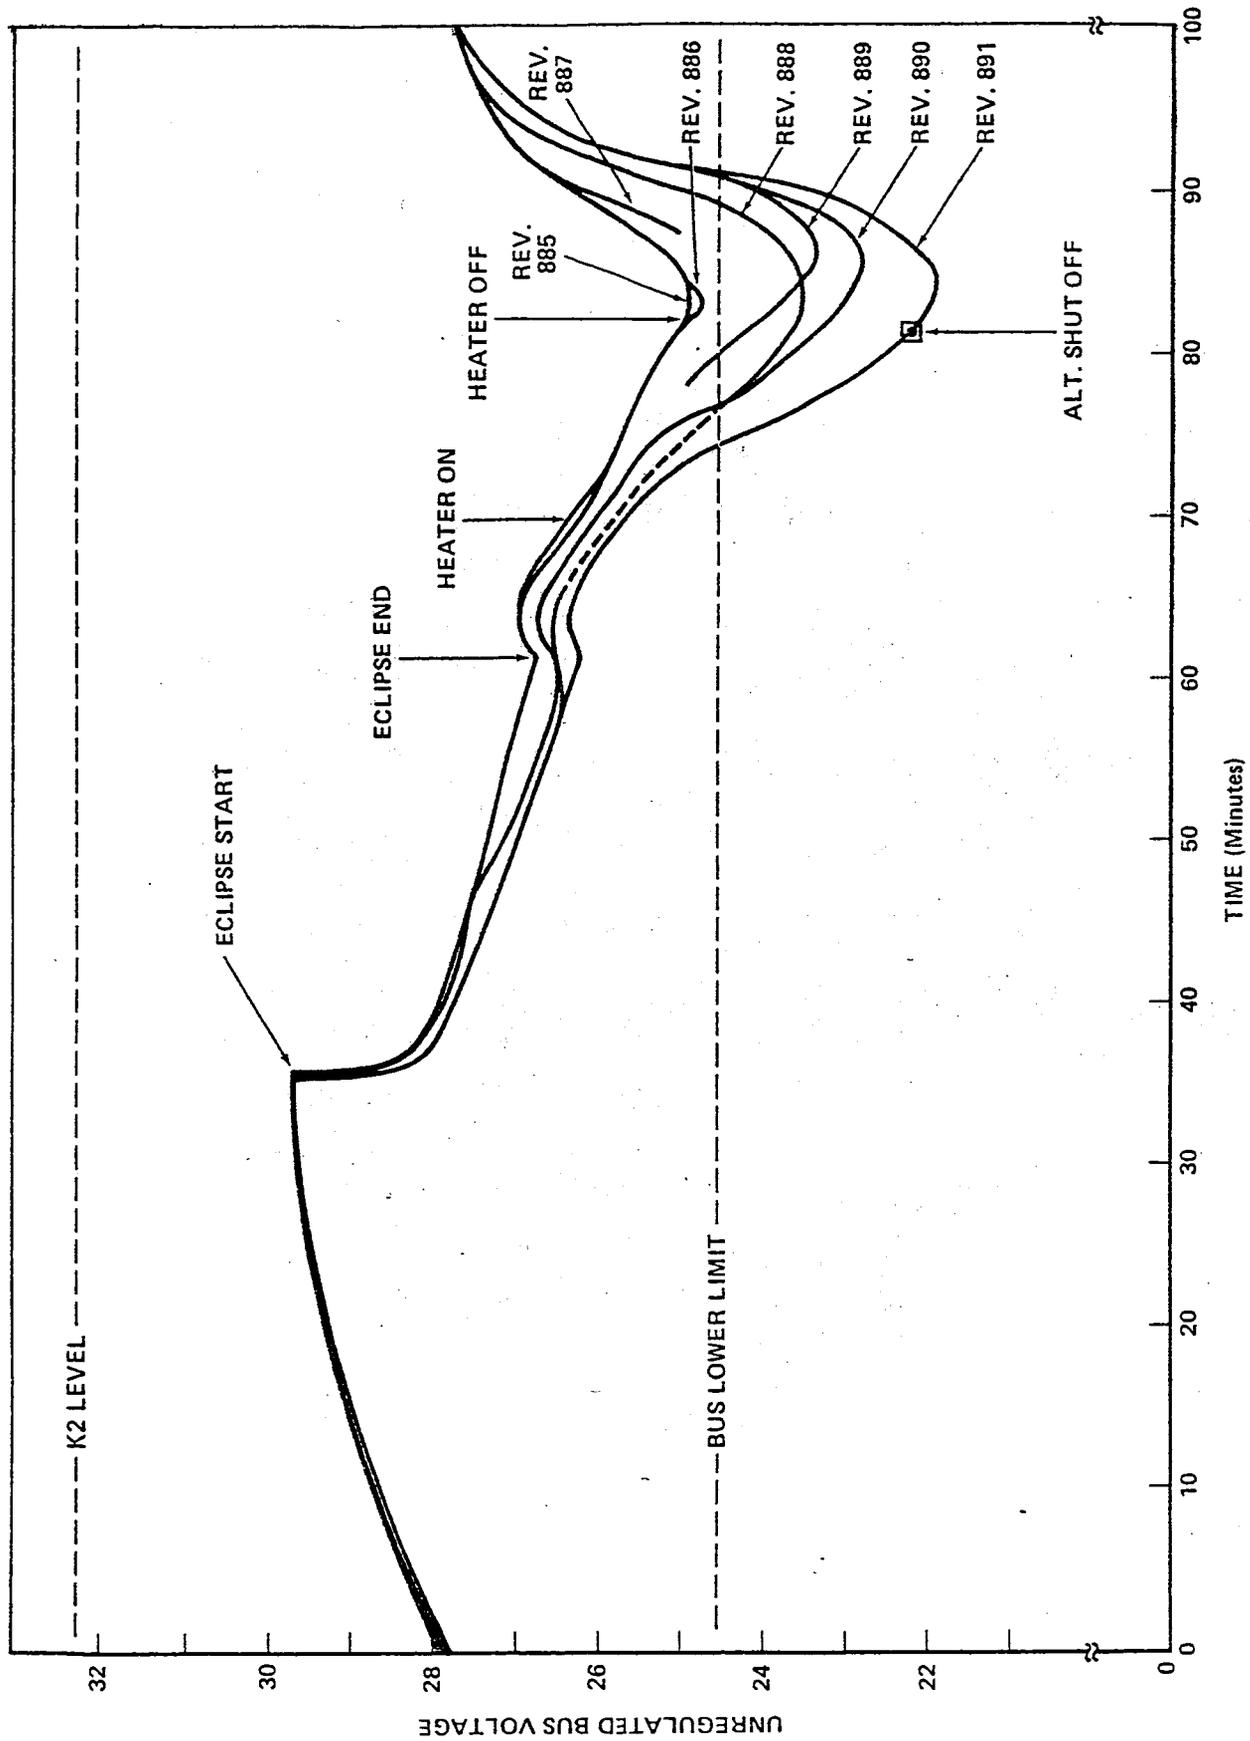
Figure 5-9. Unregulated Bus Voltage During the Low Voltage Anomaly

Bus Low Voltage Anomaly — On August 28, 1978, the altimeter transmitter turned itself off between active station passes because of a low voltage condition. This undervoltage developed because of a slow depletion of battery power as a result of the loads being slightly in excess of solar array capability. Figure 5-9 shows the unregulated bus voltage for several revolutions prior to the low voltage anomaly. These data indicate that, at least for six orbits, the batteries did not

reach a fully charged state; i.e., K2 did not open, thus indicating less than a 90 percent full charge. In fact, examination of the data after the failure of October 9 revealed that for three days preceding this low voltage anomaly none of the K1 or K2 relays had opened as they would have if the batteries were charged to a high level. As shown by the data of Figure 5-9 the battery charge was progressively depleted for each succeeding orbit during the eclipse and heater on periods. On revolution 892, with the altimeter off, the battery began to recover its charge. This information was not available to the flight controllers in real time because the low voltage point for these orbits did not occur during station passes. General information on the status of battery charge was, however, available to the flight controllers for several days from K2 relay status data. The lowest bus voltage experienced during this period was approximately 21.8 VDC; while the maximum depth-of-discharge cannot be accurately determined from the available data, it is estimated that the observed minimum battery voltage would be equivalent to that expected with almost 100 percent of rated capacity removed from a 22 cell battery. This problem probably was due to a combination of the extra heater loads and insufficient understanding of the state-of-charge of the batteries. As a result the operation of the altimeter and SAR was restricted until normal operations were resumed on September 7, 1978. No equipment damage was sustained as a result of this anomaly and the EPS performed normally in subsequent orbits.

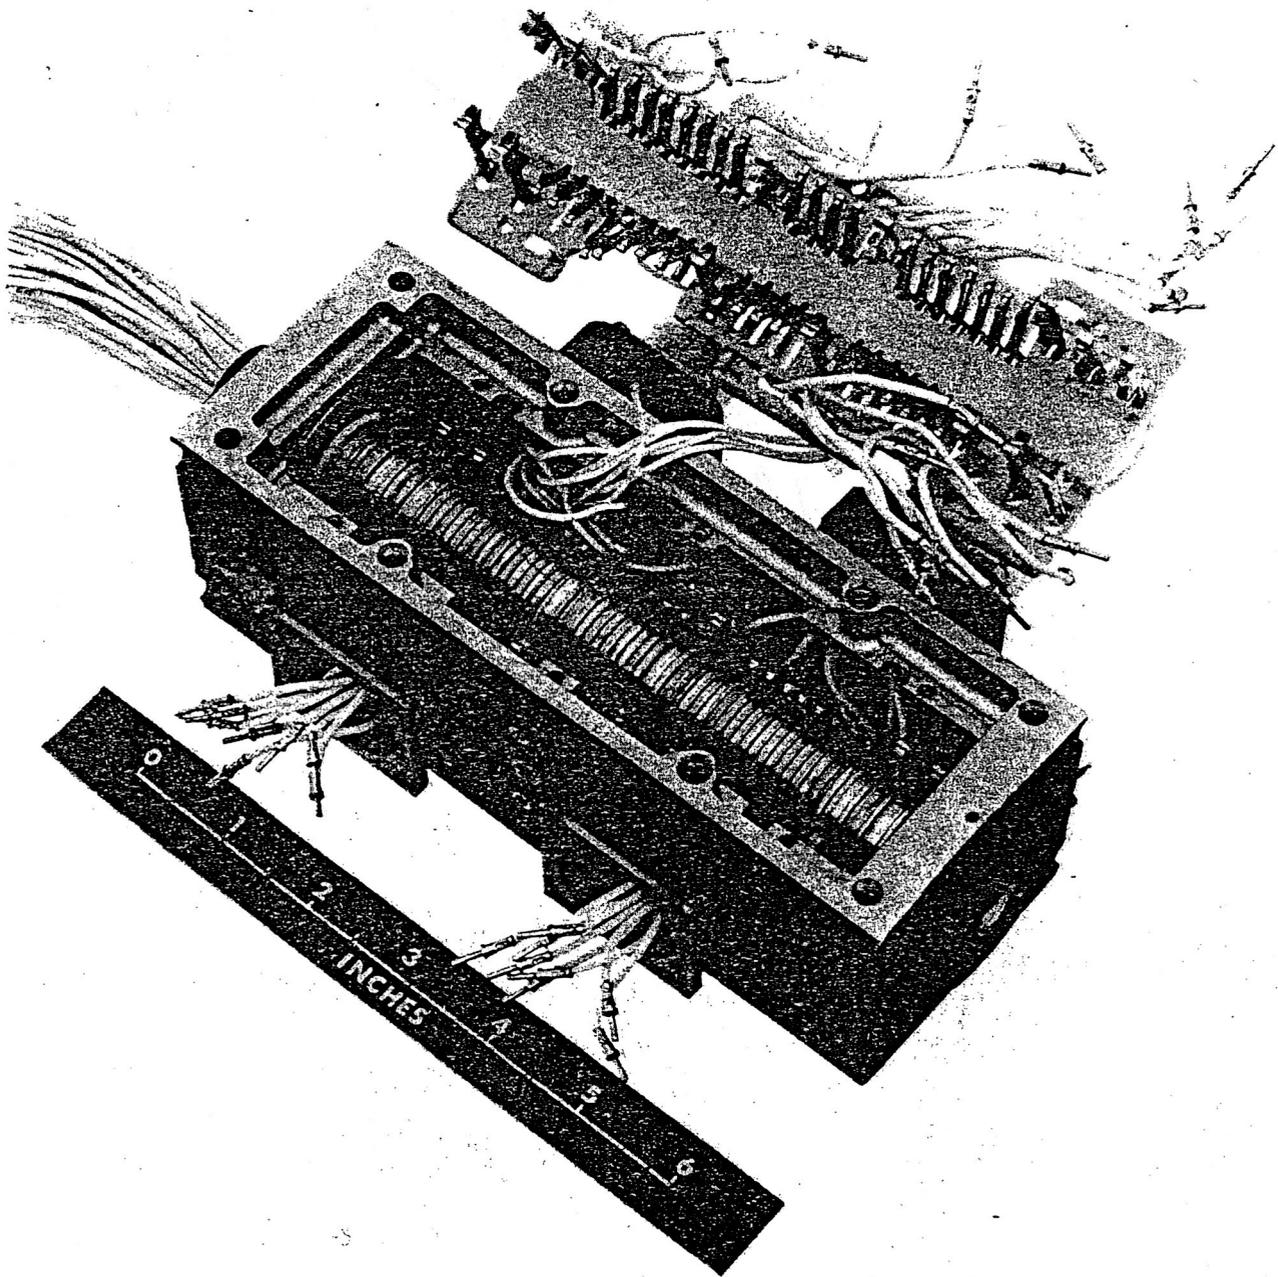
Figure 5-10. Slip Ring Assembly with Top Brush Block Removed

A photograph of a slip ring assembly of the Seasat design that has been partially disassembled to reveal the rings and brushes is presented in Figure 5-10. As can be noted, 26 of the brush assemblies were mounted on a brush block in the bottom half of the assembly. These brushes interleaved with the other 26 brushes that were attached to an upper brush block shown removed from the assembly in Figure 5-10.

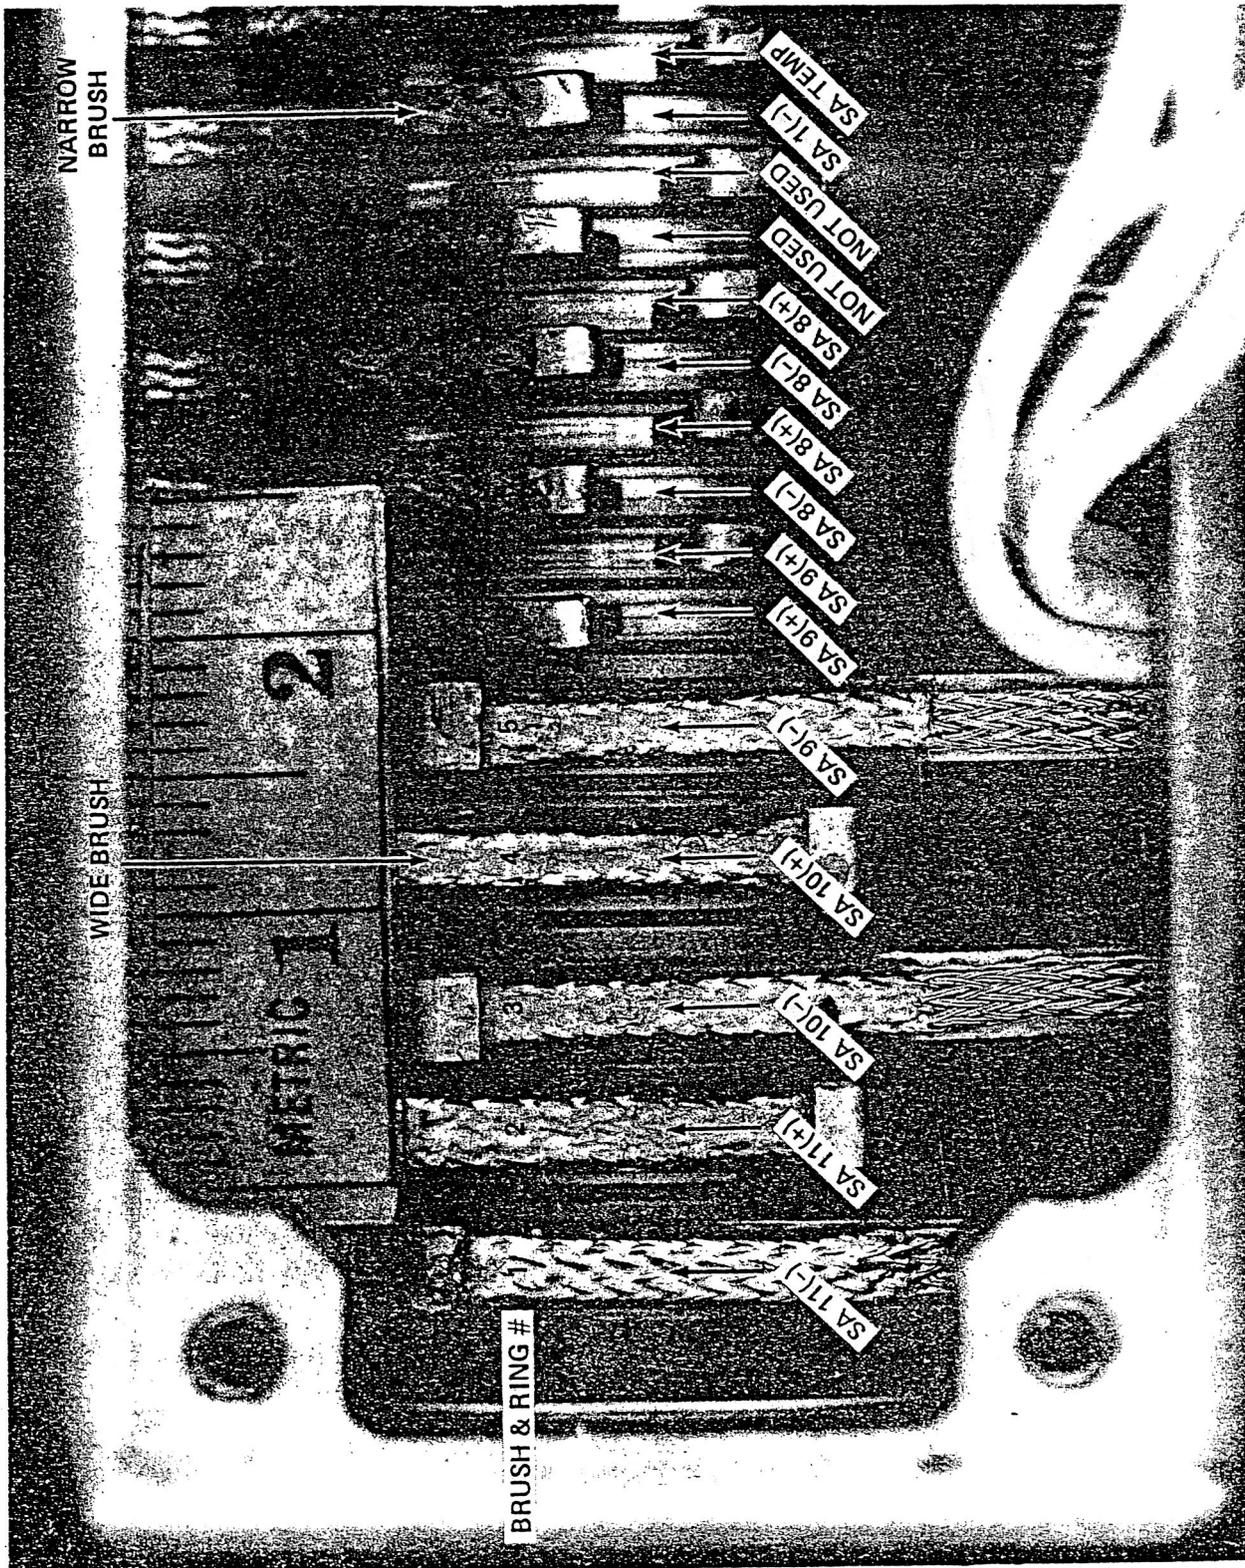
Figure 8-4. Slip Ring Assembly - Brushes 1-15 (Side Cover Removed for Viewing)

initiated either by a contaminant, by physical contact of adjacent brush and ring assemblies, or by a wire-to-brush assembly short. The explosive and destructive nature of the arc caused propagation along the slip rings adjacent to the initial fault.

The initial fault would have occurred between any two adjacent brush and ring assemblies of opposite polarity in the region of brush assemblies 1 through 11. The application of the slip ring assembly with plus power and negative return power being carried essentially on every alternate ring not only created a high potential for the failure mode that occurred, but also allowed the fault to progress along adjacent brush assemblies and rings until it reached a barrier such as unused brush assemblies. All other spacecraft systems functioned normally as long as adequate voltage levels were maintained.
