## COMPLIANT FOIL SEAL INVESTIGATIONS

Margaret P. Proctor  
National Aeronautics and Space Administration  
Glenn Research Center  
Cleveland, Ohio

2003 NASA Seal/Secondary Air System Workshop  
November 5-6, 2003

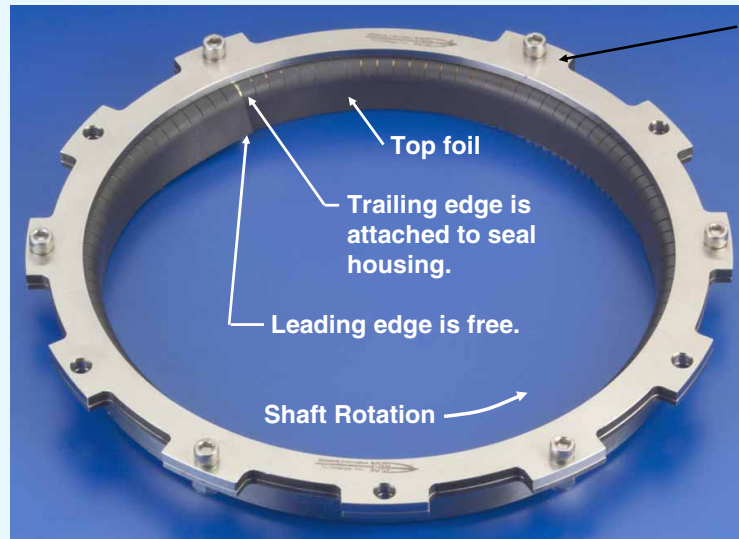
## Mohawk's 8.5 inch Foil Seal Prior to Test

Top foil is clamped to seal housing on high pressure side of seal by seal clamp.

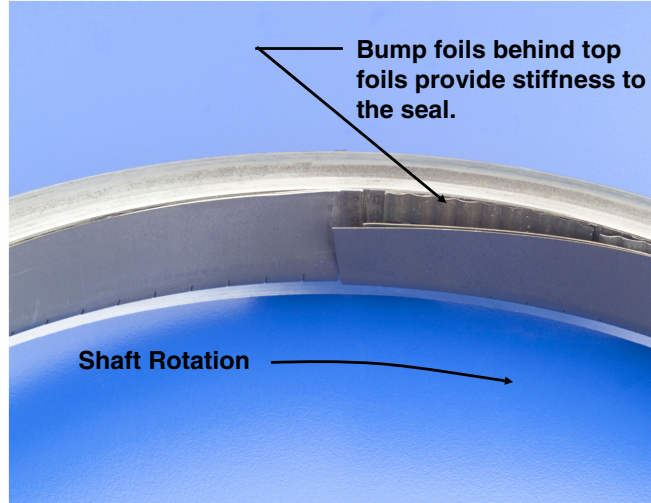
## Down Stream Edge of Foil Seal

The bump foils can be seen behind the top foil in this view of the downstream side of the seal near the leading edge. When the seal is installed over the rotor the top foil conforms to the rotor od.

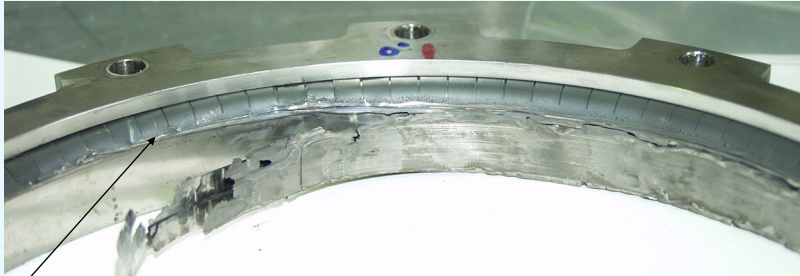
11 to 1 O'Clock position

Clean cut created by rotor edge that bends out at high speed.

This is the 8.5 inch foil seal after room temperature testing to 30,000 rpm. The seal is damaged beyond use. Parts of the top foils and bump foils were found blown behind the rotor at disassembly. The Korolon coating is rubbed off and the top foil was burned through at places. Note the clean cut at the bend in the top foil. This cut aligns with the edge of the test rotor. The test rotor has an I-beam cross section at the rim. Hence at high speeds the edges of the rotor rim bend out radially farther than the axial center of the rim. This displacement combined with the chamfer on the edge of the rotor makes a nice cutting tool.

- The damage to the seal was likely caused by a loss of clearance due to centrifugal growth of the rotor and fatigue failure of the coating, which initiated a thermal runaway condition.

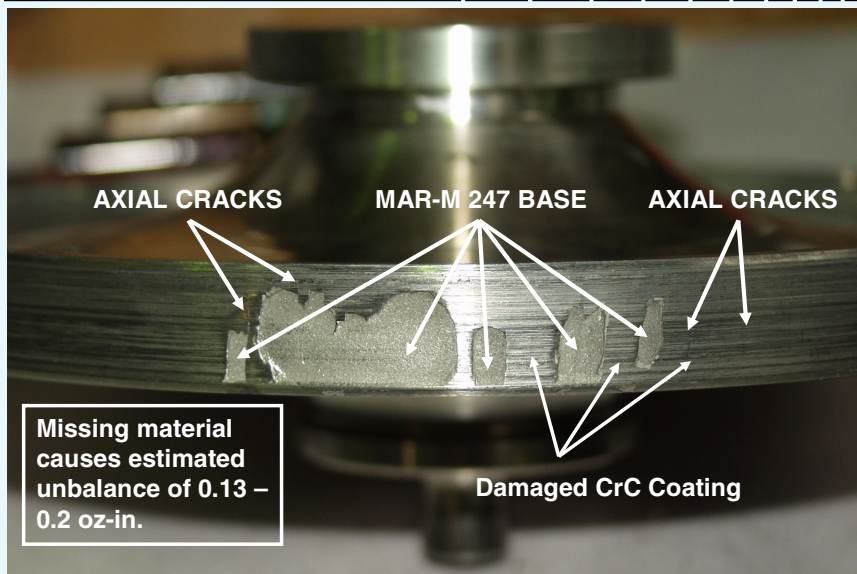
## Damaged Rotor Coating

The rotor coating failed. The Mar M-247 rotor had a 0.010 inch thick CrC coating applied by high velocity oxygen fuel thermal spraying. By measuring the areas of the missing coating and the depth of the damage, the unbalance of the missing material is estimated to be 0.13-0.2 oz-in, which is 27-40 times greater than the balance specification for the rotor. Some hairline axial cracks are visible.

- Rotor coating selection and application needs a redesign.
- A good understanding of the seal operating environment and operating limits is paramount to success.

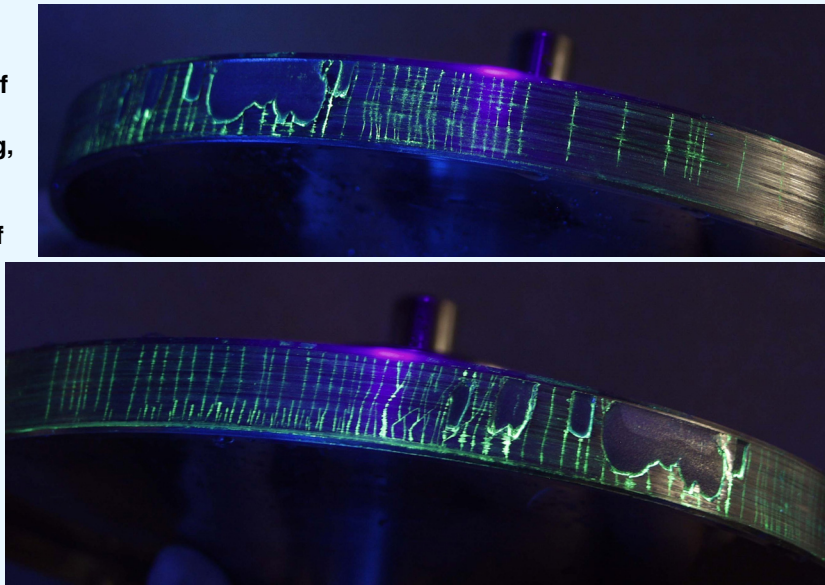
## Rotor under fluorescent penetrant dye inspection

Axial cracks, typical of heat checking, indicate fatigue failure of the coating.

Many axial cracks are visible in the rotor coating under fluorescent penetrant dye inspection. These axial cracks are typical of heat checking and indicate fatigue failure of the coating. The fatigue failure is likely due to the mismatch in coefficients of thermal expansion for the rotor material Mar M-247 and the CrC coating.
