**WTC2005-63539**

## **ANALYSIS OF BLACK BEARING BALLS FROM A SPACE SHUTTLE BODY FLAP ACTUATOR**

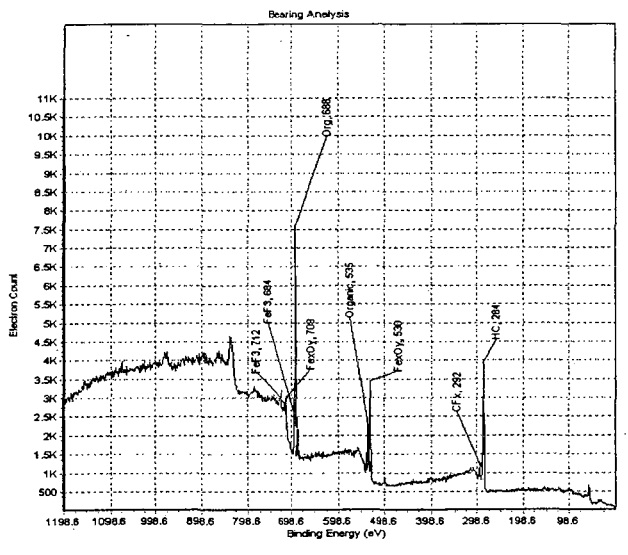
Data from the XPS analysis indicated iron fluoride and iron oxides on the black ball (Fig. 1). The color of iron fluoride is dependent on the oxidation state and state of hydration and ranges from white to yellow to green. Metal fluorides and in particular iron fluoride has been shown to catalyze the decomposition of PFPE lubricants. The amount of iron fluoride is key to telling if metal fluoride catalyzed PFPE decomposition was the primary cause of grease degradation. Under the specimen storage and shipping conditions it is likely that the iron fluoride hydrolyzed into iron oxides and hydrofluoric acid (HF). Some iron oxides and mixed hydroxy-oxides are typically black.
