Failure Analysis of Discrete Damaged Tailored Extension-Shear-Coupled Stiffened Composite Panels

Donald J. Baker*

Vehicle Technology Directorate – ARL, NASA Langley Research Center, Hampton, VA 23681

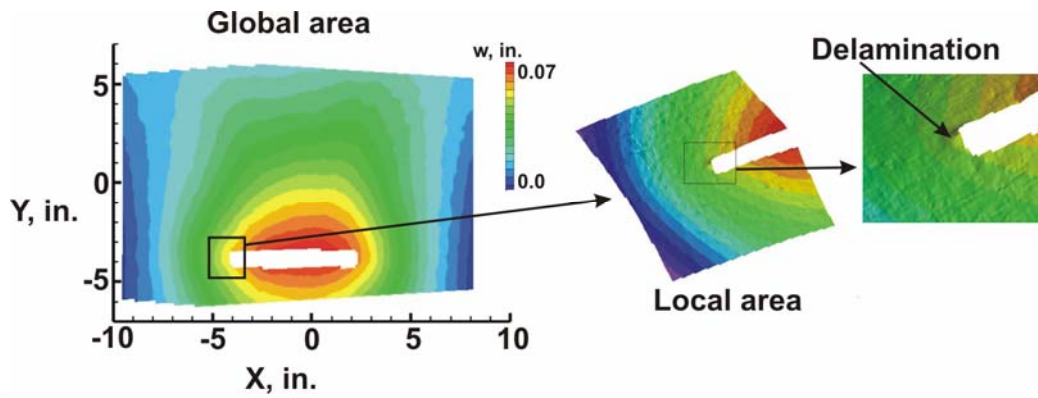
An obvious advantage of the VIC-3D system is the recording of events at timed intervals throughout the test is that phenomena that occur temporarily have a good chance of being recorded. An intermediate result from the VIC-3D system is shown in Fig. 20 for panel TP-7 where the global view indicates that the panel is bulging in the middle as determined by the concentric out-of-plane contours around the slot. These *Horizontal cut* panels also had a second VIC-3D system recording the response at a local area as defined at the left end of the slot as shown in Fig. 20. This local area, shown in Fig. 20, indicated a delamination was in progress at the corner of the slot for panel TP-7. The delamination shown is for a load of $N_y = 5.1$ kips/in. and is near the end of the slot. The appearance of the delamination started at approximately $N_y = 4.6$ kips/in. and continued to grow until $N_y = 5.61$ kips/in. The delamination could have started at a lower load but would be missed due to a strip of image data on all edges that is lost in the analysis process. There could also have been a delamination on the right end of the slot as it was not be monitored with a local set of cameras. Up to a load of $N_y = 5.61$ kips/in the delamination was only visible in the local area images. At $N_y = 5.76$ kips/in the delaminations/damage grew in size and was visible in the global view image on the L/H side of the slot as shown in Fig. 21a and the delamination/damage does not appear on the R/H side of the slot until $N_y = 5.82$ kips/in. as shown in Fig. 21b. Increasing the axial displacement until failure the damage progresses up and to the left and down and to the right as shown in Fig. 22, which is the last image frame before failure. The damage progressed to the edge of the skin, adjacent to the thickness transition to the stiffener padup as shown in Fig. 22. This damage/delamination growth compares well with the predicted damage growth shown in Fig. 7 where the damage grew to the stiffeners at reaching the maximum load. Panel TP-4 did not exhibit the local delamination as was seen in panel TP-7. Panel TP-4 appeared to fail in the skin from the corner of the slot to the edge of the skin as shown Fig. 23. The first appearance of any out-of-plane displacement in the local images is shown in Fig 23a. At the same time the out-of-plane displacements appeared in the global image as shown in Fig. 23b indicating failure from the end of the slot to the edge of the skin. Panel TP-4 reacts the same as TP-7 and the progressive failure analysis predictions that of the skin failing to the stiffeners as the load increases to the maximum load. Increasing the load resulted in the damage to grow into the padup area of the stringer on the right hand side as shown in Fig. 24.

Figure 20. Measured delamination at end of slot in panel TP-7 at a load of $N_y = 5.1$ kips/in.

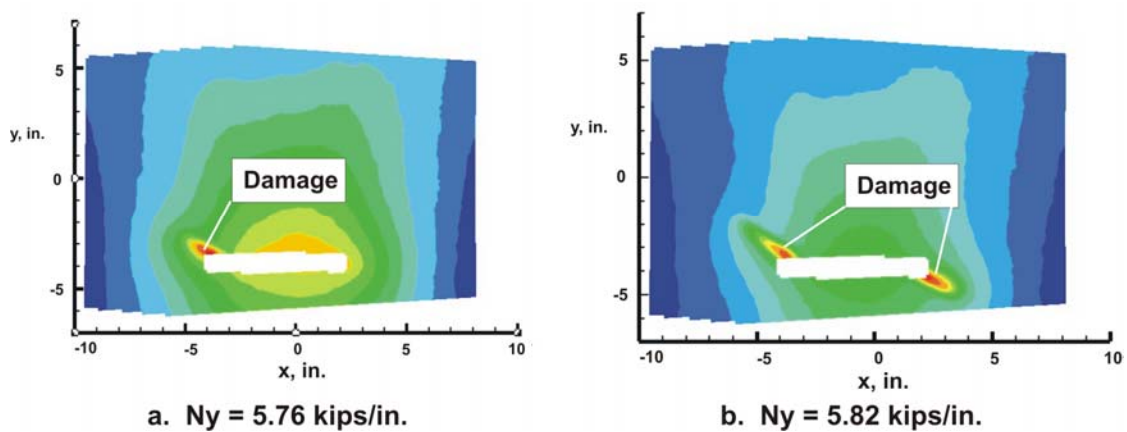
Figure 21. Measured delamination/damage at end of slot at loads shown.

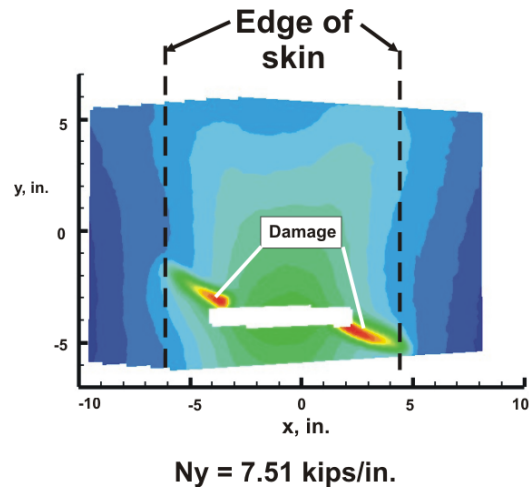
Figure 22. Measured damage propagation in panel TP-7 prior to failure.

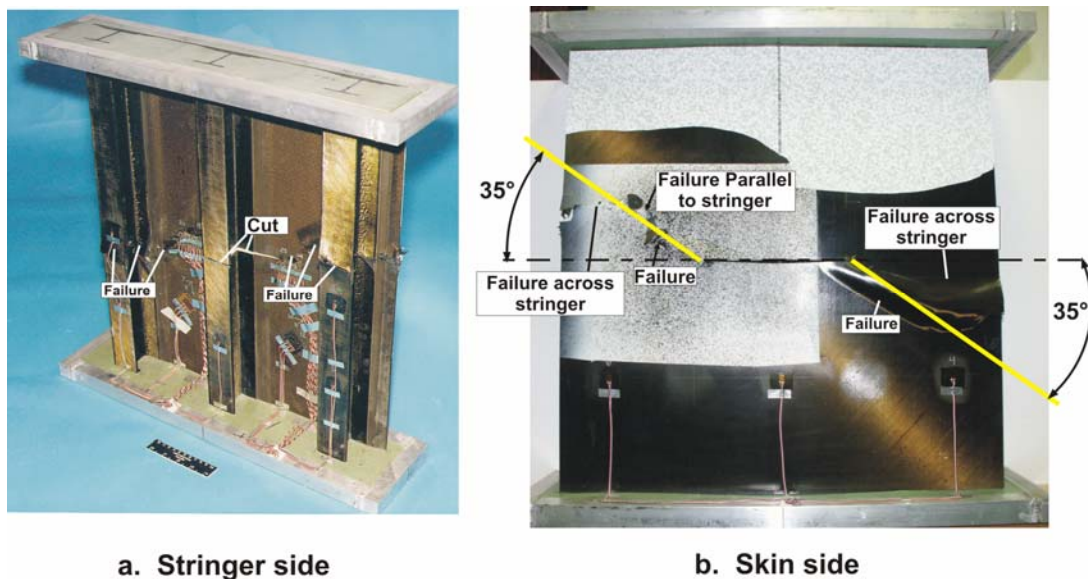
Figure 28. Failed *Horizontal cut* panel.

A photograph of the stringer side of a failed *Horizontal cut* specimen is shown in Figure 28a. As indicated in the figure, the failure progressed from each end of the slot up or down across the skin. A view of the skin side of the specimen is shown in Figure 28b. This figure indicates how the failure progressed from the right end of the slot down at approximately a 35° angle until it intersected the stringer then turned and crossed perpendicular to the stringer. Likewise, failure started at the left end of the slot and progressed up at approximately 35° until it approached the stringer, the damage turned parallel to the stringer for a short distance, then turned and crossed perpendicular to the stringer. The progressive failure analysis noted earlier, predicted that the failures would be at 35° to the specimen centerline then turn and cross perpendicular to the stringer which is a very good match with the experimental results. Both of the *Horizontal cut* panels (TP-4 and TP-7) failed in a similar manner and indicates that the fabrication sequence did not contribute to the failure where the panels were manufactured at different times.

In summary, the results shown for the *Horizontal cut* panels indicate a very good correlation between the predicted failure mode and actual failure mode. The predicted failure load of 7.87 kips/in. was less than 3% higher than the average failure load of the two *Horizontal cut* specimens. The average panel stiffness is approximately 90 % of the computed panel stiffness. This is a good strength and stiffness correlation since the exact properties of the material used in the panel was unknown.

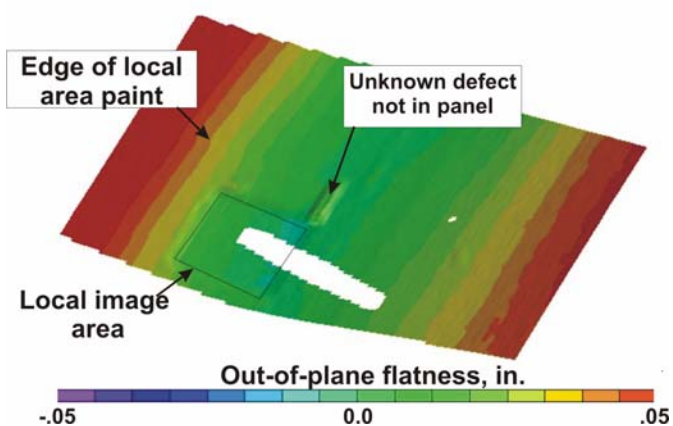
Figure 29. Profile of panel TP-5.

The profile of the *Inclined cut* panel (Fig. 4) indicates that the panel is curved across the panel width as shown in Fig. 29. The panel curvature varies up to 0.025-inches from being flat between the stringers and curves to 0.050-inches from the reference plane between the stringers and panel edges. There is no noticeable curvature in the lengthwise direction. The local area can be seen in Fig. 29 and is where a second VIC-3D system recorded the images of a small area at the end of the slot. The 0.004-inch step can be observed around the edge of the local area in Fig. 29. A defect of unknown origin, shown in Fig. 29, could be an air bubble trapped under the vinyl or a foreign object under the vinyl. The ripple in the contours as shown in Fig. 29 indicates the edge of the painted area under the vinyl for the local area images. The error (noise) in the results can be determined from the VIC-3D analysis and is less than 0.0003-inch for the *Inclined cut* panel. The panel was loaded in compression until failure occurred at 7.54 kips/in. The residual strength of the *Inclined cut* panel is 37 percent of the average strength of the undamaged panels⁴. A plot of the axial end shortening as a function of the axial load is shown in Fig. 30 as a solid line with a filled circle symbol. The transverse in-plane displacements are also shown in Fig. 30 as dashed lines with a filled circle symbol. The panel end shortening shown in Fig. 30 is a uniform function of the load until 6.1 kips/in. where the slope of the curve changes due to a local failure. The initial specimen stiffness is 103.6 kips/in./in⁴. The predicted panel end shortening and in-plane displacement is also shown in Fig. 30 as lines (solid and dashed) with a filled square symbol. The predicted panel end shortening is a linear function of the applied load until a load of 6.6 kips/in. The predicted stiffness of the panel is 111.2 kips/in/in.

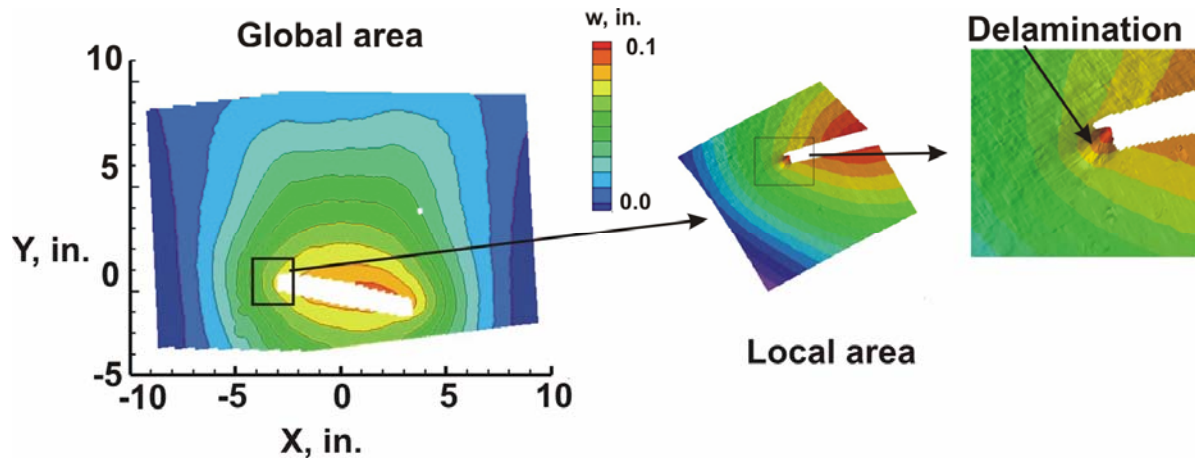
An intermediate result from the VIC-3D system at $N_y = 6.32$ kips/in is shown in Fig. 31 and indicates that the panel is bulging as indicated by the concentric displacement contours around the slot. This out-of-plane deflections is different from the predicted displacement shown in Fig. 15 where one end of the slot deflects in one direction with the opposite slot end deflecting in the opposite direction. The local area image indicates a delamination at the corner of the slot. The delamination shown in Fig. 31 first appeared at $N_y = 5.32$ kips/in. and increased in size until $N_y = 6.32$ kips/in. Damage started to show up in both ends of the slot as shown in Fig. 32 after a very small perturbation

Figure 31. Measured delamination at end of slot in *Inclined cut* panel at a load of $N_y = 6.32$ kips./in.

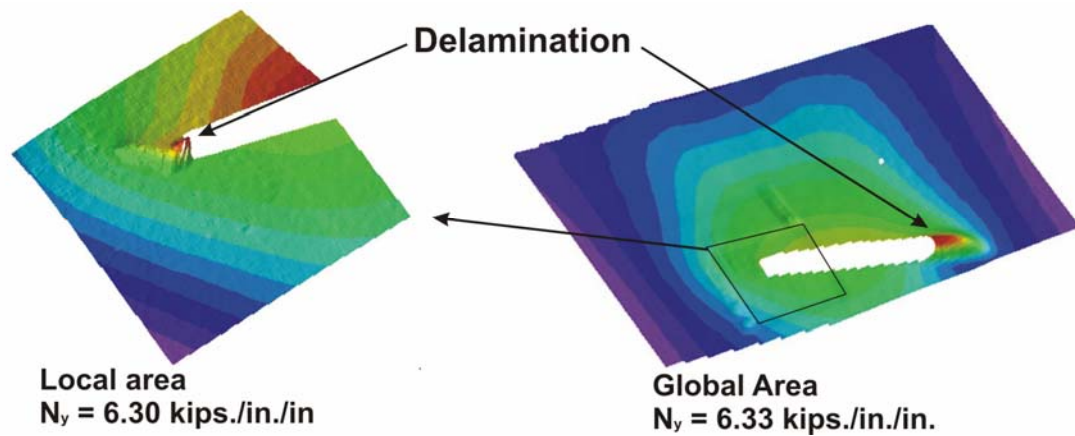
Figure 32. Measured initial failures of *Inclined cut* panel.

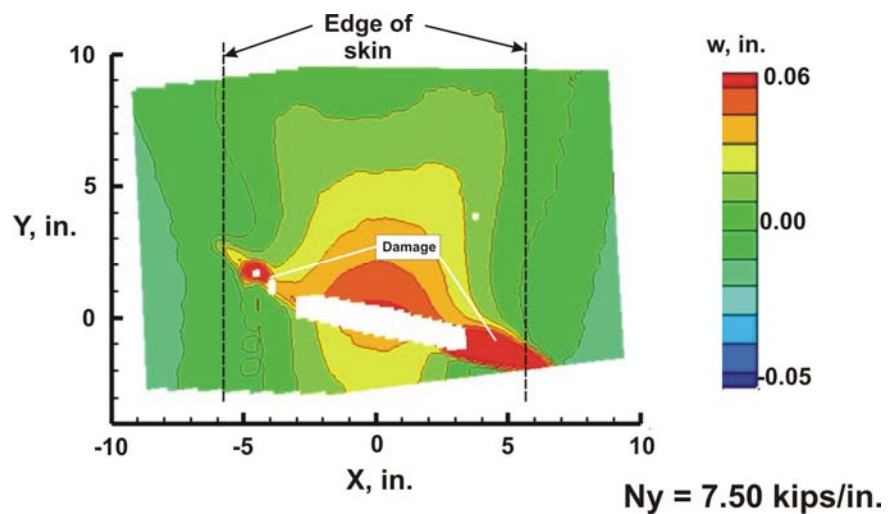
in the load. Increasing the axial displacement resulted in the damage progressing to and into the stiffeners as shown in Fig. 33 which is the last image before panel failure. Comparing Fig. 33 with the predicted failure direction shown in Fig. 14 indicates the failure direction is the same, down to the right for one end of the slot.

Figure 33. Measured out-of-plane displacements of *Inclined cut* panel at near failure.

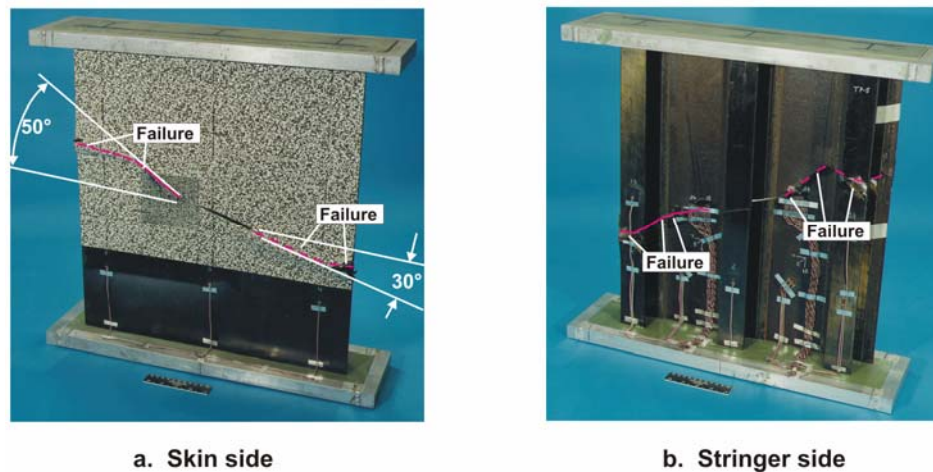
Figure 36. Failed *Inclined cut* panel.

A photograph of the failed *Inclined cut* panel is shown in Fig. 36. As indicated in Fig. 36a the failure in the skin progressed up from the L/H end of the slot at approximately a 50° angle and then turned to cross the stringer. Failure progresses in the skin from the right hand end of the slot at a 30° angle from the horizontal and then turned to cross the stringer. The progressive failure analysis predicted that failure would progress from the slot end at a 50° angle to the edge of the skin and turn to cross the stringer which matches the experimental results. Failure from the opposite slot end was not predicted by the analysis.

In summary, the results shown for the *Inclined cut* panel indicate a very good correlation between the predicted failure mode and the actual failure mode. The failure load of $N_y = 7.54$ kips/in is 88 % of the predicted failure load of the inclined panel and the actual stiffness is 93 % of the predicted panel stiffness. This is a good strength and stiffness correlation since the actual properties of the material used in the panel was unknown.
