Formation of Leading-Edge Pinholes in the Space Shuttle Wings Investigated

Programs/Projects: Space Shuttle Leading Edge Structural Subsystem

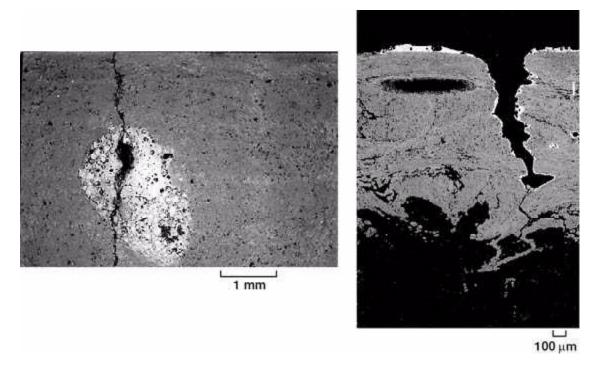
Left: Pinhole from OV-102 wing leading-edge panel 12 RH; 15 flights. Right: Cross-sectional view (backscattered electron image).

A typical pinhole is illustrated in the preceding photomicrographs. These pinholes are found primarily on the wing leading edges and not on the nose cap, which is covered when the orbiter is on the launch pad. The pinholes are generally associated with a bead of zincrich glass. Examination of the orbiter and launch structure indicates that weathering paint on the launch structure leads to deposits of zinc-containing paint flakes on the wing leading edge. These may become embedded in the crevices of the wing leading edge and form the observed zinc-rich glass.

Laboratory experiments indicate that zinc oxide reacts vigorously with the glass coating on the silicon carbide. Thus, it is likely that this is the reaction that leads to pinhole formation (Christensen, S.V.: Reinforced Carbon/Carbon Pin Hole Formation Through Zinc Oxide Attack. Rockwell International Internal Letter, RDW–96–057, May 1996). Cross-sectional examination of pinholes suggests that they are enlarged thermal expansion mismatch cracks. This is illustrated in the following photomicrographs. A careful microstructural analysis indicates that the pinhole walls consist of layers of zinc-containing glass. Thus, pinholes are likely formed by zinc oxide particles lodging in crevices and forming a corrosive zinc-rich glass that enlarges existing cracks (ref. 1).

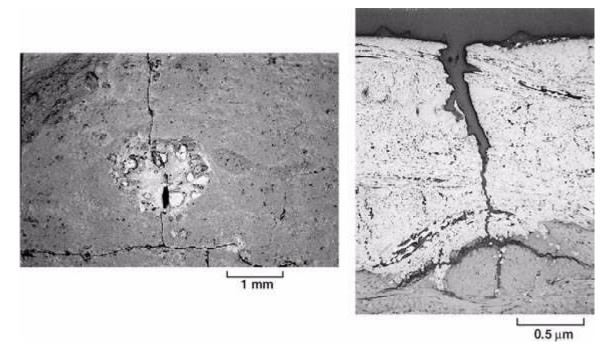
Left: Pinhole from OV-102 wing leading-edge panel; 12 RH, 15 flights. Right: Cross-sectional view with optical microscope.

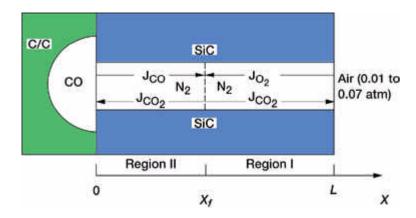
The results at higher temperatures showed good agreement with a simple diffusion-control model. This model is based on the two-step oxidation of carbon to carbon monoxide and carbon dioxide. The fluxes are illustrated in the final figure. The model indicates a strong dependence on pinhole diameter. For smaller diameters and short times, the oxidation of carbon is very limited.

Model for the oxidation of a carbon/carbon composite at the bottom of a pinhole in a SiC coating.
