Contaminated Solar Array Handrail Samples Retrieved From Mir Analyzed

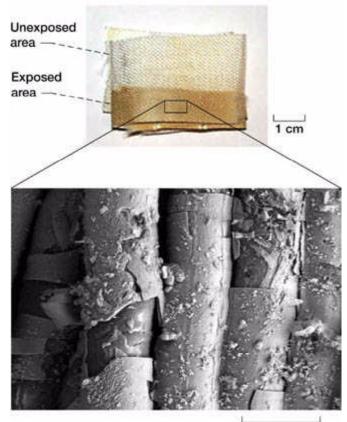
Flexible handhold fabric tape from the Russian solar array retrieved after 10 years of exposure to the low-Earth-orbit space environment on Mir. A very thick (»1.6-mm) brown oxidized silicon contaminant layer developed during the 10-yr space exposure.

Optical microscopy and FESEM imaging showed that the brown stained areas have thick layers of contamination that have crazed and spalled-off the surfaces in some regions. An area where the cross section of the contaminant is visible in FESEM imaging shows the film to be approximately 1.6-µm thick. The figure shows contaminated (space-exposed) and uncontaminated (protected) areas of the flexible handhold fabric along with a highmagnification FESEM image showing the thick contaminant layer coating the fabric fibers. The contaminant caused a 41-percent increase in the solar absorptance of the flexible handhold fabric. Energy-dispersive spectroscopy revealed that the brown contaminant on both samples is composed of oxidized silicon with very little carbon content. There is no silicon present on the unexposed fabric overwrap, and very small amounts in the white paint. Therefore, the contaminant layer on both handrail samples is attributed to silicone contamination from other spacecraft materials that were oxidized by atomic oxygen while in orbit. A significant source of the silicone contamination has been determined to be from the solar array itself, specifically from the silicone compounds used to laminate the solar array panel. FESEM images of the handhold fabric show areas where the contaminant layer has spalled off the organic fibers and atomic oxygen erosion has occurred. This implies that flakes of the thick contaminant coating spalled off while in space and became

a source of particulate contamination.
