High Temperature Chemistry in the Columbia Accident Investigation

Nathan Jacobson and Elizabeth Opila
NASA Glenn Research Center
Cleveland, OH 44135

David Tallant and Regina Simpson
Sandia National Laboratories
Albuquerque, NM 87185

Initial estimates on the temperature and conditions of the breach in Columbia's wing focused on analyses of the slag deposits. These deposits are complex mixtures of the reinforced carbon/carbon (RCC) constituents, insulation material, and wing structural materials. However it was possible to clearly discern melted/solidified Cerachrome® insulation, indicating the temperatures had exceeded 1760°C. Current research focuses on the carbon/carbon in the path from the breach. Carbon morphology indicates heavy oxidation and erosion. Raman spectroscopy yielded further temperature estimates. A technique developed at Sandia National Laboratories is based on crystallite size in carbon chars. Lower temperatures yield nanocrystalline graphite; whereas higher temperatures yield larger graphite crystals. By comparison to standards the temperatures on the recovered RCC fragments were estimated to have been greater than 2700°C.

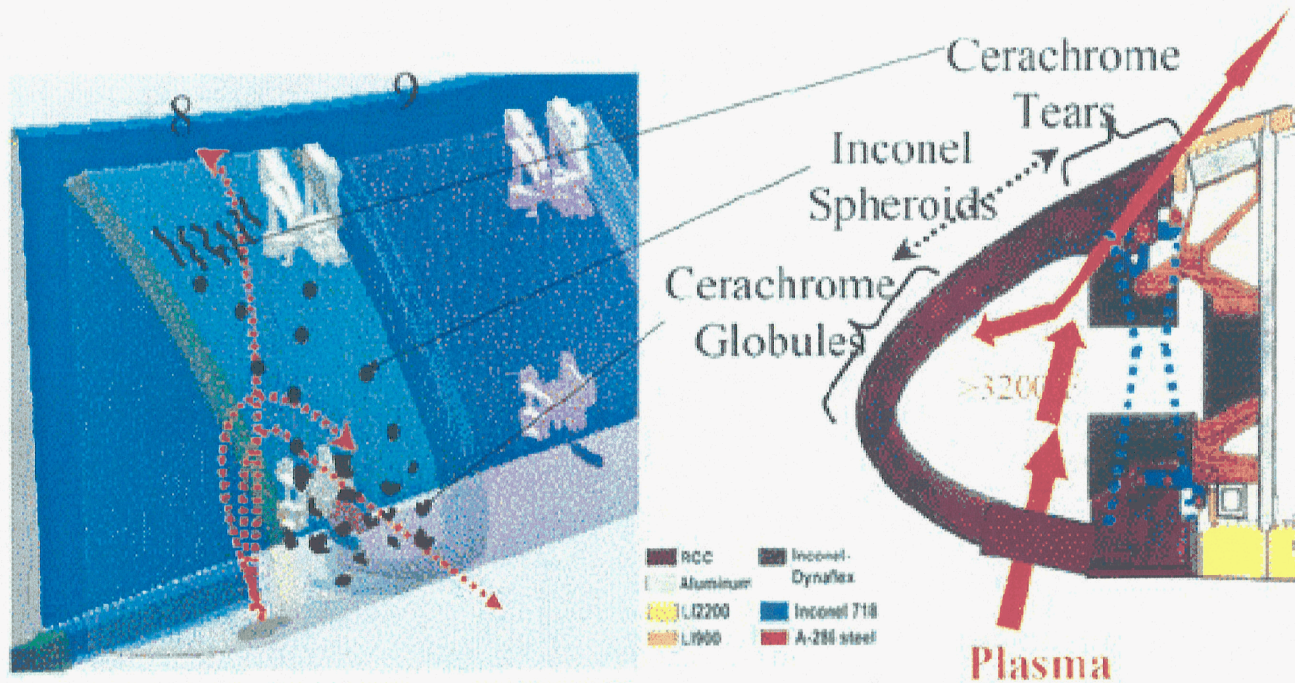
Identification of Breach

- Multi-NASA Center Team Effort—JSC, MSFC, LaRC, GRC
- Key features of recovered leading edge RCC
 - Large deposits of 'slag'—solidified Cerachrome insulation, aluminum alloys, Fe alloys — *on backside*
 - 'Knife edge' appearance of RCC (reinforced carbon/carbon)—known to occur when an exposed edge of RCC is heavily oxidized

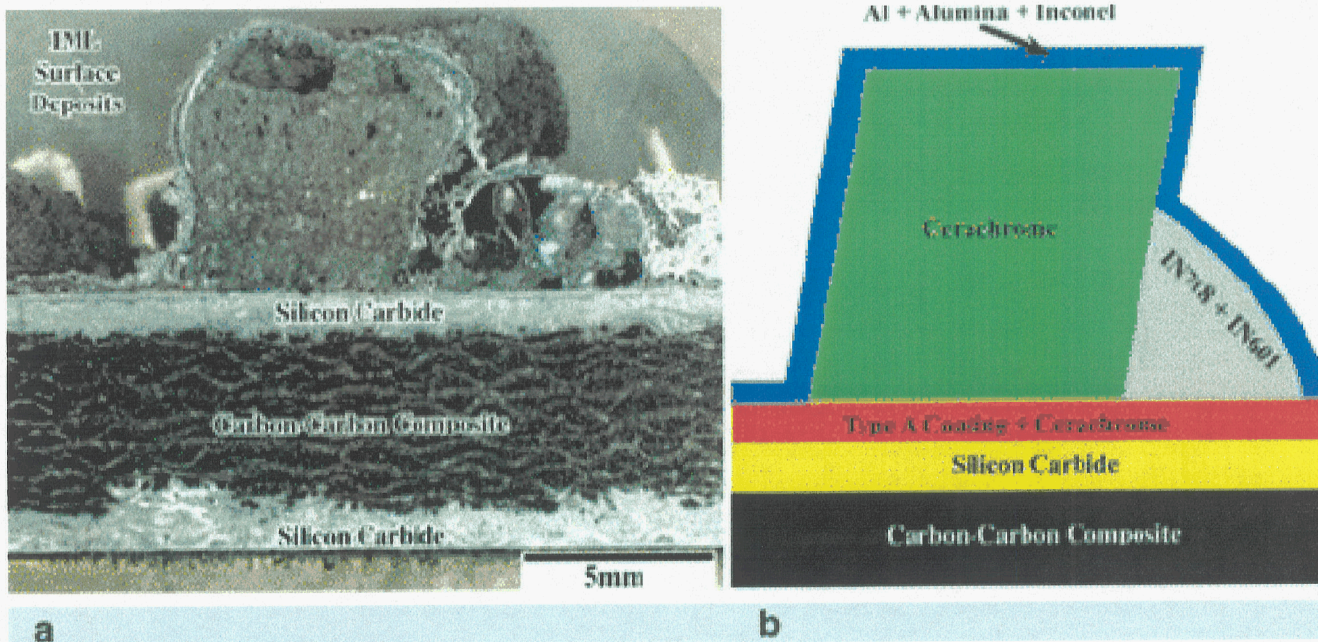
Previous Temperature Estimates

- Cerachrome® mp 1760°C—95% aluminosilicate; 3% chromia
- Mullite forms at ~1100°C
- Examination slag deposits from upper portion of Panel 8 identified mullite and melted Cerachrome ⇒ 1760°C or greater

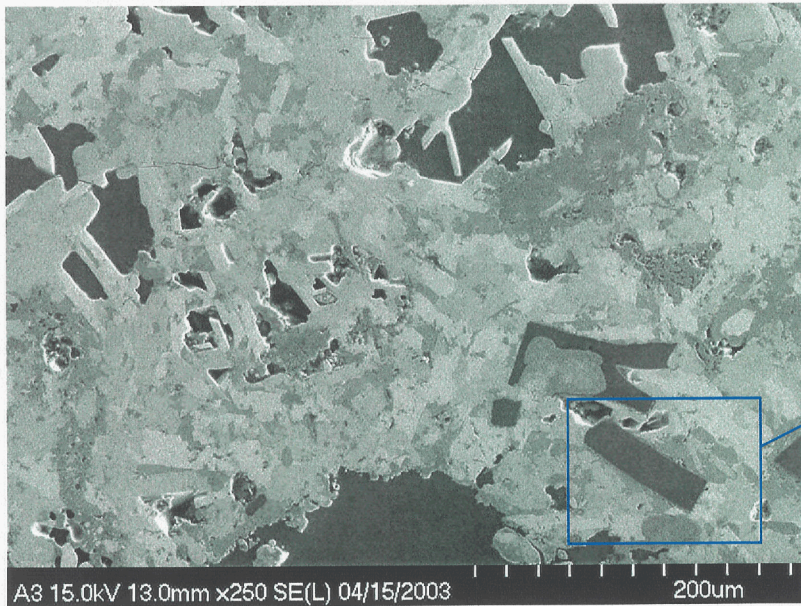
Slag Deposits—Complex Mixtures of Wing Constituents

Solidified metals and ceramics

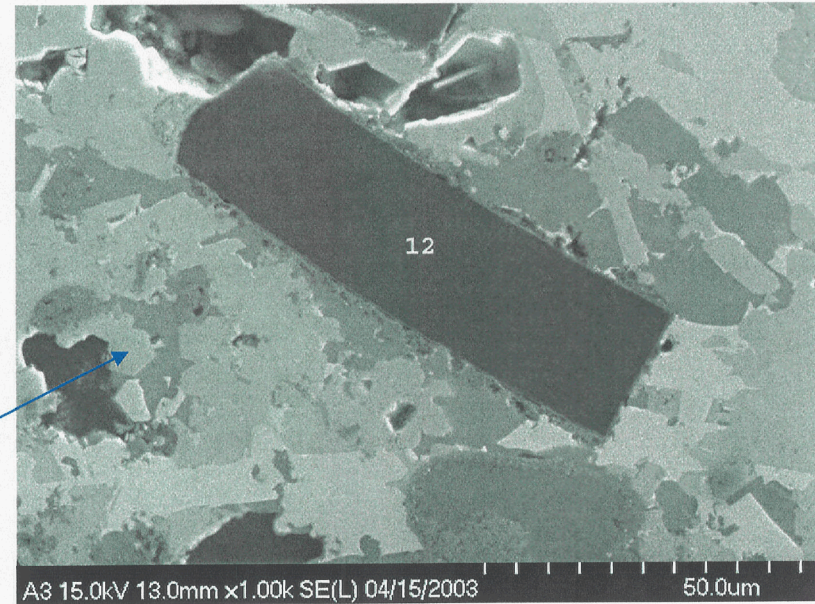
Region 12 – portion of carbon fiber

Region of Melted Cerachrome

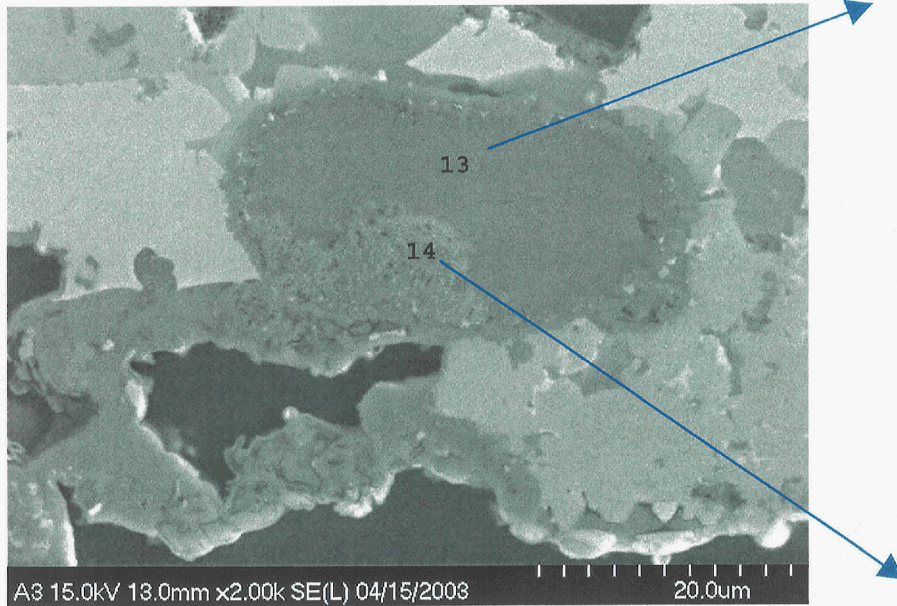
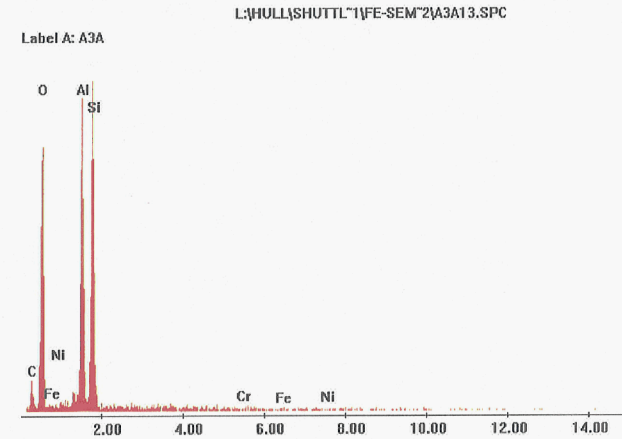
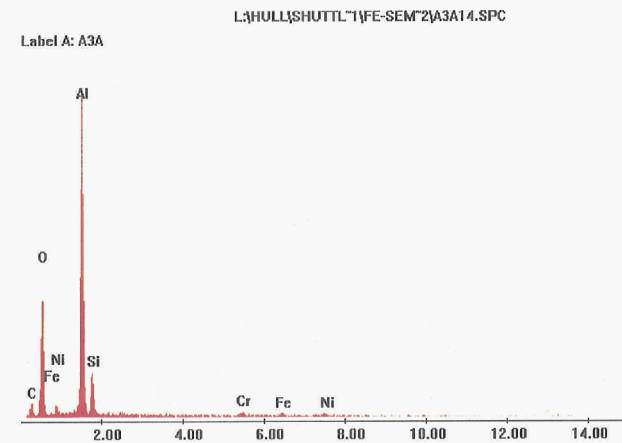
Only well-understood Feature for Temperature Determination

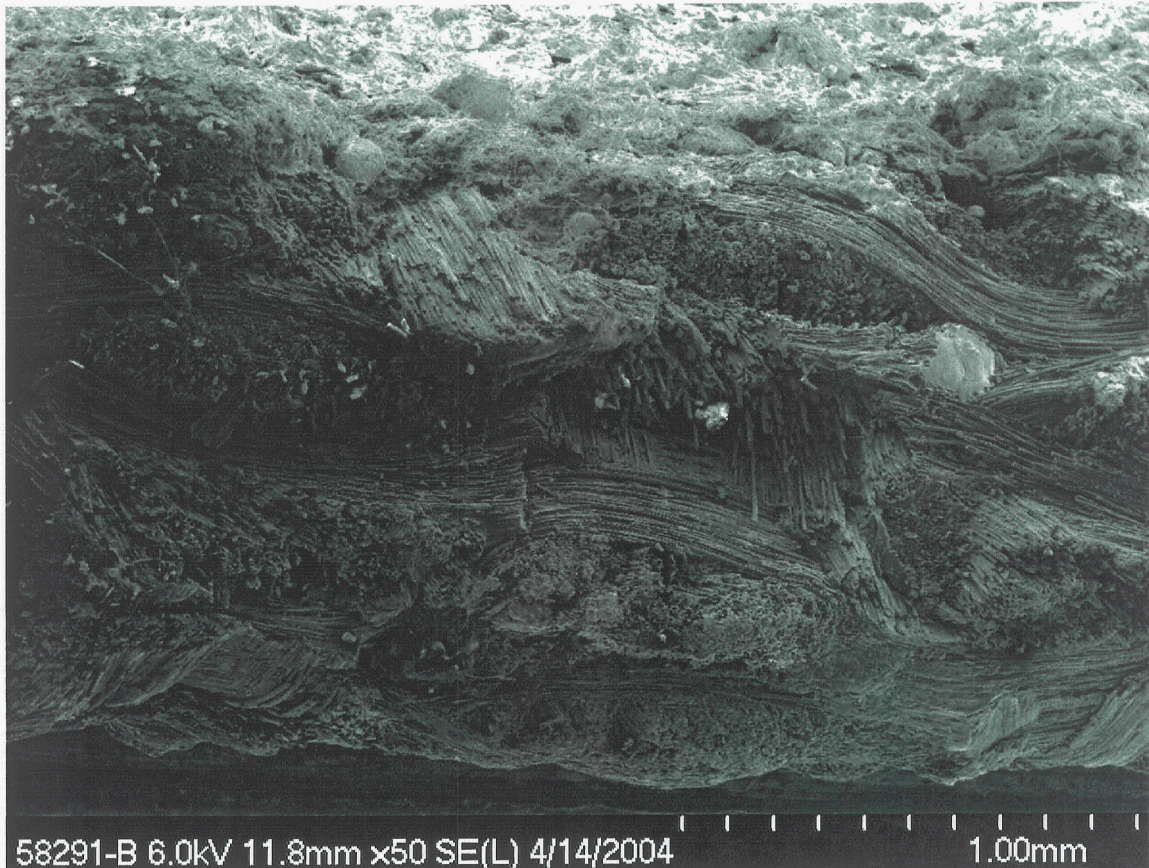
Typical Appearance of RCC Cross Section Fragment

Inner mold line

Slag—solidified
insulation (Cerachrome)
and metals

**Fractured/oxidized carbon
fibers and matrix—Focus
of this study**

Outer mold line

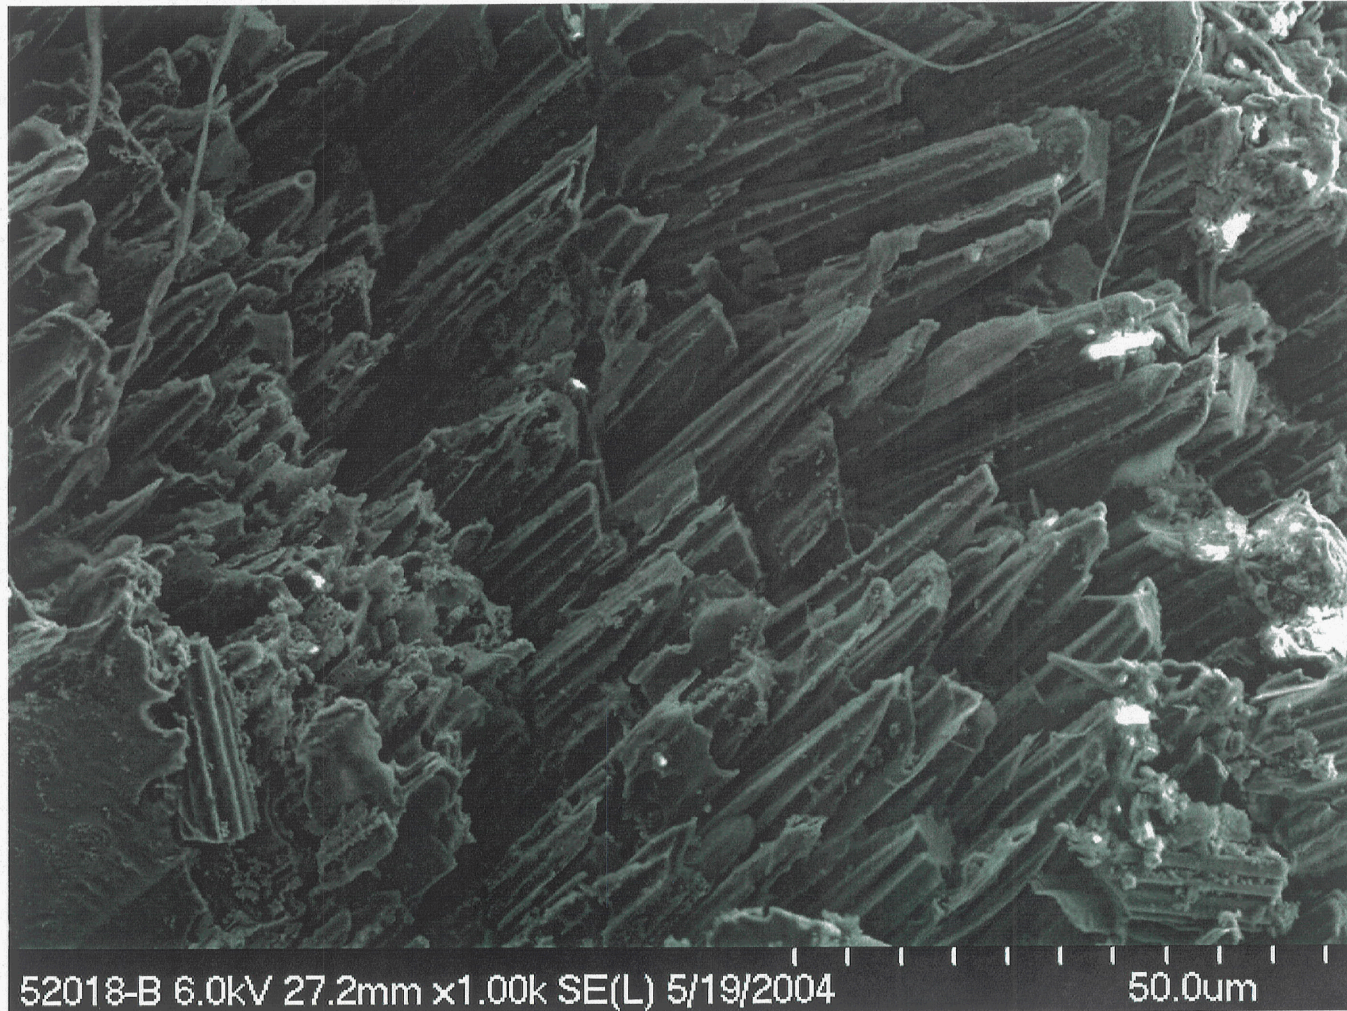
Panel 8

Characteristic Pointed Fibers from High Temperature Oxidation

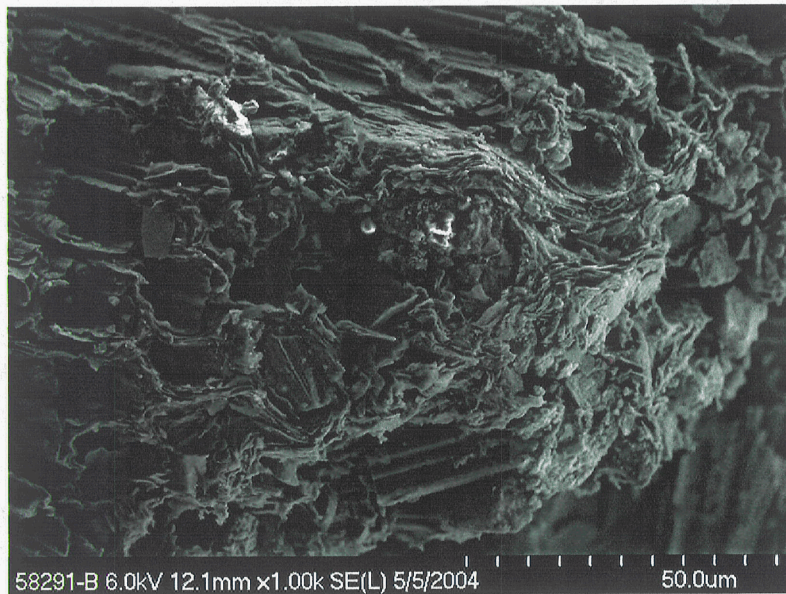
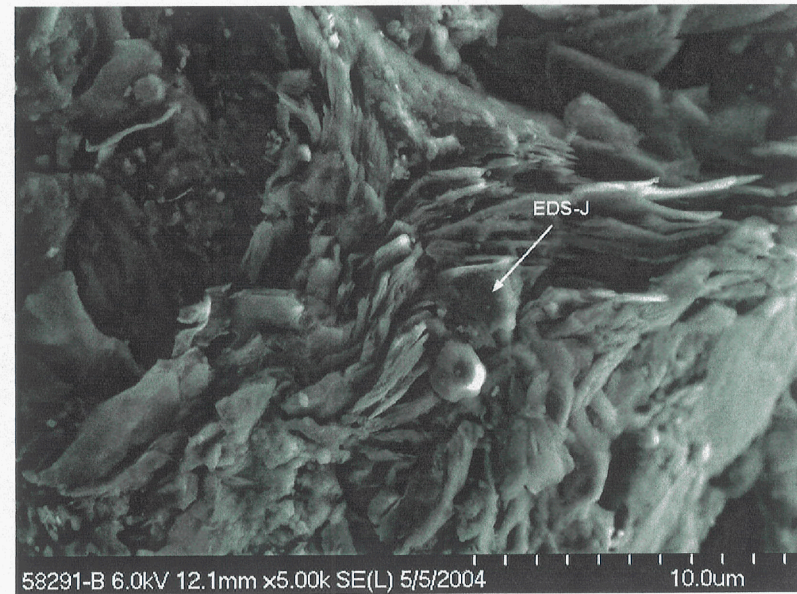
Extensive Oxidation and Erosion of Fibers and Matrix

Panel 8—This layered, plate-like structure is characteristic of heavy erosion in Carbon

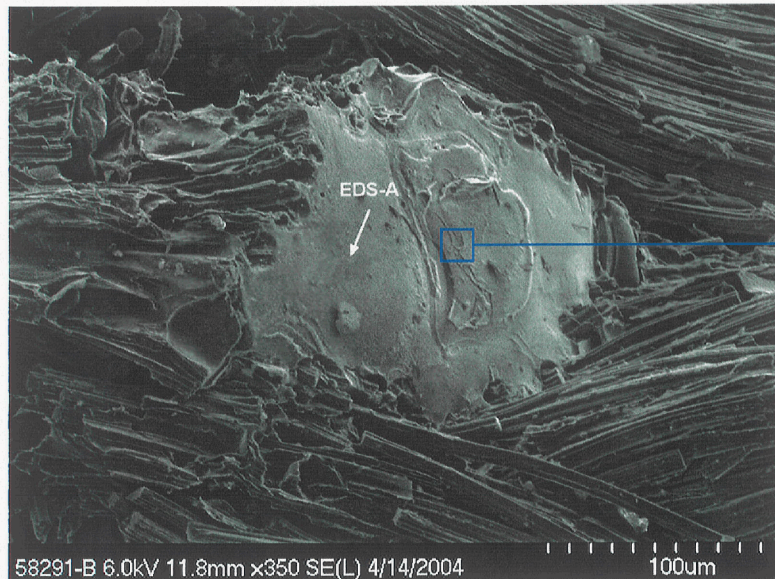
Overall View

Unusual Features in Carbon Matrix

Flowing Carbon? Melting Point of Carbon is 3500 K

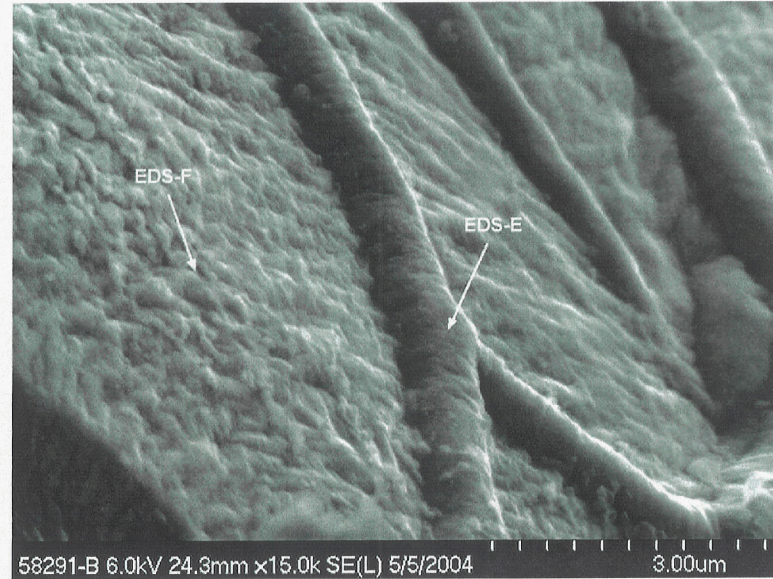
Close-up of veins—all Carbon

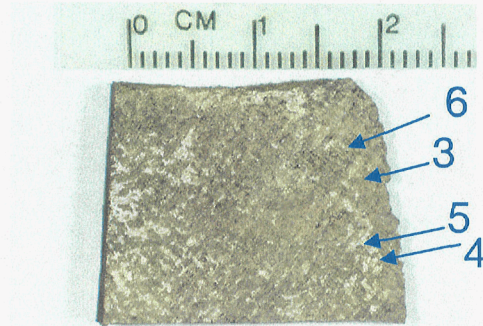
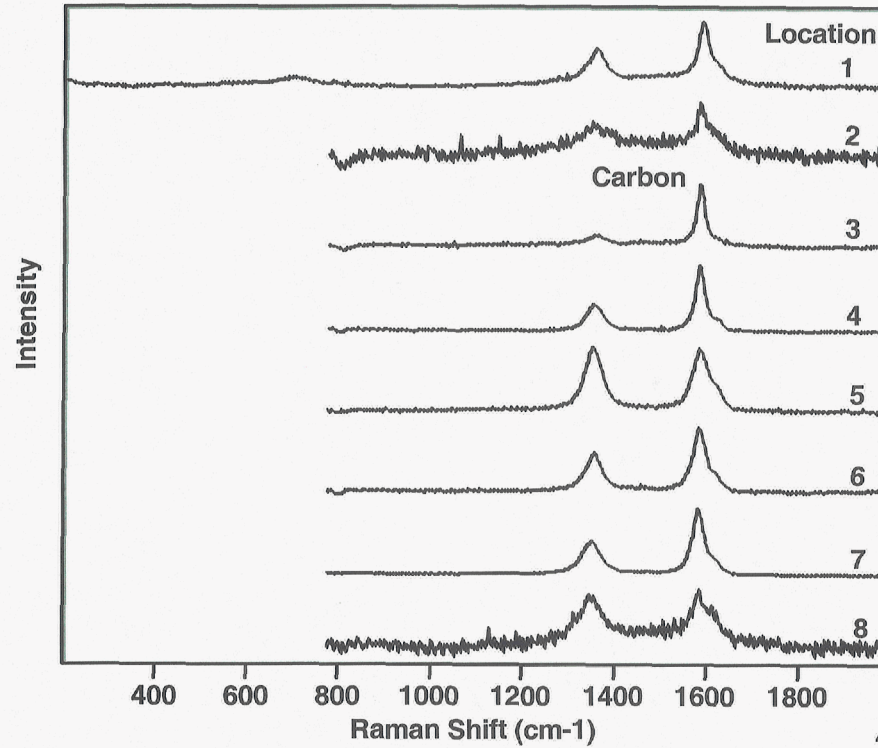
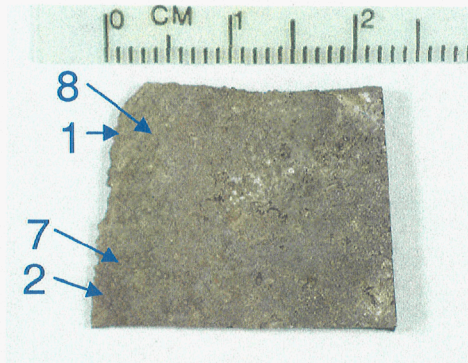
Item #49619A

Raman Analyses of Portion of Upper Panel 8, near Breach

Location	Location Description	Summary of Identified Bands
1	Knife edge	2700 C carbon plus small amount of low temp carbon
2	Knife edge	2700 C carbon plus small amount of low temp carbon
3	Knife edge	>> 2700 C carbon (off scale of reference carbons)
4	Knife edge	> 2700 C carbon (off scale of reference carbons)
5	Up slope	2400 C carbon
6	Up slope	2700 C carbon
7	Up slope	> 2700 C carbon (off scale of reference carbons)
8	Up slope	2400 C carbon
