Fractographic Examination of the Vertical Stabilizer and Rudder from American Airlines Flight 587

Matthew R. Fox* and Carl R. Schultheisz†
National Transportation Safety Board, Washington D.C.

The first major structural component failure of a composite part on a commercial airplane occurred during the crash of American Airlines Flight 587. The fractured composite lugs that attached the vertical stabilizer to the aircraft tail and the fractured composite honeycomb rudder were examined as part of the National Transportation Safety Board investigation of the accident. In this paper the composite fractures are described and the resulting clues to the failure events are discussed.

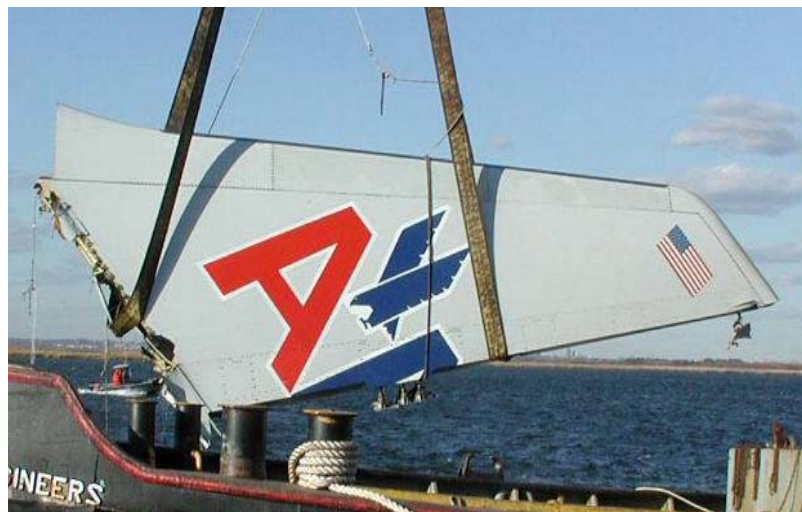
The vertical stabilizer was largely intact with no significant areas of skin buckling. An overall view of the vertical stabilizer as it was being recovered from the water of Jamaica Bay is shown in Figure 3. At the lower end, each of the six attachment locations were separated either by fractures that intersected the lug attach hole or by fractures through the structure above the hole. A schematic drawing of the lower end of the vertical stabilizer is shown in Figure 4, where a general fracture location for each lug is shown with overall views of each of these lug fractures. Portions of rib 1, the rib 1 rib-to-skin attach angle, and the lower end of the forward spar also were fractured. Along the trailing edge, the trailing edge panels were damaged in several locations. A more detailed description of the damage is presented in reference 4.

Figure 3. Vertical stabilizer as recovered from Jamaica Bay.

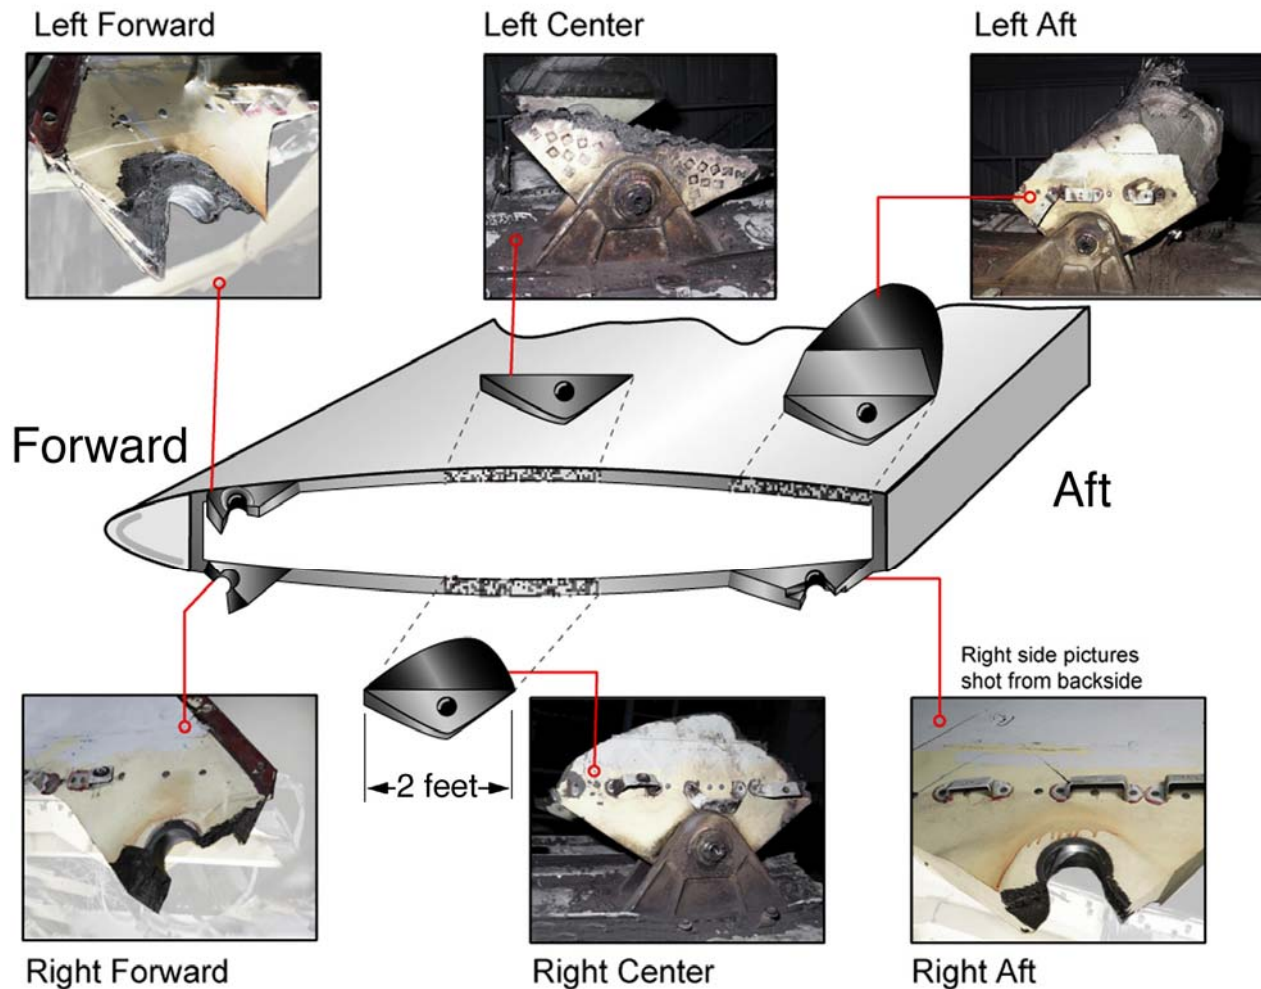
Figure 4. Overall views of main lug fractures with relative locations on vertical stabilizer.

The right aft, right forward, and left forward main lugs had translaminar fractures that intersected the attachment hole, and the remaining lugs had translaminar fractures in the structure above the lug. Each of the lugs had delaminations in the lug area and/or in the structure above the lug. Details of the fractographic examination are presented in references 5 and 6. Some of the delaminations extended into the main portion of the vertical stabilizer, and the extents of these delaminations were determined using nondestructive inspection (NDI), including ultrasonic inspection and x-ray-computed tomography scanning and imaging. Results of the NDI of the vertical stabilizer are presented in references 7 and 8.

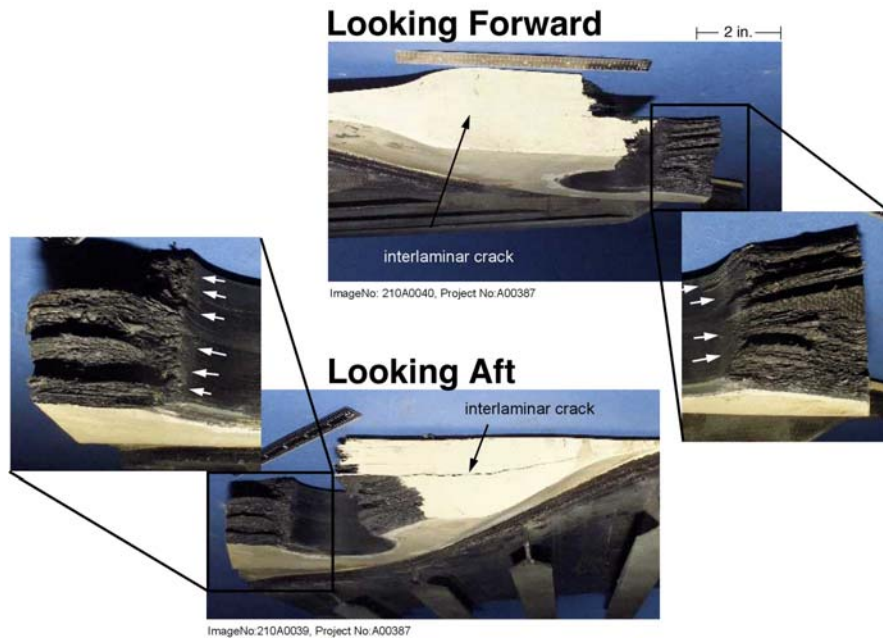
The right aft lug failed by translaminar fracture through the bolt hole as shown in Figure 5. The translaminar fracture surfaces had a rough appearance consistent with fracture primarily under tensile loading. Fractures on each leg of the lug were on different translaminar planes, and the change in planes occurred near the center of the lug thickness. On the aft side of the bolt hole, the outboard side of the fracture was in a plane nearly perpendicular to the zero-degree fiber direction, and the inboard side of the fracture was in a plane approximately parallel to the 45-degree fiber direction. On the forward side of the bolt hole, the outboard side of the fracture was in a plane approximately parallel to the zero-degree fiber direction, and the inboard side of the fracture was in a plane nearly

Figure 5. Right aft lug translamellar fractures (pictured from below the lug).

indicating that fracture occurred at the forward side first, and then the lower ligament hinged about the aft side.

parallel to rib 1. Bearing damage was observed at the bore surface near both fracture surfaces, as indicated by white unlabeled arrows in Figure 5.

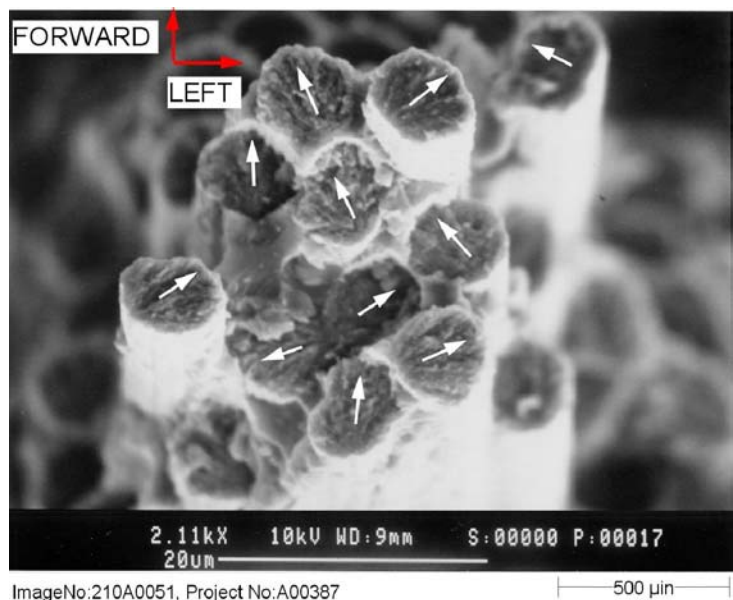
On translamellar fractures, the ends of some fibers were oriented roughly perpendicular to the fracture plane. A typical SEM view of these fiber ends on one of the translamellar fracture surfaces is shown in Figure 6. Fiber ends such as those shown in Figure 6 were examined using SEM to help determine the fracture mechanism and propagation direction. For fibers having radial patterns indicative of tensile fracture, the local fracture propagation direction could be determined from the direction of the radial pattern of several fibers^{9,10}. Then, general directions of fracture propagation for the translamellar fractures could be determined by averaging the directions indicated by the

Figure 6. Fractured carbon fibers showing crack growth directions.

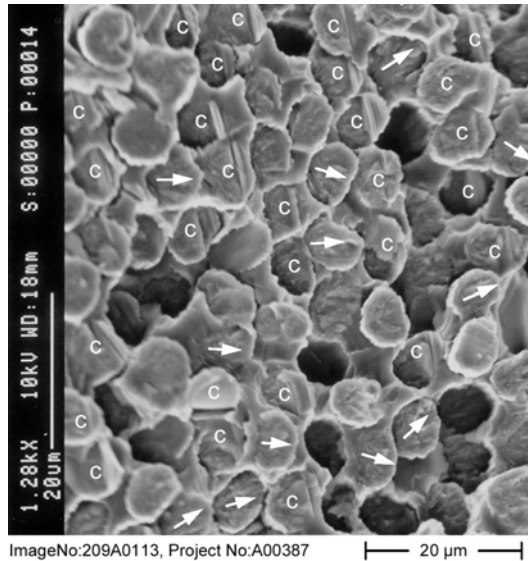
Fractures on the right forward lug intersected the lug hole. Translamellar fracture features were relatively rough, consistent with overstress fracture under tensile loading. Some evidence of local compressive loading was observed near the aft side of the lug,

Figure 7. Fractured carbon fibers showing compression chop marks (C).

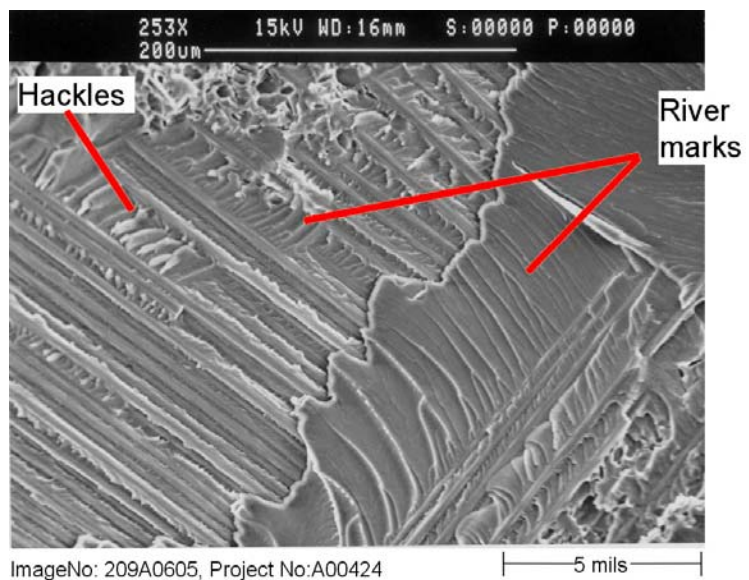
River marks were observed in matrix-rich areas in the vicinity of the bundle crossings, and could be seen in the base of hackles in the transition from a bundle at one orientation to a perpendicular crossing bundle. The river marks in the matrix-rich bundle crossings were used to identify a general direction of fracture propagation upward and aftward for both of the large delaminations (at the forward left and aft left attachments). The use of the river marks at the base of the hackles to determine delamination growth direction was explored in the examination of the delaminations at the forward right lug.

Figure 8. Delamination fracture features.

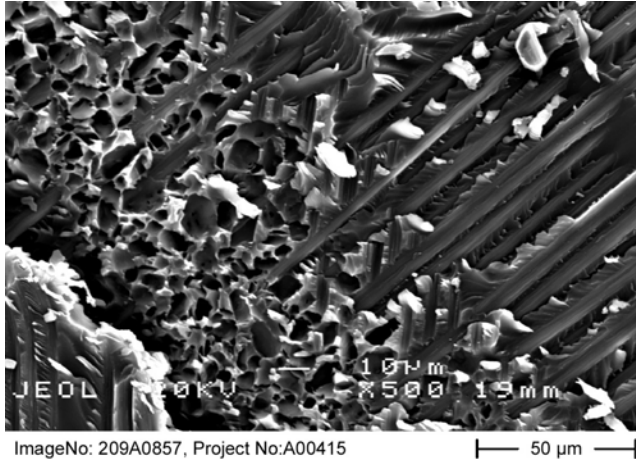
Figure 9. Porosity in matrix rich regions where bundles cross.

At the matrix-rich areas where bundles crossed, some porosity was observed having a somewhat angular appearance as shown in Figure 9. These pores were identified as arising from excess curing agent that had crystallized within the matrix. Such crystals could have been physically removed in the fracture process or dissolved by the water from which the vertical stabilizer was recovered.

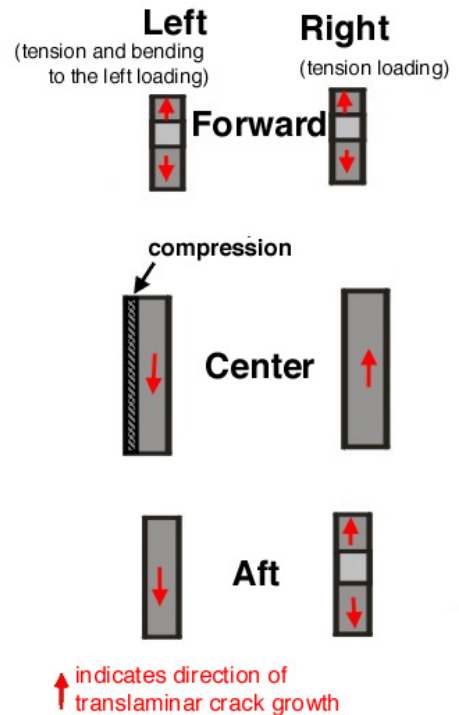
A summary of the observed fracture patterns is shown in Figure 10. The schematic drawing represents a horizontal cross-section of the vertical stabilizer through the main attachment lugs as viewed from above. Lug cross-sections with a light band at the center represent the lugs that failed through the bolt hole. Solid lug cross-sections represent fractures above the bolt holes. Arrows on the lug surfaces indicate the approximate direction of fracture observed on the translaminar surface. On the left center lug, the area of compression fracture features near the outboard side is indicated. The results showed that the failure pattern of fracture in tension on the right side was consistent with an overall bending of the vertical stabilizer to the left. On the left side, the failure pattern of tension and bending to the left was consistent with an overall bending of the vertical stabilizer to the left after fracture of the lugs on the right side.

It was noted that the only compression translaminar failure features were present on the vertical stabilizer at the outboard side of the center aft lug. Typically, composites have less strength in compression than tension. However, the design of the vertical stabilizer was such that the magnitude of the lug failure loads in tension were less than in compression. Furthermore after failure of the lugs on the right side, the curvature of the panel would cause tension loading in the forward and aft lug and compression in the center lug with continued bending to the left. Other unknown factors, such as changes in air loading as the vertical stabilizer deflected after the initial fractures on the right side, would further influence the failure patterns on the left side.

Figure 10. Main lug fracture pattern summary (viewed from above).

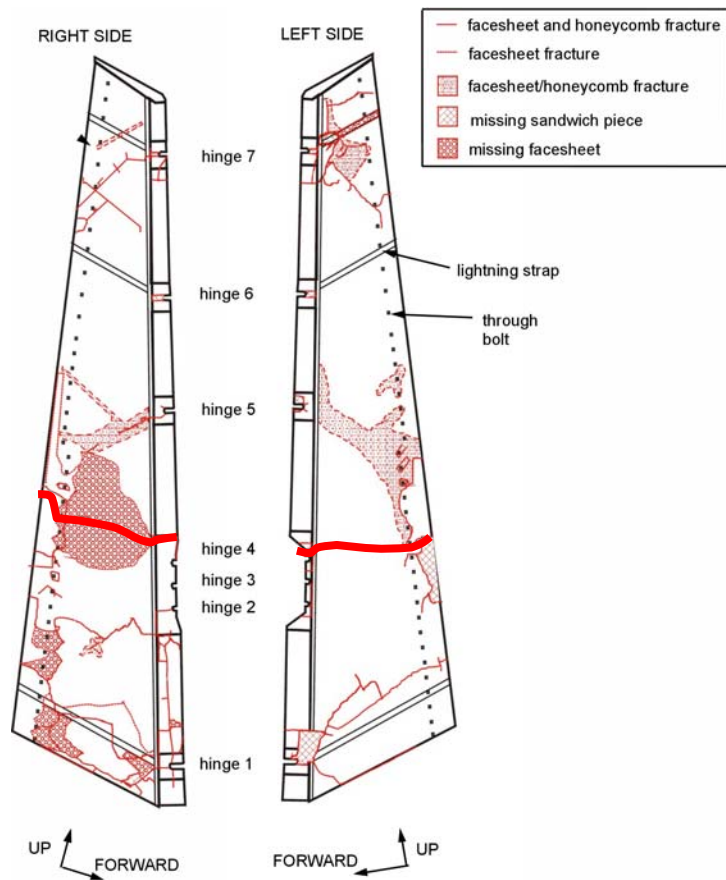
Figure 11. Rudder visible damage.

The rudder had a chordwise fracture through the skin panels on both sides of the rudder near hinge 4 as highlighted in Figure 11. The fractured facesheets of the honeycomb panels in this region were examined. The only fibers running perpendicular to the fractured surface were glass fibers in the adhesive layer that bonded the facesheet to the Nomex core. Chop marks indicating compression failure were found on some of the glass fibers on the inner and outer facesheet on the left side of the rudder and were also found on the inner facesheet on the right hand side. No compression markings were found on the outside facesheet of the right side. An explanation of how these failures occurred would be that the left side failed first due to a bending moment to the left. Once the left side failed the right side sandwich panel would carry the bending moment putting the inside facesheet in compression.

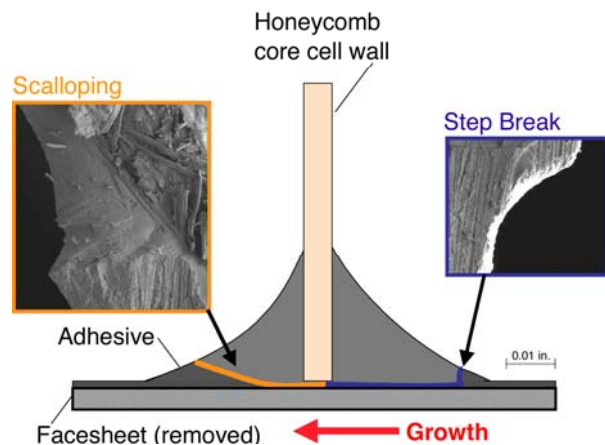
A large section of facesheet was peeled from the Nomex core in the area of hinges 2, 3, and 4. The facesheet was not recovered, but the fractured adhesive attached to honeycomb was examined and found to have step and scalloping features as seen in Figure 12 that indicated a fracture direction. River markings found in the scalloped region supported this interpretation of the

Figure 12. Fracture of the rudder honeycomb core from the facesheet.

fracture growth direction. From samples taken from three separate regions, the facesheet appeared to have been peeled from the forward side of the rudder skin panel toward the trailing edge.

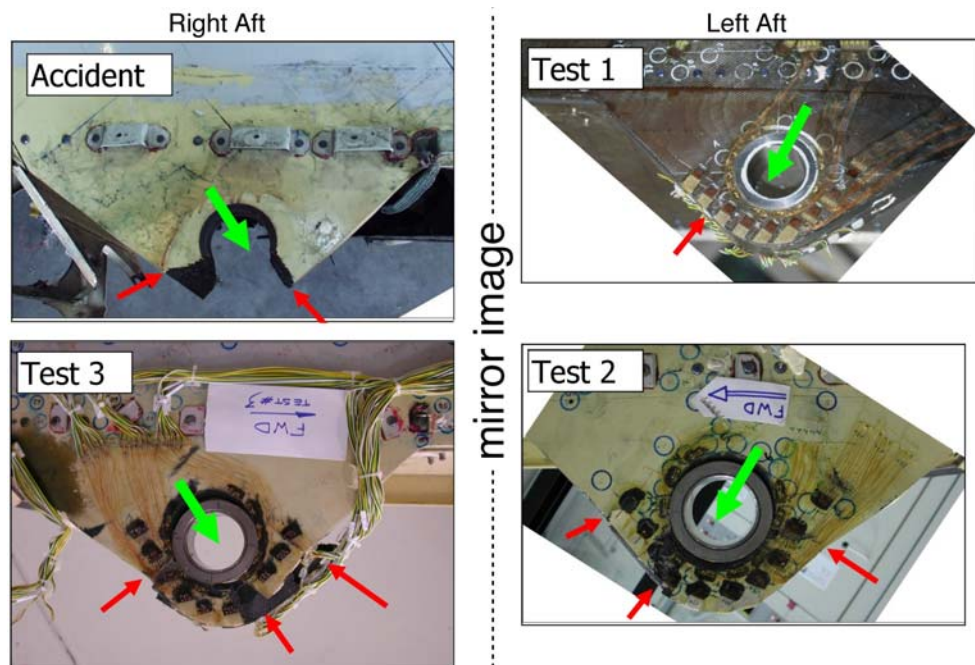
Overall views of the lugs from each test are shown in Figure 13 (outboard surface view). A similar view of the accident right aft lug also is shown in Figure 13. Unlabeled red arrows indicate where translaminal fractures intersected the outboard surfaces of the lugs, and an unlabeled large green arrow indicates loading direction (the force vector for the horizontal and vertical loading components for each lug). The lugs from the first and second

Results from the fractographic examination showed that fractures in the test lugs occurred at locations similar to those on the accident right aft lug. In the first test, loading was interrupted after fracture occurred as shown in Figure 13. The translaminal fracture was located at a position on the forward part of the lug in a plane nearly parallel to the resultant

Figure 13. Aft lugs from accident and subsequent subcomponent tests.

force direction, similar to one of the translaminal fractures in the accident right aft lug. Fracture features for the lugs from tests 2 and 3 were similar to each other. The outboard side of each of these lugs had a translaminal fracture on the forward sides of the holes in a plane nearly parallel to the loading direction and another translaminal fracture at the aft side of the hole in a plane approximately perpendicular to the loading direction, fractures similar to that of the accident lug. In addition on the outboard sides, a compression buckling fracture was observed on the forward sides of each lug above the fracture parallel to the loading direction, which is different from features on the accident lug but was attributed to constraints of the loading fixture. On the inboard sides of lugs 2 and 3, fracture locations were on translaminal planes different from that of the outboard side of the lug. This change in fracture planes was similar to that of the accident right aft lug.

Each subcomponent test lug had translaminal fractures that intersected the lug hole and had delaminations that were located within the lug, features similar to the accident right aft lug. Each lug had a translaminal fracture at the forward lower side of the hole on the outboard side of the lug, including the first test, which was interrupted and had no other translaminal fractures. The fracture at the forward lower side of the hole corresponds to one of the translaminal fracture locations on the accident lug. The second test lug showed changes in translaminal fracture planes that were qualitatively similar to that of the accident right aft lug. These results indicated that the accident right aft lug had fracture features consistent with being the first lug fracture from a substantially intact vertical stabilizer and rudder under accident load conditions.
