Combustion Device Failures During Space Shuttle Main Engine Development

Otto K. Goetz
NASA

5th International Symposium on Liquid Space Propulsion
Long Life Combustion Devices Technology

Chattanooga, Tennessee
October 27-30, 2003

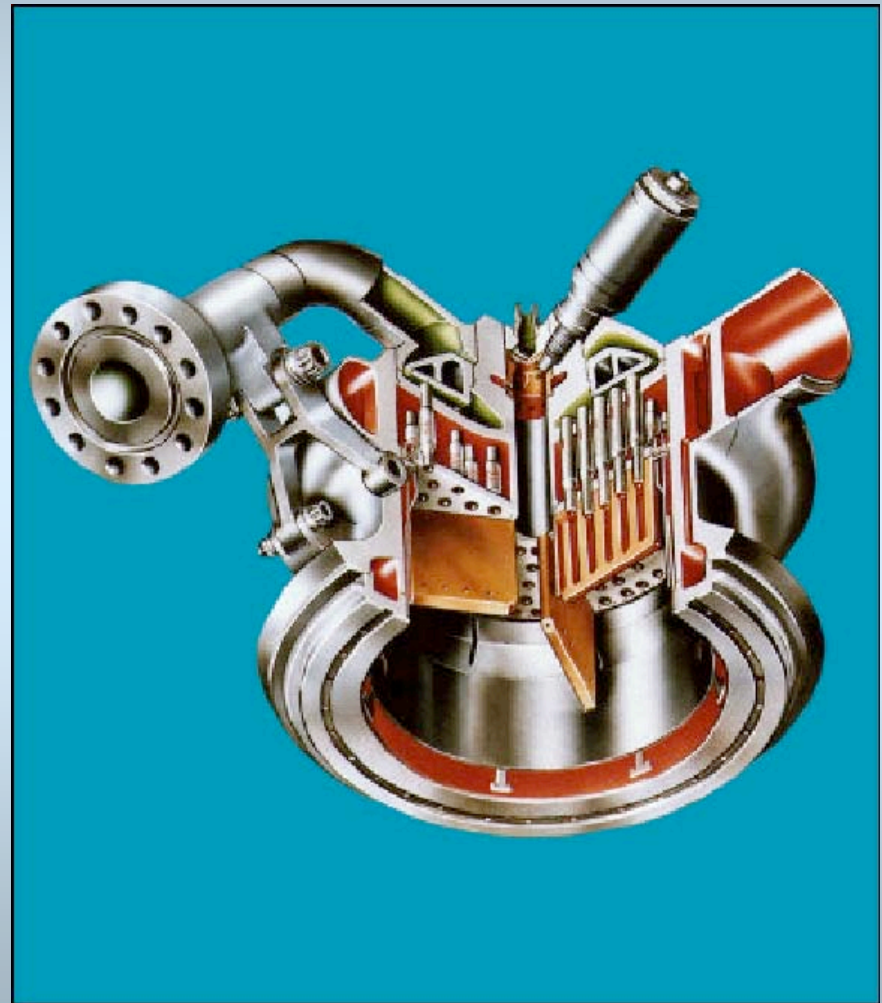
Engine 2106, Test 902428, July 1, 1987

Failure: Interpropellant braze joint

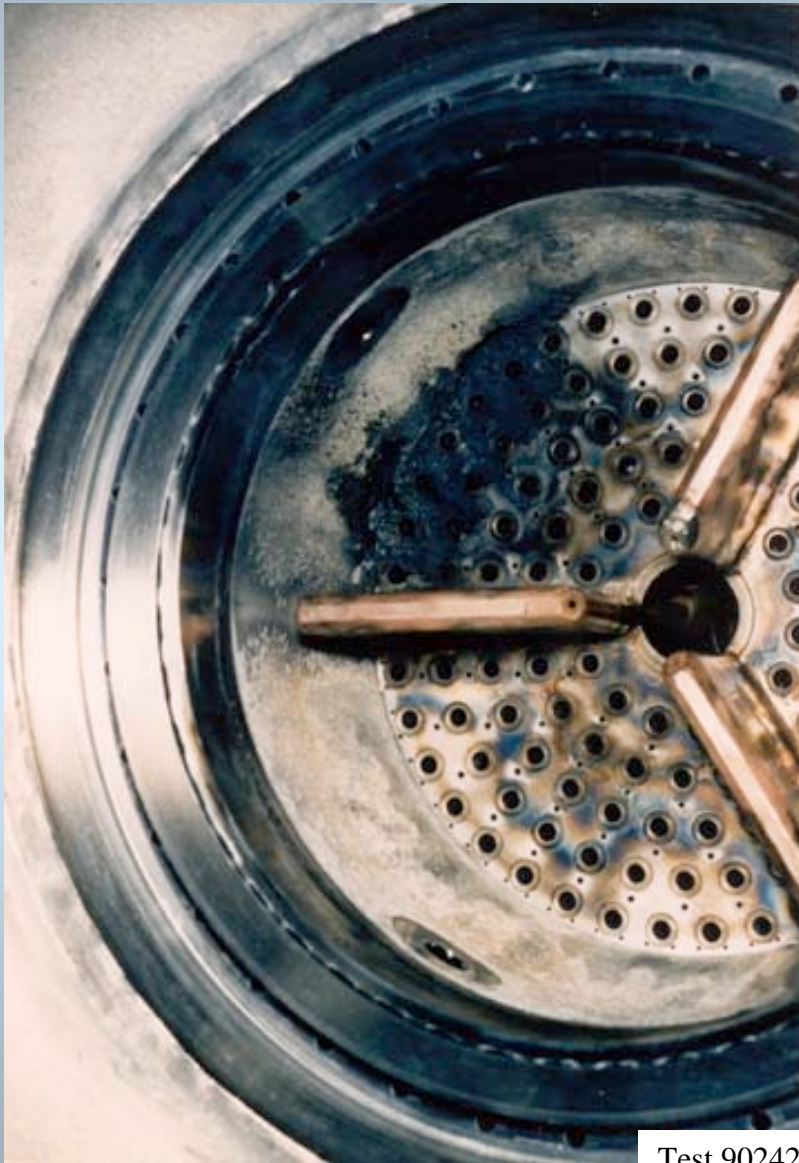
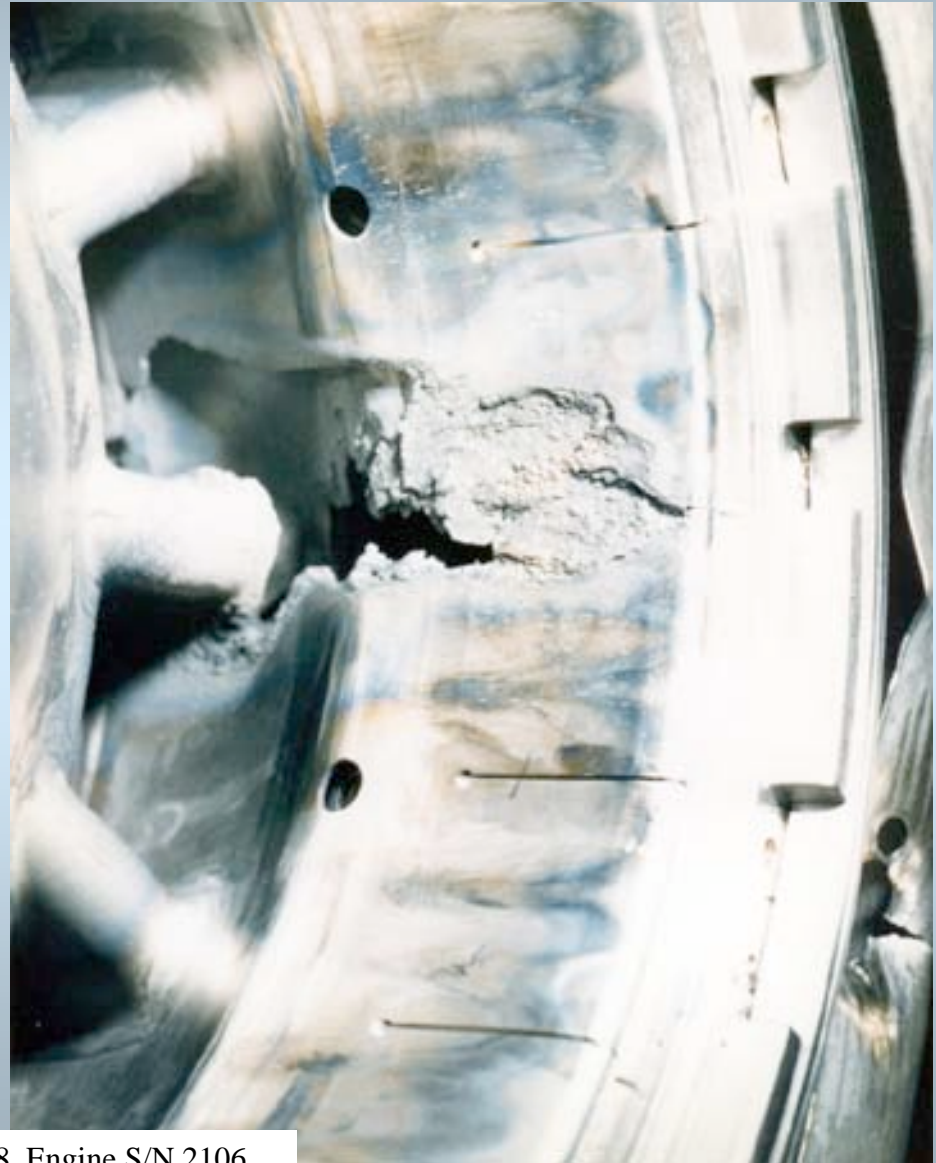
Test 902428, Engine S/N 2106

Incident Description: Test 902428 proceeded normally until 163 seconds when the High Pressure Oxidizer Turbopump (HPOTP) turbine discharge temperature channel A began to increase without any increase in channel B. These changes indicated a hot streak in the Oxidizer Preburner (OPB). The data showed an increasing loss of turbine power beginning at 167 seconds and continuing to 188 seconds. Subsequent to 188 seconds, the overall engine power level decreased until the fuel turbine temperature lower limit was violated at 204.12 seconds and the test was terminated.

Post test inspections revealed moderate erosion in one quadrant on the OPB faceplate and a hole through the HPOTP turbine inlet sheet metal. Leakage tests of the OPB interpropellant plate conducted on the engine revealed leak at baffle number 2, row A pin (2A).

Cause: Poor quality braze joints (greater than 90 percent porosity) at row A baffle pin to interpropellant plate joint. The large porosity was related to poor process control techniques used in the laboratory furnace. The poor quality braze joint failure was most probably due to low cycle fatigue.

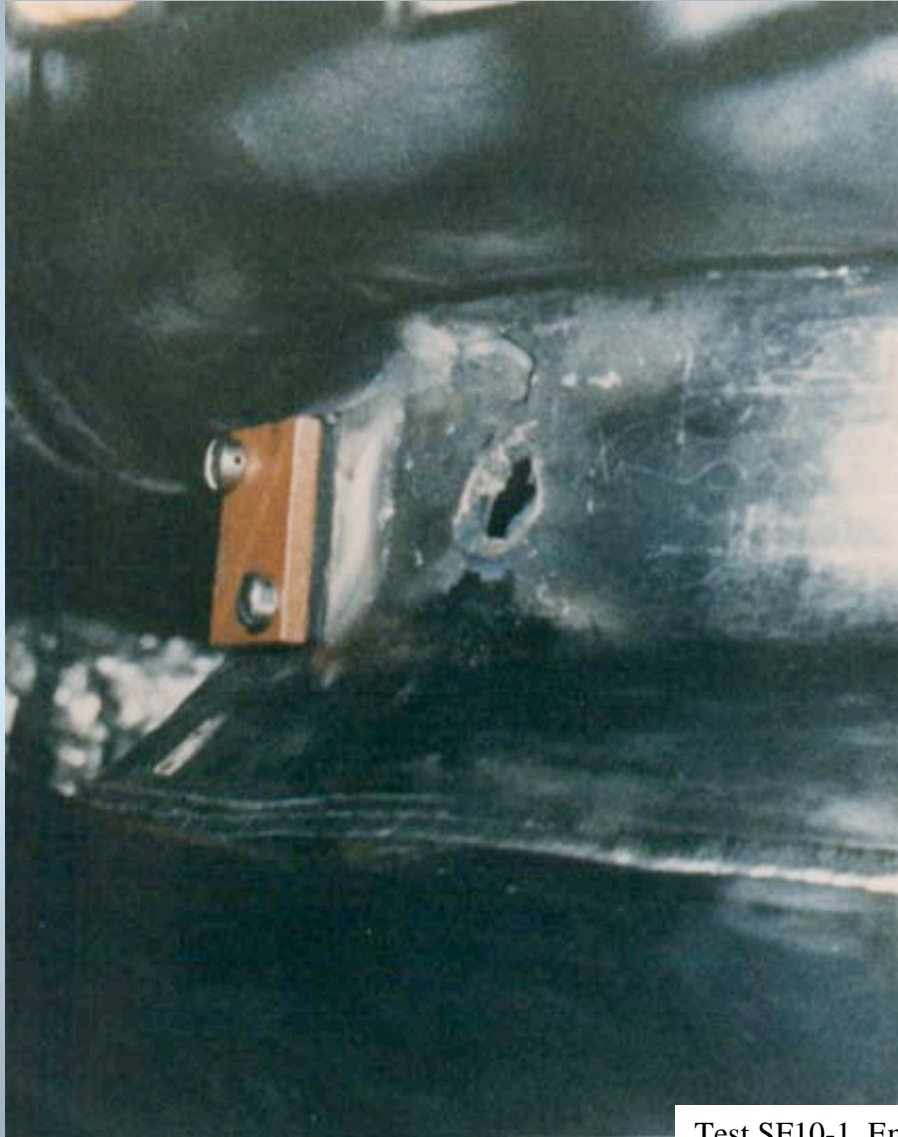
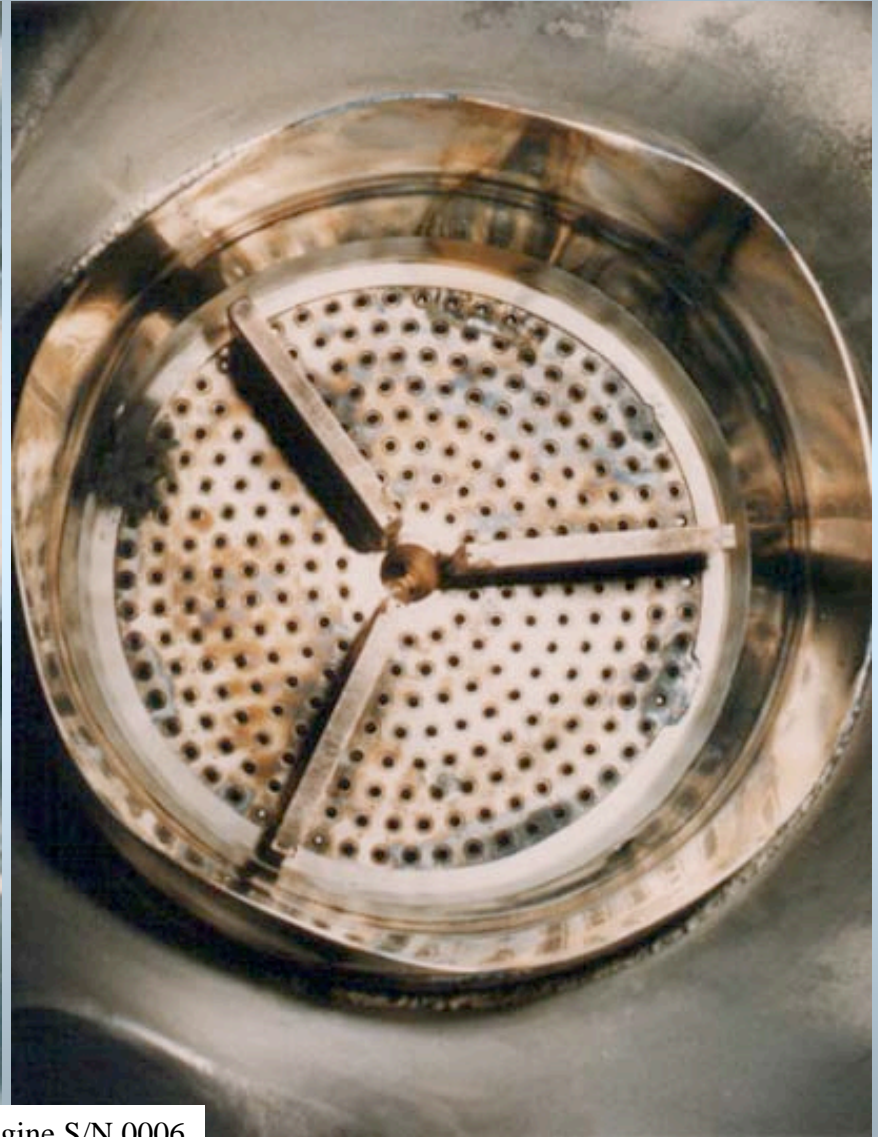
Test SF10-1, Engine S/N 0006

Failure: Fuel Preburner Body Burnthrough

Incident Description: Test SF10-1 was prematurely terminated at 106.6 seconds when fire detectors and hazardous gas detectors triggered in the aft fuselage, and the fire detect redline observer terminated the test.

Cause: Individual element Lox posts were not concentric with the fuel annuli, causing a fuel restriction on the outboard side of the outer row elements.

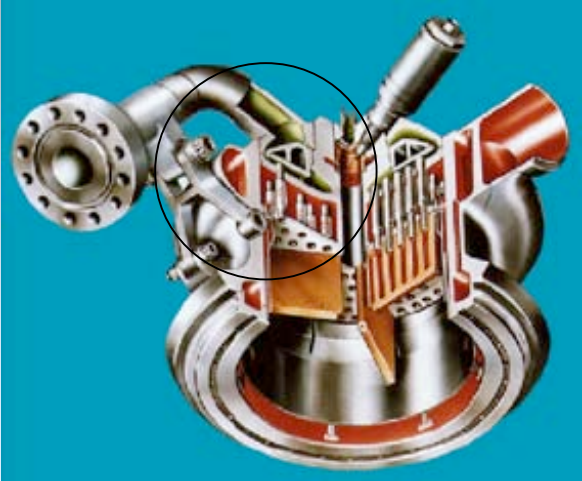
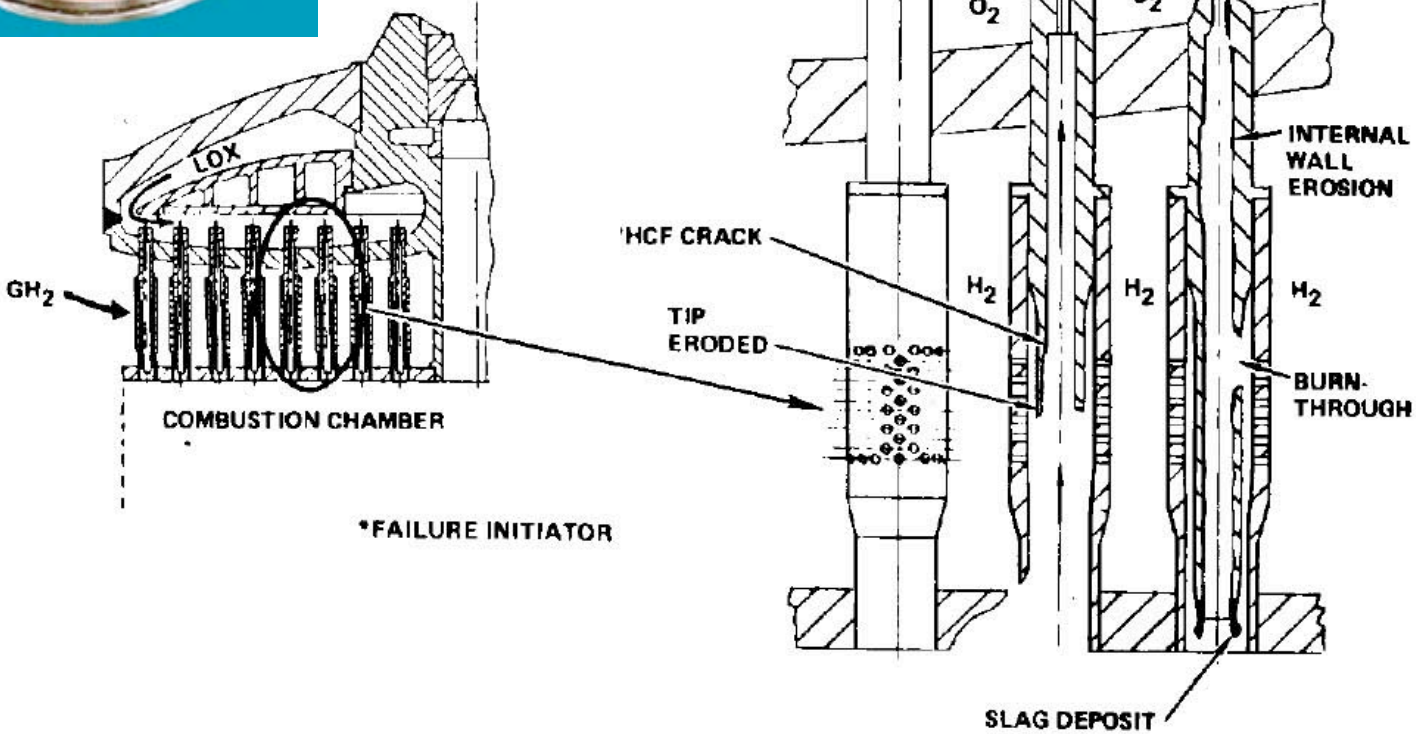
Test 901307, Engine S/N 0009

Failure: Fuel Preburner Injector element erosion

Incident Description: Test 901307 proceeded through programmed shutdown. A metallurgical examination revealed a crack in one Lox post in the fuel preburner. Fuel mixes with Lox through the crack, ignites, and burns the Lox post tip. GH2 backflows into the Lox dome through the damaged element after shutdown has been initiated. The recirculating GH2 ignites with residual Lox and causes additional injector damage.

Cause: High Alternating stresses resulting from combined mainstage mechanical vibration and flow induced vibration associated with element hydrogen flow.

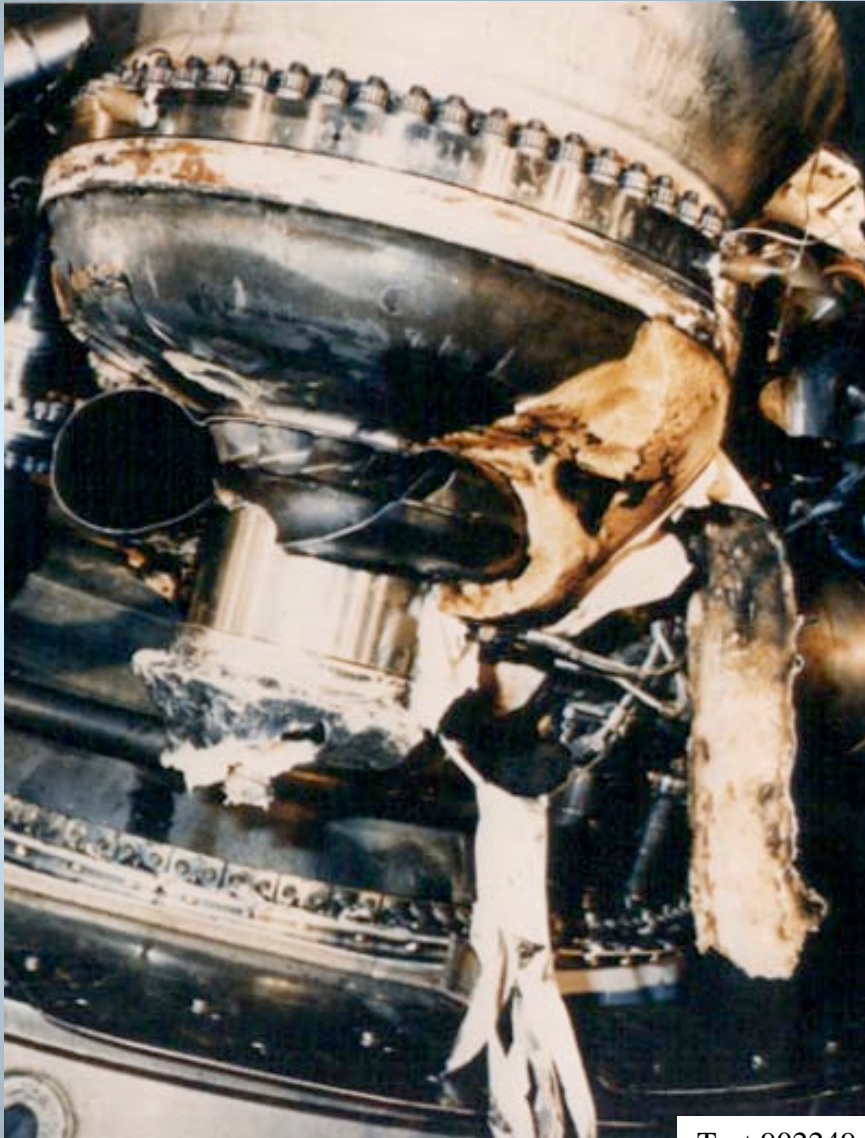
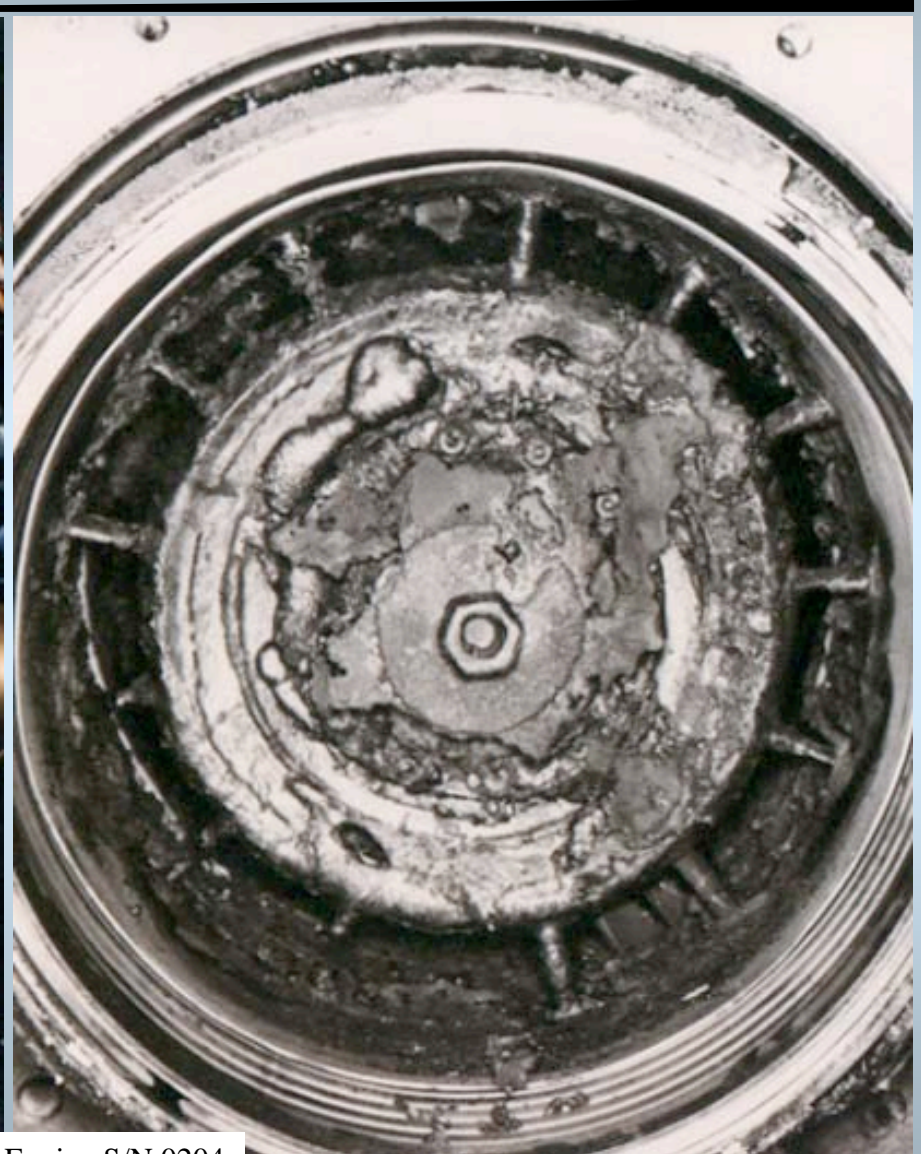
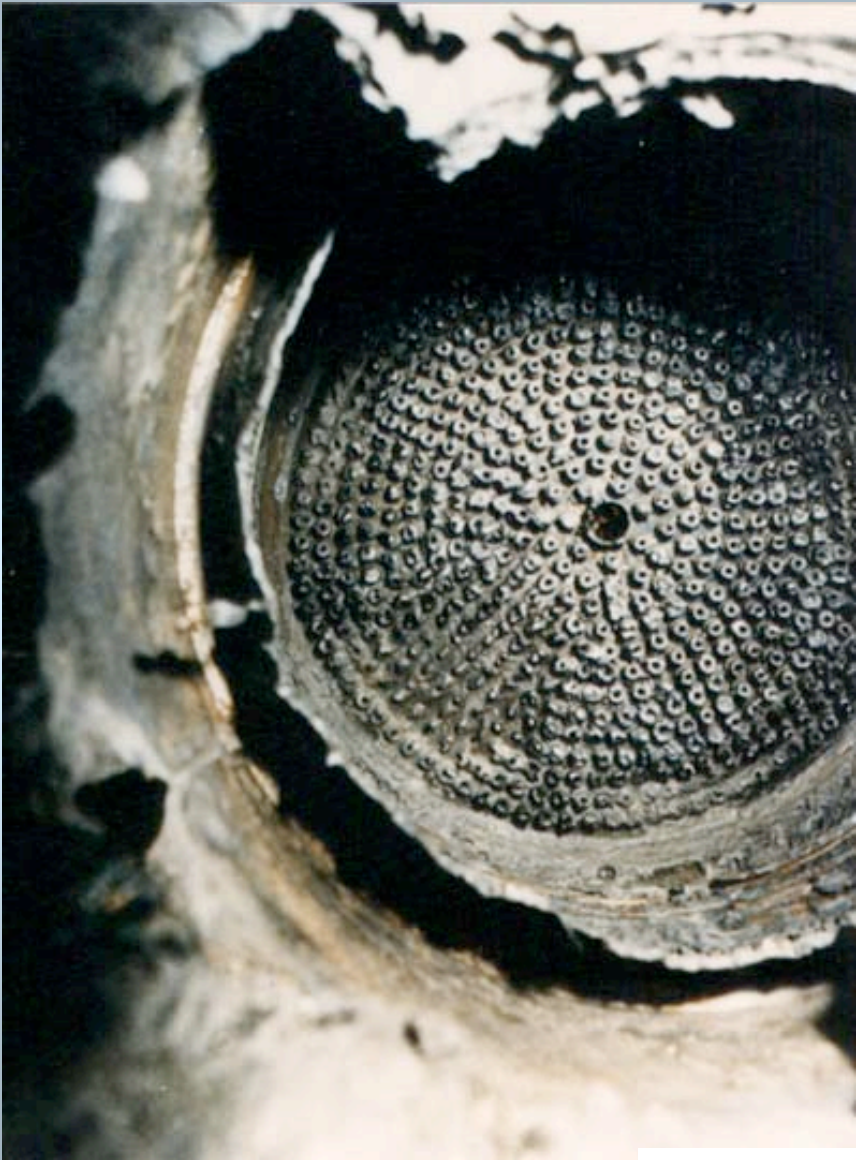
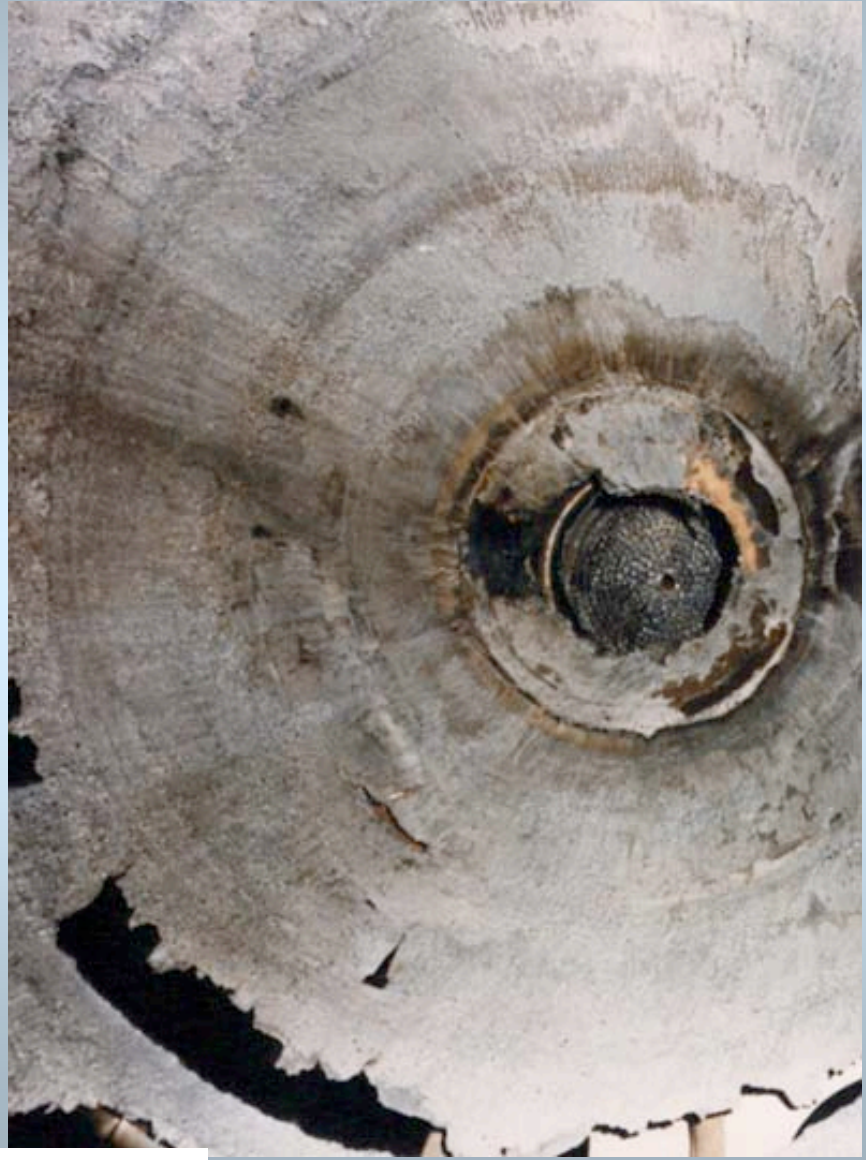
Test 902249, Engine S/N 0204

Failure: High Pressure Fuel Turbopump (HPFTP) turbine blade failure

Incident Description: Test 902249 was terminated at 450.58 seconds when the HPFTP accelerometer measurements exceeded the redline value. Posttest inspection of the engine revealed a section of the HPFTP inlet volute missing, severe damage to the Main Combustion Chamber (MCC) and Main Injector, the nozzle, HPFTP and HPOTP turbine sections, the heat exchanger and the Hot Gas Manifold. The missing section of the HPFTP inlet volute caused the loss of all of the fuel from the engine leading to a highly oxygen rich shutdown.

Cause: FPB injector face had experienced damage during a prior test and had been repaired by plugging several oxidizer posts in one quadrant resulting in a circumferential temperature gradient in the preburner. Localized high temperature streaking caused disbonding of the first stage turbine tip seals; excessive rubbing of the blades caused blade failure, sudden rotor speed decay and resulting HPFTP inlet volute rupture and Lox rich shutdown.

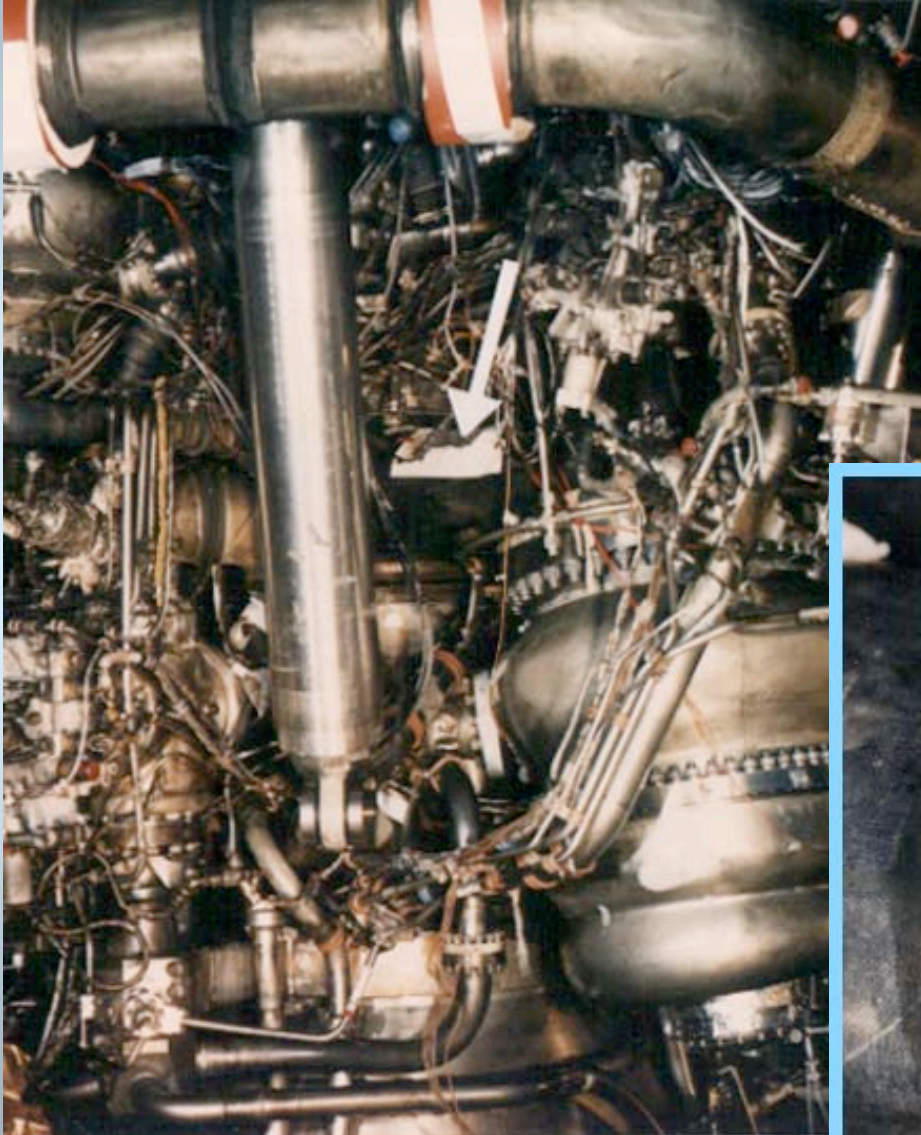
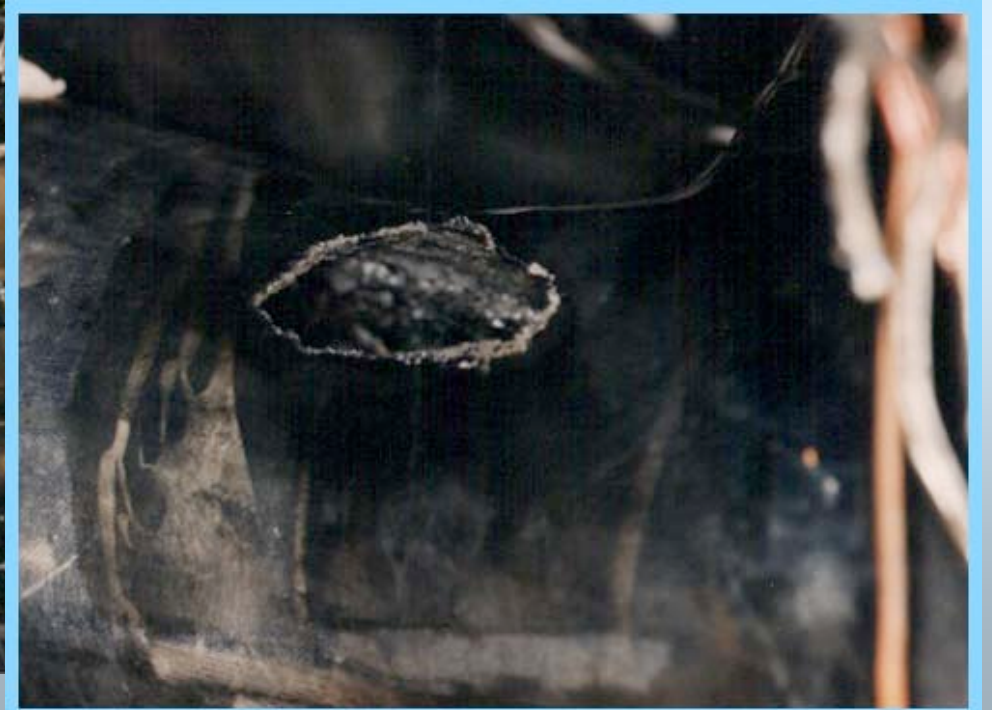
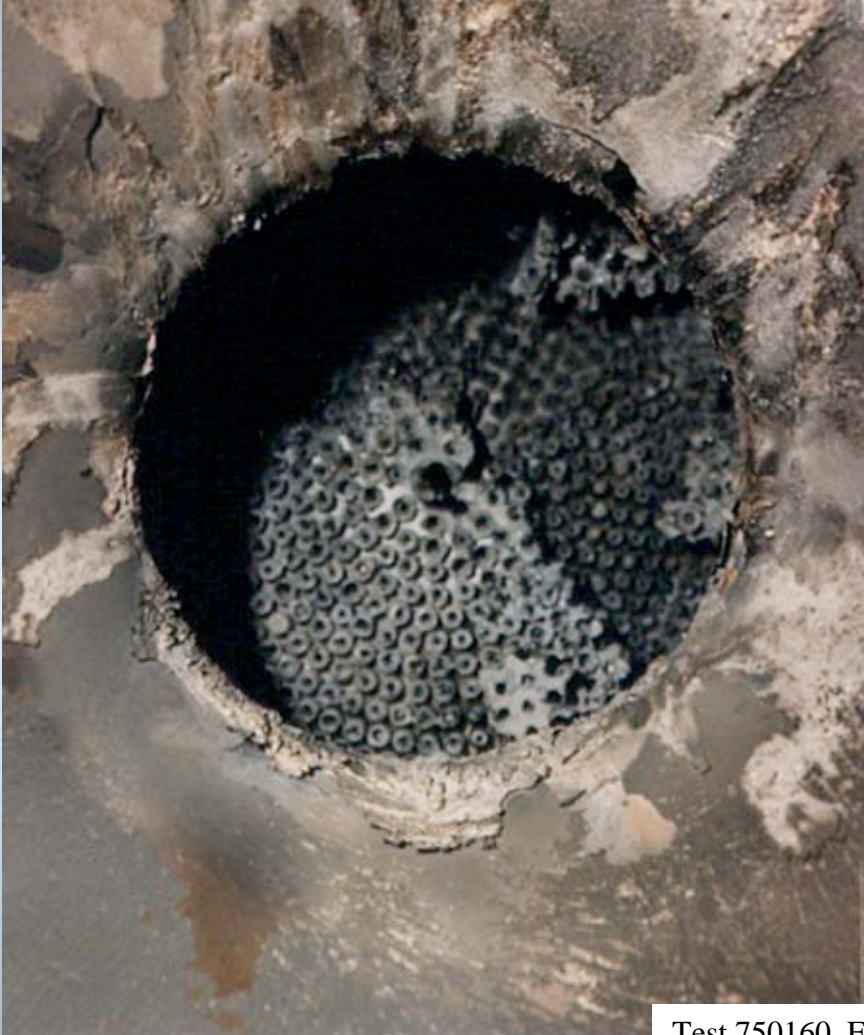
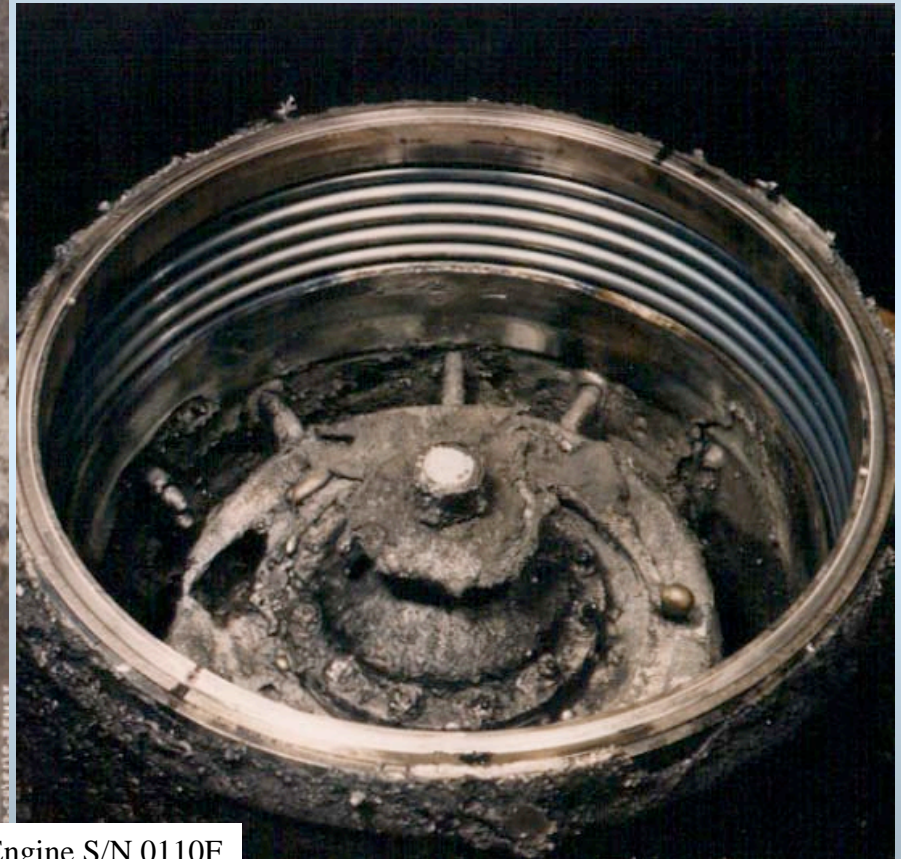
Test 750160, Engine S/N 0110F

Failure: Fuel Preburner Fuel Supply Blockage - Ice

Incident Description: Test 750160 was prematurely terminated at 3.16 seconds by the HPFTP Turbine discharge temperature redline. Posttest hardware inspection revealed severe erosion damage to the high pressure fuel and oxidizer turbines, main injector, MCC, nozzle, and hot gas manifold. A hole burned through the left side transfer tube resulting in a rupture of the Fuel Preburner Oxidizer Valve actuator hydraulic line and an external fire.

Cause: Data analysis, hardware condition and supporting laboratory tests identified the cause of the incident as EDM water contamination of the fuel system upstream of the fuel preburner. The formation of ice during engine start resulted in fuel flow restriction in some fuel preburner elements. This restriction produced one or more abnormally high temperature combustion gas zones which cause turbine blade erosion and/or failure. The resulting decay in fuel flow to the engine produce excessive combustion gas mixture ratio and subsequent erosion damage.

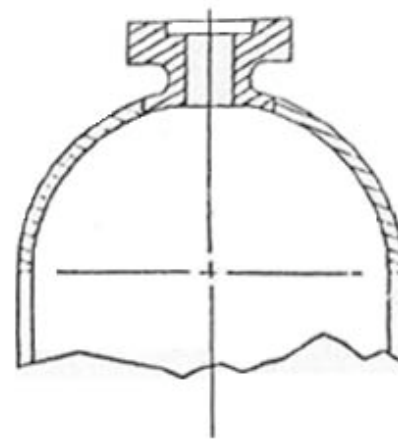
Engine S/N 0207 (One of Nine
Powerheads)

Failure: FPB Instrumentation Boss Crack

Incident Description: Test 901468 was prematurely terminated at 203.86 seconds when the external powerhead temperature redline was exceeded. Visual inspection revealed a crack in the weld forward of the stub to the joint flange.

Cause: High cycle fatigue of welded in port. Not flight configuration and only power head in service with welded in instrumentation ports.

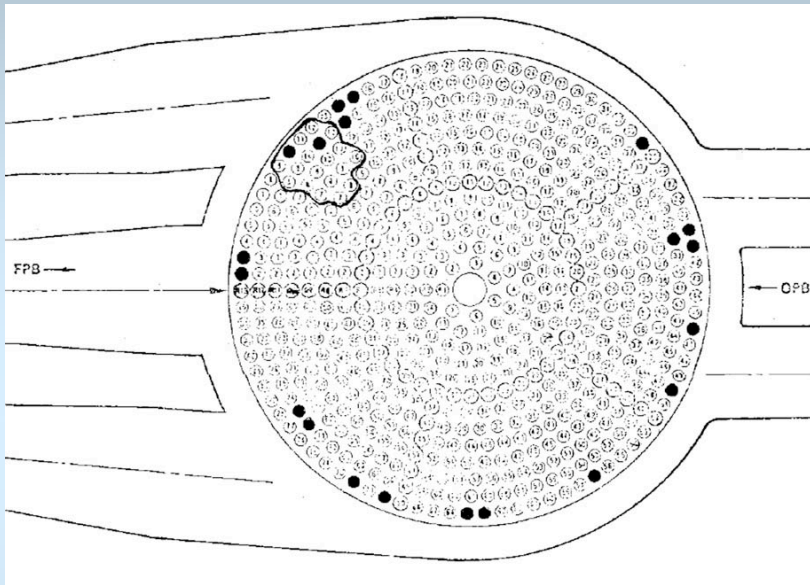
Test 901173, Engine S/N 0002

Incident Description: Test 901173 was terminated at 201.17 seconds when the HPFTP turbine discharge temperature redline was exceeded. At approximately 200.7 seconds, Lox post 10, Row 13 cracked through at the tip radius between the primary and secondary faceplates. Hot gas flow into the lox post ignited and burned out the post. Lox pouring into the face coolant manifold cause burn through of primary and secondary faceplates. Ejection of burned debris caused severe nozzle tube ruptures (46 tubes). Fuel loss couple with engine control reactions to maintain MCC pressure increased the HPFTP turbine temperature to increase until the redline was exceeded.

Cause: High cycle fatigue of the Lox post due to flow and mechanical vibration.

Location of Cracked Posts
and Burnout Area

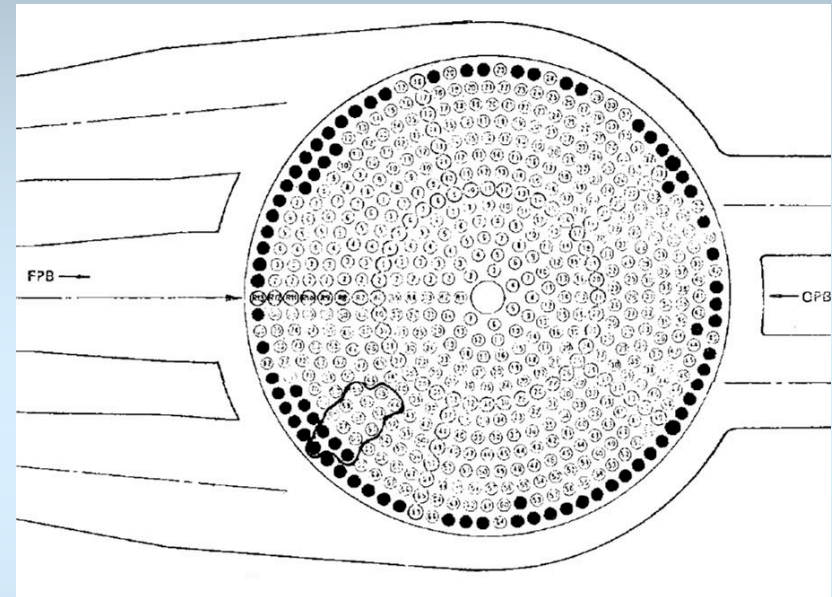
Test 901183, Engine S/N 0005

Incident Description: Test 901183 was terminated at 51.1 seconds by the HPFTP accelerometers because of an unrelated problem. At approximately, 24 seconds, failure of a group of Lox posts began. The condition appears to have limited itself and engine operation stabilized. 15 Lox posts were eroded back to the secondary faceplate and a section of the primary faceplate was burn away. The MCC hot gas wall received minor scalding and the nozzle had a failed saddle patch at one location.

Cause: High cycle fatigue of the Lox post due to flow and mechanical vibration.

Location of Cracked Posts
and Burnout Area

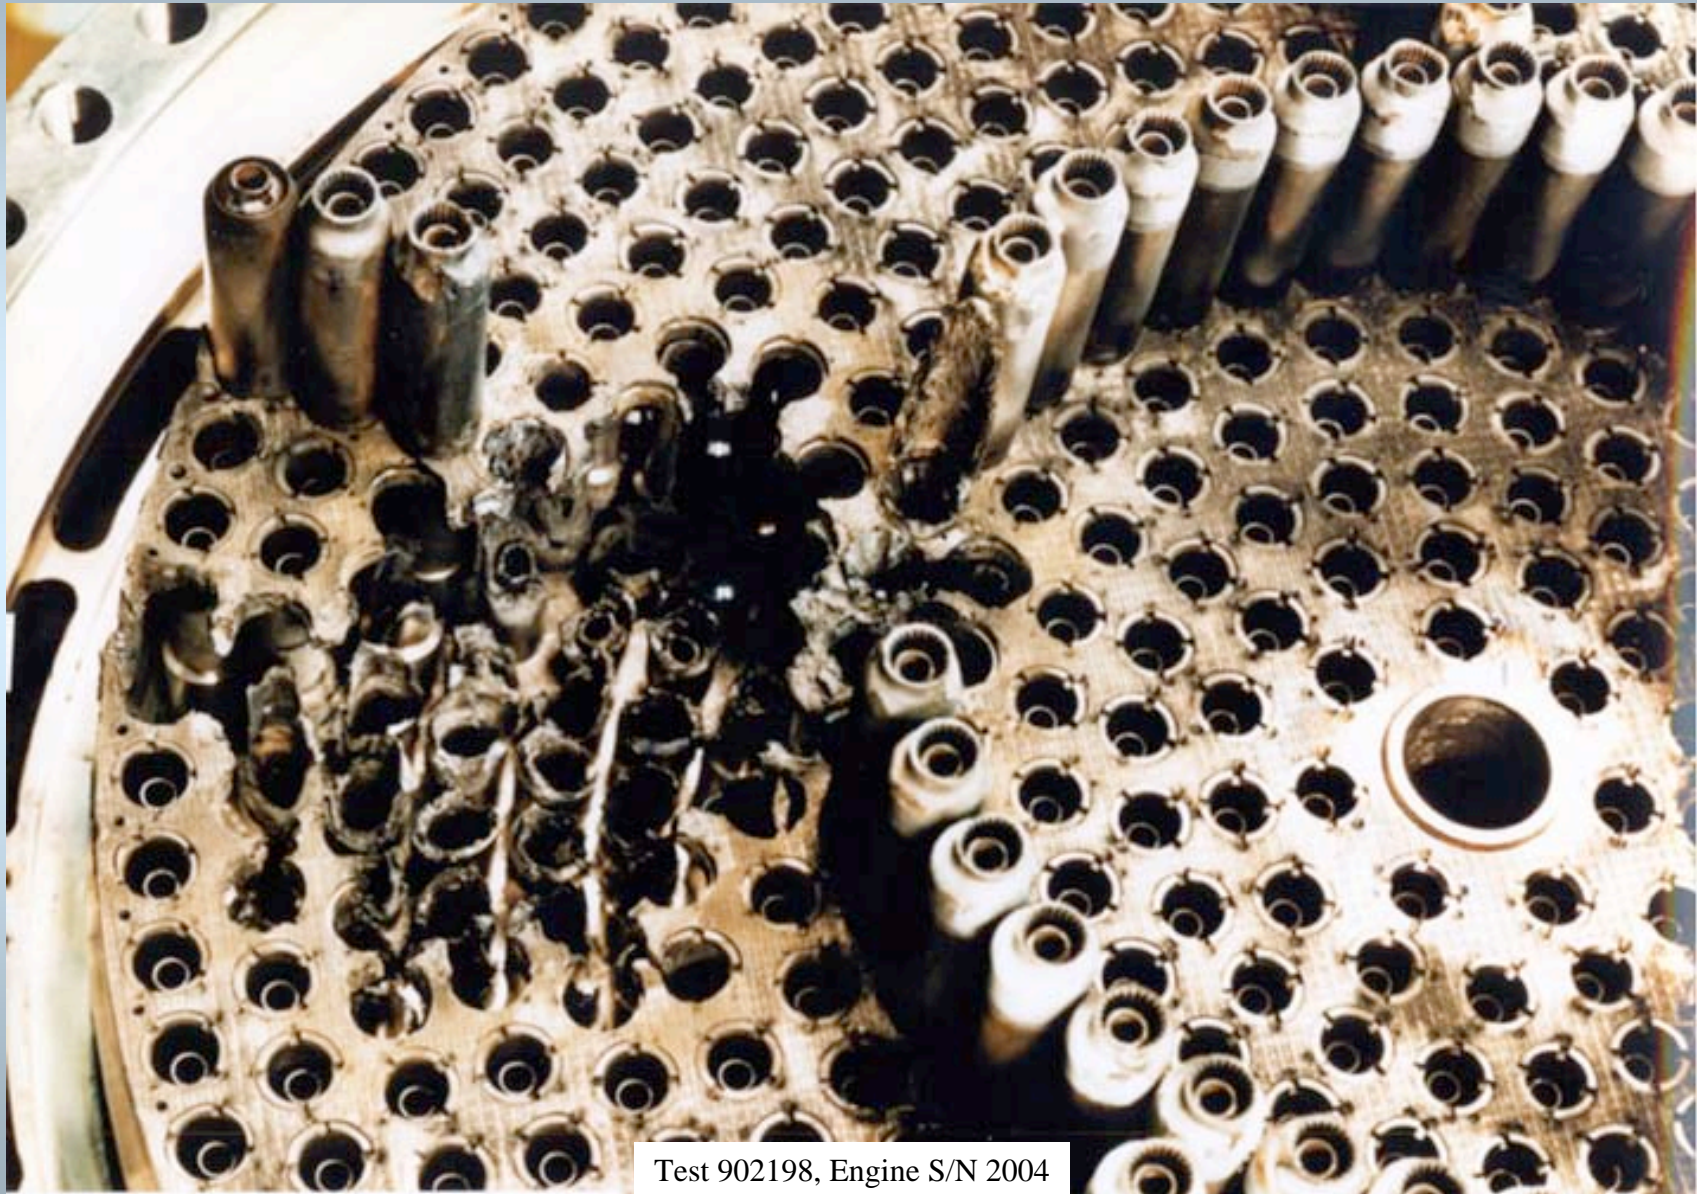
Test 902198, Engine S/N 2004

Incident Description: Test 902198 proceeded normally until 5.5 seconds when data indicated an unscheduled decrease in MCC pressure. At this same time, other engine parameters also indicated anomalous engine behavior and that the problem was localized to the MCC injector. The engine system continued to degrade until cutoff was initiated at 8.52 seconds after the HPOTP turbine discharge temperature exceed the redline value.

Posttest hardware inspection and disassembly revealed that the MCC injector was partially damaged, the MCC had slight erosion between two acoustic cavities, and the nozzle had several tubes dented and/or ruptured from the injector debris exiting the engine. No other hardware was damaged.

Cause: The cause of the failure was high cycle fatigue of the Lox post due to flow and mechanical vibration. Metallographical examination of the disassembled injector in rows 13, 12, and 11 revealed that 62 posts were cracked. A cross section of the fillet area of post 61 in row 12 revealed longitudinal wavy lines indicative of the type of cold working accompanying HCF. Visual observation earlier in the disassembly of the injector indicated that post 61, row 12, was the failed post. Post 61 had the most uniform burning with molten metal and slag 360°. The high cycle fatigue of the Lox posts was caused by mechanical vibration of the powerhead and flow induced vibration from the hot gas combined with high steady-state stresses.

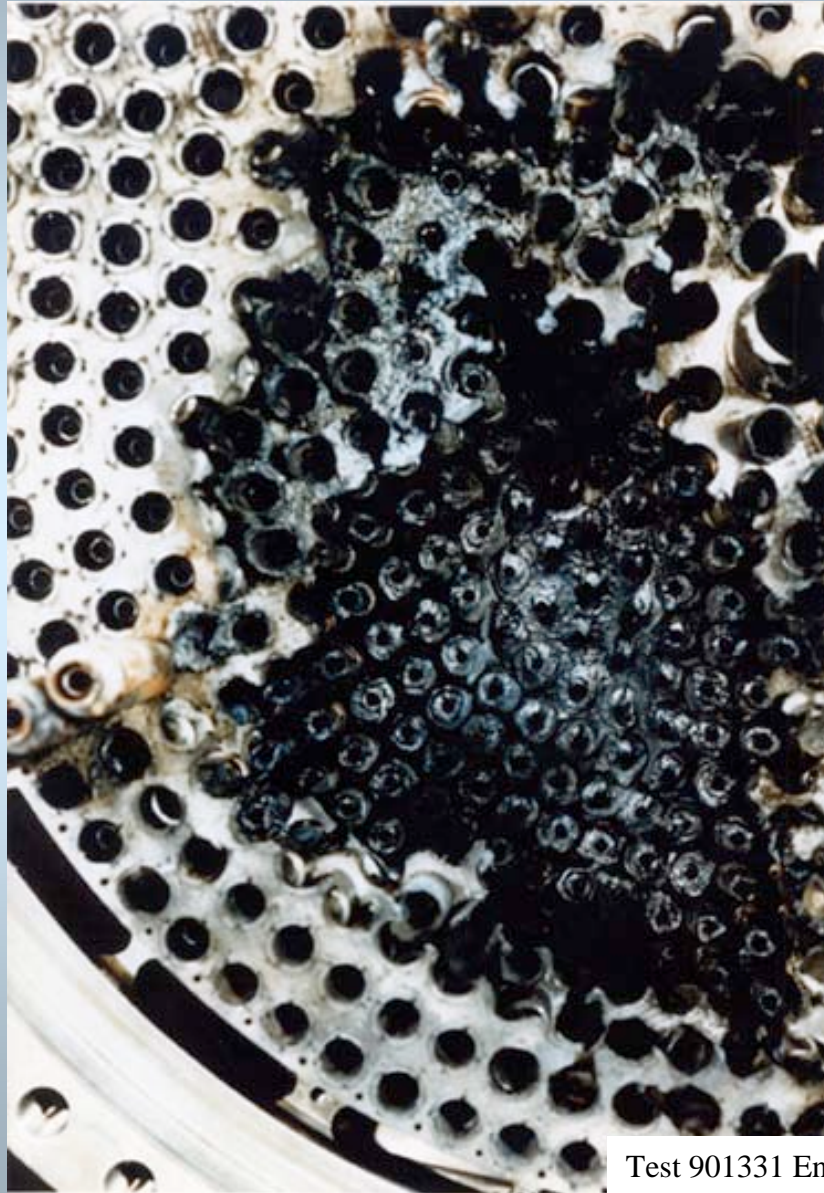
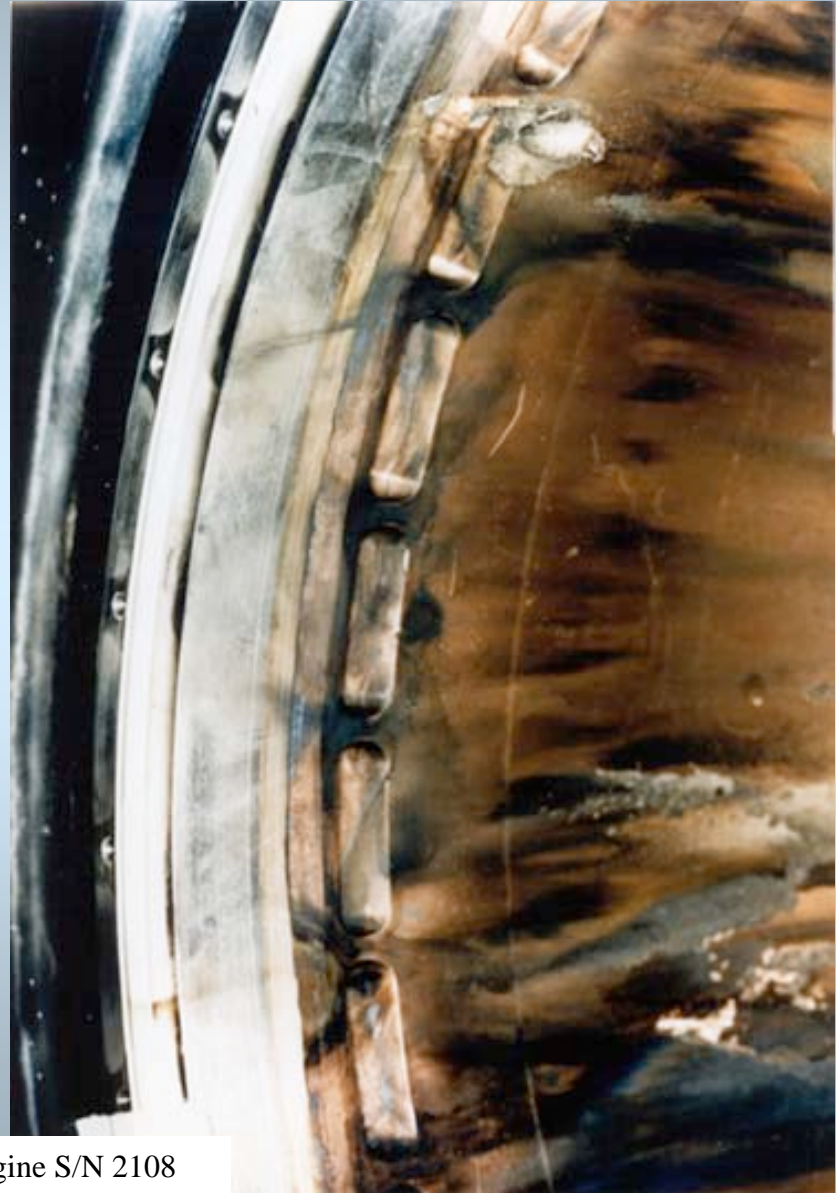
Test 901331 Engine S/N 2108

Incident Description: Test 901331 proceeded normally until 233.14 seconds when the High Pressure Oxidizer Turbopump turbine discharge temperature exceeded the redline value.

Inspection of the engine revealed extensive damage on the fuel preburner side of the main injector with burnthrough of 169 Lox posts, major erosion of the primary and secondary faceplates, major erosion of the interpropellant plate, and six Lox post shields damaged. The nozzle sustained shrapnel damage to approximately 60 tubes, and the MCC acoustic cavity suffered erosion damage.

Cause: Lox post number 79 in row 13 failed in the 316L material at the inertial weld (which joins a 316L post to an INC0718 interpropellant plate stub) . The post failure was caused by high cycle fatigue. There was a much larger increase in flow induced vibration in going from RPL to FPL; than had been estimated in life calculations. Furthermore, the modifications which had been made in the high pressure fuel pump to adapt it to FPL operation increased the severity of the flow induced vibrations at all power levels.
