Combustion Device Failures During Space Shuttle Main Engine Development

Otto K. Goetz
NASA

5th International Symposium on Liquid Space Propulsion
Long Life Combustion Devices Technology

Chattanooga, Tennessee
October 27-30, 2003

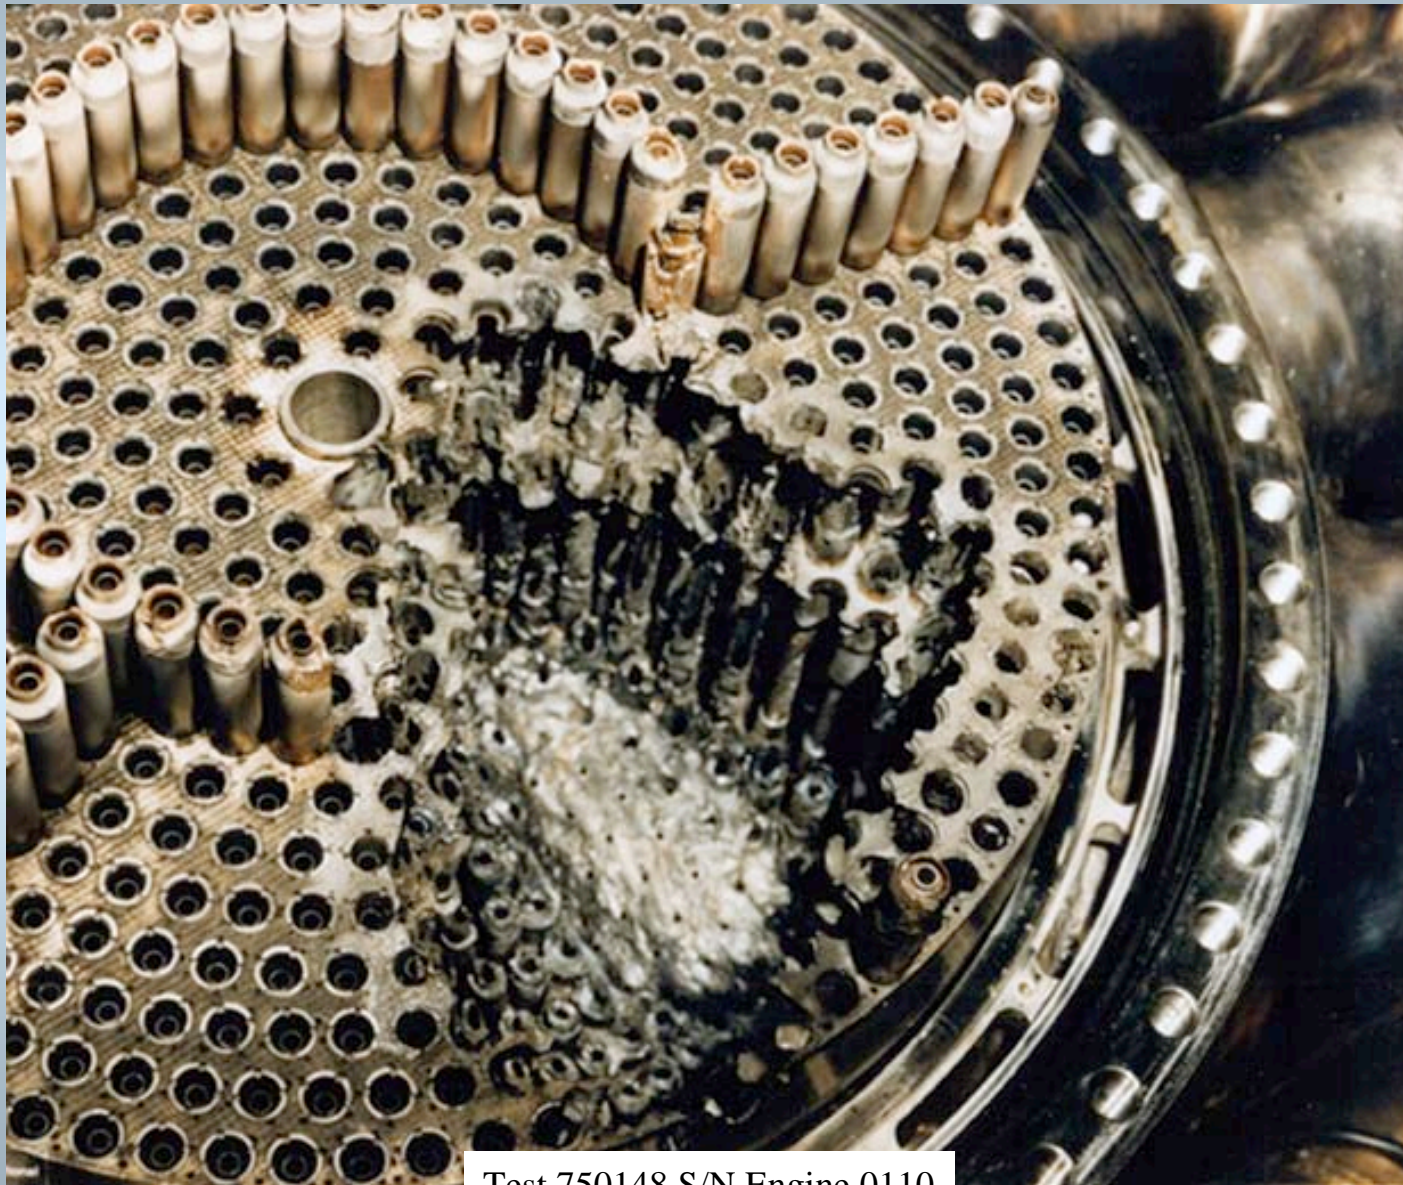
Test 750148 S/N Engine 0110

Incident Description: Test 750148 proceeded normally until 16.0 seconds when the HPOTP turbine discharge temperature exceeded the redline value.

Inspection of the engine revealed extensive damage of the fuel preburner side of the main injector with burn-through of 149 Lox posts, erosion of the primary and secondary face plates, and erosion of the interpropellant plate. The nozzle sustained shrapnel damage to approximately 150 tubes and the MCC suffered erosion damage.

Cause: High cycle fatigue of Lox post caused by random mechanical vibration of the powerhead and flow induced vibration from the hot gas combined with high steady-state stresses. The damage pattern of the injector indicates the failure occurred at the inertia weld of post 12, row 13. However, the posts in this vicinity were largely consumed by the fire, including the fatigue crack where the failure initiated. Post 12, row 12, which is very near the indicated failure location, had been reworked and the acceptance requirements relaxed, making this post a credible candidate as the failure initiation point. 5. All evidence points to high cycle fatigue near a Lox post inertial weld as being the single cause.

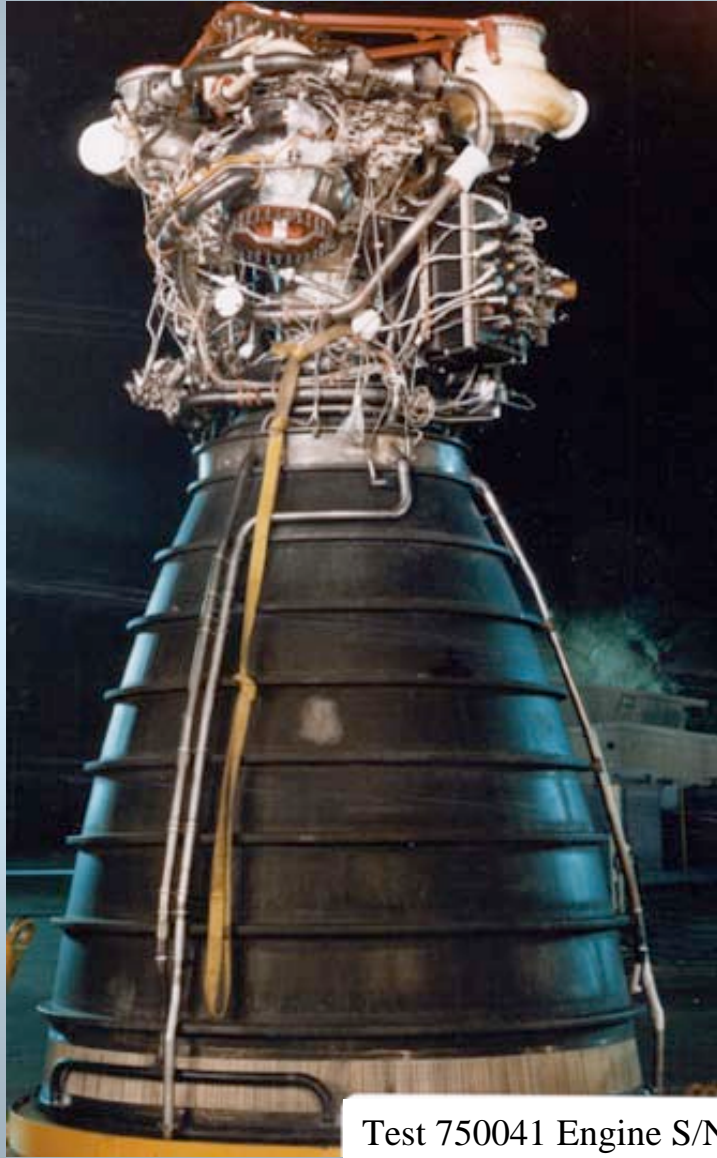
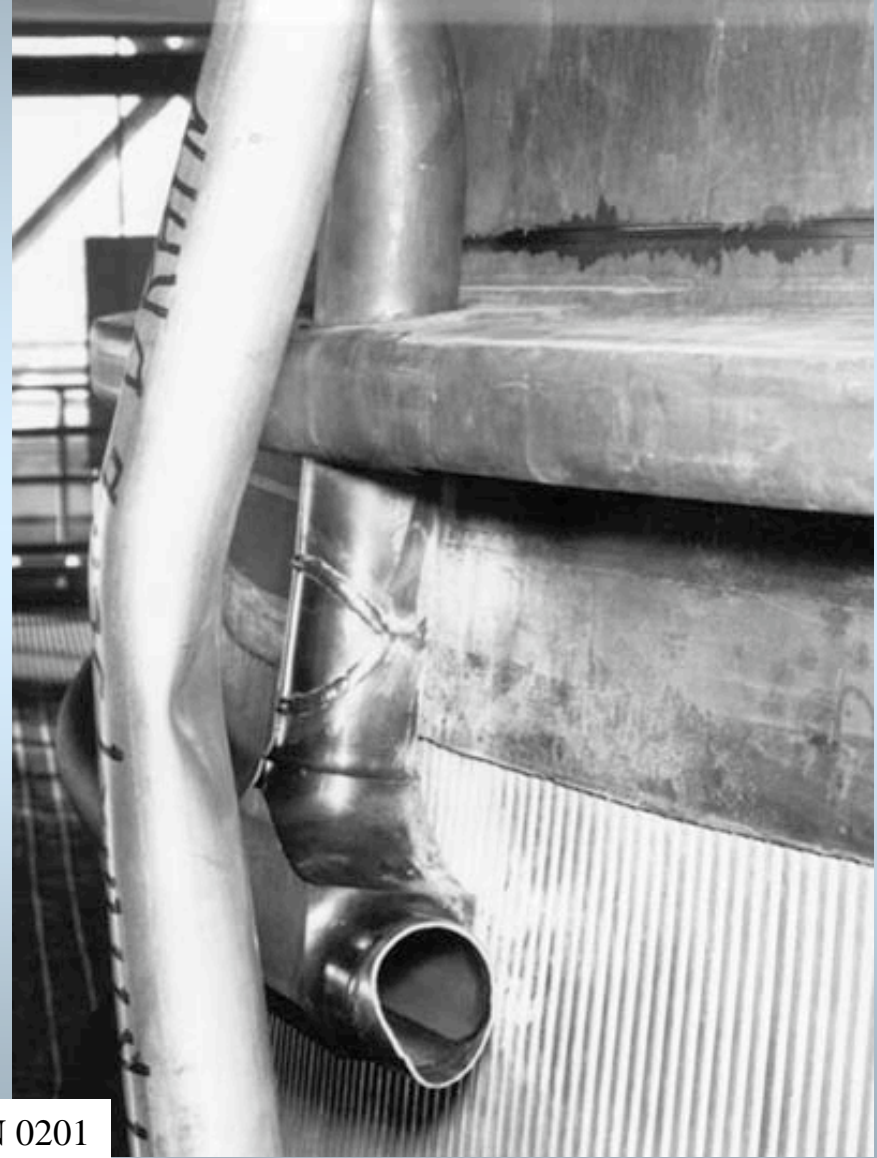
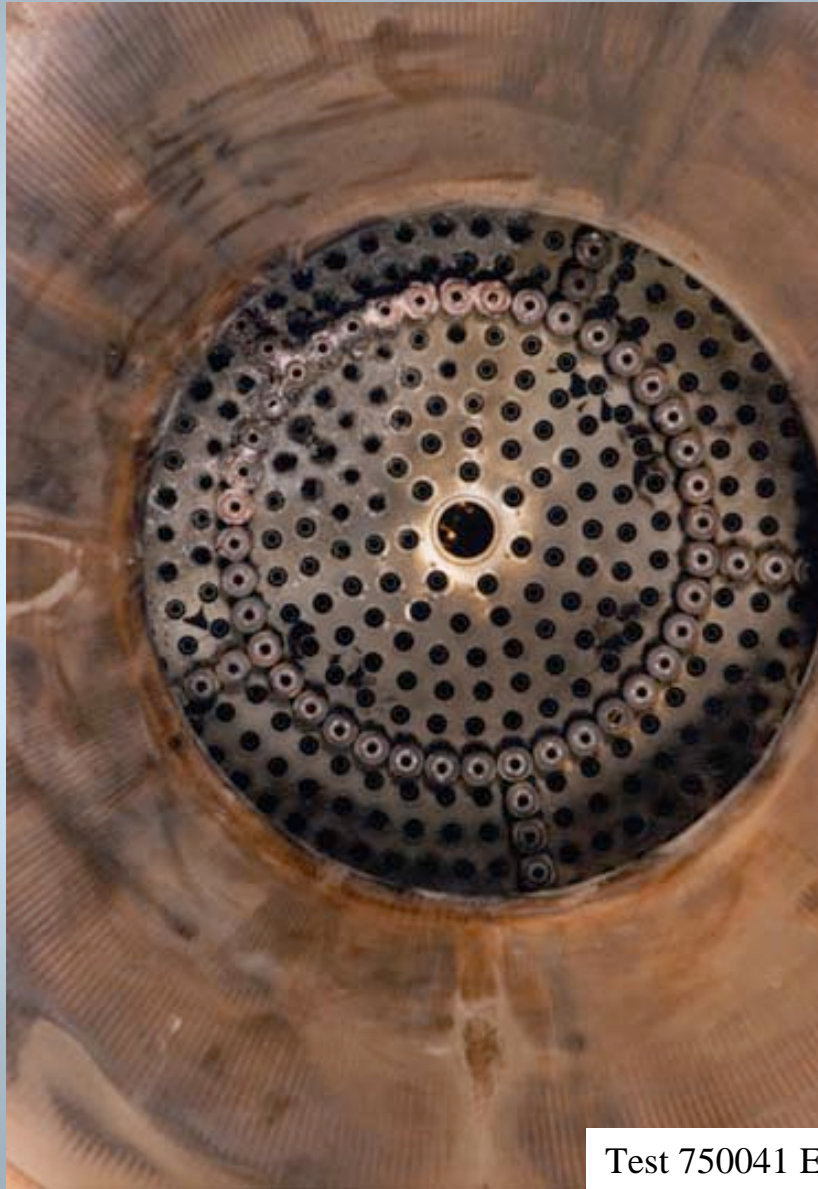
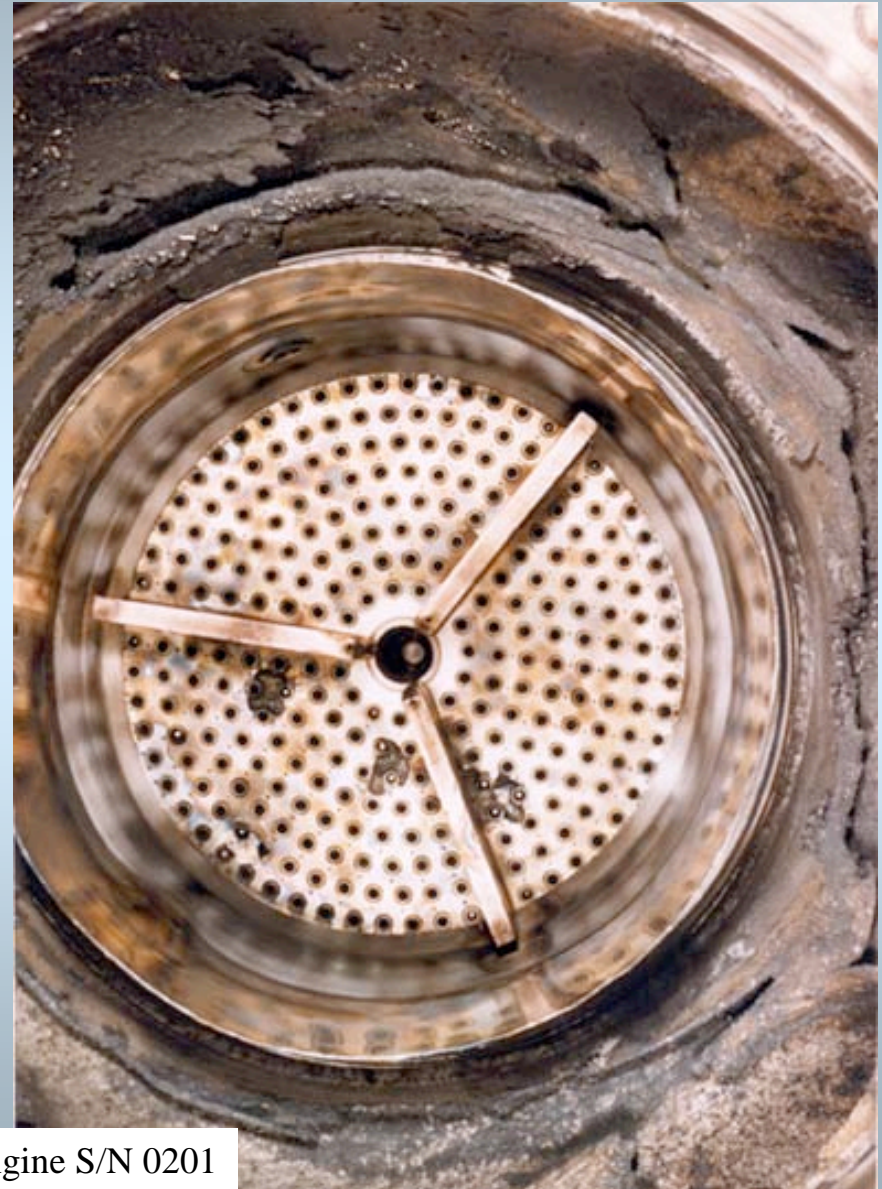
Test 750041 Engine S/N 0201

Incident Description: Test 750041 was automatically terminated at 4.296 seconds when the HPFTP turbine discharge temperature exceeded the redline value. The engine sustained considerable damage internally due to the loss of hydrogen flow during shutdown. Review of the motion picture film and data evaluation indicates that there were actually two incidents in this test. The first incident was the hot start which resulted in an high initial temperature spike in the high pressure fuel turbopump turbine discharge temperature. When the engine reached steady state the temperature again exceeded the redline value and shutdown was initiated. The second incident was the failure of the hydrogen feed line (steerhorn) to the nozzle. This occurred as the engine preceded through shutdown. This caused loss of hydrogen to the engine and the resulting damage. Damaged hardware included extensive overheating and erosion of both HPFTP and HPOTP turbines, extensive overheating and massive tube ruptures in the nozzle, extensive erosion of the main injector (not repairable), extensive slag deposited on the MCC, erosion of the fuel preburner liner and body, and extensive erosion of the hot gas manifold liner (fuel side).

Cause: A small crack was found in the failed steerhorn which was the initiation point of the failure. Metallurgical analysis of the failed area indicated that all of the damage may have been accumulated in this one test. Engineering analysis of this test however, could not identify any loads high enough to fail the steerhorn in this one test. It was postulated that the steerhorn could have accumulated damage from previous testing without cracking. Strain gages were place on engines being hot fired and previously unidentified 200-400 Hz oscillations were found during the start and shutdown transients. The loads from these oscillations had not been included in the design of the steerhorn. Utilizing data obtained with strain gages from eleven tests gives a projected life of 44 tests for minimum fatigue properties. The nozzle from engine 0201 had accumulated 12,109 seconds of test time during 48 tests.

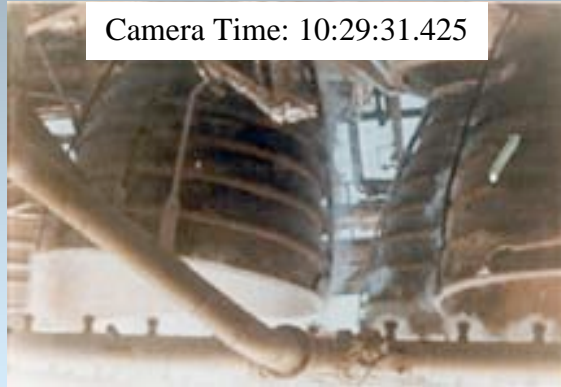
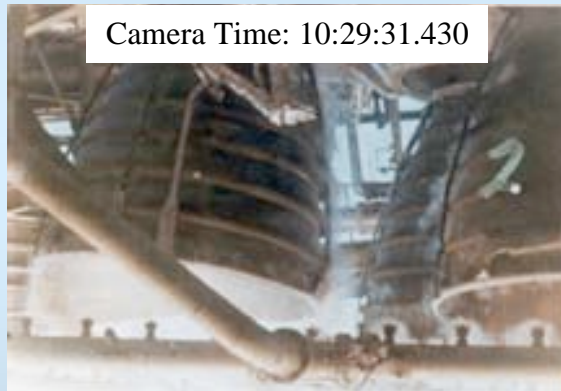
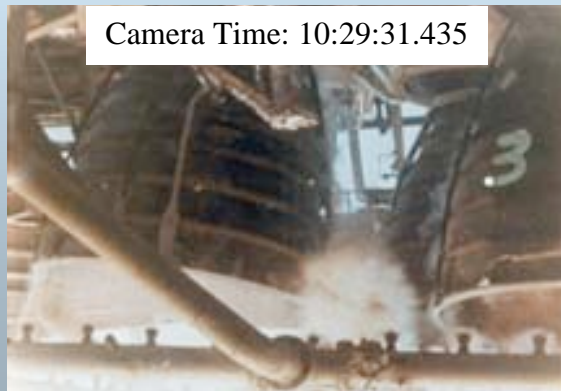
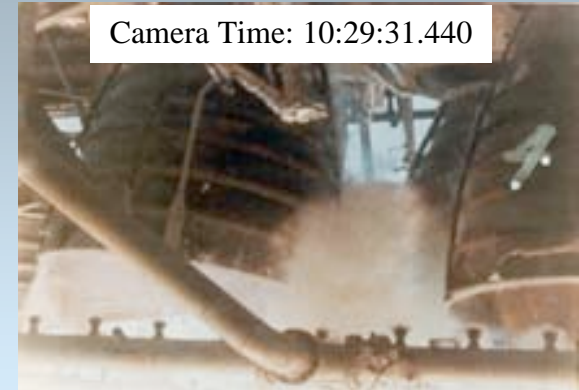
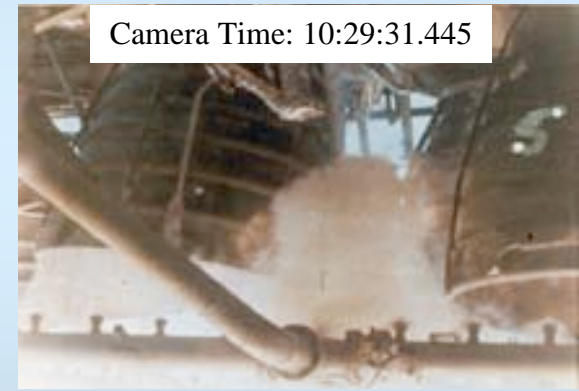
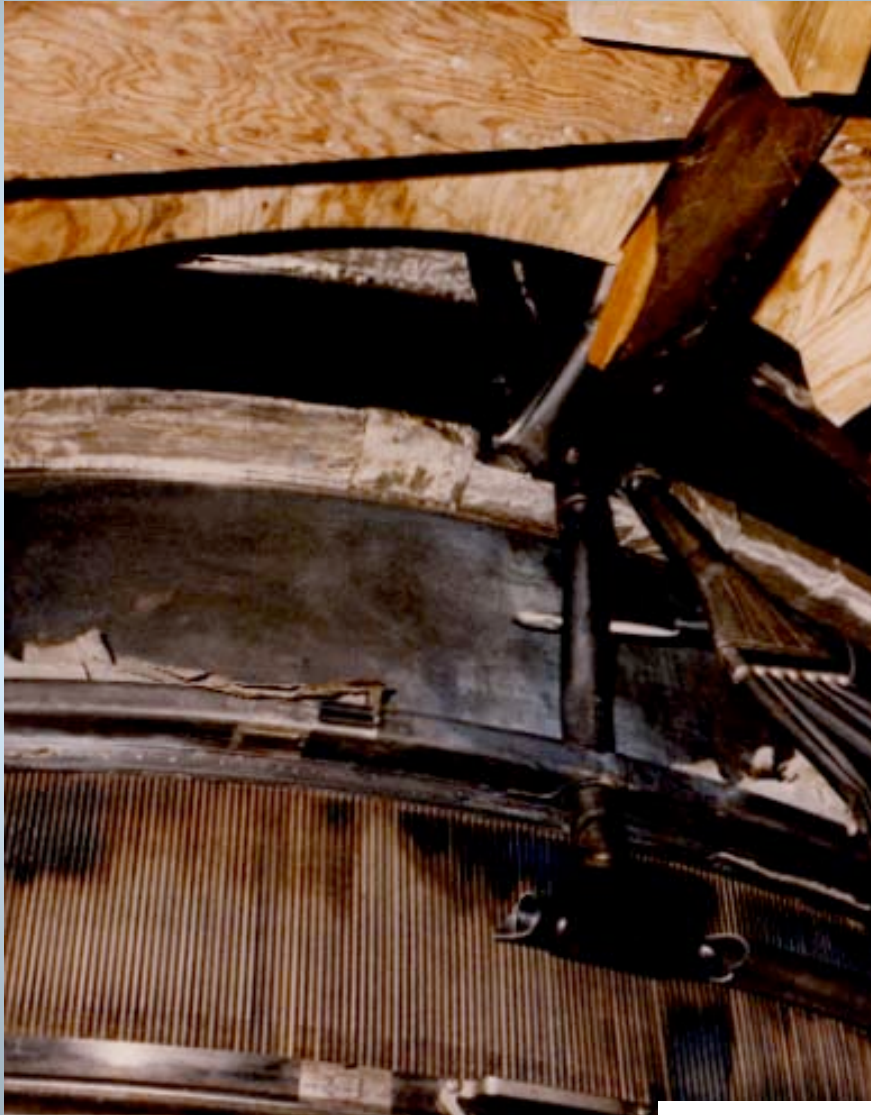
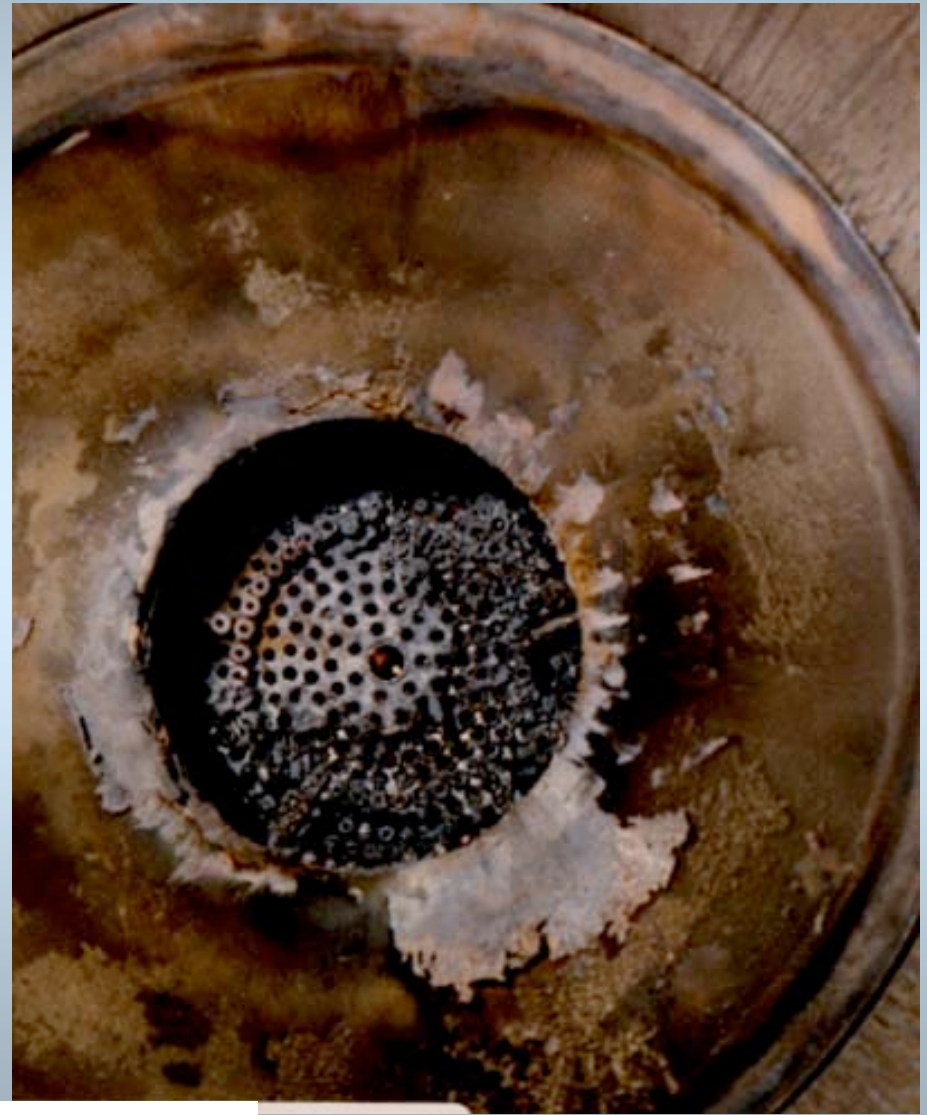
Test SF6-3, Engine S/N 2002

Incident Description: Test SF6-03 was automatically terminated at simulated liftoff (To plus 4.848 seconds when the HPOTP secondary seal cavity pressure on Engine Position 3 (Engine S/N 0006 exceeded the maximum redline value. During the shutdown sequence, the nozzle steerhorn on Engine Position 1 (Engine S/N 2002) failed. The resulting loss of fuel following the failure caused extensive internal damage due to overheating. Damaged hardware included extensive overheating and erosion of both HPFTP and HPOTP turbines, extensive overheating and massive tube ruptures in the nozzle, extensive erosion of the main injector (not repairable), extensive erosion of the MCC (not repairable), and extensive erosion of the Hot Gas Manifold liner (fuel side).

Cause: The steerhorn failure occurred during the period of maximum nozzle deflections due to exhaust plume separation; however, the data obtained from strain gage measurements located on the steerhorn were below the levels necessary to fail the steerhorn. Subsequent investigations revealed that improper weld rod material was utilized in the fabrication of the steerhorn which significantly reduced the load carrying capability of the assembly.

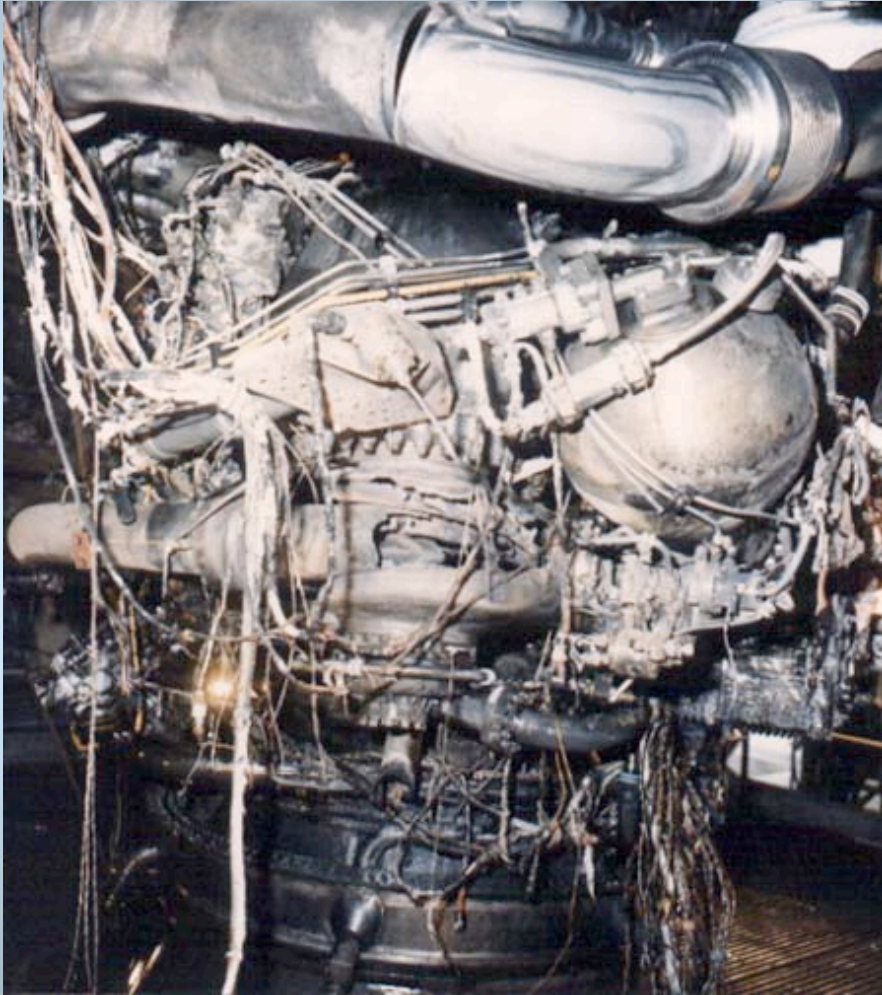
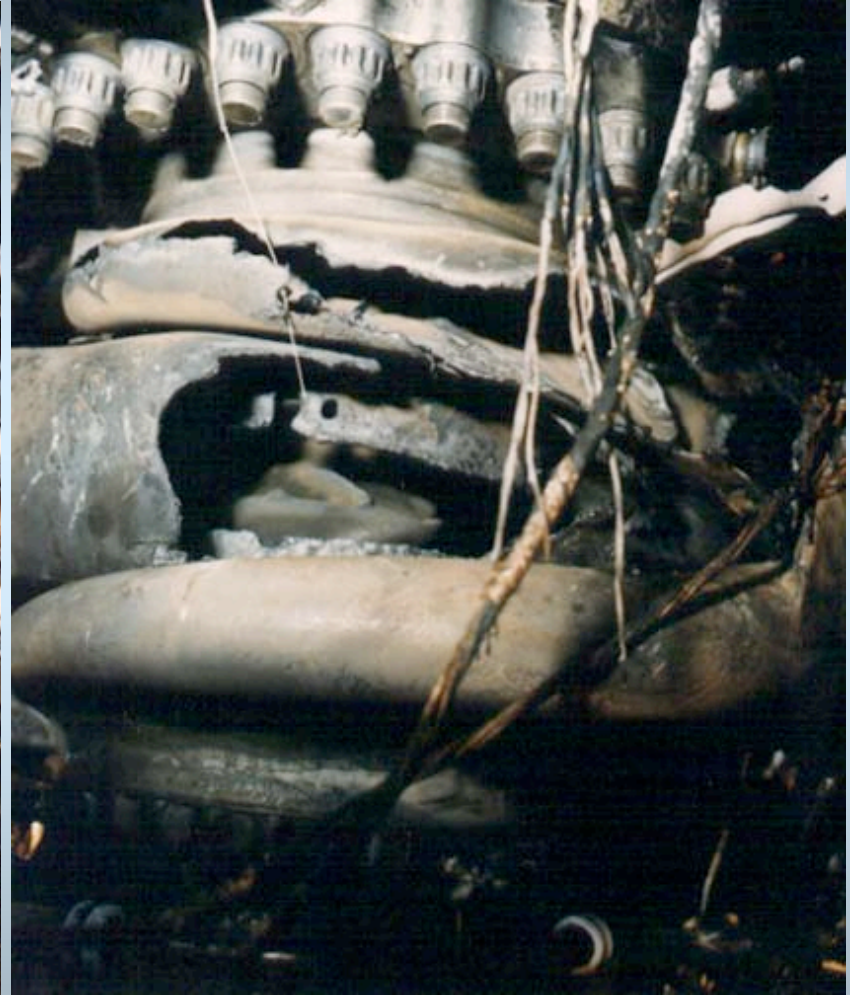
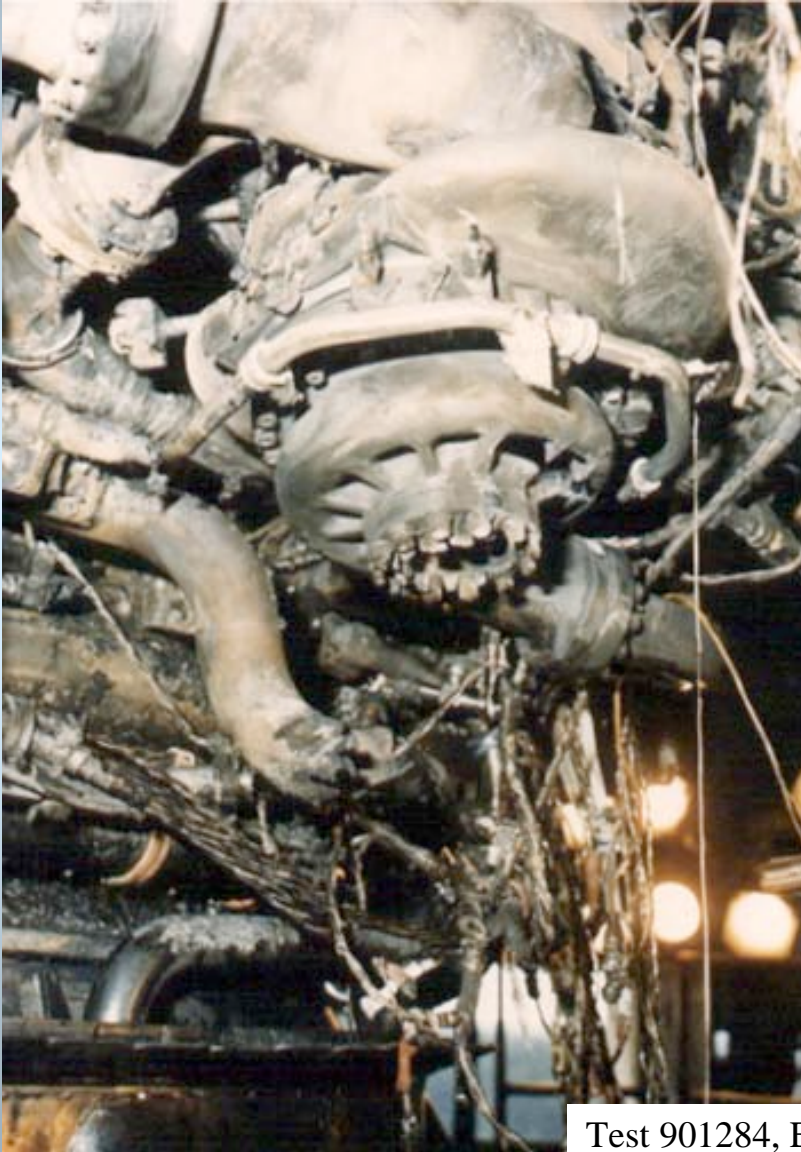
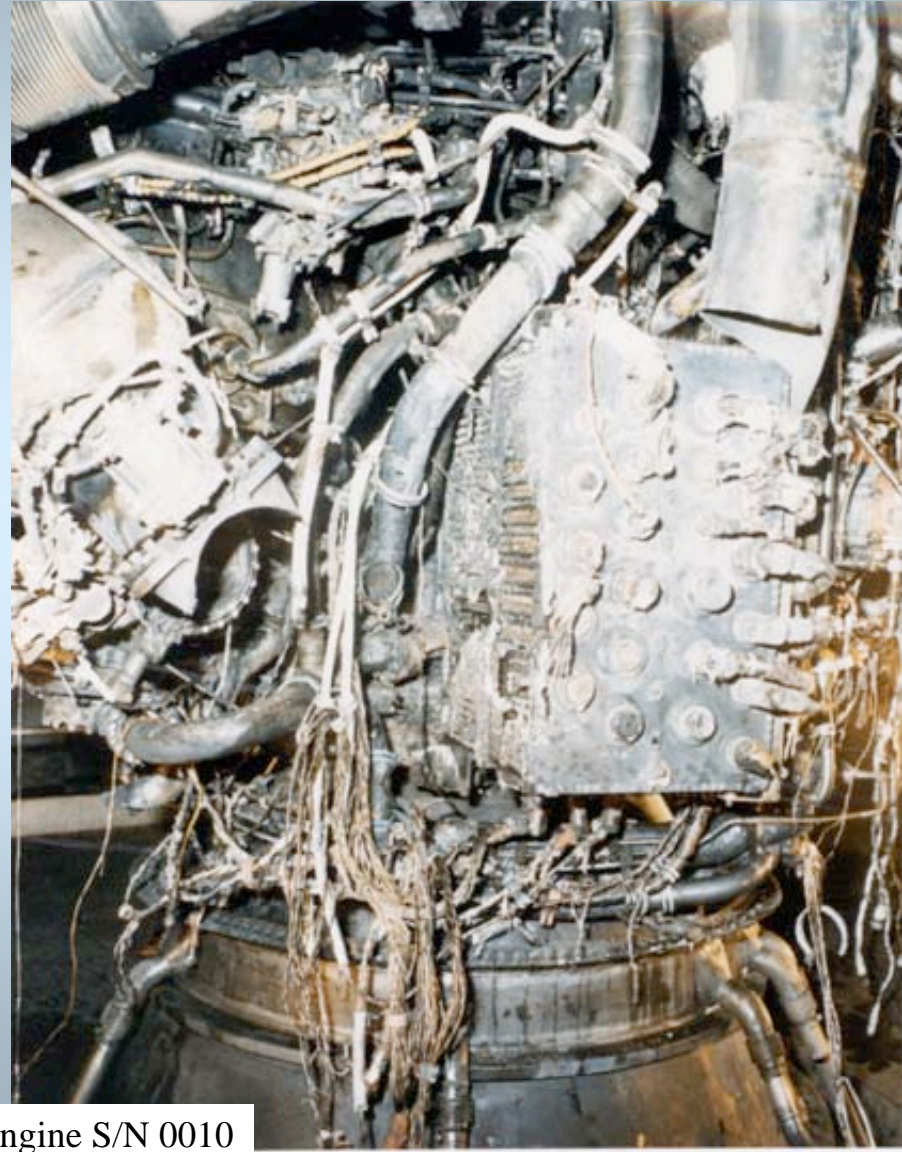
Test 901284, Engine S/N 0010

Incident Description: Test 901284 was prematurely terminated at 9.82 seconds when pneumatic shutdown was initiated due to loss of the engine controller.

An erroneously high reading combustion chamber pressure caused the Controller to close the Oxidizer Preburner Oxidizer Valve to reduce Pc to the desired value. A few milliseconds later, the Controller calculated a mixture ratio of 9.0 and commanded the Fuel Preburner Oxidizer Valve full open in an attempt to reduce the MR to 6.0. The immediate result of the Controller actions, based on an erroneous Pc, was operation in an abnormal mode, characterized by high fuel flow and low turbine temperature. The HPOTP turbine inlet temperature fell below a value which led to freezing of water in the turbine gases. The ultimate result of the Controller actions was a fire in the HPOTP at about 9.7 seconds due to rubbing in the area of the Lox primary seal. The rubbing was caused by a high axial load which displaced the rotor assembly toward the pump end of the HPOTP housing.

Cause: Two unrelated events caused this failure to prorogate to a catastrophic failure. First, Channel B of the Engine Controller cut itself off at 3.25 seconds because of failure of electronic components in the facility power supply. Secondly, at 3.9 seconds, the Lee Jet orifice, used to purge the Channel A Pc transducer passage, became dislodged and caused the Pc transducer to sense MCC coolant flow pressure instead of Pc. The reason for the Lee Jet orifice dislodging was a poorly machined Lee Jet housing that went undetected. It was out of specification and should have been noted.

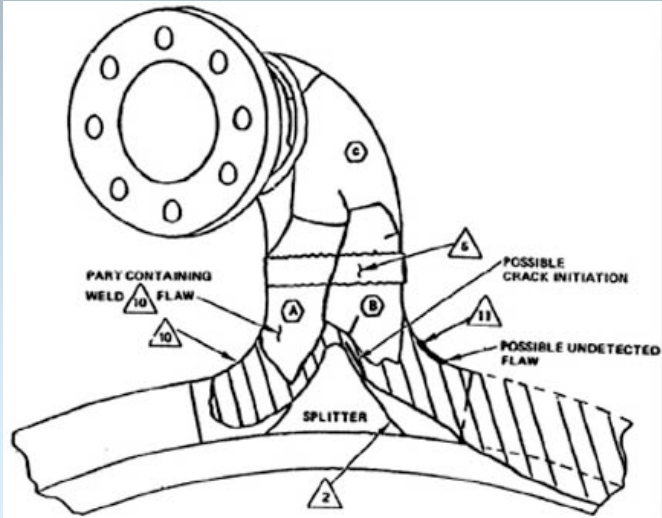
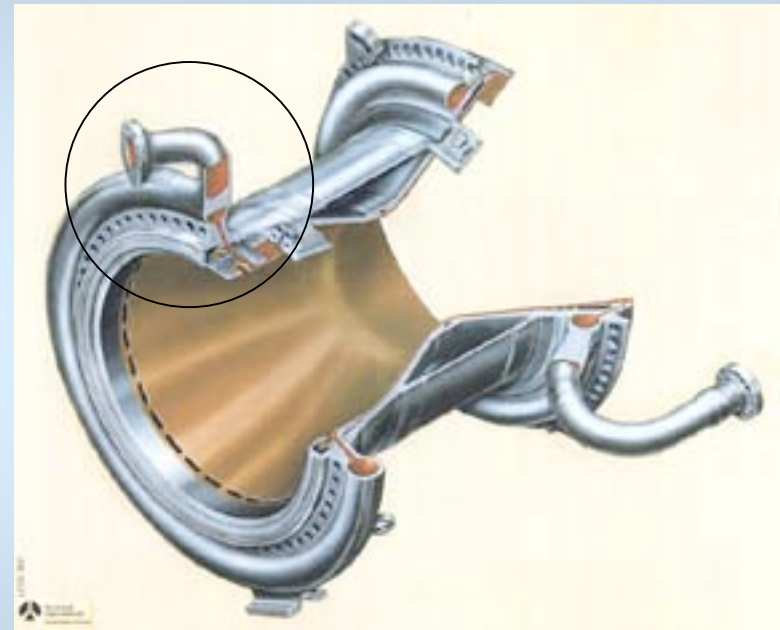
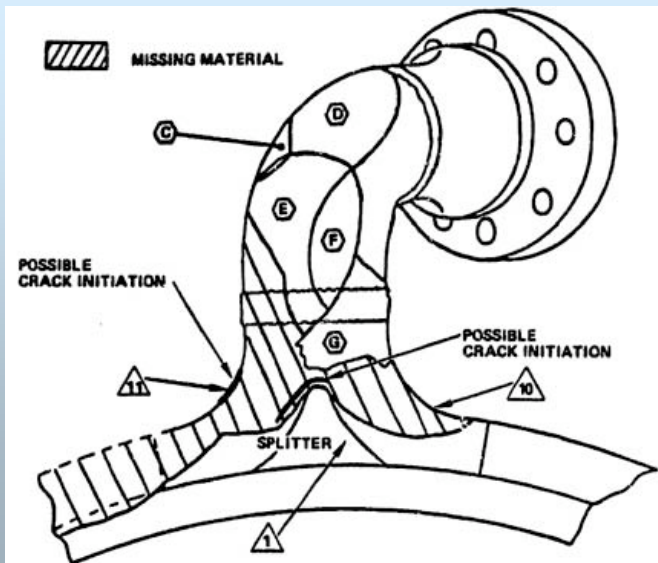
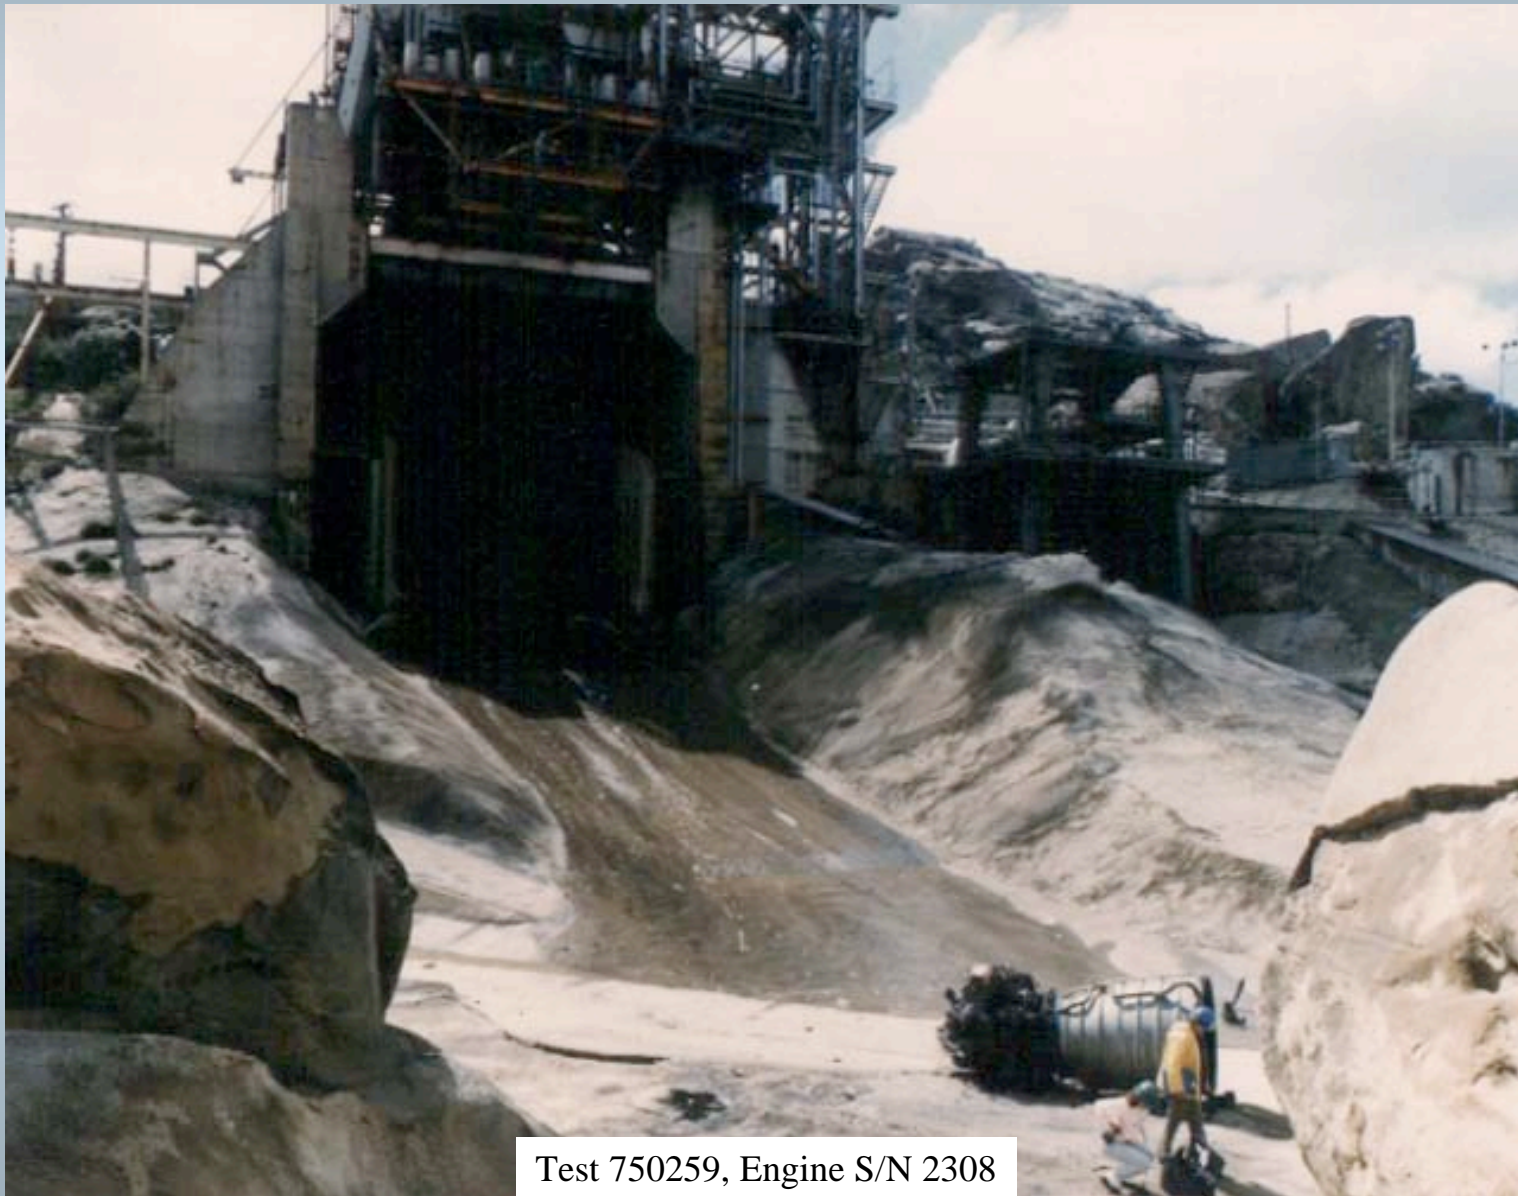
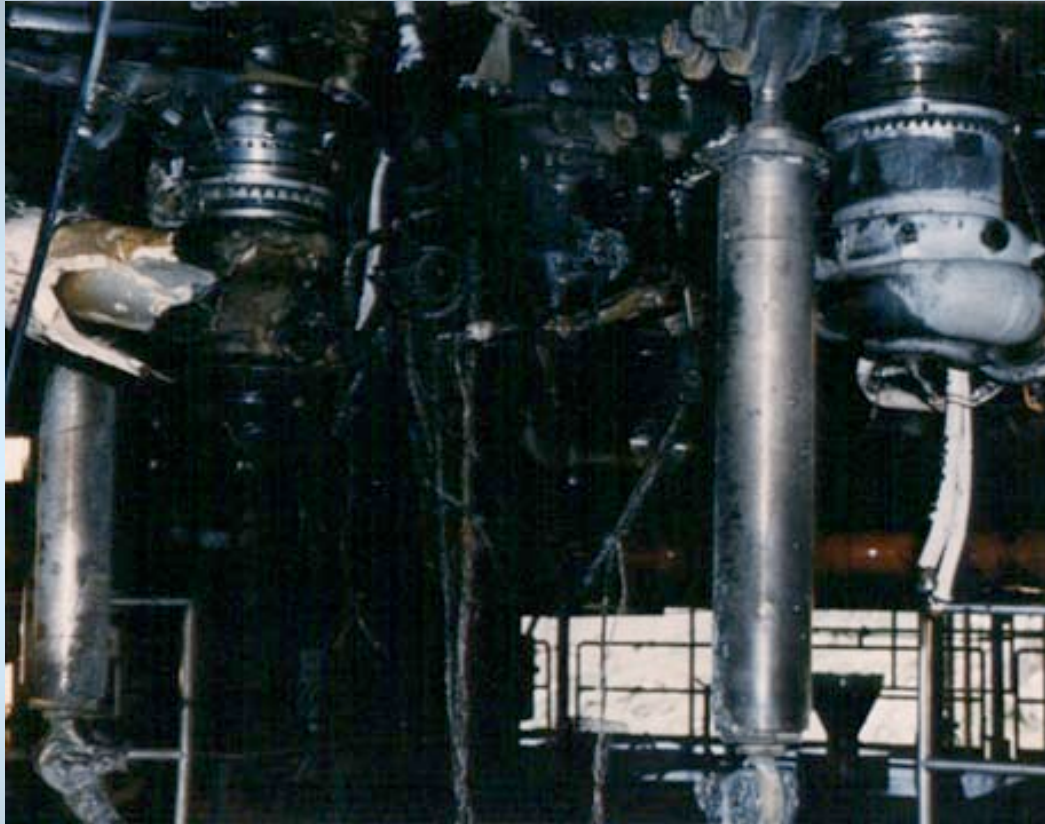
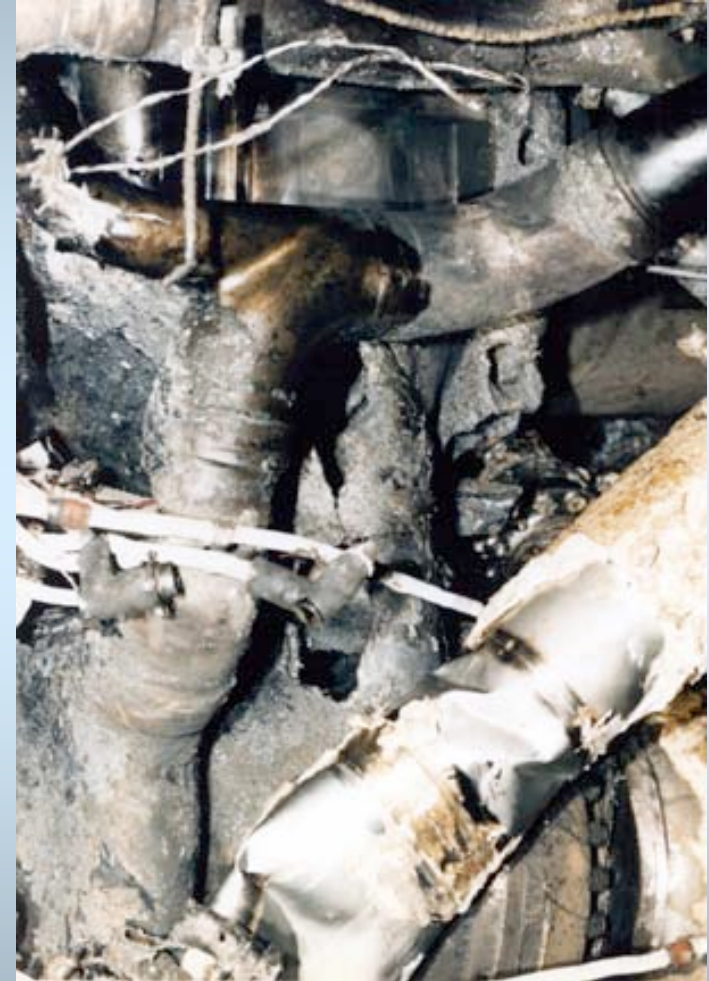
Test 750259, Engine S/N 2308

Incident Description: Test 750259 was prematurely terminated at 101.5 seconds by the HPFTP accelerometer redline. In the incident, the engine was severed from the test stand as a result of an oxygen rich fire and came to rest in the stand spillway.

Catastrophic failure of Engine 2308 was caused by rupture of the MCC outlet manifold neck which resulted from an initial fatigue crack that grew to instability. In response to the rupture, the low-pressure fuel turbopump rapidly decayed in speed, further indicating the source of the leak to be in the MCC outlet system. The speed drop rapidly reduced discharge pressure (inlet pressure to the high-pressure pump) and the high-pressure fuel pump went into deep cavitation. As a result of deep cavitation, the high-pressure fuel pump speed increased to a value 30% over FPL nominal, rapidly increased pump vibration which exceeded the vibration redline, and led to a cutoff command. Following cutoff, the fuel cavitation condition resulted in reduce engine fuel flow and a severe oxygen-rich condition. Burnout of the turbines, burn-through of the hot-gas manifold and severe erosion of the gimbal bearing produced conditions leading to separation of the engine below the low-pressure pumps.

Cause: The precise origin and initiation mechanism for the failure was not established. Fatigue or an undetected defect were both postulated as potential failure modes for welds No. 1, 2, or 11 of the MCC outlet neck. The most probable cause of failure was determined to be fatigue (endurance) crack initiation at splitter welds No. 1 or 2.
