CAUSES AND MITIGATION OF FUEL VALVE PILOT SEAL EXTRUSION IN SPACE SHUTTLE ORBITER PRIMARY RCS THRUSTERS

ABSTRACT

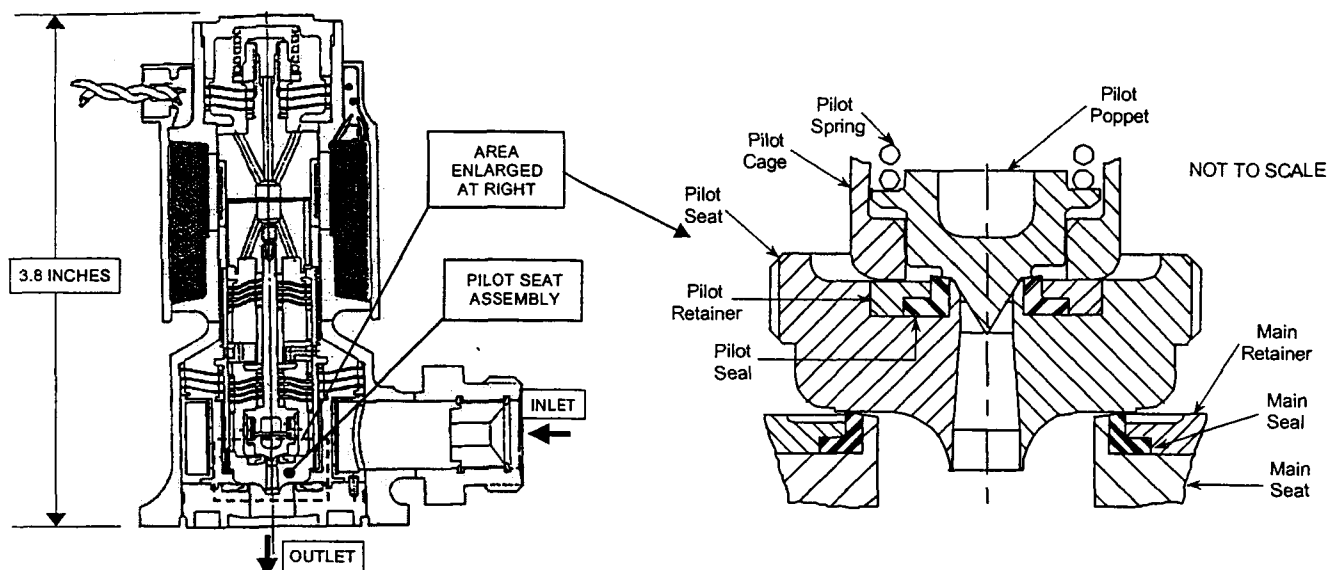
Figure 1 Pilot operated valve cross section showing the location of the polytetrafluoroethylene pilot seal.

Extrusion of the pilot seal restricts the flow of propellant around the pilot poppet, thus impeding or preventing the main valve stage from opening. It can also prevent the main stage from staying open with adequate force margin, particularly if there is gas in the main stage actuation cavity. During thruster operation on-orbit, pilot seal extrusion may be indicated by low or erratic chamber pressure (low P_c) or failure of the thruster to fire upon command (Fail-Off). During ground servicing, pilot seal extrusion may be indicated by slow gaseous nitrogen (GN_2) main valve opening times (≥ 38 ms), slow water main valve opening response times (> 33 ms), shallow pressure drop or liquid flow perturbation across the main stage, or an abnormally shaped (off-nominal) valve opening response current trace. Poppet lift tests and x-ray radiography have also been used to determine the presence of pilot seal extrusion during ground servicing. While the above tests are nondestructive; the most reliable means to characterize and quantify extrusion is post-mortem metrology performed on removed pilot seat assemblies (Marquardt P/N 235681).

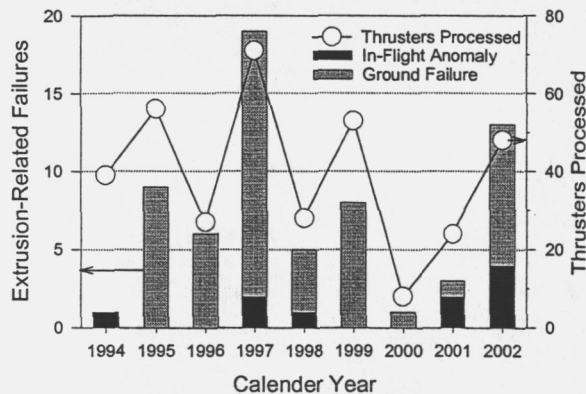
In addition to the above 16 IFAs, another 52 fuel valves (Table 1, bottom; Table 2) with extruded pilot seals were detected between 1994 and 2003 during routine and nonroutine thruster repair and replacement (R&R) at the NASA Johnson Space Center (JSC) White Sands Test Facility (WSTF) Depot, giving a total of 68 extrusion cases. The overall flight plus ground extrusion failure rate has remained fairly constant since 1994,^{††} with the number of failures typically peaking in years when entire ship sets are returned for water flushing to remove metal nitrate salts (Figure 2).

Figure 2 Distribution of PRCS fuel valve pilot seal extrusion cases from 1994 to 2003.

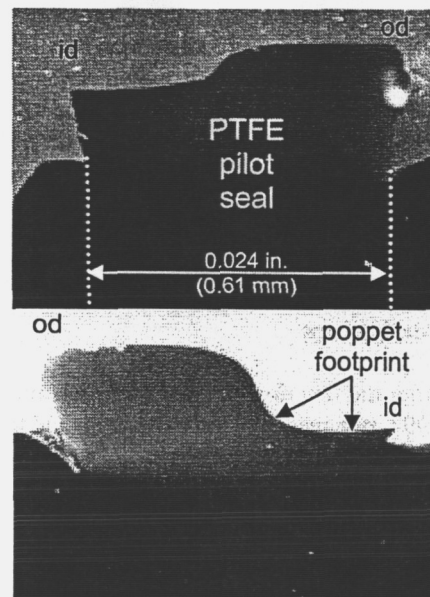
Two types of fuel valve pilot seal extrusion have been observed: extrusion of the entire seal across the sealing (inner diameter, *id*) and nonsealing (outer diameter, *od*) surfaces of the pilot seal (*Type I extrusion*); and preferential extrusion of the non-sealing (*od*) surface of the pilot seal (*Type II extrusion*) (Figure 3).^{§§}

Figure 3 Impression replicas of fuel valve pilot seals showing Type I (top) and II (bottom) extrusion.

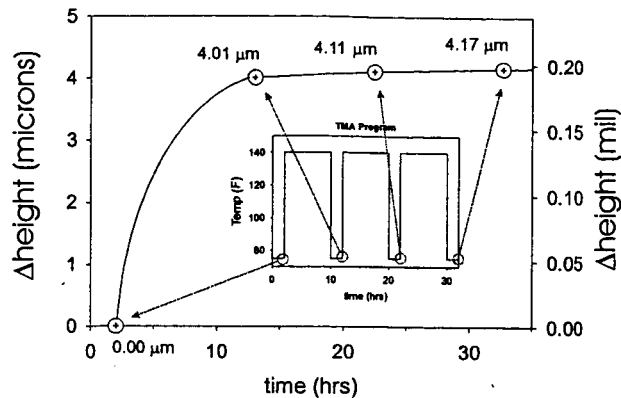
To evaluate the effect of thermal cycling on extrusion, new pilot seat assemblies were cycled in a TMA furnace to 60 °C (140 °F). After three cycles ~4 microns (0.2 mil) of pilot seal *od* extrusion was produced (Figure 4). The amount of recovery (return to the original dimension) was nearly quantitative after the second and subsequent heatings. Subsequent heatings to higher temperatures produced more extrusion, again with time-dependent recovery noted between heatings (data not shown). Similarly, thermal cycling of an unextruded oxidizer valve pilot seal to 80 °C (175 °F) produced ~7 microns (0.3 mil) of *od* extrusion (data not shown), again with nearly quantitative recovery after the second and subsequent heatings.

Figure 4 Thermomechanical analysis data showing incremental extrusion of a pilot seal after three consecutive 8-hr. excursions to 60 °C (140 °F) under conditions of negligible sealing load.

211 ± 102 μm (8.3 ± 4.0 mil, n=35).^{§§§} Therefore, the TMA data suggest that factors other than thermal cycling contribute to extrusion. However, it must be noted that the load on the pilot seal during TMA (0.098 N (0.022 lb_f)) was negligible compared to the load in service due to poppet spring-loading and liquid propellant system pressure (25 N (5.6 lb_f)). In fact, the load in service is large enough to cause *ca.* 20 percent lateral cold flow^{¶¶¶} of the PTFE, leading to ‘mushrooming’ of the PTFE outside of the metal cavity. It is proposed herein that the resulting excess plug of PTFE outside of the pilot seal cavity effectively hinders recovery of the pilot seal after heating, leading to more extrusion than shown in Figure 4.

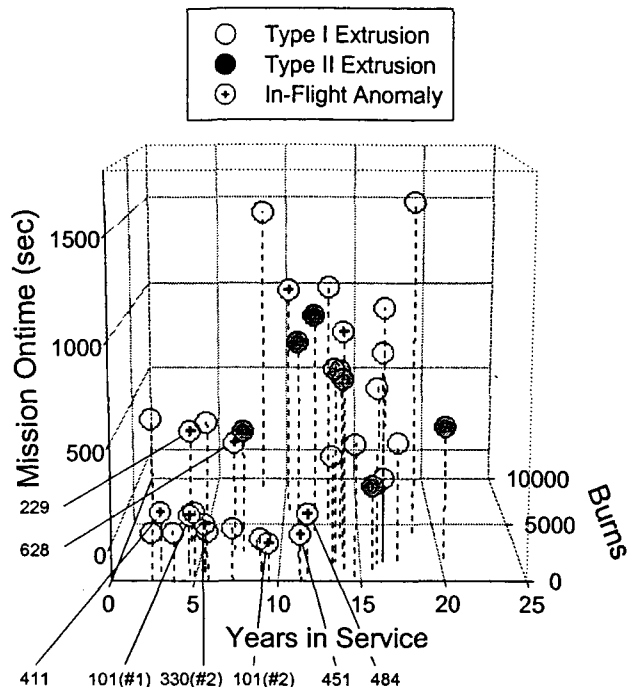
A review of service history records revealed an apparent link between extrusion type and years in service. For example, verified Type II cases have, on average, logged more years in service (13.5 ± 3.9 years, n = 7), than verified Type I extrusion cases (9.8 ± 5.2 years, n = 31) (Figure 5).^{####} Similarly, Type I extrusion cases had, on average, fewer burns and lower mission ontime than Type II cases. This suggests that cumulative load at temperature and the number of valve actuations during firing are important determining factors of extrusion type. Interestingly, all ten extrusion-related IFAs exhibit Type I extrusion, a majority of those (8 of 10 cases) failed with unusually low burns, ontime, and years in

Figure 5 Distribution of extrusion type with selected service history parameters for thrusters of verified extrusion type (based on metrology data).

service. These may be considered to have failed prematurely (see Figure 5, thrusters 101 #1, 101 #2, 229, 330, 411, 451, 484, and 628).

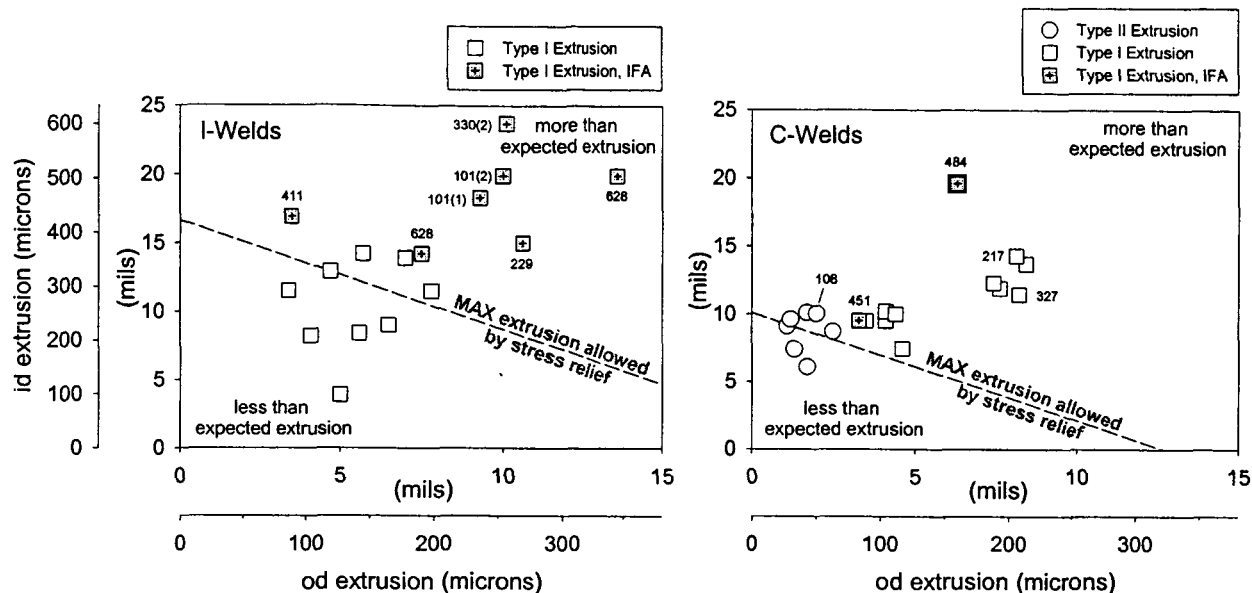
Figure 6 Distribution of intermittently (left) and circumferentially-welded (right) extrusion cases showing observed (symbols) versus expected (dashed lines) extrusion due to stress relief of the PTFE pilot seal.

Examination of extruded pilot seals that failed in service gave extruded volumes as high as 2.85 mm³ (1.74 · 10⁻⁴ in.³) for I-welded seat assemblies (fuel valve S/N 605 on thruster 330) and 2.52 mm³ (1.54 · 10⁻⁴ in.³) for C-welded seat assemblies (fuel valve S/N 749 on thruster 484). These volumes are significantly higher than the amount allowed by stress relief (Figure 6). Furthermore, pilot seals involved in IFAs tended to have the largest od and id extrusion, and exceeded the maximum allowable extrusion due to stress relief in all 10 cases.

Comparison of Figures 5 and 6 shows that premature valve failure is characterized by excessive extrusion above the amount allowed by

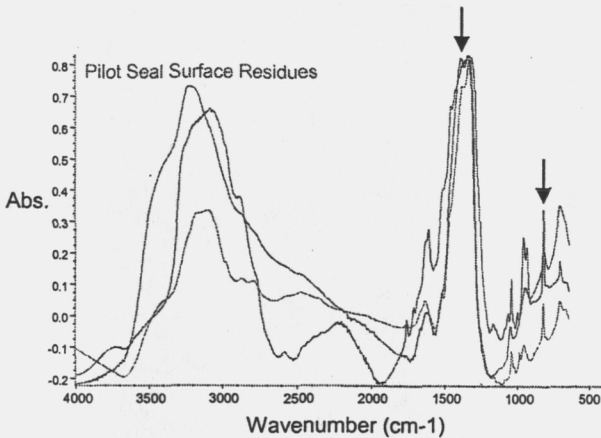
Figure 7 Representative FTIR spectra of FORP residues found on extruded pilot seals from 3 different fuel valves (arrows point to characteristic nitrate absorbances)

FTIR and HPLC/IC analyses of residues such as those depicted in Figure 7 gave the first known, conclusive identification of nitrate anion *inside* a fuel valve pilot seal cavity. HPLC/IC identified methylammonium nitrate (MAN) as the majority constituent in both internal and external fuel valve

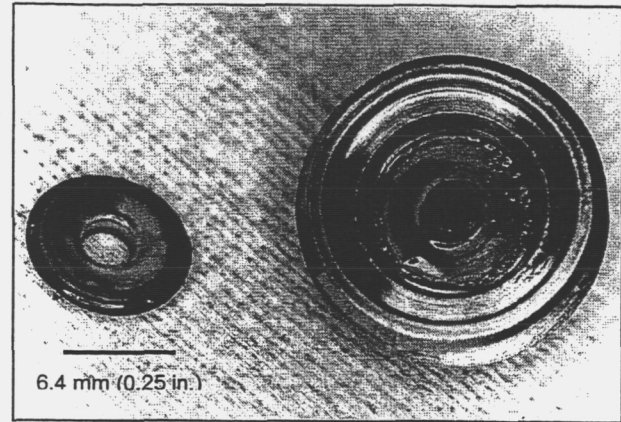
Figure 8 PRCS thruster S/N 217 pilot seat assembly with the retainer and pilot seal removed showing a large quantity of FORP inside the pilot seal cavity.

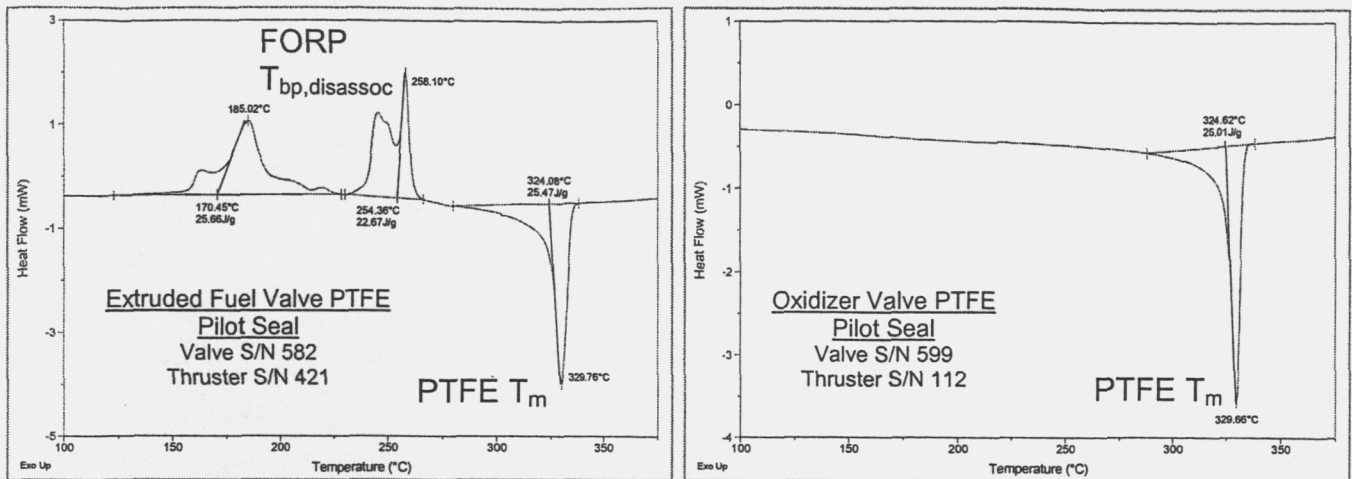
Figure 8 DSC thermograms showing a) FORP that is intimately associated with a fuel valve pilot seal (left), and b) the corresponding lack of FORP observed in conjunction with an oxidizer valve pilot seal (right) (Exo Up).

DSC data on extruded fuel valve pilot seals (Figure 9, left) removed from valve S/Ns 254, 508, 553, 582, 672, 718, 764, 893, and 895, showed that FORP was intimately associated with bulk PTFE (i.e., was not removed by previous decontamination, thruster flush, or HPLC/IC rinses). The FORP exotherm to PTFE endotherm peak ratio was 2.2 ± 0.8 ($n=9$), indicating similar amounts of FORP were associated with the PTFE, regardless of the amount of FORP observed inside the pilot seal cavity. The FORP composition as revealed by the presence of higher (MAN) and lower (MHN) temperature exothermic transitions attributable to FORP melting and/or disassociation, varied from seal to seal, but was uniform about the circumference of a given seal. These exotherms were not apparent during the second heating, indicating the FORP had volatilized or

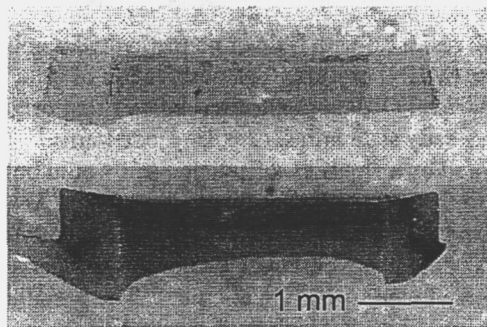
Figure 10 Heat-induced FORP-decomposition resulting in discoloration of a fuel valve pilot seal (valve S/N 254, bottom). An identically heated oxidizer valve pilot seal (valve S/N 599, top) is shown for comparison.

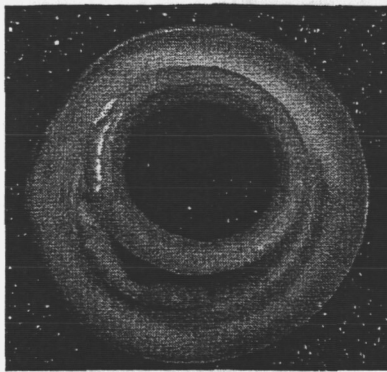
One of the more interesting failure analyses was conducted on the pilot seal from thruster S/N 101 (2nd failure), fuel valve S/N 544 (involved in an IFA on STS-108). Removal of the retainer revealed little or no FORP inside the pilot seal cavity, despite the presence of an oxidizer valve with well-documented history of GHe and oxidizer leakage. Most surprising was the presence of a fracture or void along the pilot seal *od* (Figure 11). This fracture was similar to one

Figure 11 Fracture/void located along the outer diameter (at 7 o'clock) of an extruded pilot seal removed from thruster S/N 101, fuel valve S/N 544. The inner (hole) diameter is 2.8 mm (0.11 in.).

Scanning Electron Microscopy (SEM) of the area immediately above the fracture region of the S/N 544 pilot seal revealed axial fissuring, suggesting tensile failure. SEM also revealed the presence of fine scale features immediately above and below the fracture, namely, machining grooves that had been introduced during latheing operations to fashion the preform from bar stock, suggesting the absence of temperatures well in excess of the 330 °C (625 °F) melting point for PTFE. DSC of PTFE cut from fracture area showed no FORP (similar to the thermogram shown in Figure 9, right), in contrast to the previous results obtained on 9 extruded pilot seals that did not exhibit any fracturing.

The two leading explanations for the fracture are 1) origination from a preexisting flaw introduced during fabrication, and 2) occurrence of a highly localized exothermic event involving FORP. A more remote explanation accounting for the lack of FORP could be exposure to high energy (450 keV accelerating potential) radiation during attempts to measure the amount of extrusion by X-ray Computed Tomography.
