**Development of Non Destructive Evaluation Techniques for the In-Situ Inspection
of the Orbiter's Thermal Protection System**

José M. Hernández
NASA – Johnson Space Center
Houston, Texas

**IEEE Symposium
Guadalajara, Mexico**

**Jose M. Hernandez
NASA - Johnson Space Center
April 2, 2004**

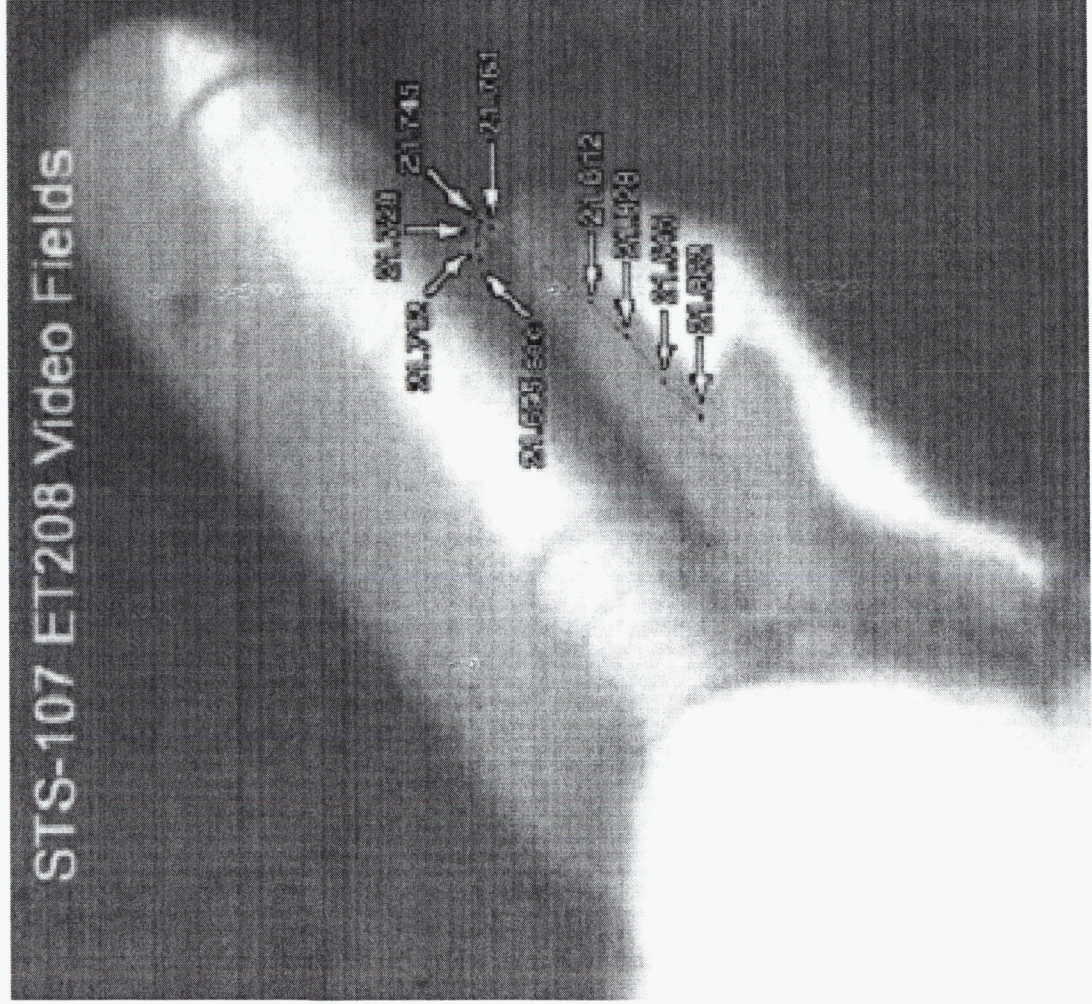
- T+81 sec after launch of STS-107 a piece of debris was noted to come off the external tank (ET) and impact the LH wing of the Shuttle
- Analysis during the flight identified a zone where the debris had the potential to impact
 - MLG Door, Wing, RCC and Carrier Panel
- Tasks were initiated to better understand foam projectile impacts on potential impact zones and develop improved in-situ NDE inspection techniques

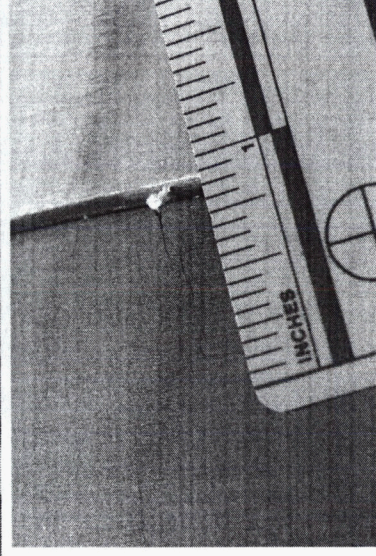
Two full scale RCC panel tests were conducted during the Investigation

- Panel 6
 - Material: BX 250 foam
 - Dimensions: 5.63" x 11.56" x 21.38"
 - Mass: 763.8 g (1.68 lb)
 - Actual launch velocity: 768 ft/sec
 - CG angle of impact: 20.6°
 - 5½" long through thickness crack
 - Located on the lock side approximately 6" below the stagnation
 - Transverses the entire rib width, extends through the lock side channel and onto panel lower face.
 - Approximate 3/4" crack on the lower face
 - T-seal crack 2.5" long on rib

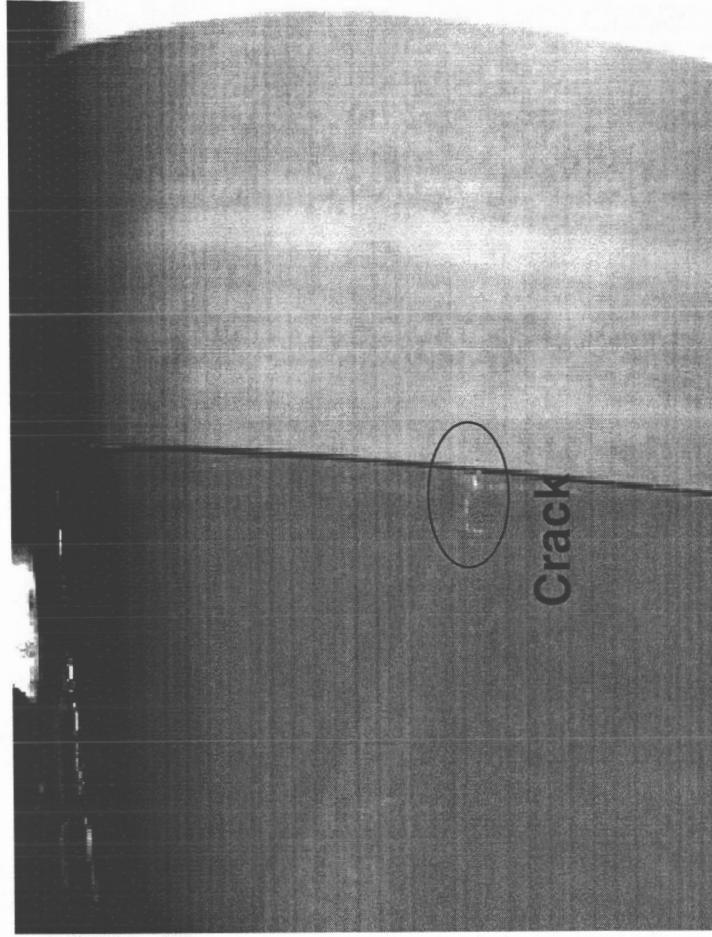
OV-103 6L Post Impact

Thermal Image of the crack through the part

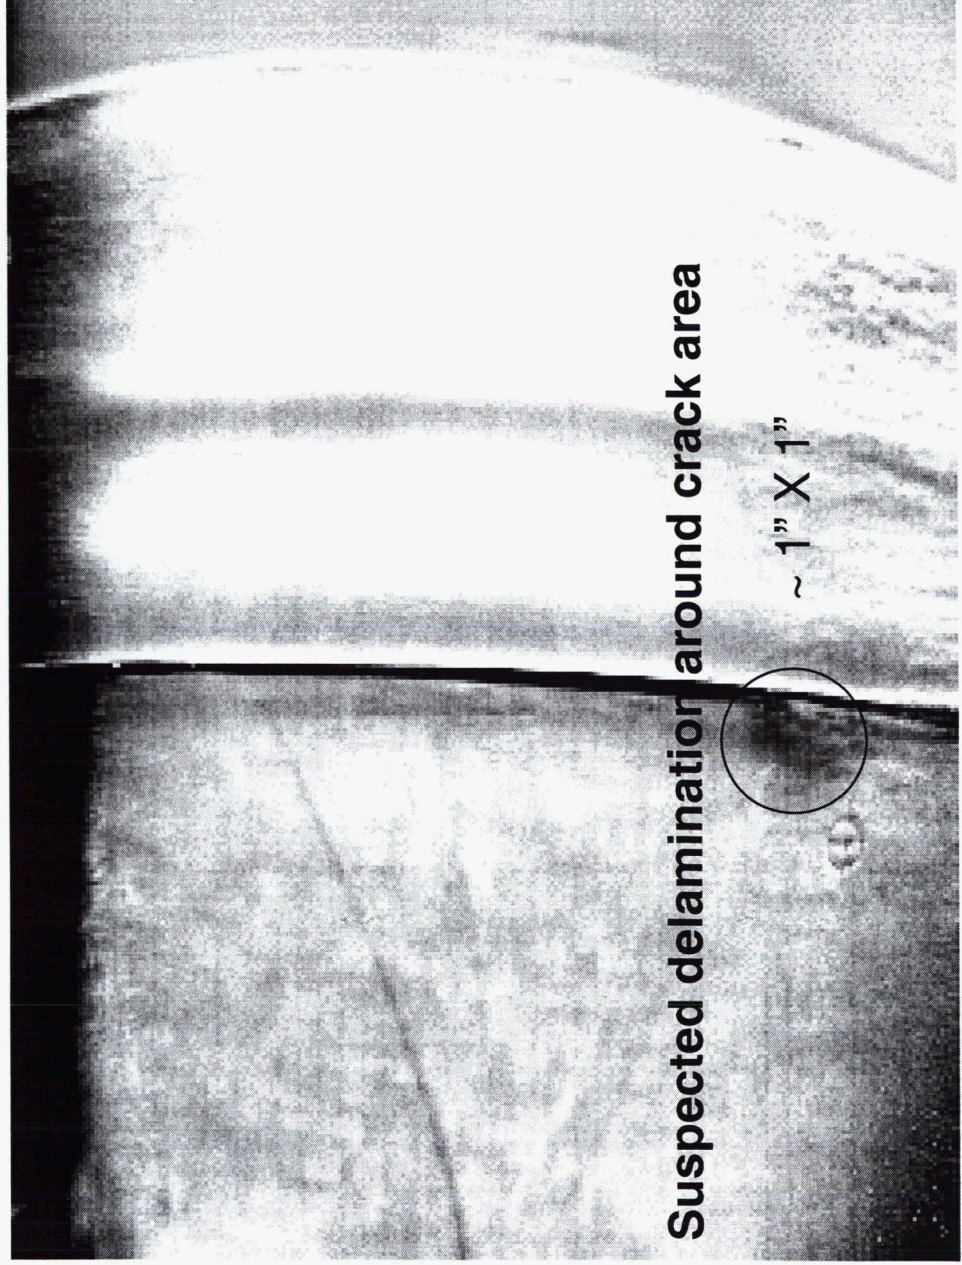
OV-103 6L Post Impact PCA Analysis of thermal data
