NASA/TM—2005-214021

Analysis of Carbon/Carbon Fragments From the Columbia Tragedy

David R. Tallant and Regina L. Simpson
Sandia National Laboratories, Albuquerque, New Mexico

Nathan S. Jacobson
Glenn Research Center, Cleveland, Ohio

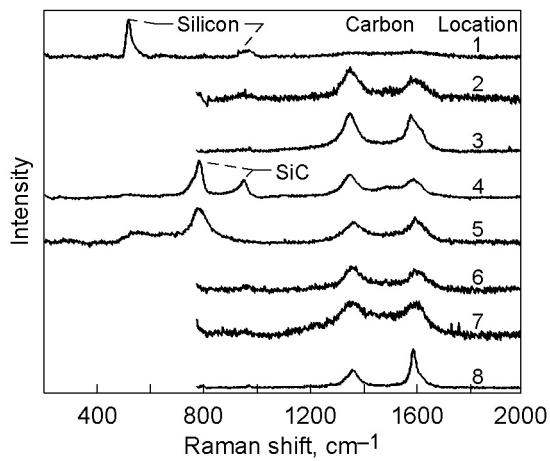
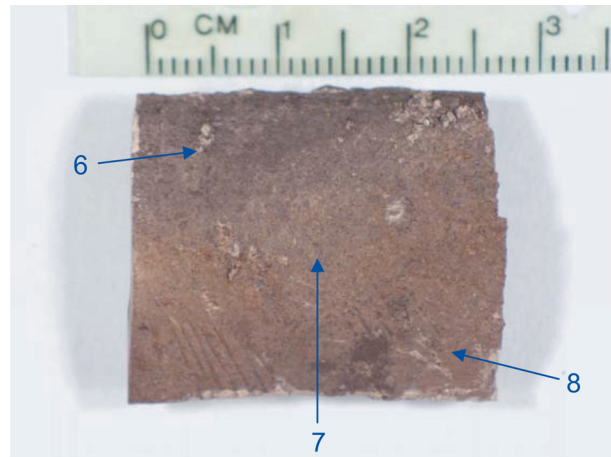
Figure 14.—Raman spectra and analyses of sample 1860A.

Sample 1860B (Panel 9) results are shown in Figures 13 and 14. The micrograph shows the pointed fibers, again indicating exposure to high temperature oxidizing gases. The Raman results are in Figure 14. Locations 1 and 2 are from the fracture surface. At location 1 the carbon Raman bands are low-temperature (400 to 1000 °C) and charcoal-like, which probably indicates deposition of pyrolysis products from after the break-up or contact with organic materials in the soil in which the part landed. However, the presence of Raman bands due to elemental silicon in the spectrum from location 1 indicates that, at some point, a much higher temperature was experienced. If the elemental silicon came from the

SiC layer of the RCC composite, the temperature at this location must have exceeded the point at which an appreciable Si(g) vapor pressure is generated (~2000 °C). Locations 3 to 7 indicate intermediate (1000 to 2000 °C) temperature carbon and silicon carbide, apparently a remnant of the SiC layer in the RCC composite. However, the Raman spectrum from location 8 indicates some very high temperature carbon, which may have deposited during the accident.

Location	Location Description	Summary of Identified Bands
1	Sloping edge, concave side	Microcrystalline silicon, 400 °C carbon
2	Sloping edge, concave side	1800–2200 °C carbon*
3	Edge, concave side	1800 °C carbon
4	Center, concave side	Silicon carbide, 1800–2200 °C carbon, amorphous carbon
5	Near side, concave side	Silicon carbide, 1600 °C ? carbon
6	Lower, convex side	1600 °C carbon
7	Center, convex side	1000 °C carbon
8	Upper, convex side	Silicon carbide (minor), > 2700 °C carbon

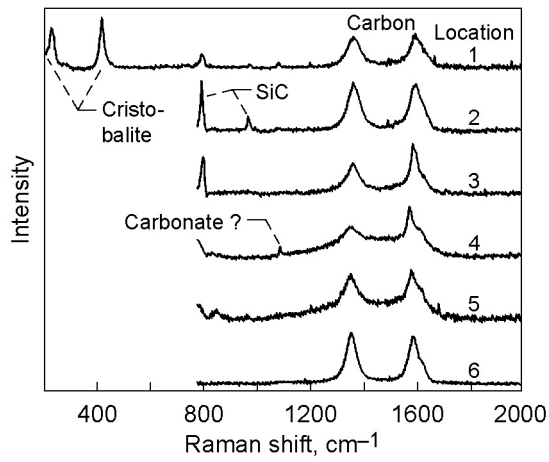
Figure 24.—Raman spectra and analyses of sample 2200A.

Location	Location Description	Summary of Identified Bands
1	Knife edge, smooth side	SiO ₂ (cristobalite), silicon carbide, 2400 °C carbon
2	Knife edge, smooth side	Silicon carbide, 2400 °C carbon
3	Knife edge, rough side	Silicon carbide, 2700 °C carbon
4	Knife edge, rough side	Carbonates ?, 2700 °C carbon plus low temperature carbon ?
5	Crack, near edge, rough side	2100–2300 °C carbon plus low temperature carbon
6	Crack, near center, rough side	2300 °C carbon
