JPL Publication 2005-2

Genesis Failure Investigation Report

JPL Failure Review Board, Avionics Sub-team

July 2004

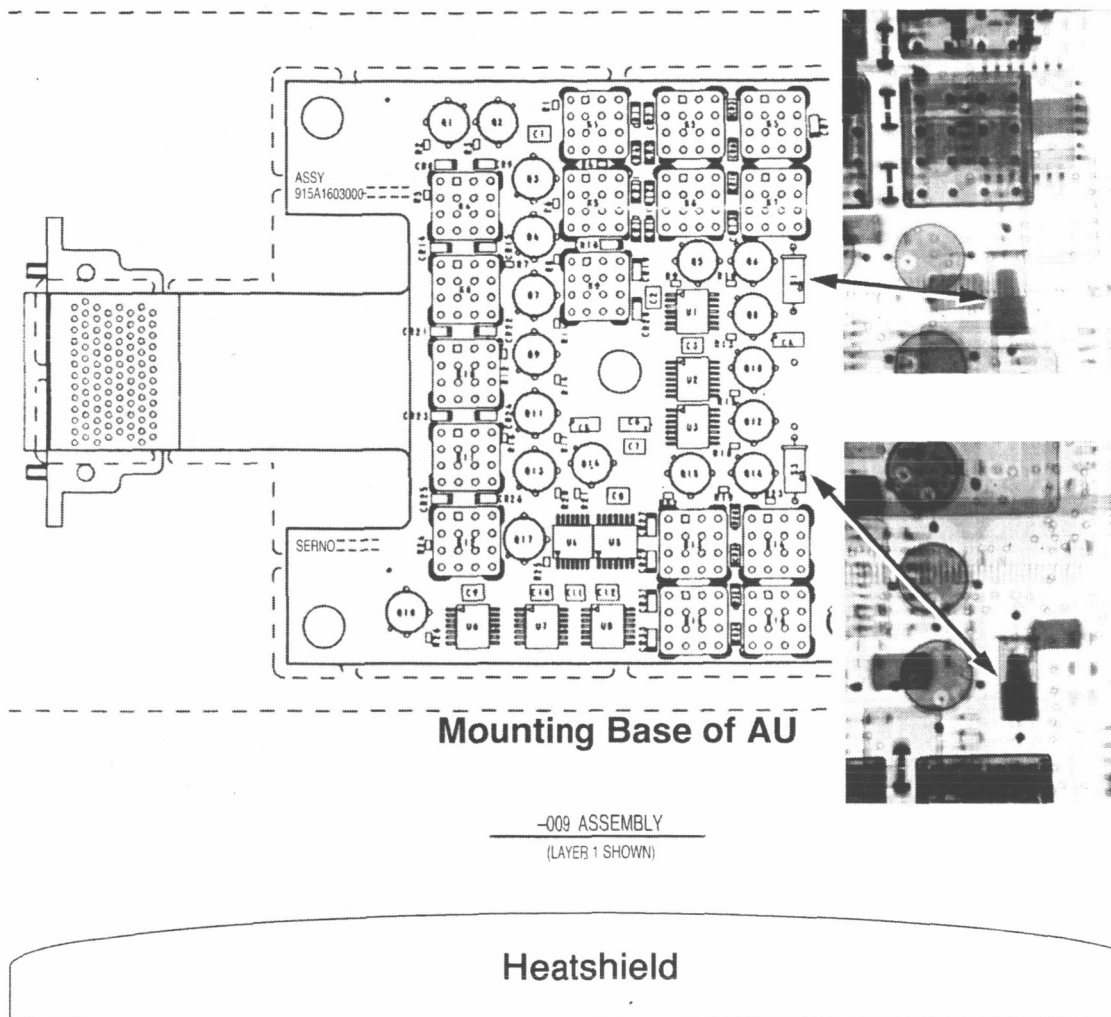
Figure 2-13. X-Ray of board indicating that installation of G-switches matches board layout drawing

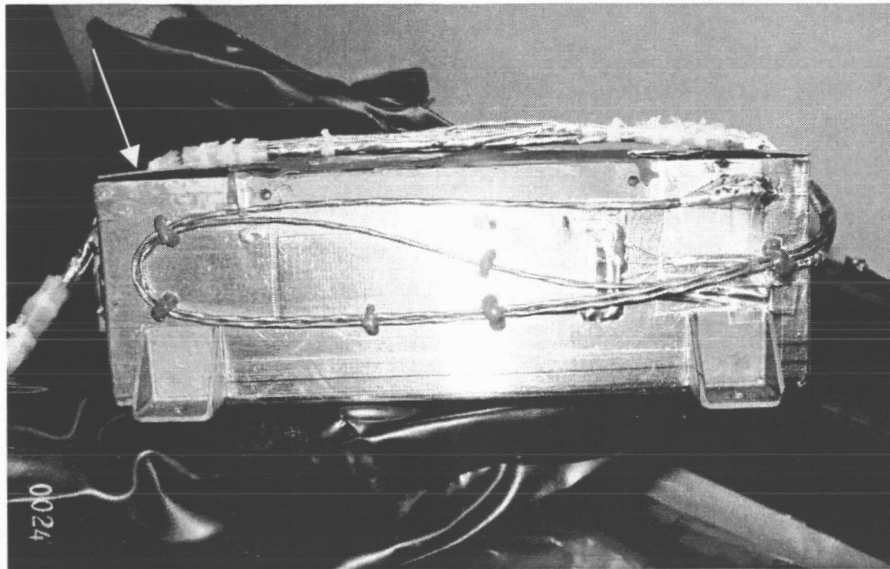
With the exception of a bowed top cover and some discoloration/staining on the top cover and black Kapton (Figures B-3, B-4), the battery surprisingly escaped severe damage from the hard landing. Physical dimensions of the battery were measured and were found to be comparable to pre-flight measurements, with the exception of height. This discrepancy is due to the bowing of the top cover.

Figure B-3. Battery showing bowed cover

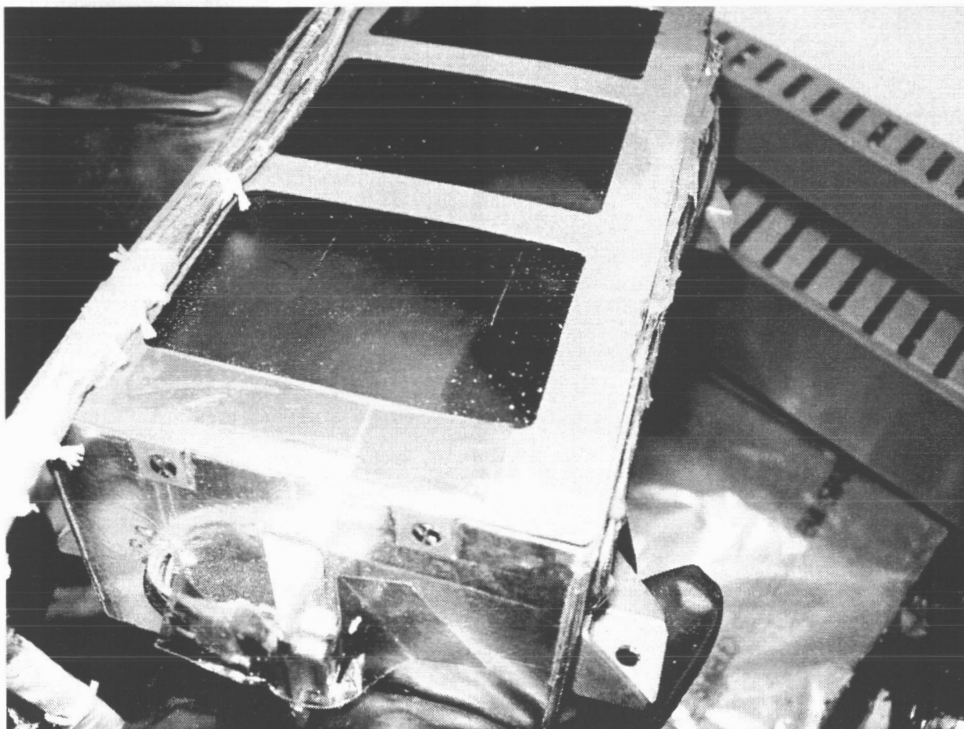
Figure B-4. Battery showing stained glass

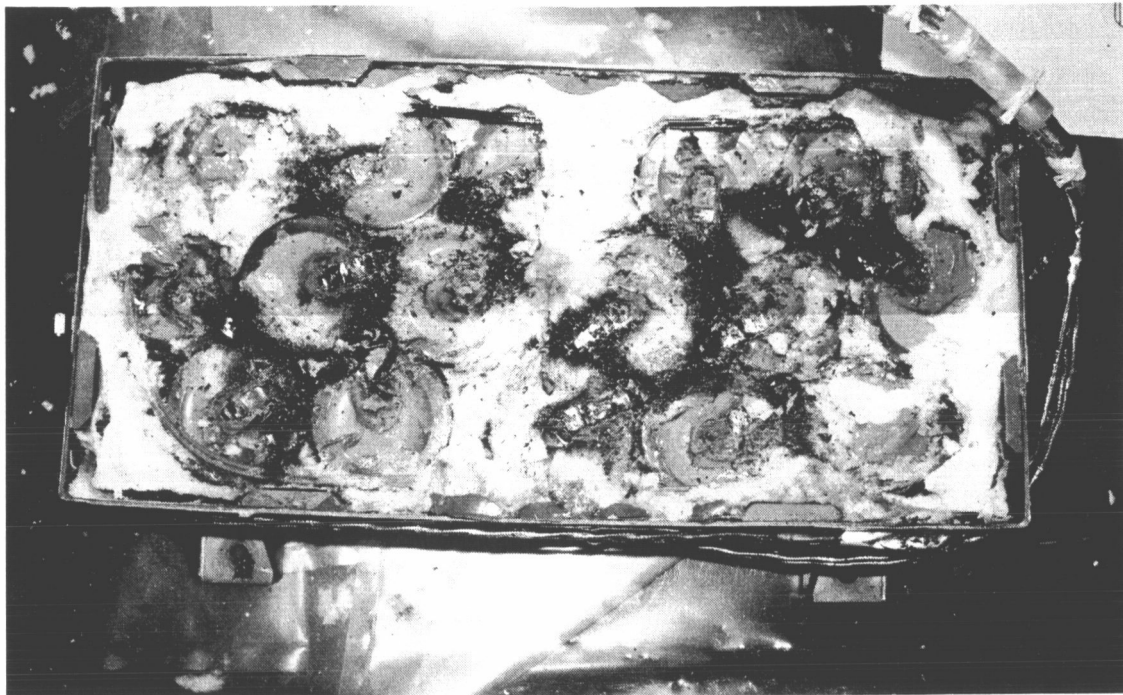
Pieces of the pyrolyzed foam were removed and revealed significant corrosion over the top of cells (Figure B-8). A piece of foam was tested to see how high a temperature would be required to pyrolyze it to a condition similar to the foam in the SRC battery. The foam started discoloration at 140°C and showed significant discoloration at 200°C.

Figure B-8. SRC battery cell tops

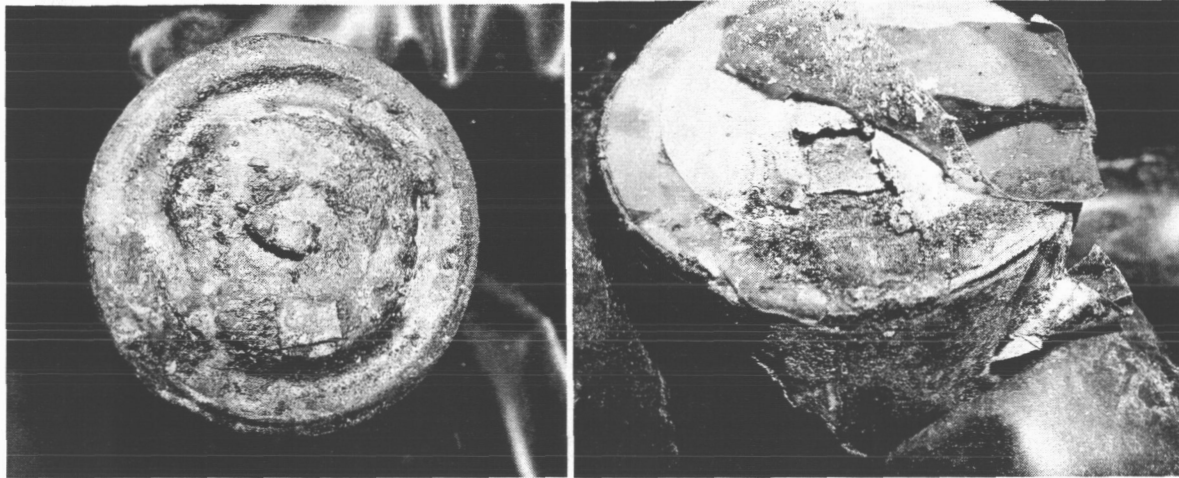
The cells were removed from the battery housing after all the interconnect tabs were cut. The cells showed significant corrosion at the bottoms, where the vent points were located, and also displayed significant heat damage underneath the cell interconnect tabs. Typical cell bottom and cell top photos are shown as Figures B-9 and B-10, respectively. Close inspection of the cells revealed that all cells had vented.

Figure B-9 (above left). Picture taken of a typical cell bottom (Cell 3A) after removal, illustrating the excessive corrosion evident due to the release of SO_2

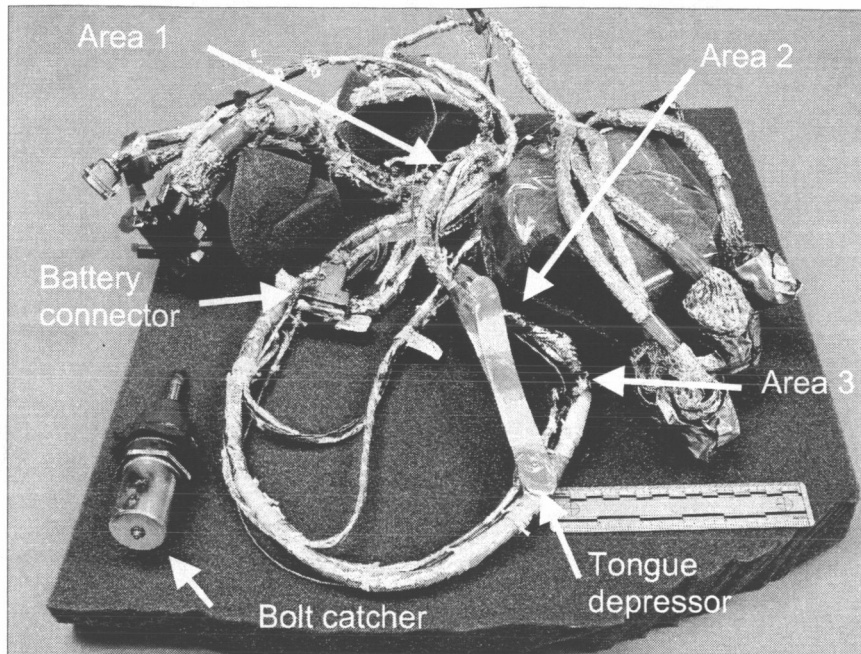
Image No.:0411A00200, Project No.: 2004110004

Figure 1. Overall view of the as-received wiring harness and bolt catcher. Wrap disturbance at areas 1 to 3 are indicated. Also, a splice consisting of wood tongue depressors for stabilization during shipping is indicated.

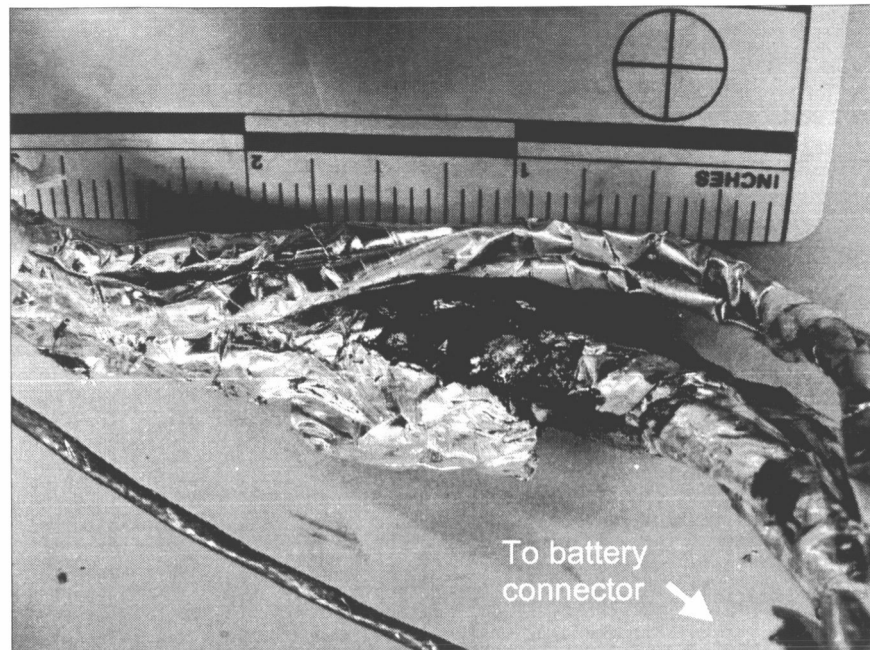
Image No.:0411A00208, Project No.: 2004110004

Figure 3. Another view of the wrap disturbance at Area 1.

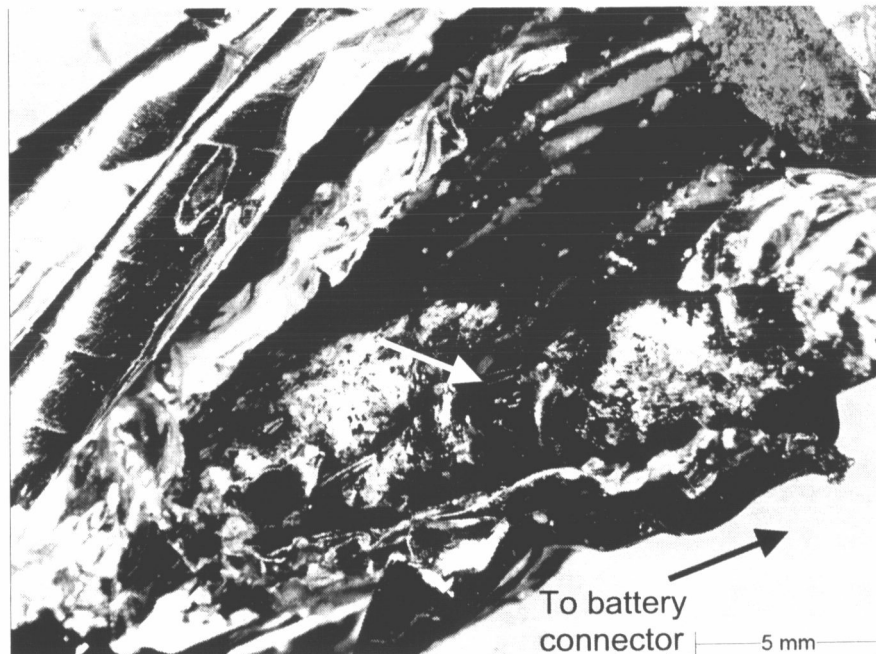
Image No.:0411A00229, Project No.: 2004110004

Figure 4. A closer view of Area 1. An unlabeled arrow indicates exposed power cable strands with missing insulation.

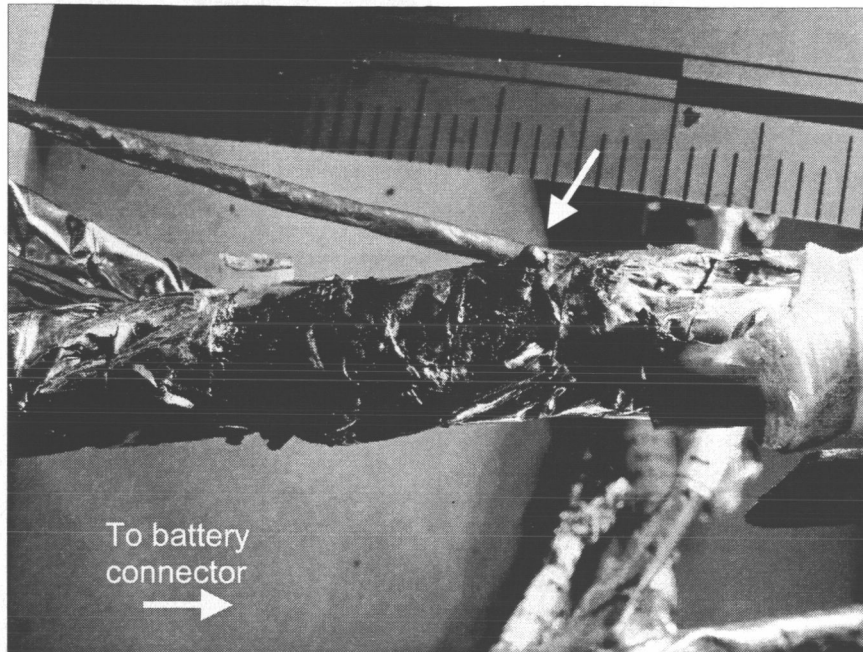
Image No.:0411A00206, Project No.: 2004110004

Figure 5. Close view of the damage at Area 2. An unlabeled arrow indicates where a melt bead penetrated the aluminized Mylar wrap.

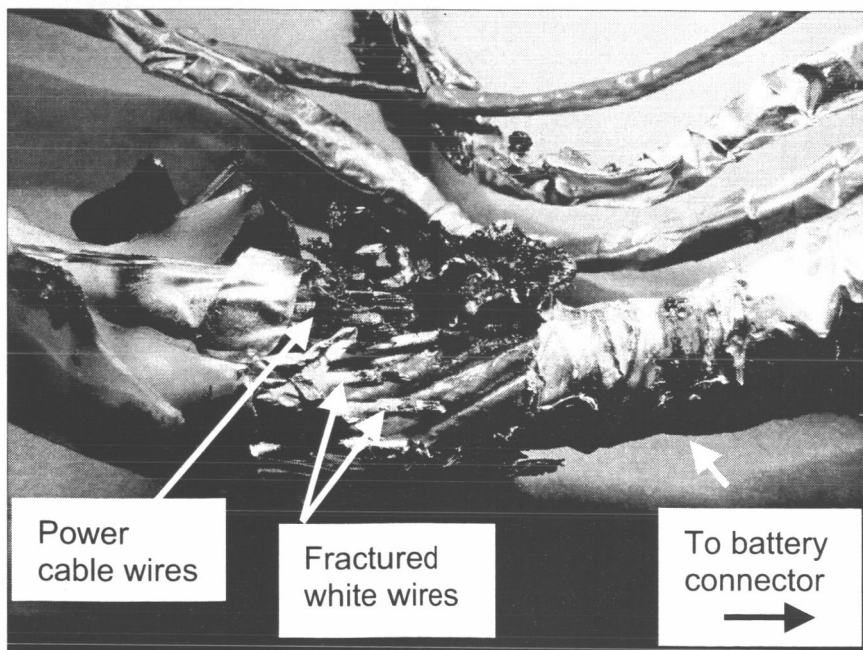
Image No.:0411A00204, Project No.: 2004110004

Figure 6. Close view of the damage at area 3. The unlabeled arrow indicates the direction of viewing for figure 7.

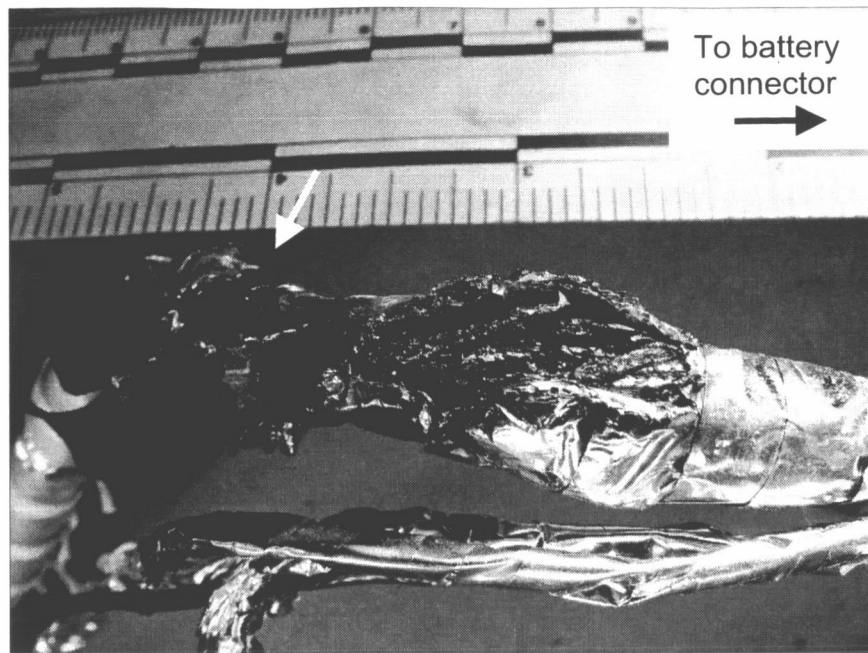
Image No.:0411A00207, Project No.: 2004110004

Figure 7. Damage at area 3 adjacent to the damage shown in figure 6 located closer to the battery connector. The unlabeled arrow indicates the direction of viewing for figure 6.

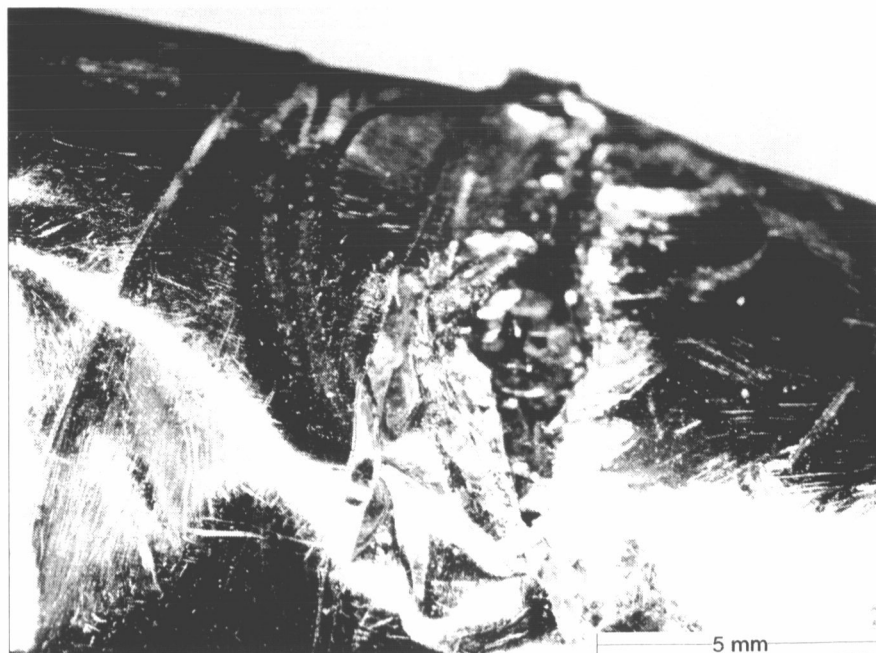
Image No.:0411A00210, Project No.: 2004110004

Figure 8. View of the damage at area 4.

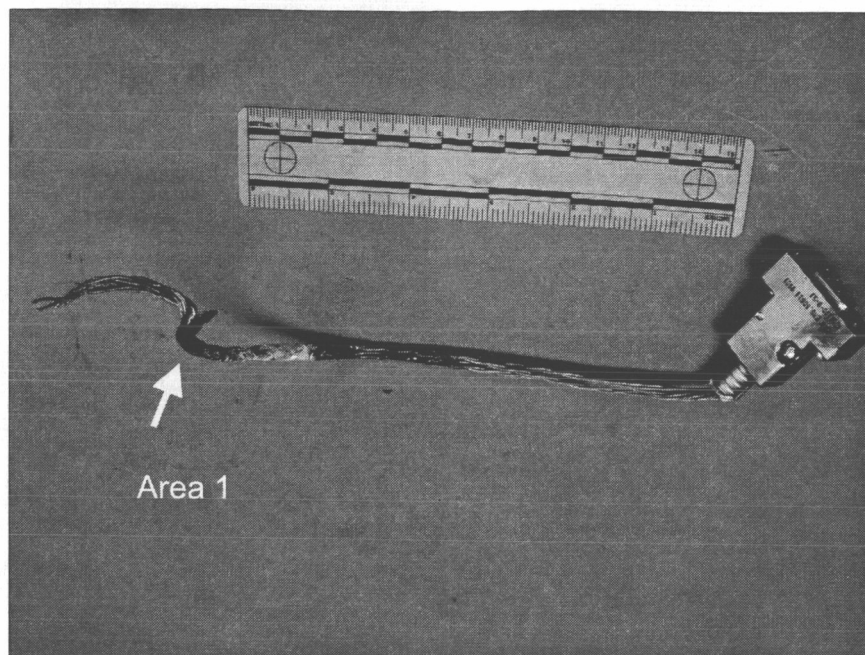
Image No.:0411A00246, Project No.: 2004110004

Figure 9. View of the battery connector and power cable after removal of the outer aluminized Mylar wrap. The cable strands were melted and fractured in the vicinity of Area 1.

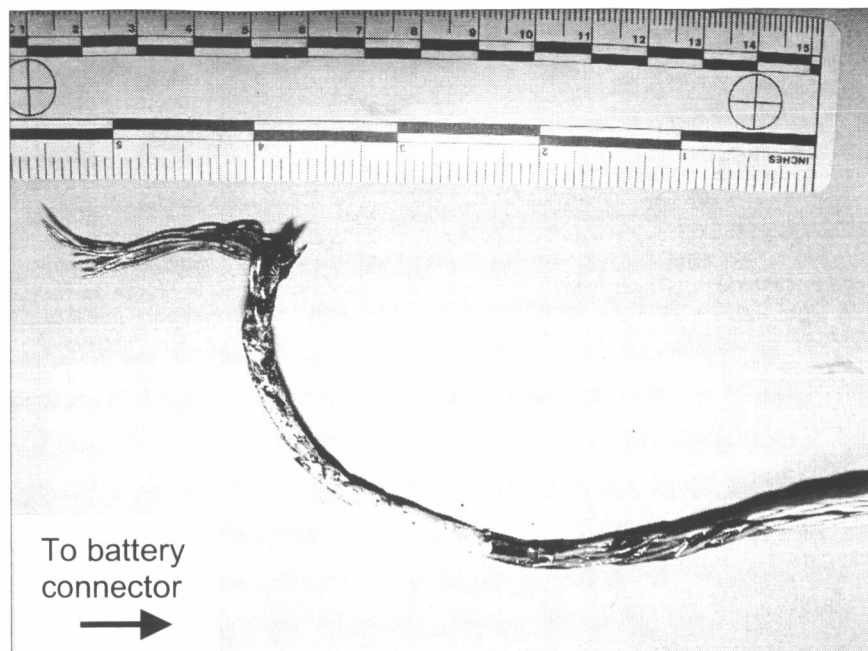
Image No.:0411A00255, Project No.: 2004110004

Figure 11. Closer view of the damaged end of the power cable piece shown in figure 9.

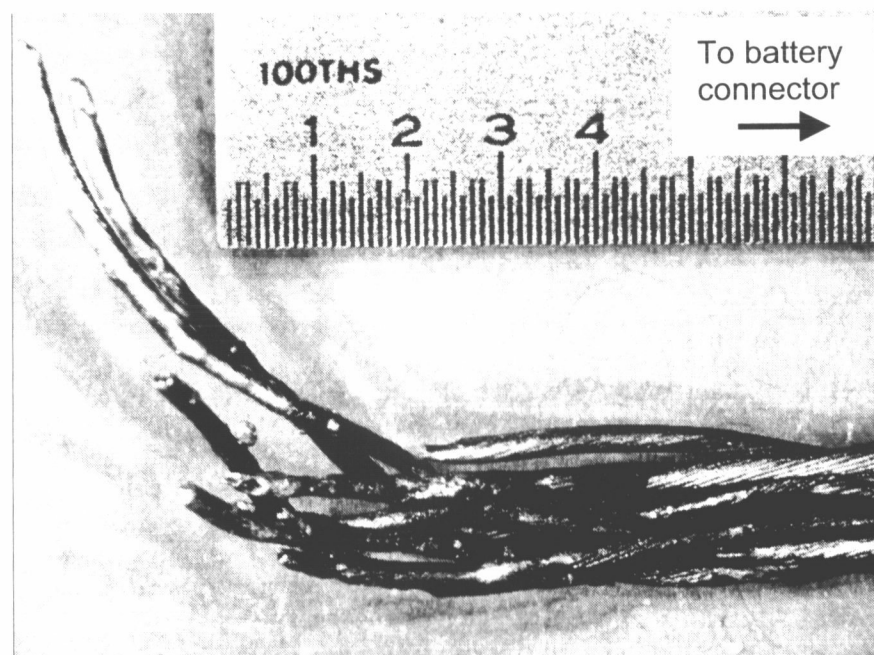
Image No.:0411A00242, Project No.: 2004110004

Figure 12. Closer view of the melted and fractured strands of the power cable piece shown in figure 11.

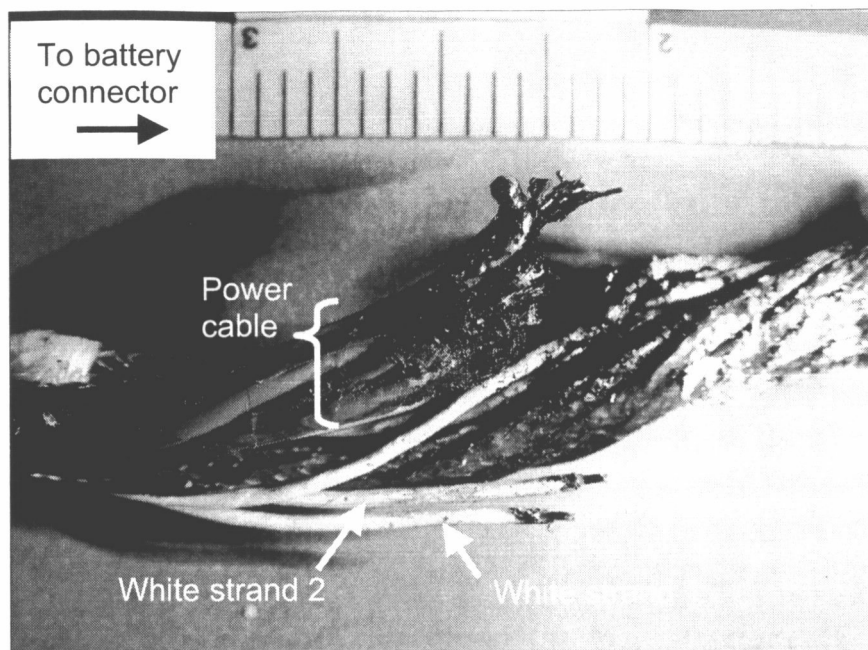
Image No.:0411A00295, Project No.: 2004110004

Figure 15. Close view of the damage at area 3 after removal of the outer aluminized Mylar wrap.

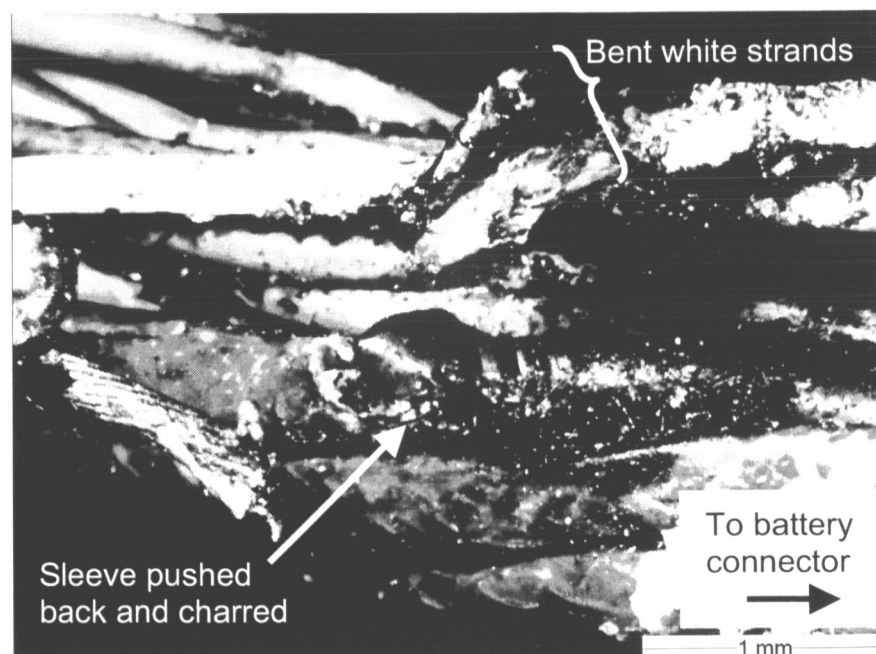
Image No.:0411A00578, Project No.: 2004110004

Figure 16. Close view of the damage in area 3 showing the bent mating ends of white strands 1 and 2. Damage to the Kapton sleeve of an adjacent strand also is indicated in the figure.

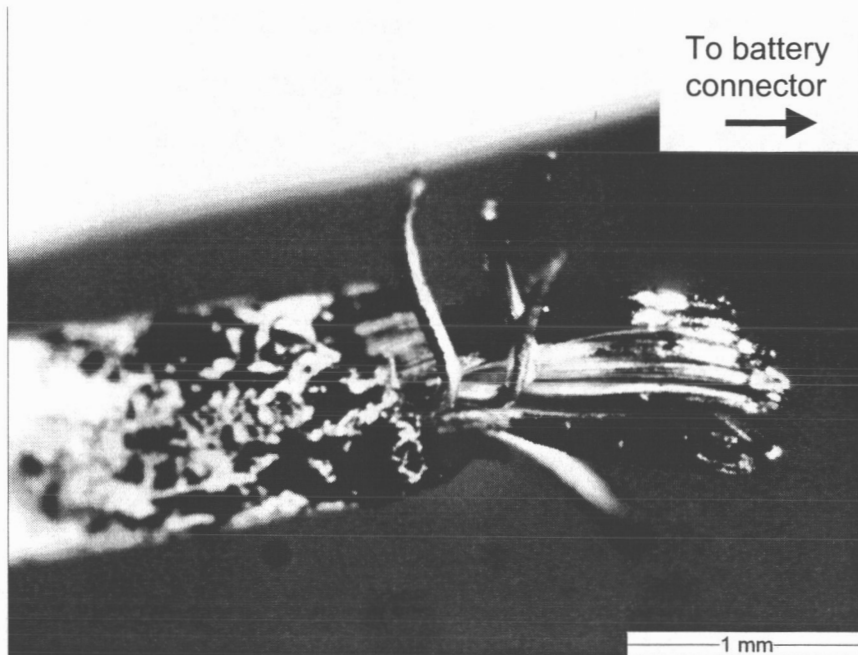
Image No.:0411A00568, Project No.: 2004110004

Figure 17. Close view of white strand 1 in Area 3. Several strands were bent during the wrap removal process.

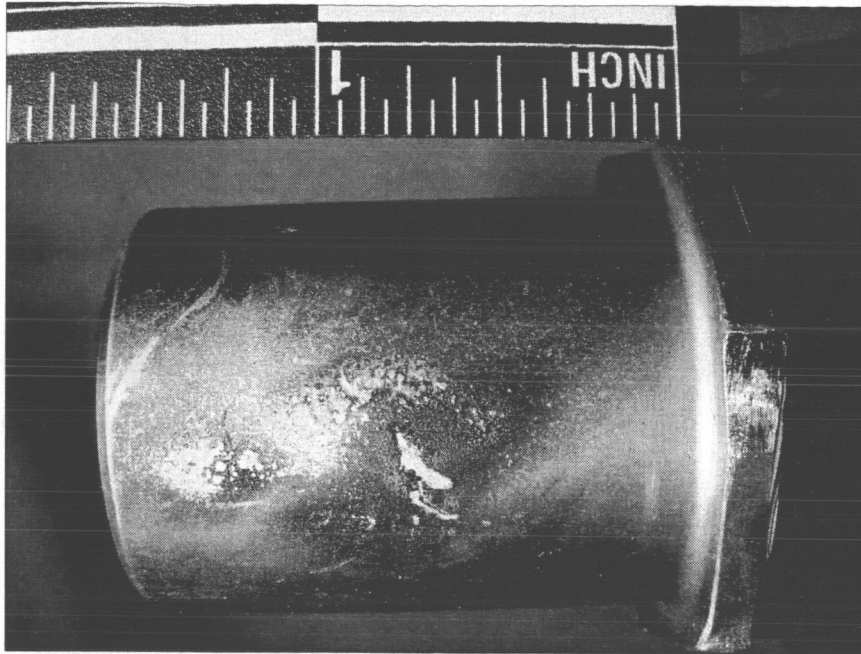
Image No.:0411A00319, Project No.: 2004110004

Figure 39. Close view of deposits on the bolt catcher.

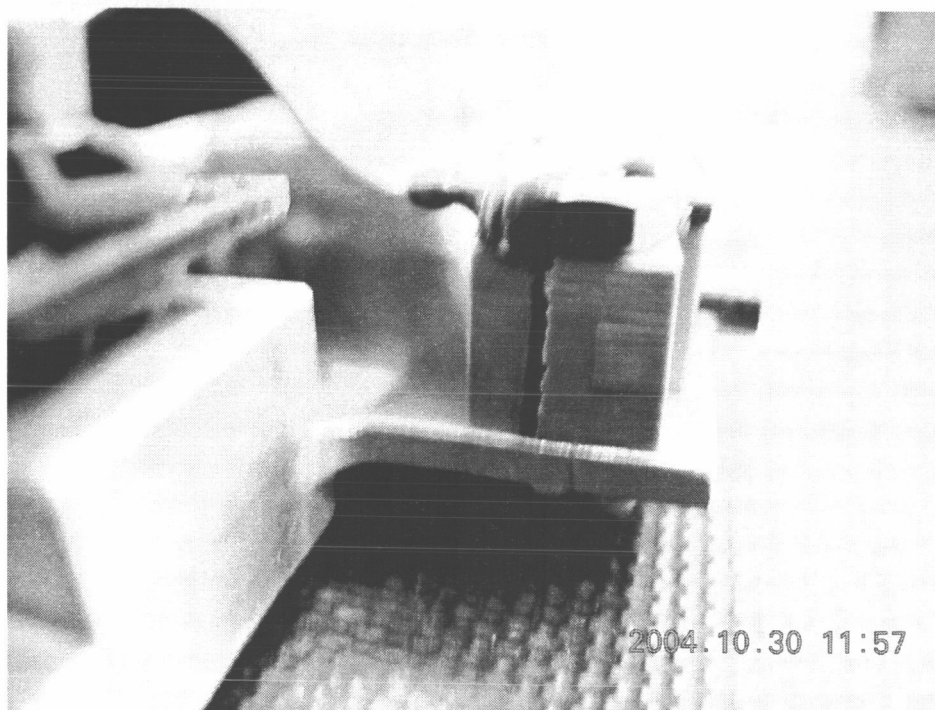
Figure G-2. Cracked P1 Connector on Relay Card SN 001

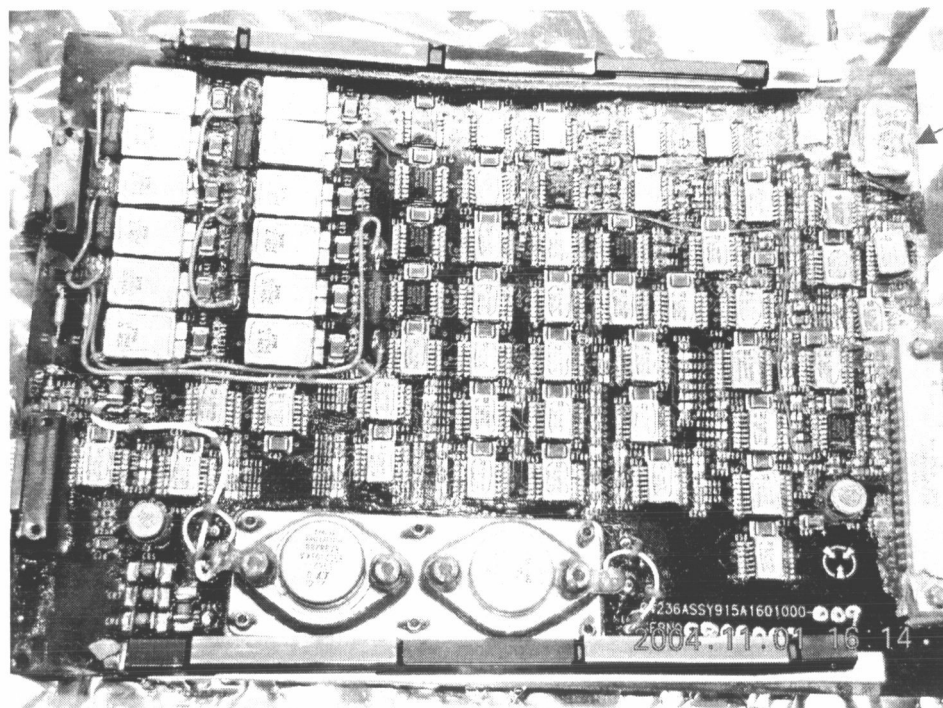
Note physical damage in this corner.

Figure G-6. Avionics Box B EST Card SN 002

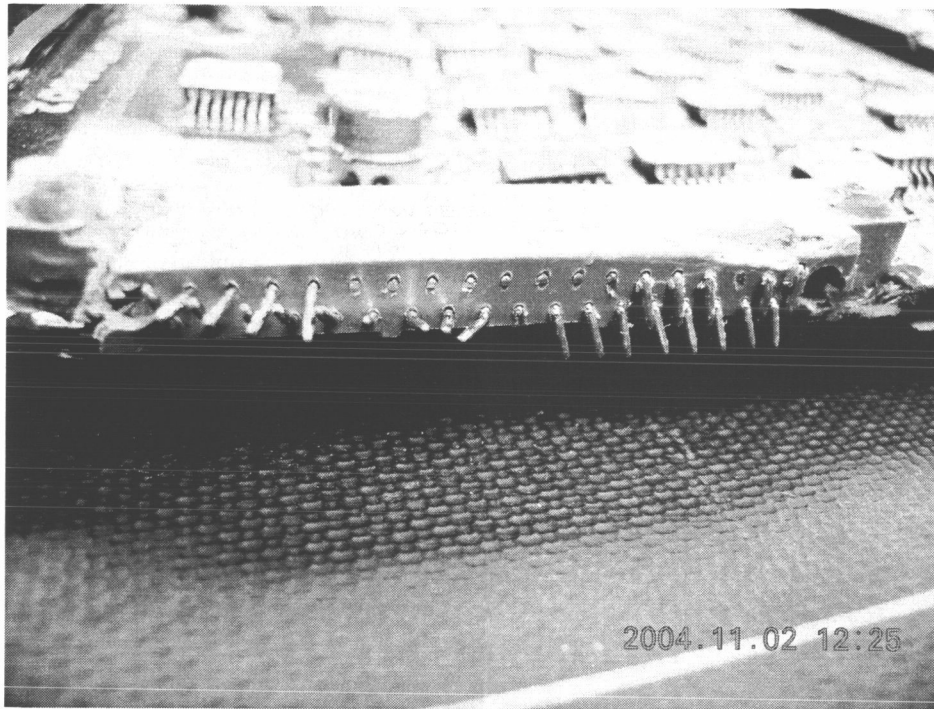
Figure G-7. EST SN002 P1 Connector

Pyro output continuity testing could not be performed because of connector damage.
