# **Debris/Ice/TPS Assessment and Integrated Photographic Analysis of Shuttle mission STS-109**

Armando Oliu  
Process Engineering/Mechanical System Division/ET-SRB Branch,  
Kennedy Space Center, Florida

**March 1, 2002**

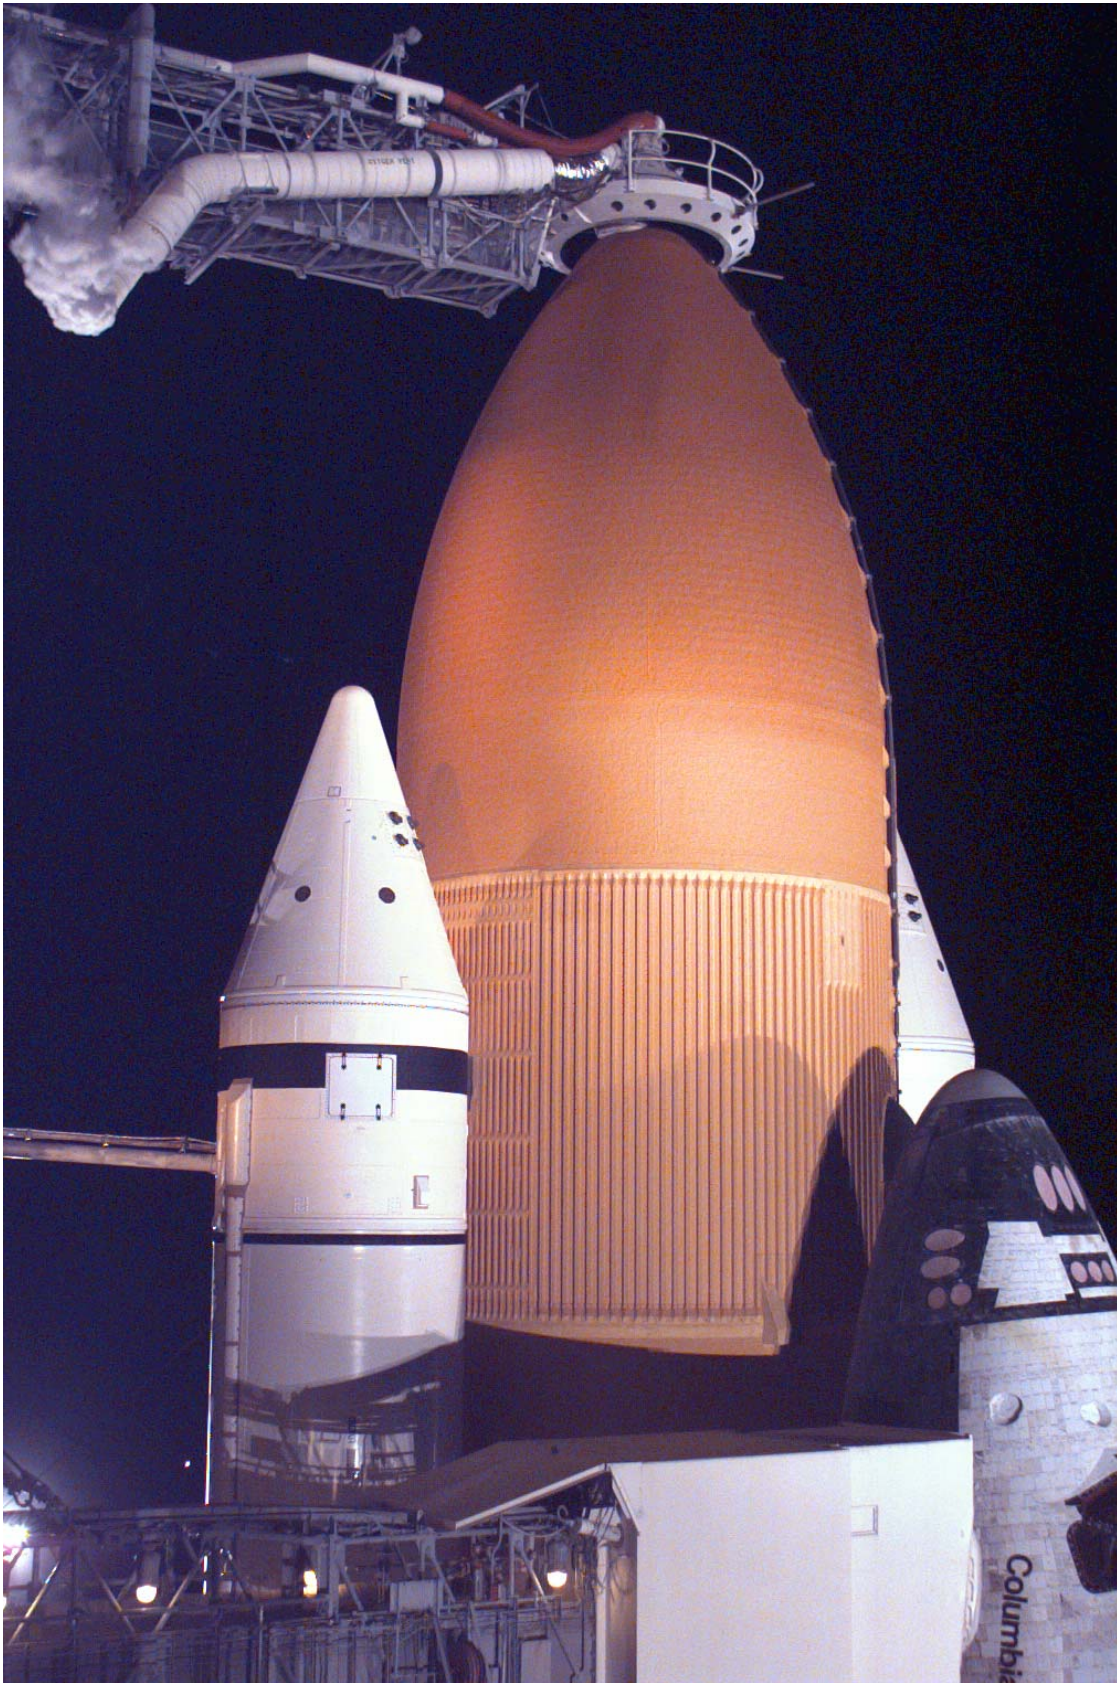
**Photo 2: LO2 tank acreage.**

No condensate was present on the LO2 tank acreage. Surface temperature ranged from 28 to 47 degrees Fahrenheit. There were no acreage TPS anomalies.

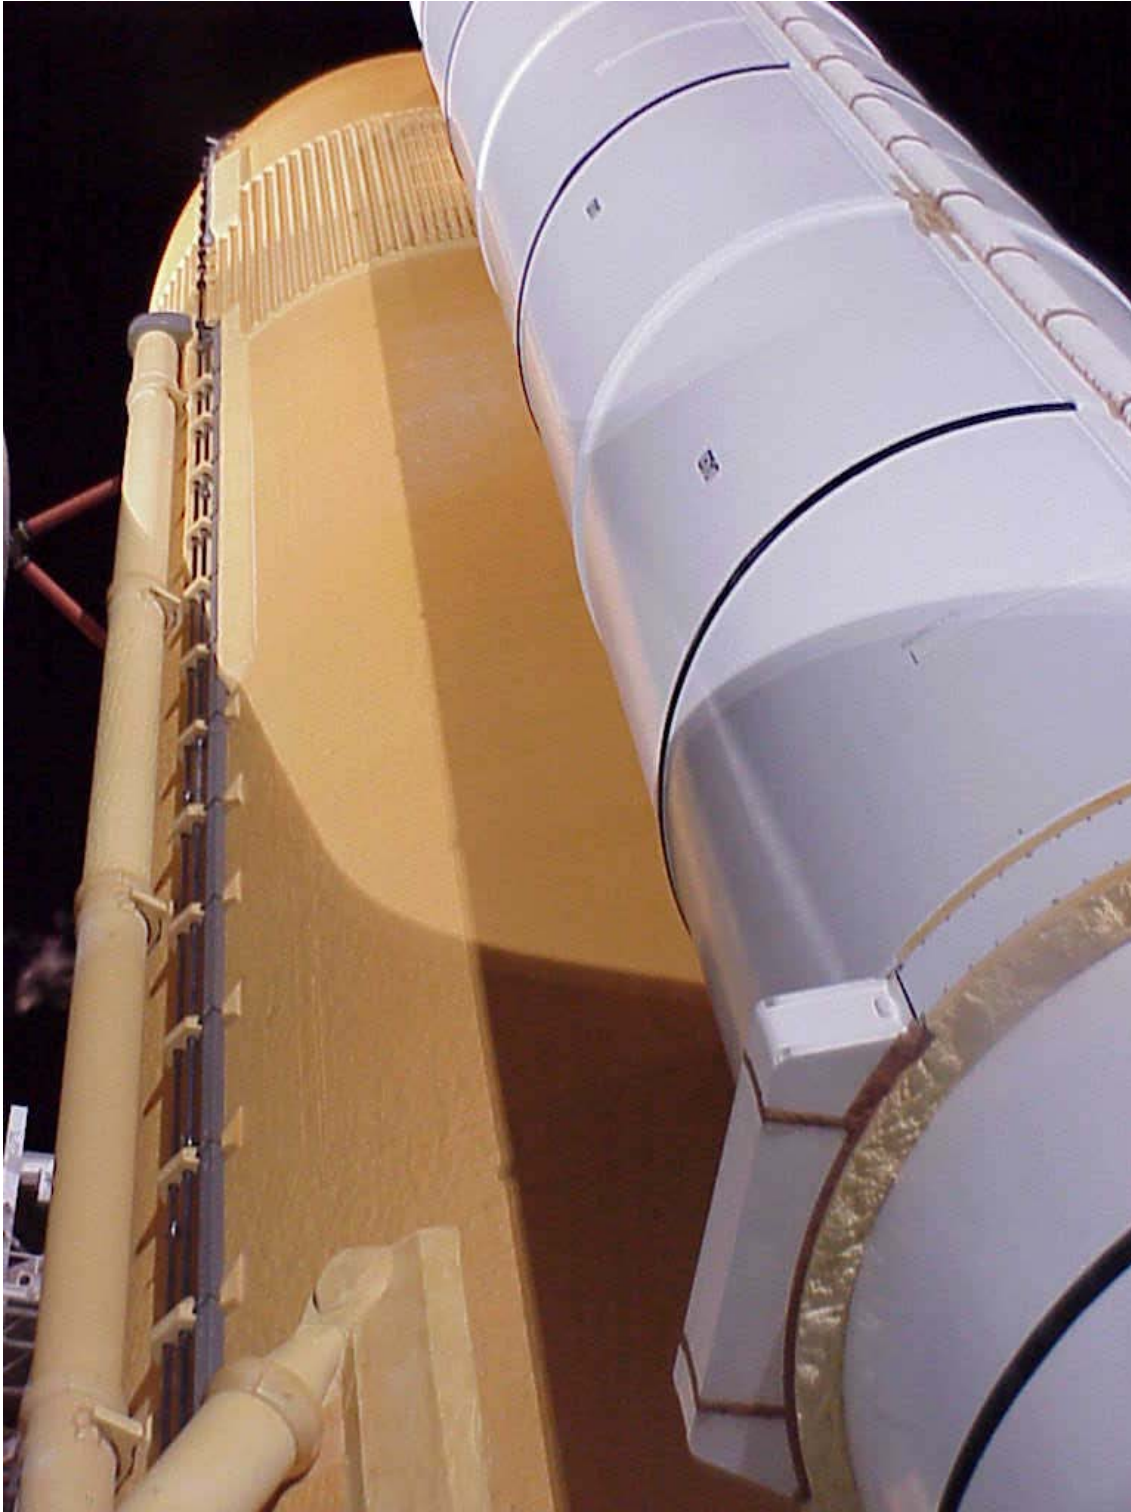
**Photo 3: LH2 tank acreeage.**

No condensate was present on the LH2 tank acreeage. Surface temperature ranged 28 to 48 degrees Fahrenheit. Light frost was present in all quadrants. There were no acreeage TPS anomalies.

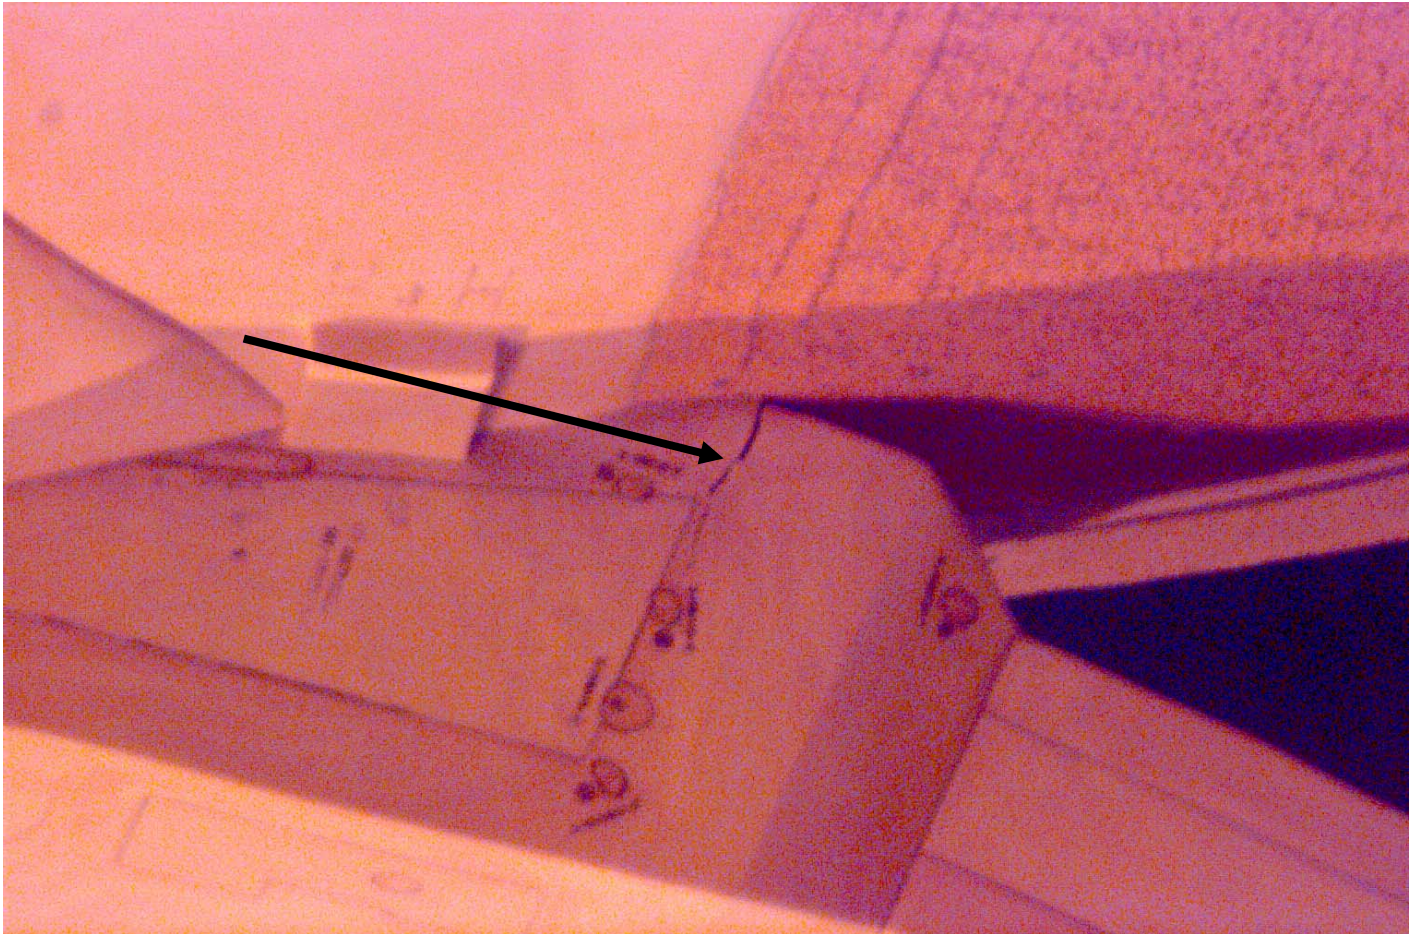
**Photo 4: Crack in -Y Vertical Strut TPS**

An 8 inch long and 1/4 inch wide stress relief crack was observed in the –Y vertical strut TPS with no offset. This condition has been observed on previous vehicles and found acceptable for flight per the NSTS-08303 criteria.

An 8 inch long and 1/4 inch wide stress relief crack was observed in the -Y vertical strut TPS with no offset. This condition has been observed on previous vehicles and found acceptable for flight per the NSTS-08303 criteria.

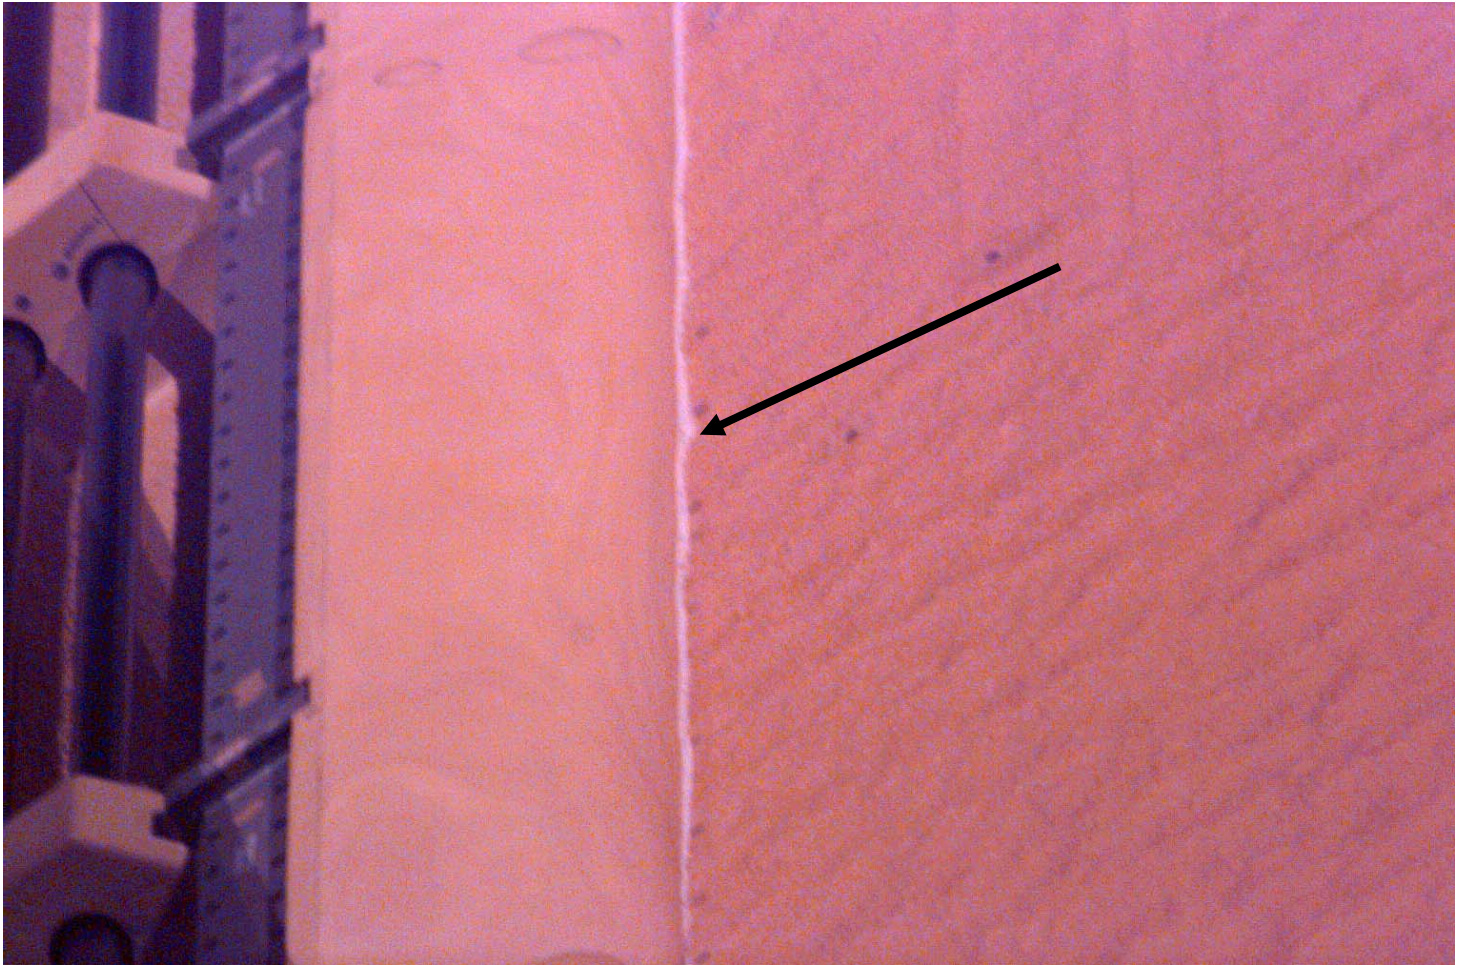
**Photo 5: Frost on PAL ramp to LH2 tank acreage**  
This is a light frost formation and acceptable per NSTS-08303.

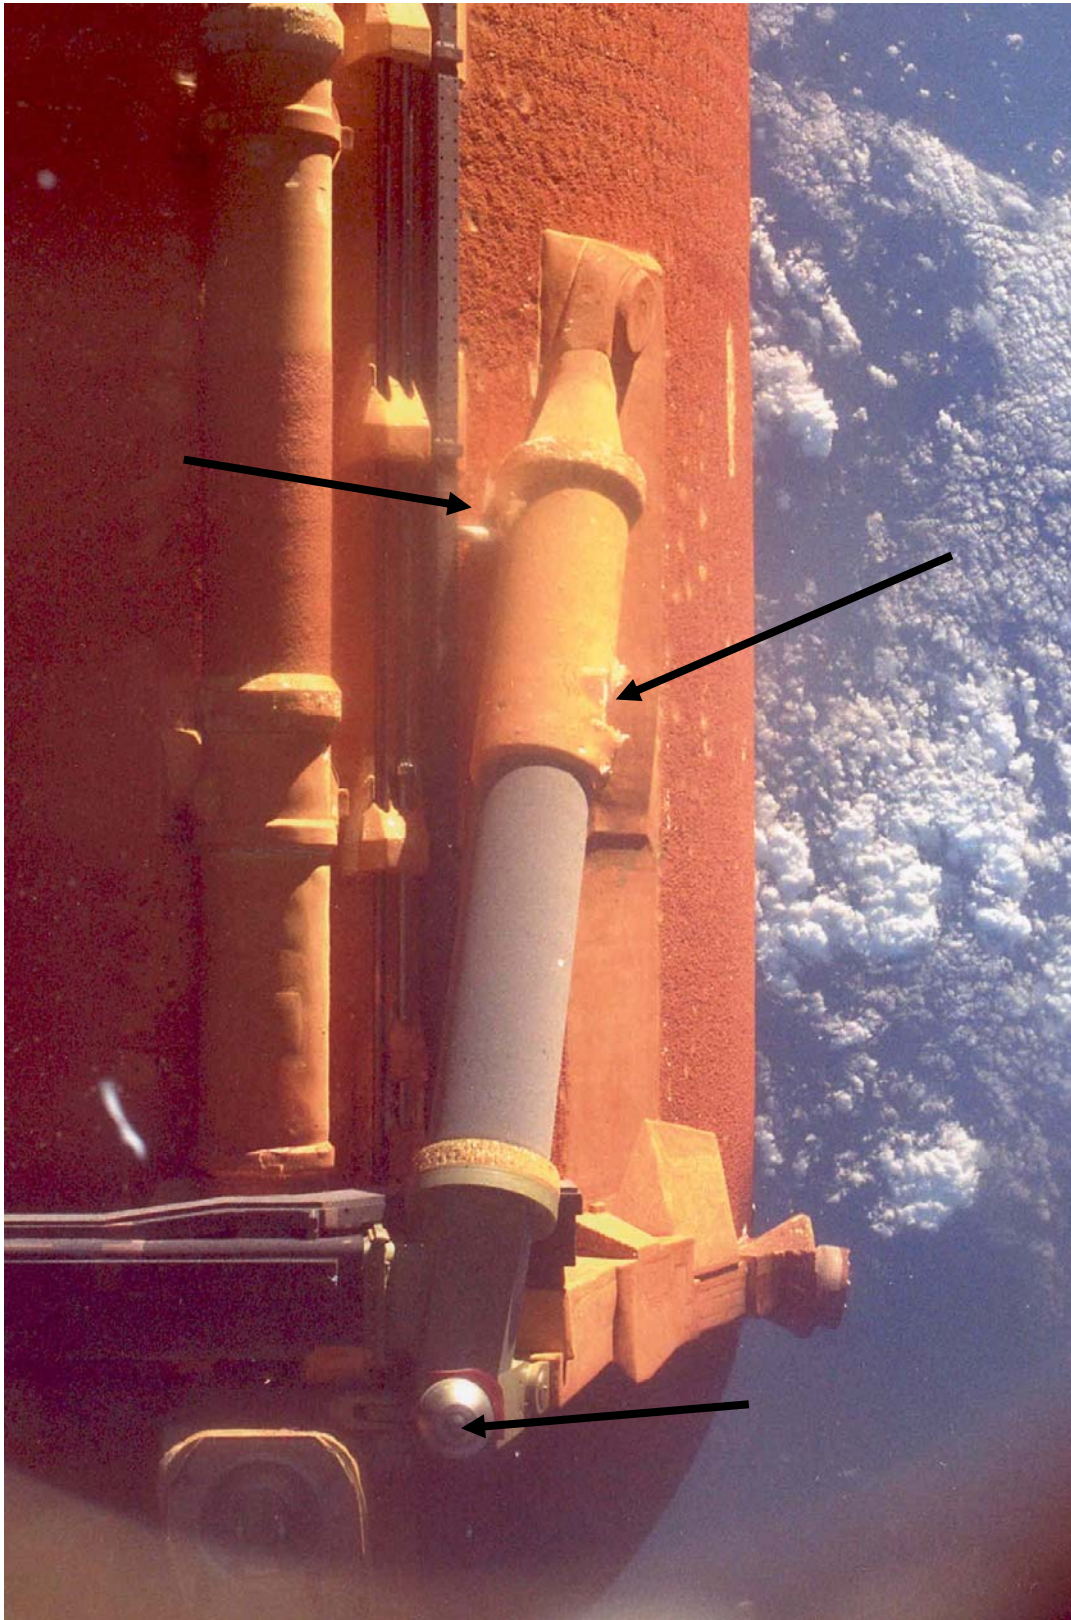
**Photo 6: External Tank post separation**

Large divots on +Y thrust strut TPS. EO-3 separation bolt protruding slightly.

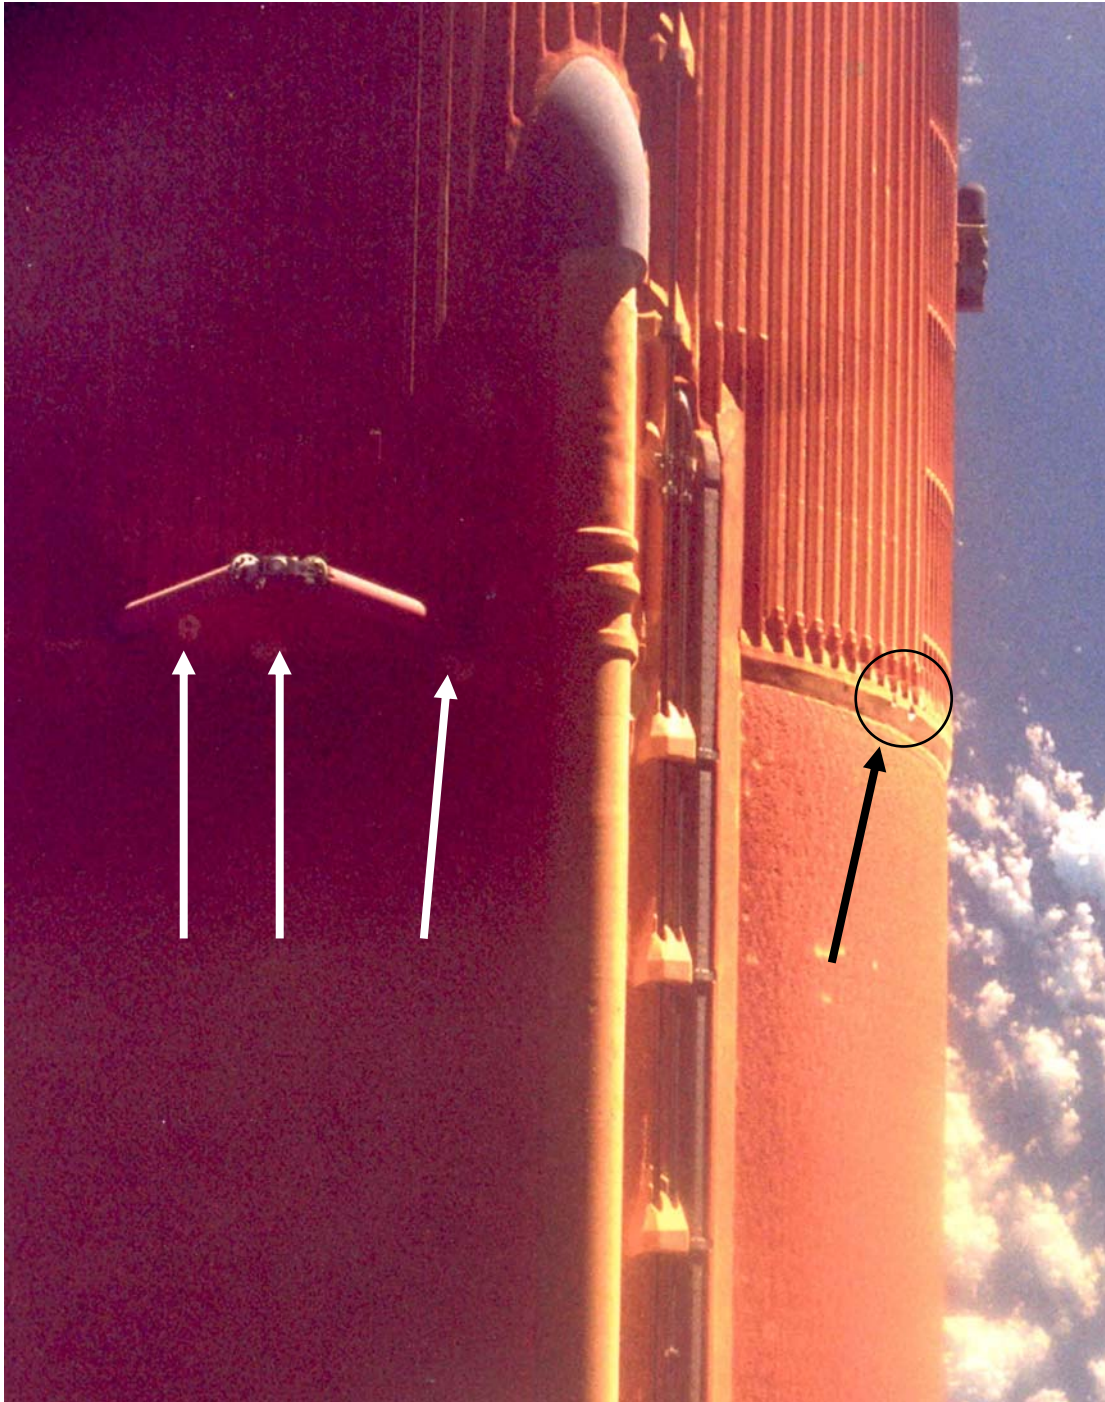
**Photo 7: External Tank post separation**

Three divots observed on the intertank-to-LH2 tank flange between the bipods. One of the divots extends into the acreage foam.

Two small divots near the +Y thrust panel on the intertank to LH2 tank flange. Three divots observed on the intertank-to-LH2 tank flange between the bipods. One of the divots extends into the acreage foam.

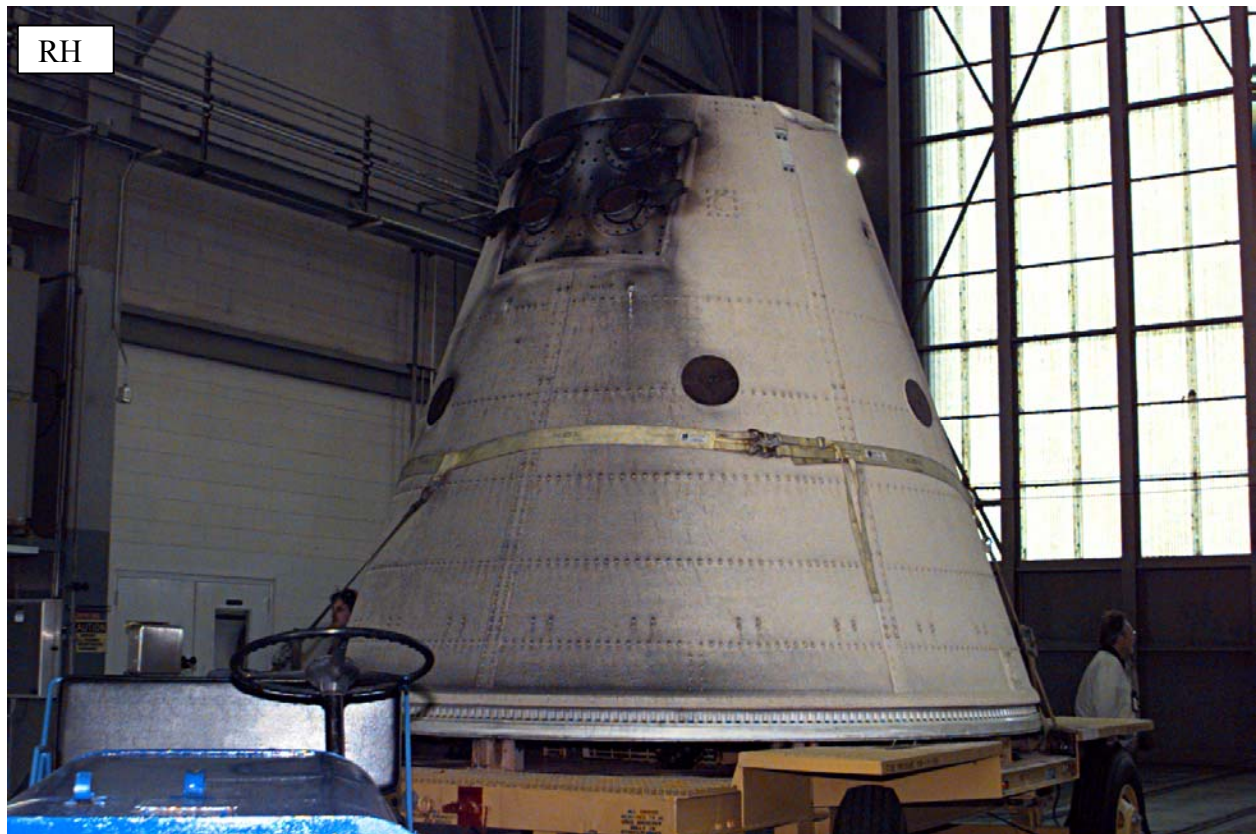
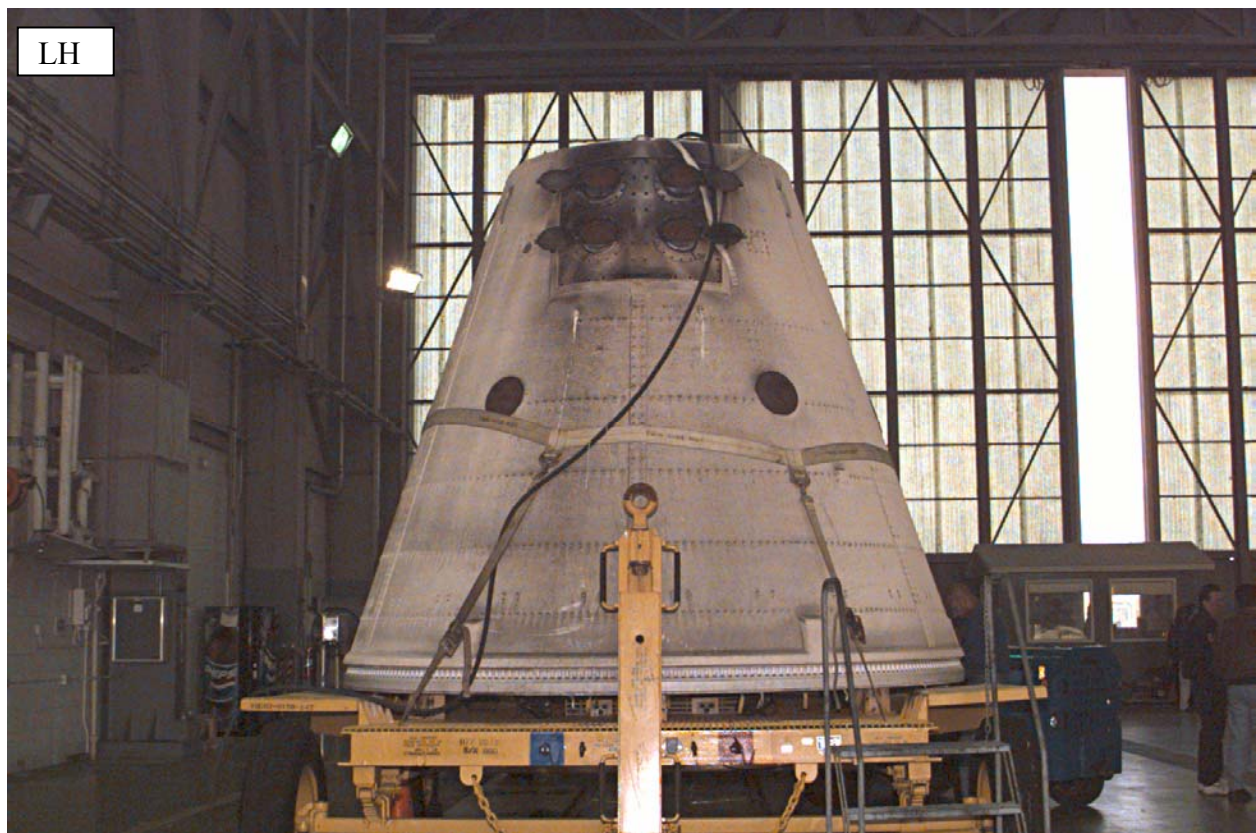
**Photo 8: Frustum Post Flight Condition**

The frustums exhibited no debonds/unbonds or missing TPS.  
All eight BSM aero heat shield covers had fully opened and locked.

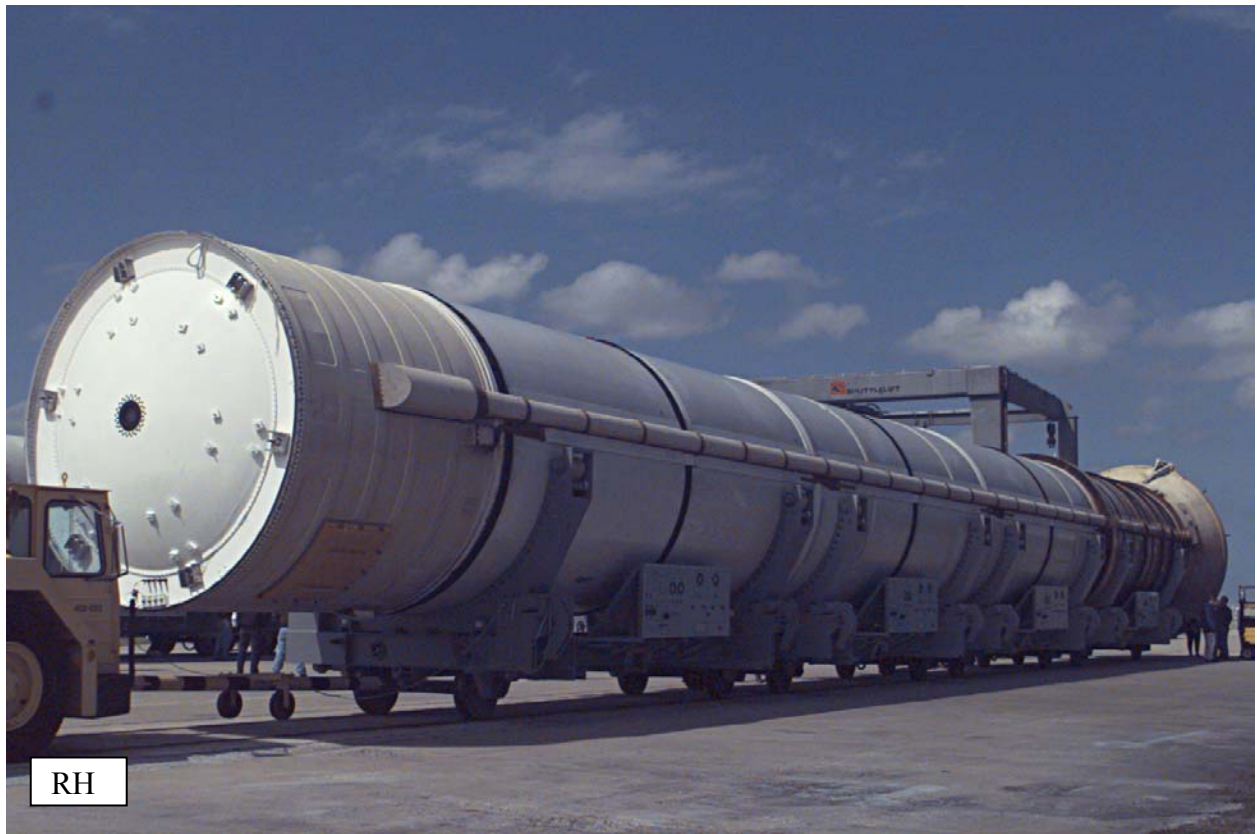
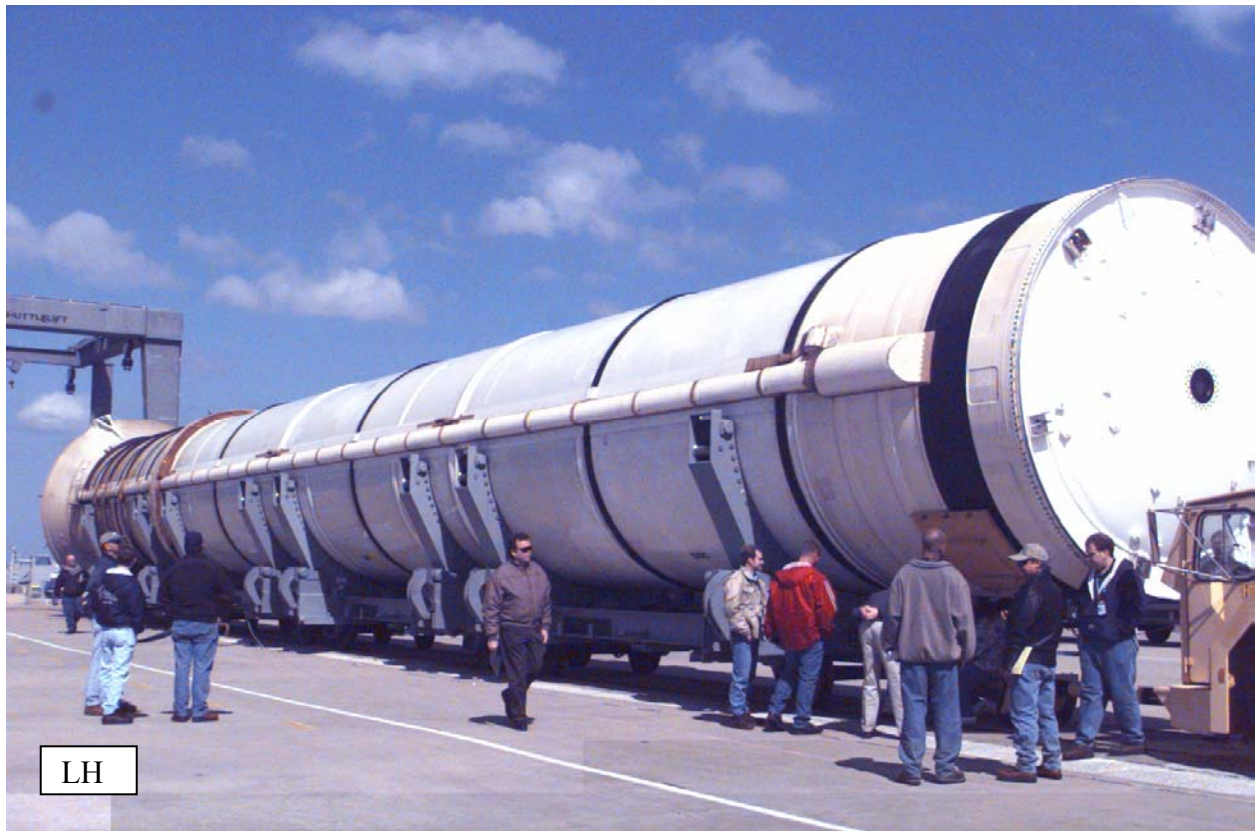
**Photo 9: SRB Post Flight Condition**

Both SRBs were found in good condition regarding debris assessment

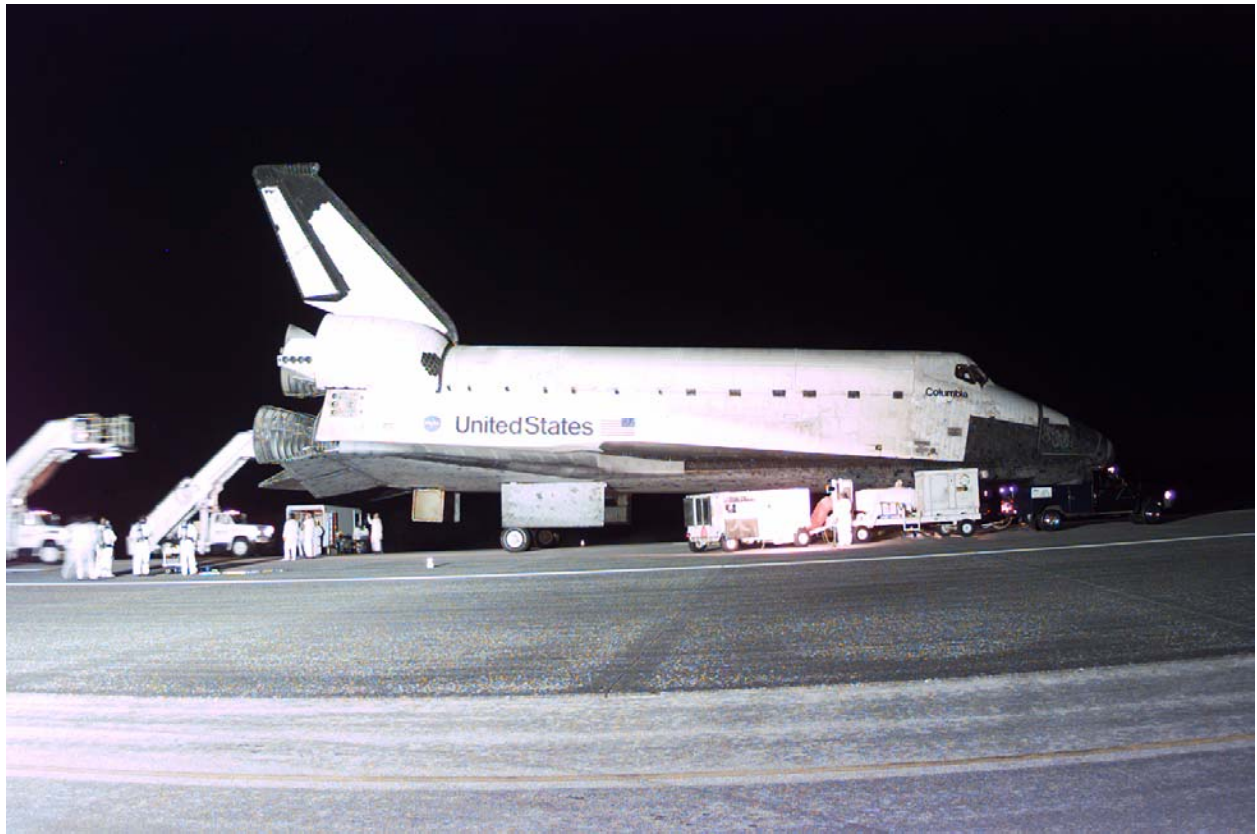
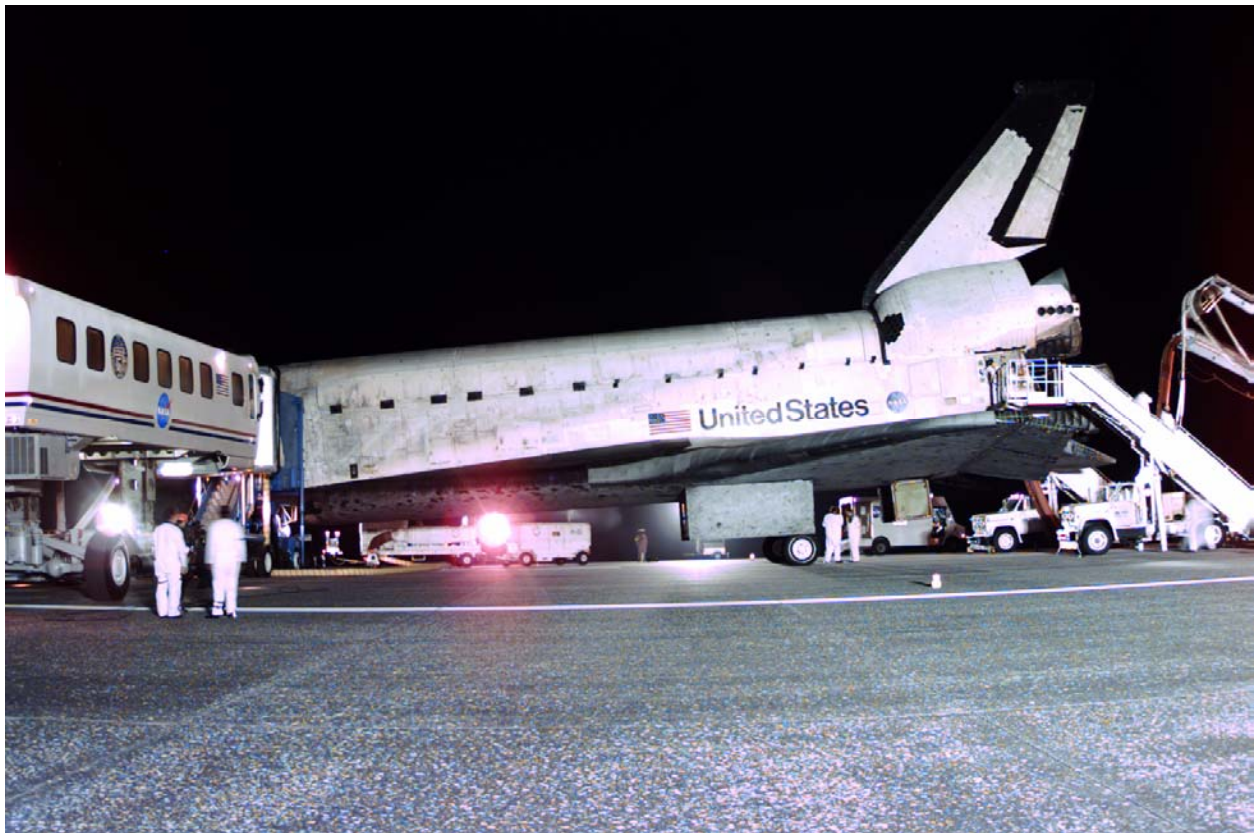
**Photo 10: Overall View of Orbiter**

The Orbiter TPS sustained a total of 98 hits of which 18 had a major dimension of 1-inch or larger. Both the total number of Orbiter TPS debris hits and the number of hits 1-inch or larger were within established family.

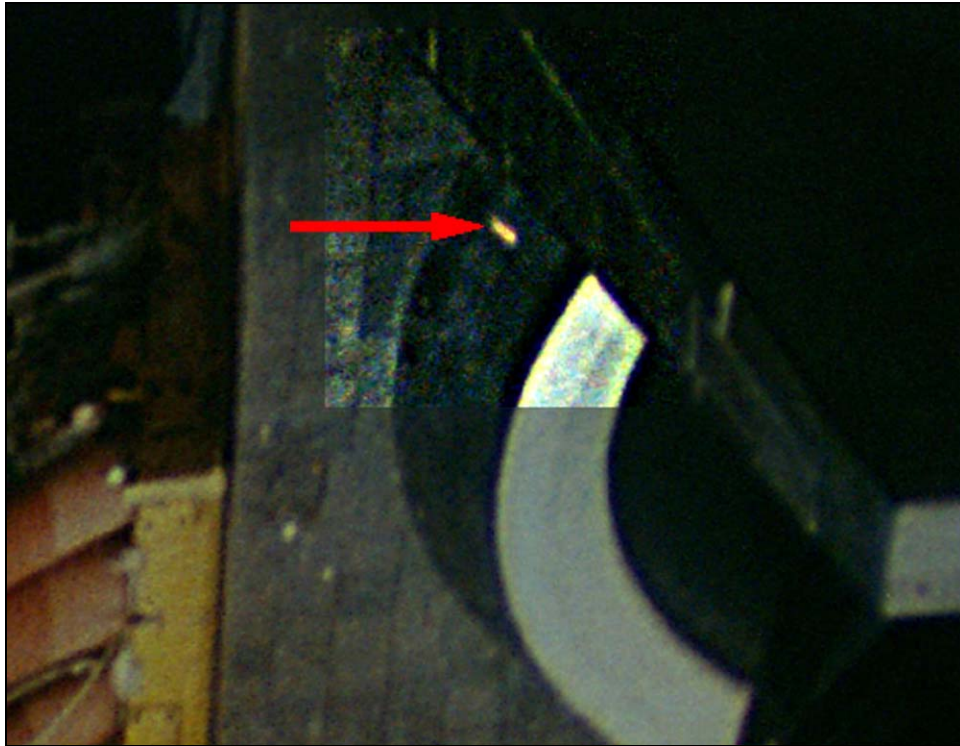
A rectangular-shaped, red-colored piece of debris (probably a tile shim) appeared to detach from the base heat shield between the left RCS stinger and the left OMS nozzle and fell aft between the SSME cluster during SSME ignition (11:21:58.546 UTC). The same object was seen on camera E19 coming from behind SSME #1 and then falling aft between the SSME cluster at 11:21:59.725 UTC. On camera E76, this same object was seen falling aft near the rim of SSME #1 (11:21:59.942 UTC). (Cameras E19, E20, E76)

**Figure 2.3.1 (A) Red-colored Debris near Base Heat Shield (Camera E17)**

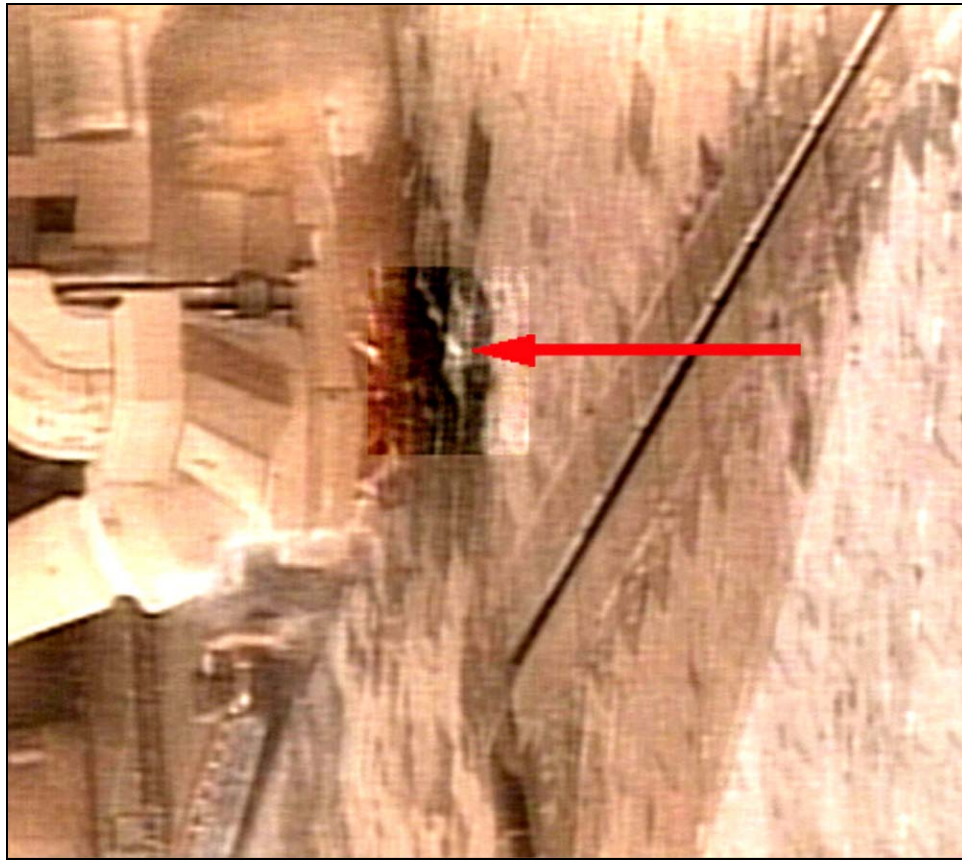
**Figure 2.3.1 (B) Ice Contacts Orbiter Tiles Near LH2 Umbilical (Camera OTV009)**

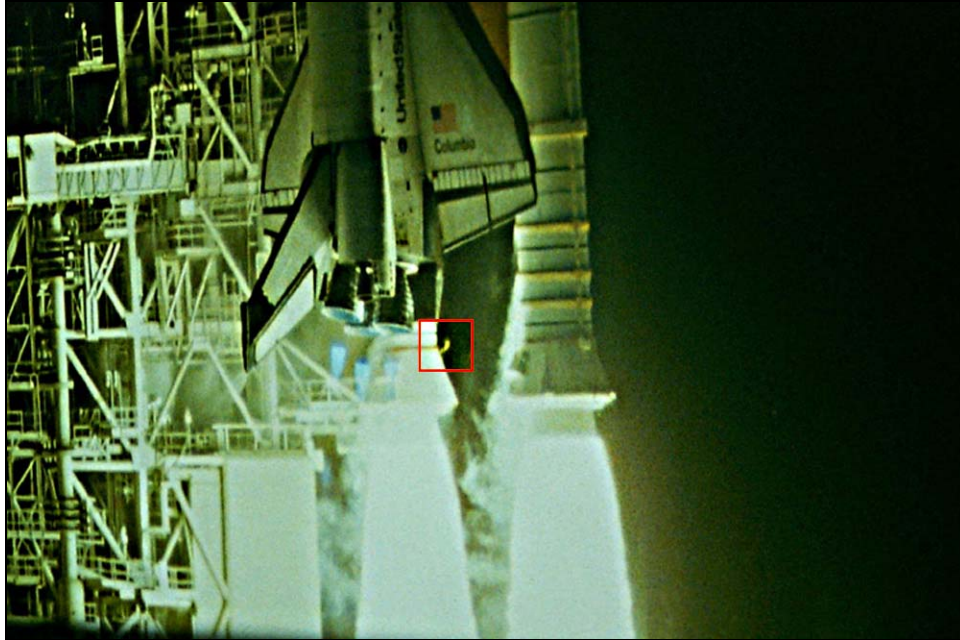
Several pieces of orange-colored debris (probably ET/Orbiter umbilical well purge barrier material) were seen falling aft along the body flap, along with pieces of ET/Orbiter umbilical well ice, at liftoff (11:22:00.229 UTC). (Camera E18)

**Figure 2.3.1 (E) Umbilical Purge Barrier Material seen Falling Aft During Liftoff (Camera E76)**

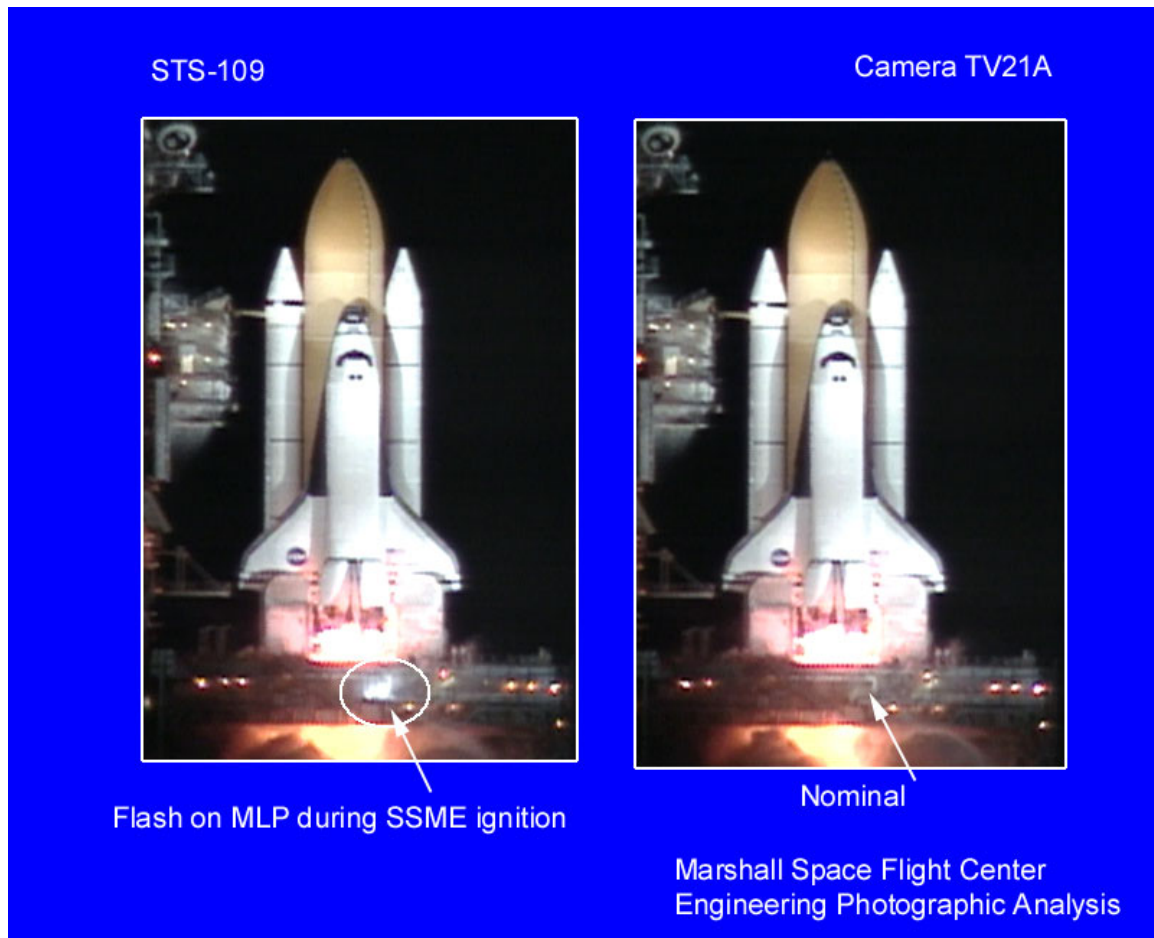
A bright, bluish colored flash was observed on the MLP during SSME ignition.

**Figure 1. TV21A: Flash on MLP**

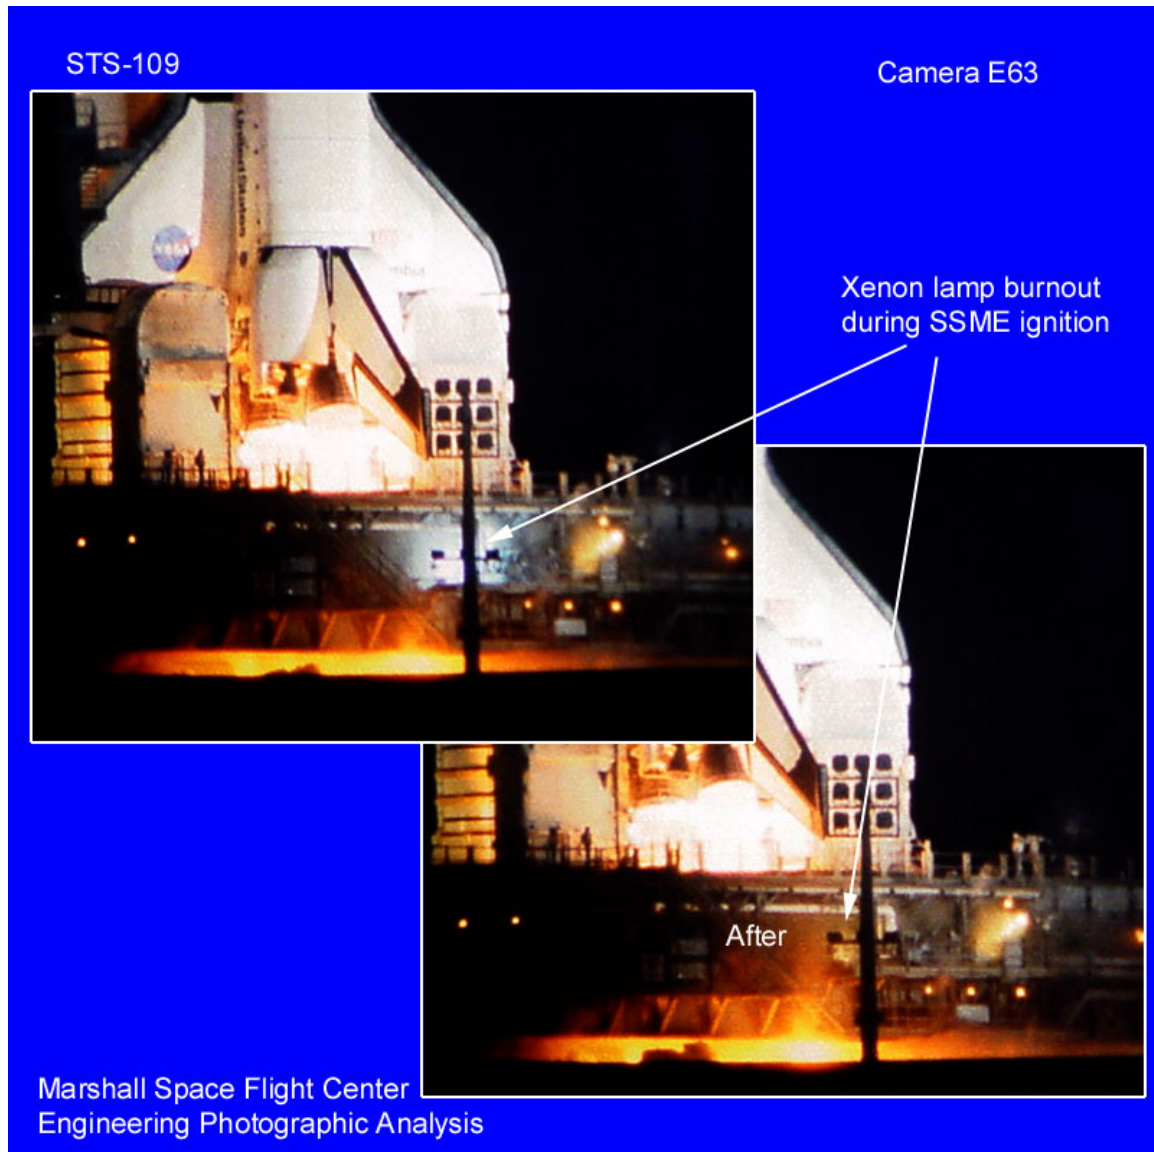
A bright bluish colored flash was observed on the MLP during SSME ignition. It appears that the flash was a Xenon bulb burnout.

**Figure 2. Film Camera E63: Flash on MLP**

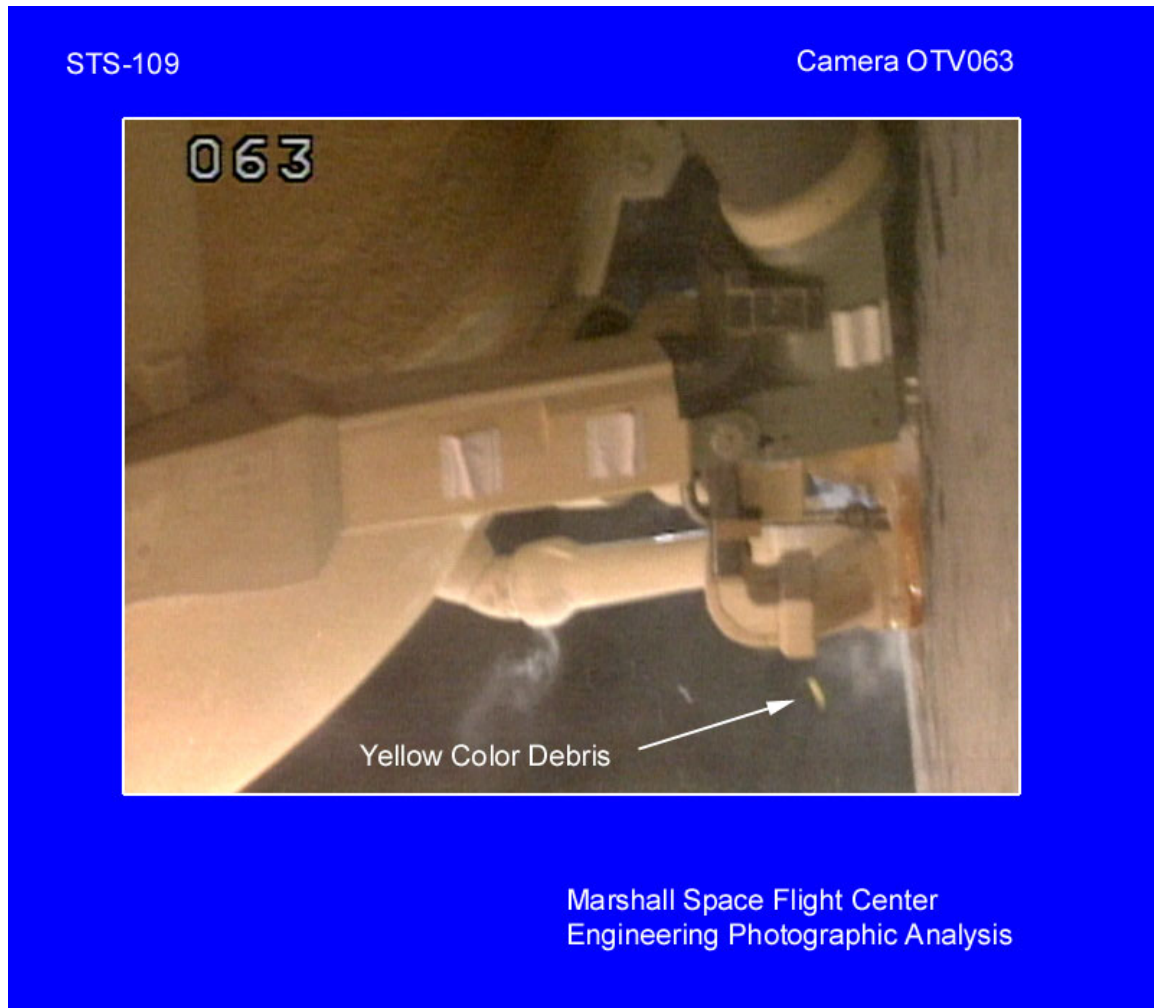
A yellowish colored debris item was observed at liftoff. Another view of this debris item was captured by Video Camera TV009, Figure 4.

**Figure 3. Video Camera OTV063: Yellow-Colored Debris**
