# **Debris/Ice/TPS Assessment and Integrated Photographic Analysis of Shuttle mission STS-109**

Armando Oliu  
Process Engineering/Mechanical System Division/ET-SRB Branch,  
Kennedy Space Center, Florida

**March 1, 2002**

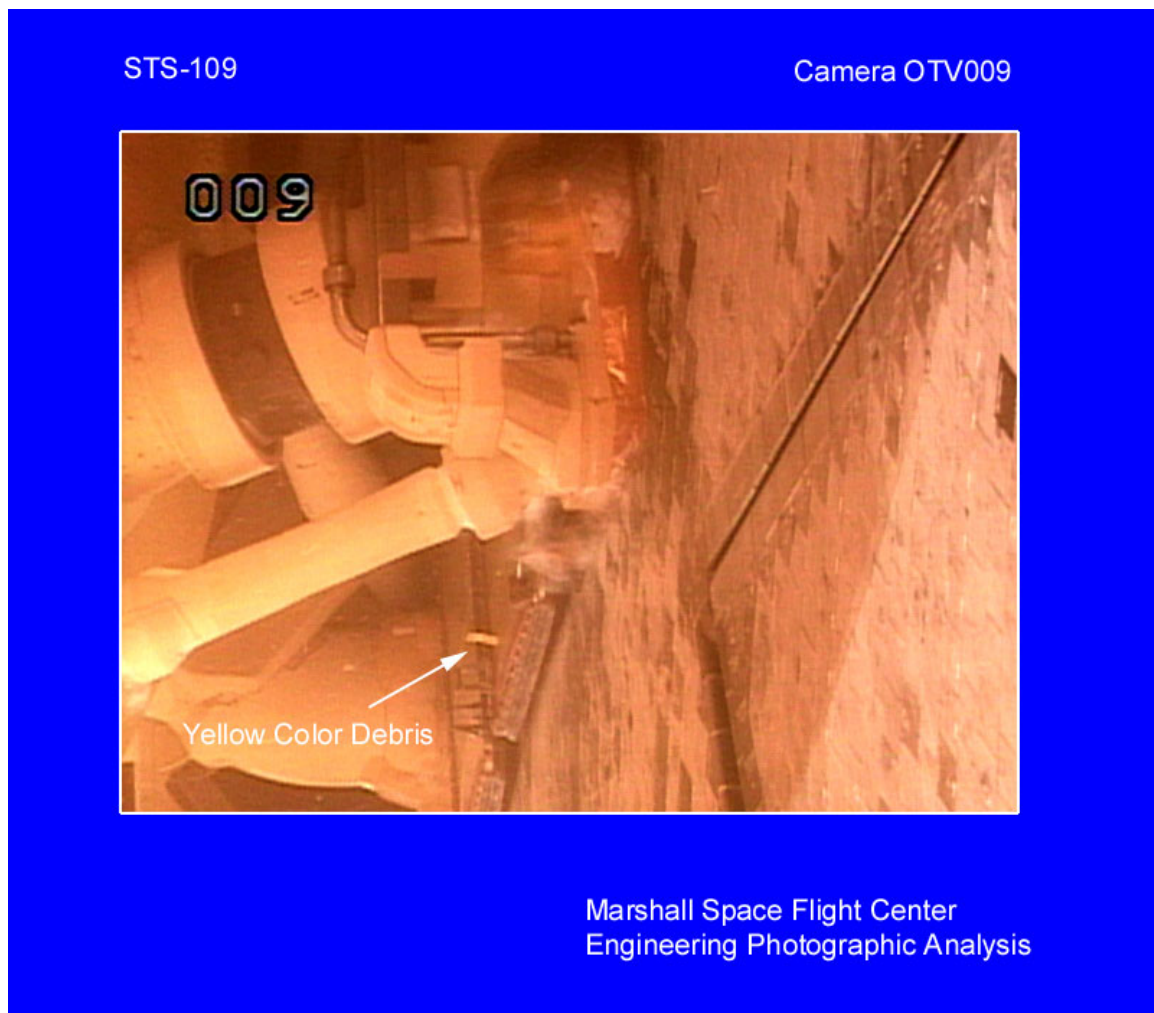
A yellowish colored debris item was observed at liftoff.

**Figure 4. Video Camera TV009: Yellow Colored Debris**

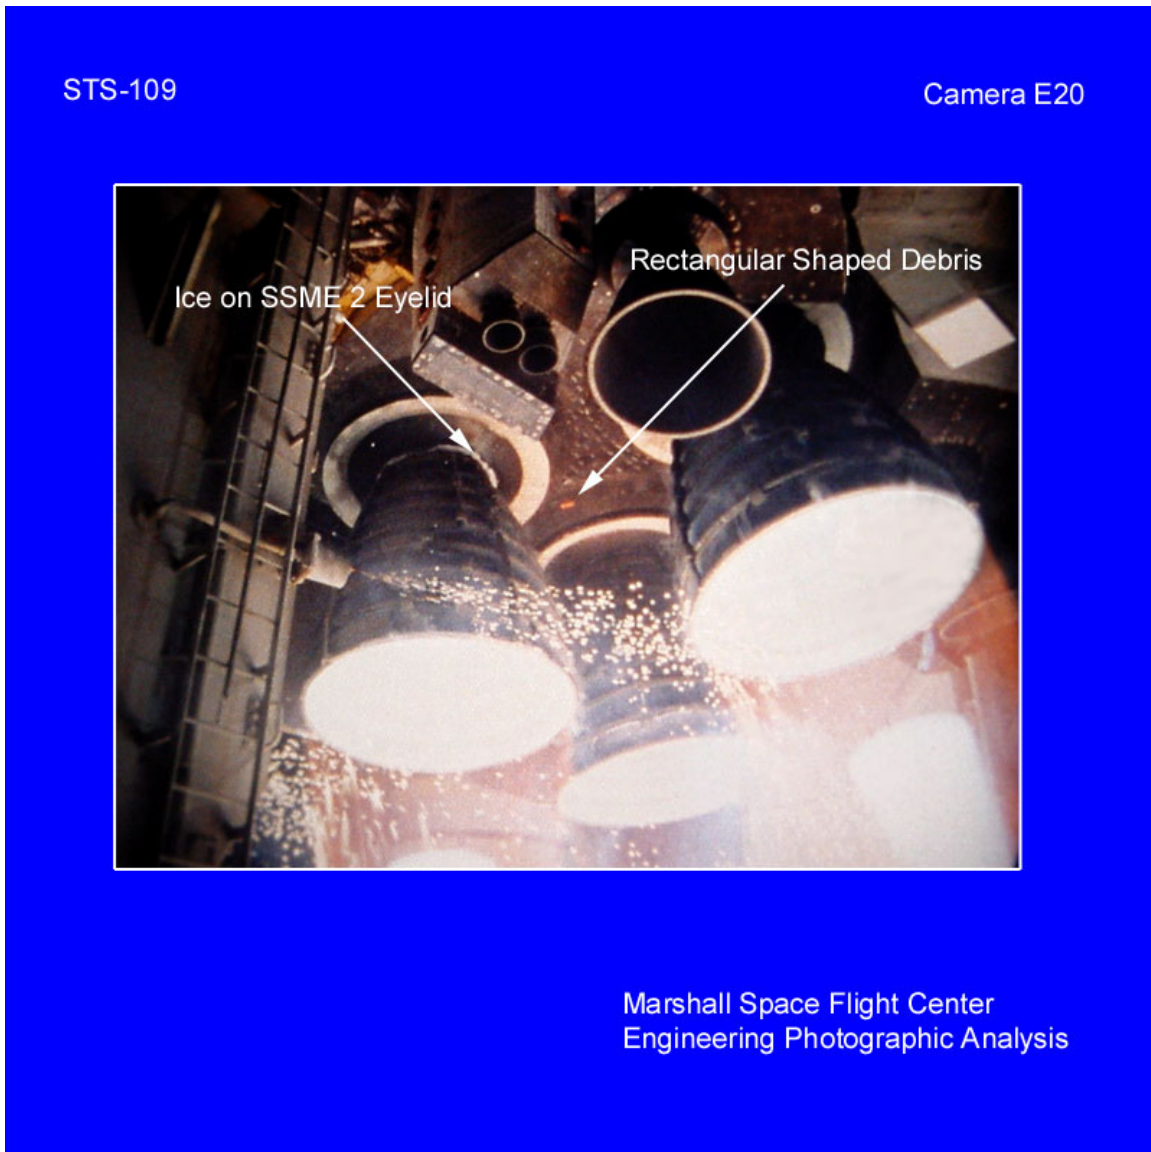
Ice was observed on SSME#2 eyelid. Also, a reddish colored rectangular shaped debris item was observed at liftoff.

**Figure 5. Film Camera E20: Rectangular Shaped Debris**

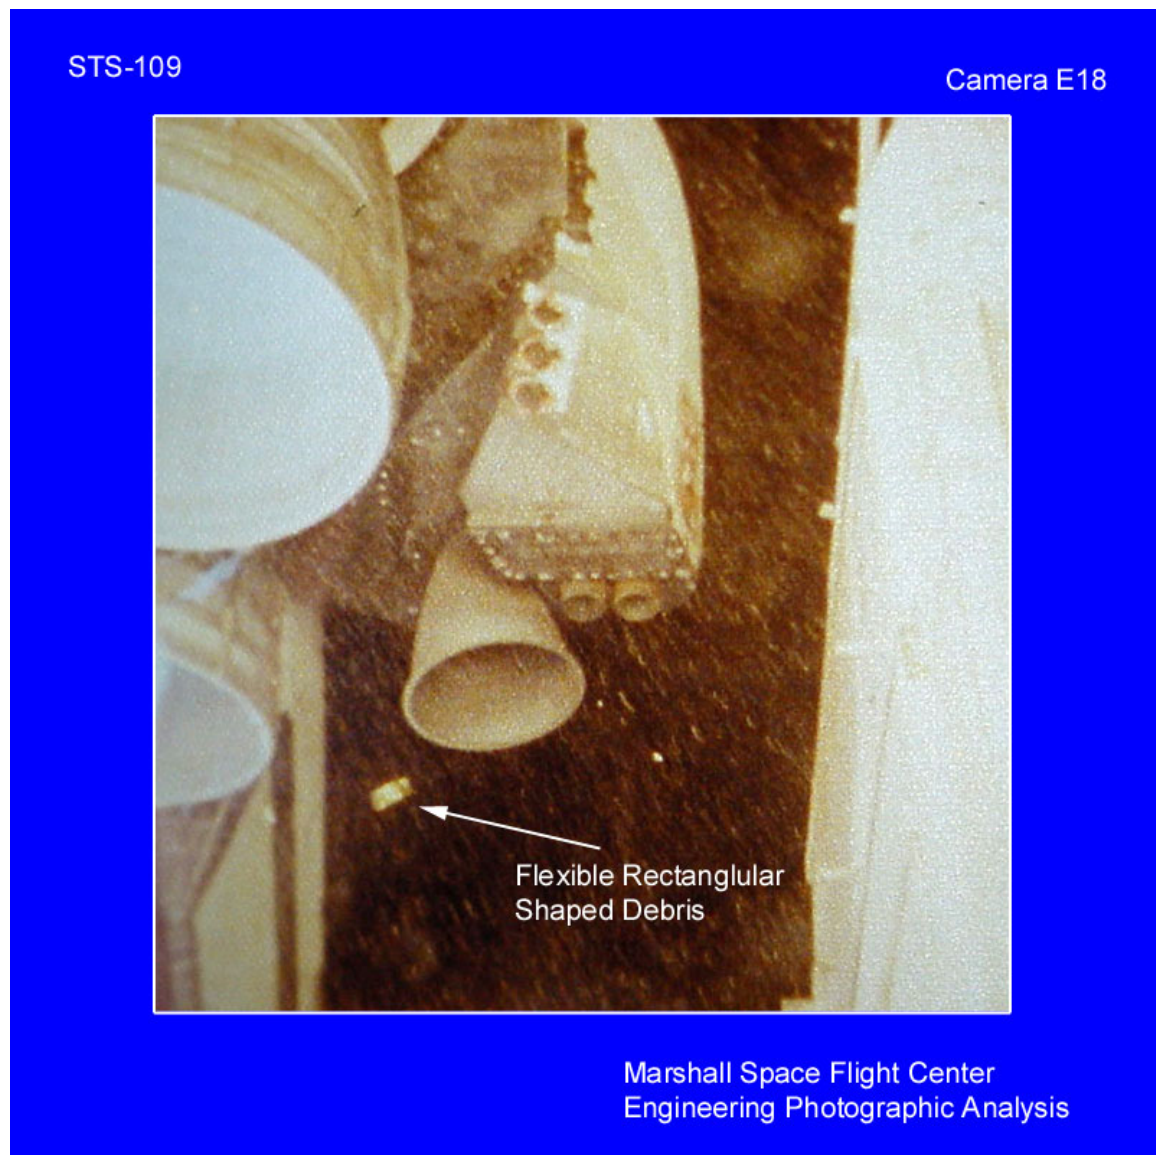
A flexible rectangular shaped debris item was observed at liftoff.

**Figure 6. Film Camera E18: Rectangular Shaped Debris**

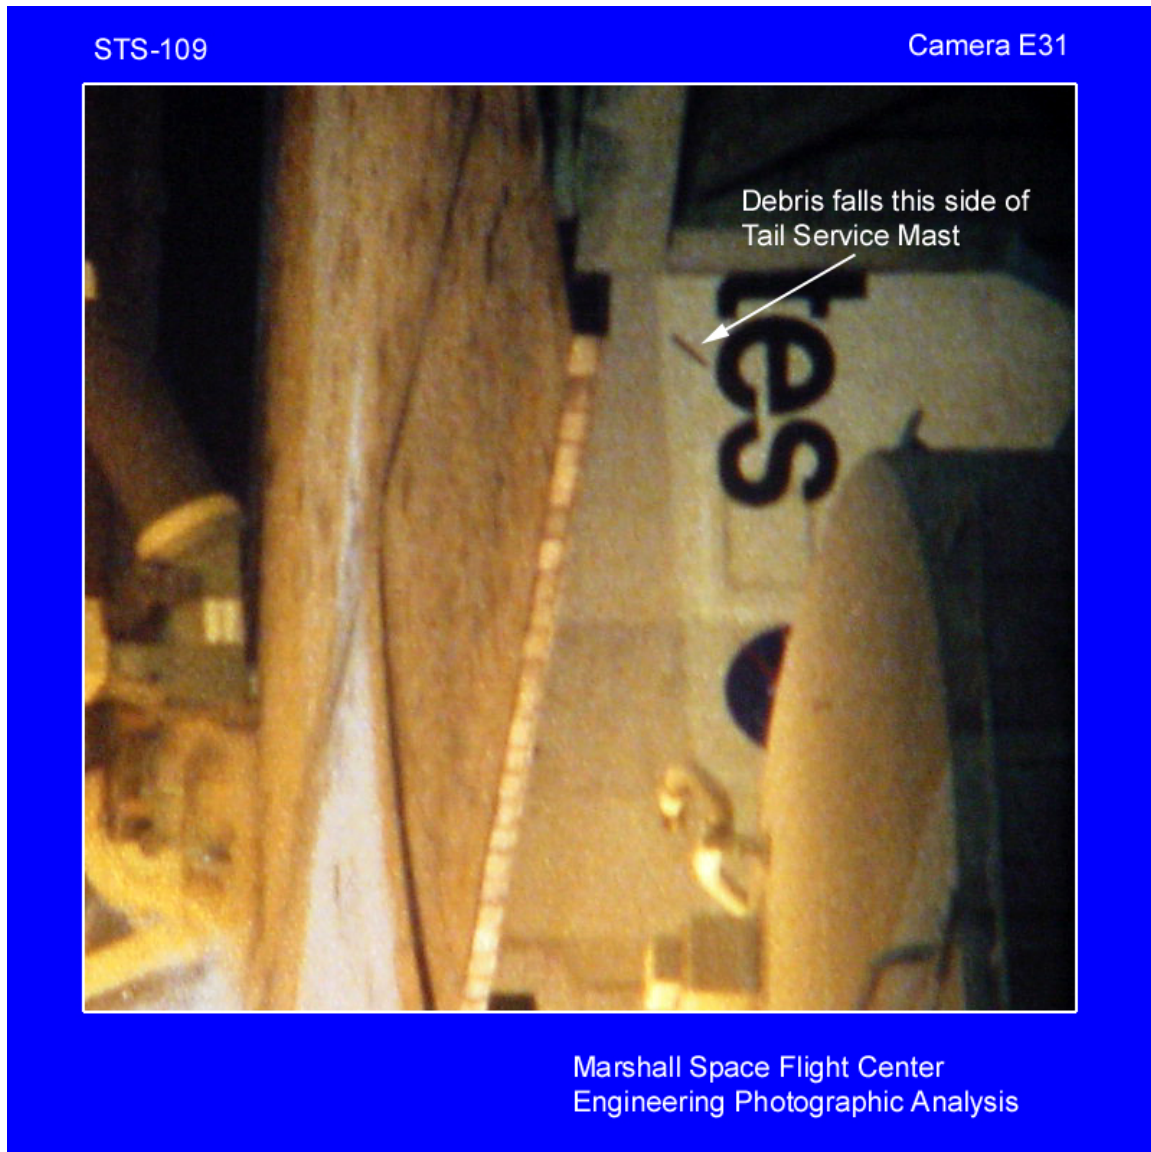
A long thin rectangular shaped debris item was observed falling apparently on the +Z side of the left Orbiter wing.

**Figure 7. Film Camera E31: Rectangular Shaped Debris**

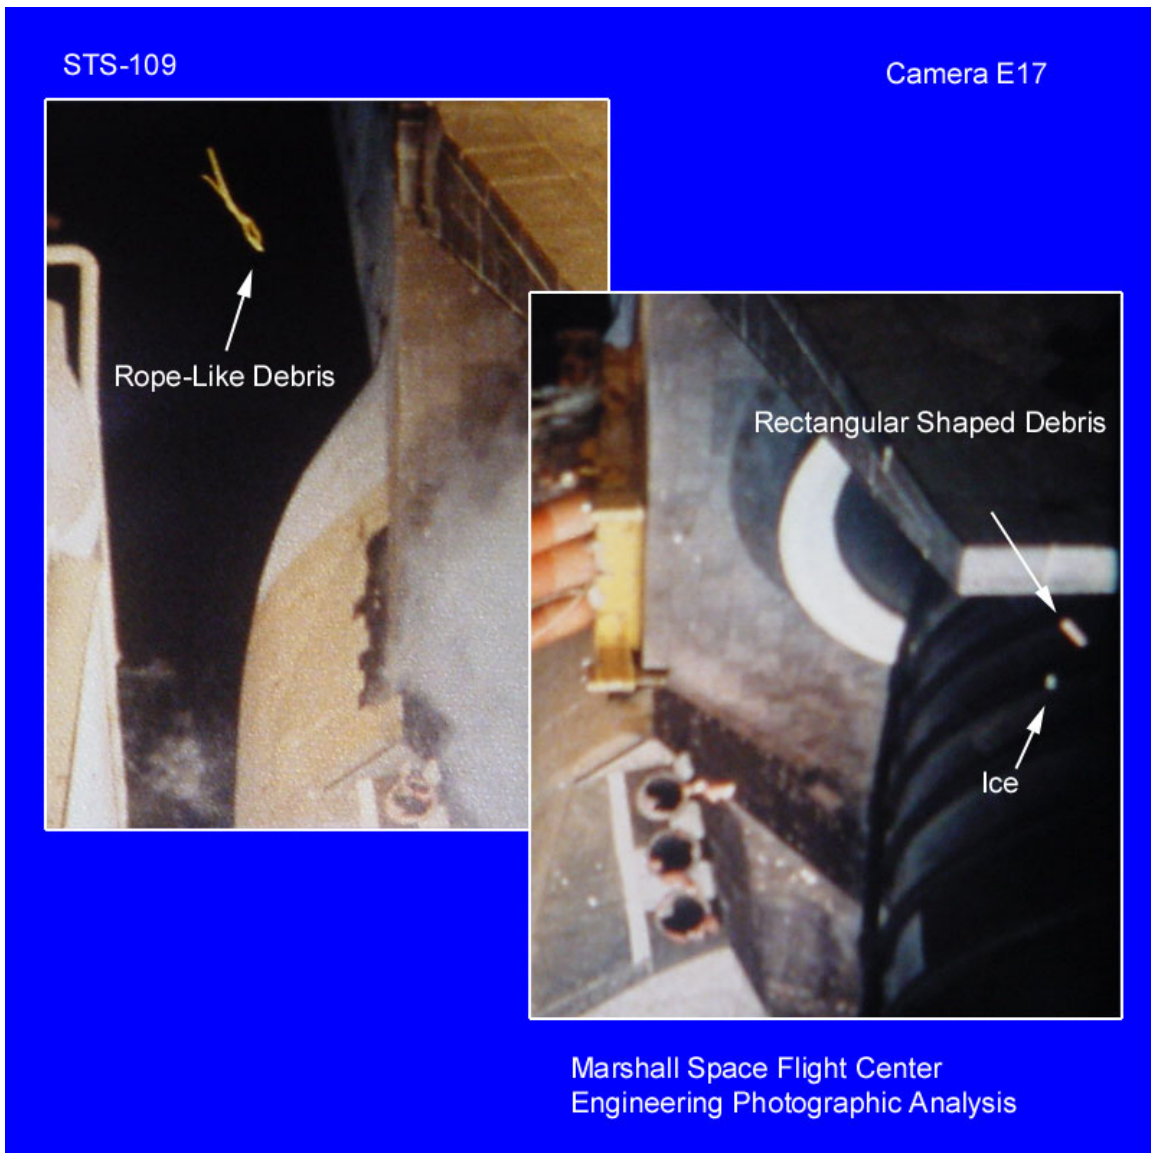
A rope-like debris item and a rectangular shaped debris item were observed during liftoff.

**Figure 8. Film Camera E17: Debris**

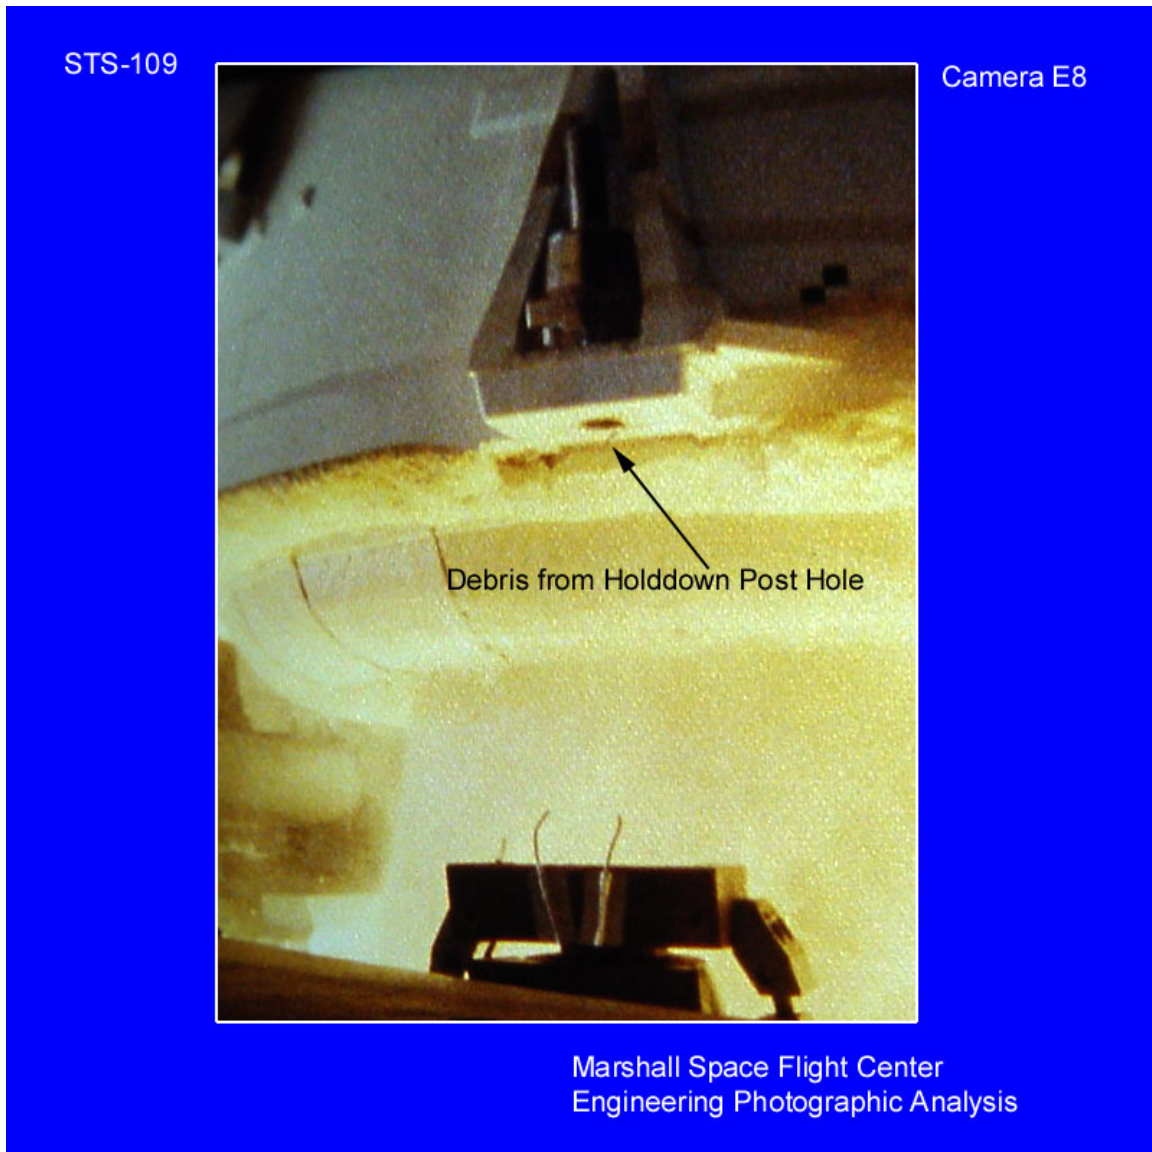
A small debris object was observed falling from Holddown Post M2 hole just after liftoff. Also, but not imaged, debris was noted falling from Holddown Post M5 hole (Film Camera E12).

**Figure 10. Film Camera E8: HDP M2 Debris**

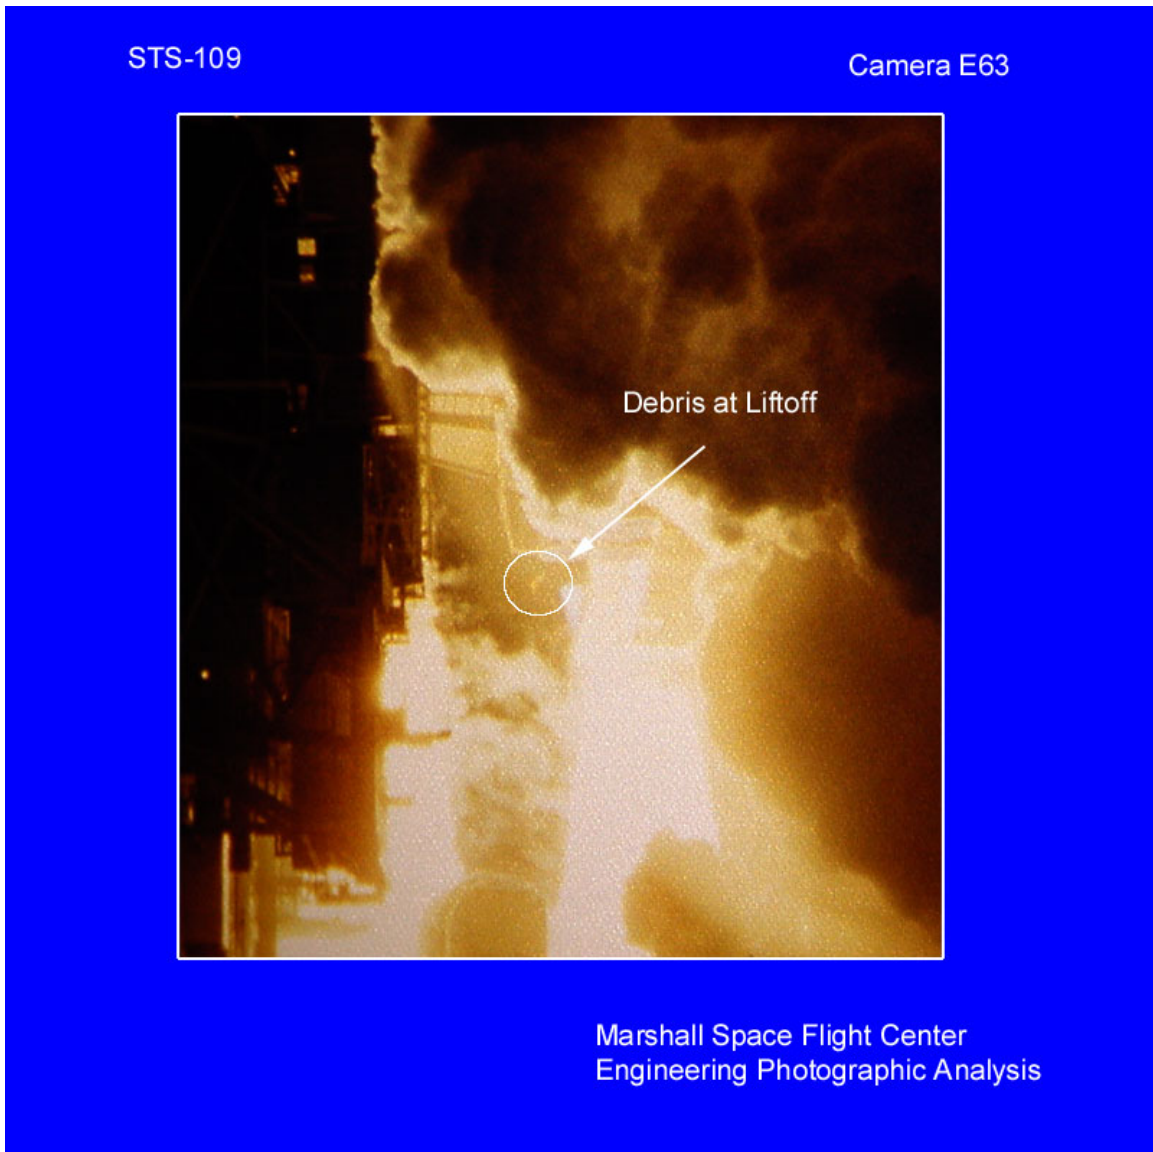
Debris falling aft of vehicle was noted during liftoff. This debris was probably purge barrier material. Other views of this debris was obtained from Film Camera 223, Figure 12, and Film Camera E62, Figure 13.

**Figure 11. Film Camera E63: Debris Falling Aft**

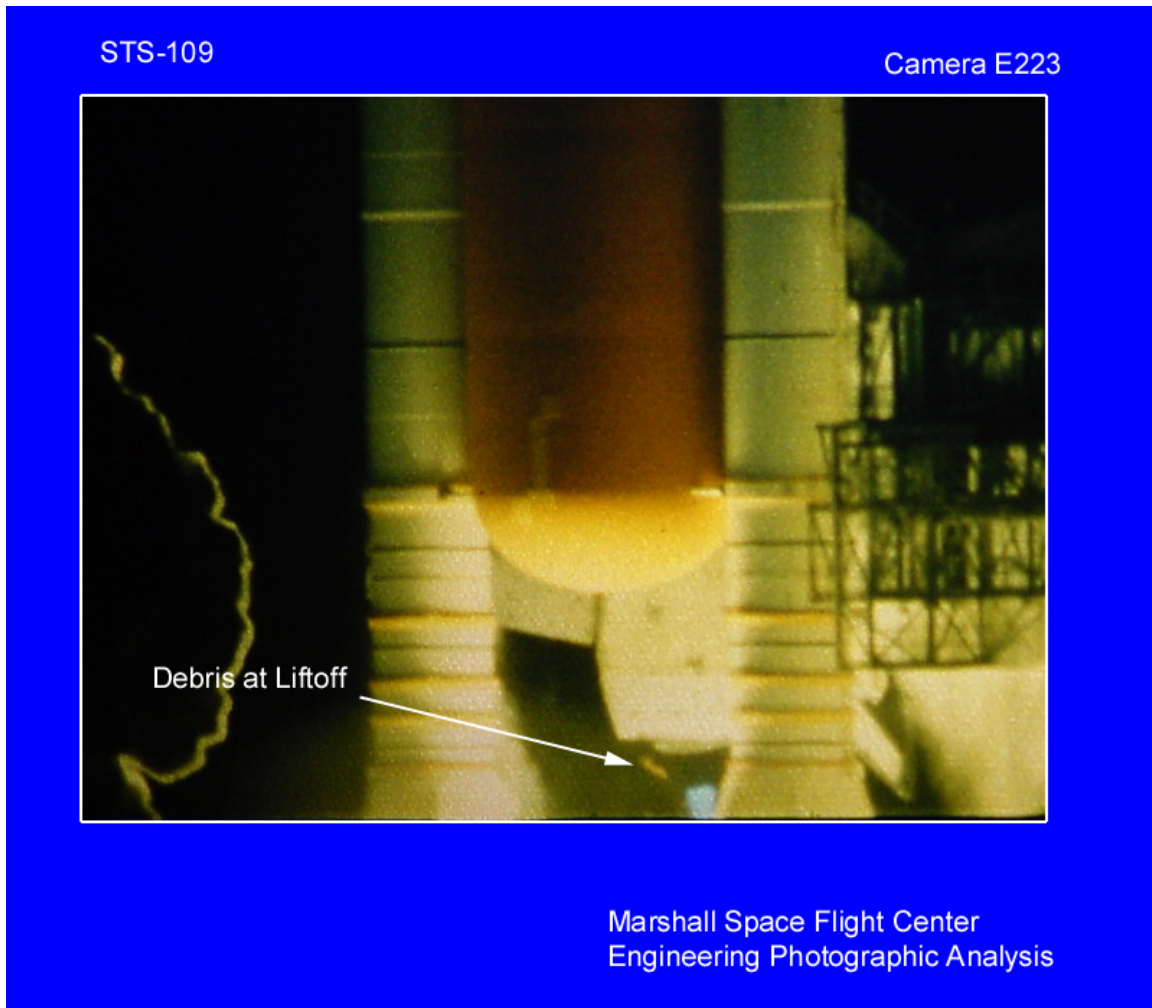
Debris object observed falling aft of the Orbiter after liftoff and before Orbiter clears the tower. Object has a paper-like quality and yellowish color and is presumed to be purge barrier material.

**Figure 12. Film Camera E223: Debris Falling Aft**

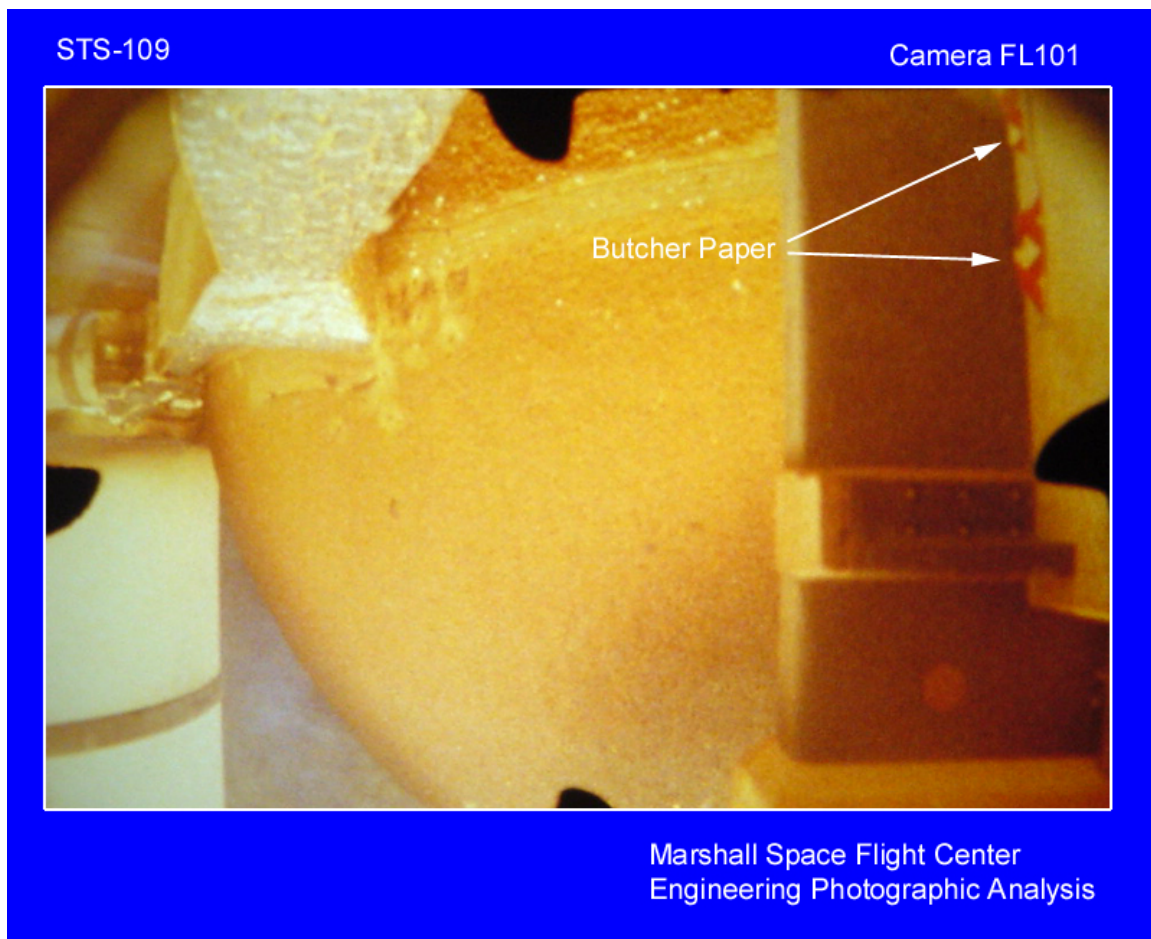
Butcher Paper was still attached to the vertical strut at SRB separation.

**Figure 19. Film Camera FL101: Butcher Paper at SRB Separation**

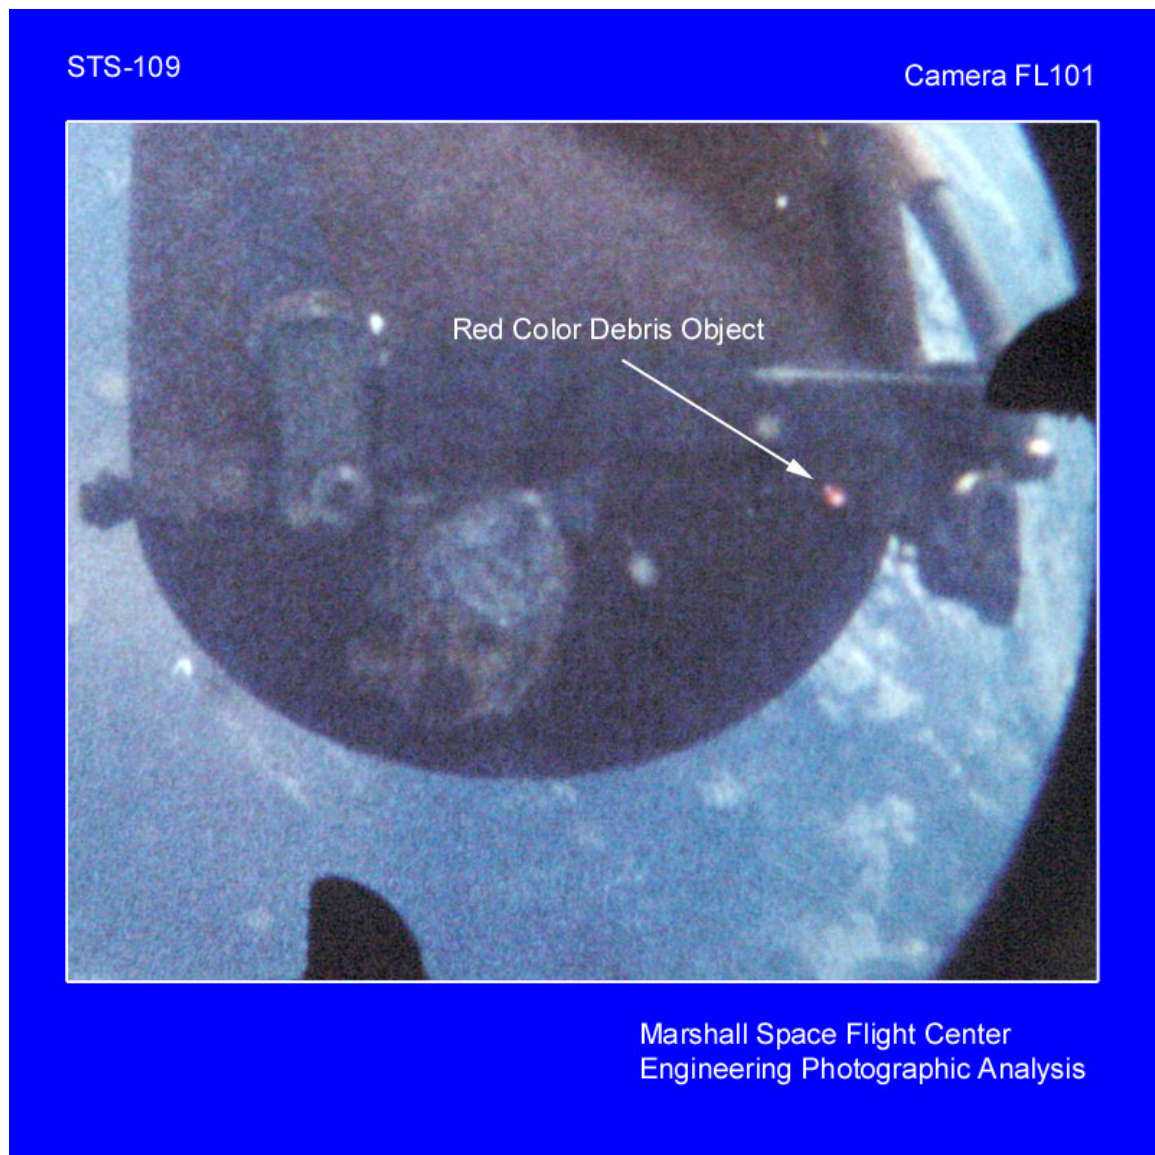
A red colored debris item was noted just after ET Separation.

**Figure 20. Film Camera FL101: Debris at ET Separation**

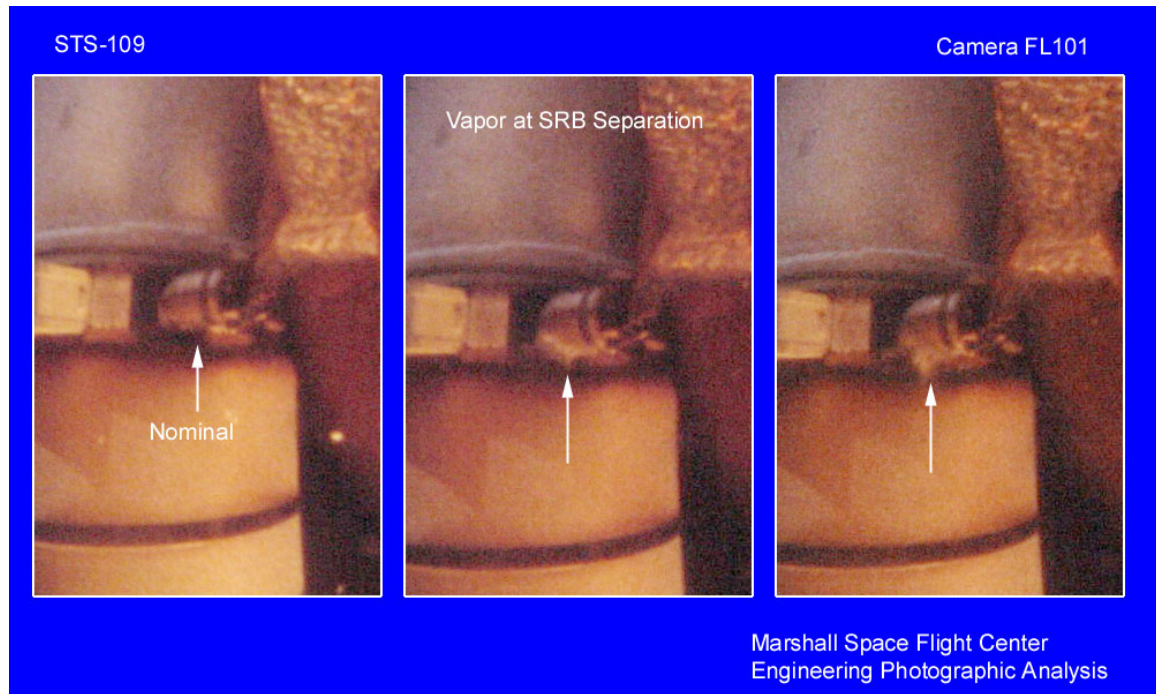
Vapors were noted during SRB separation at the pull-away electrical interface EB-9, located on the aft top stabilization strut.

**Figure 21. Film Camera FL101: Vapors at SRB Separation**

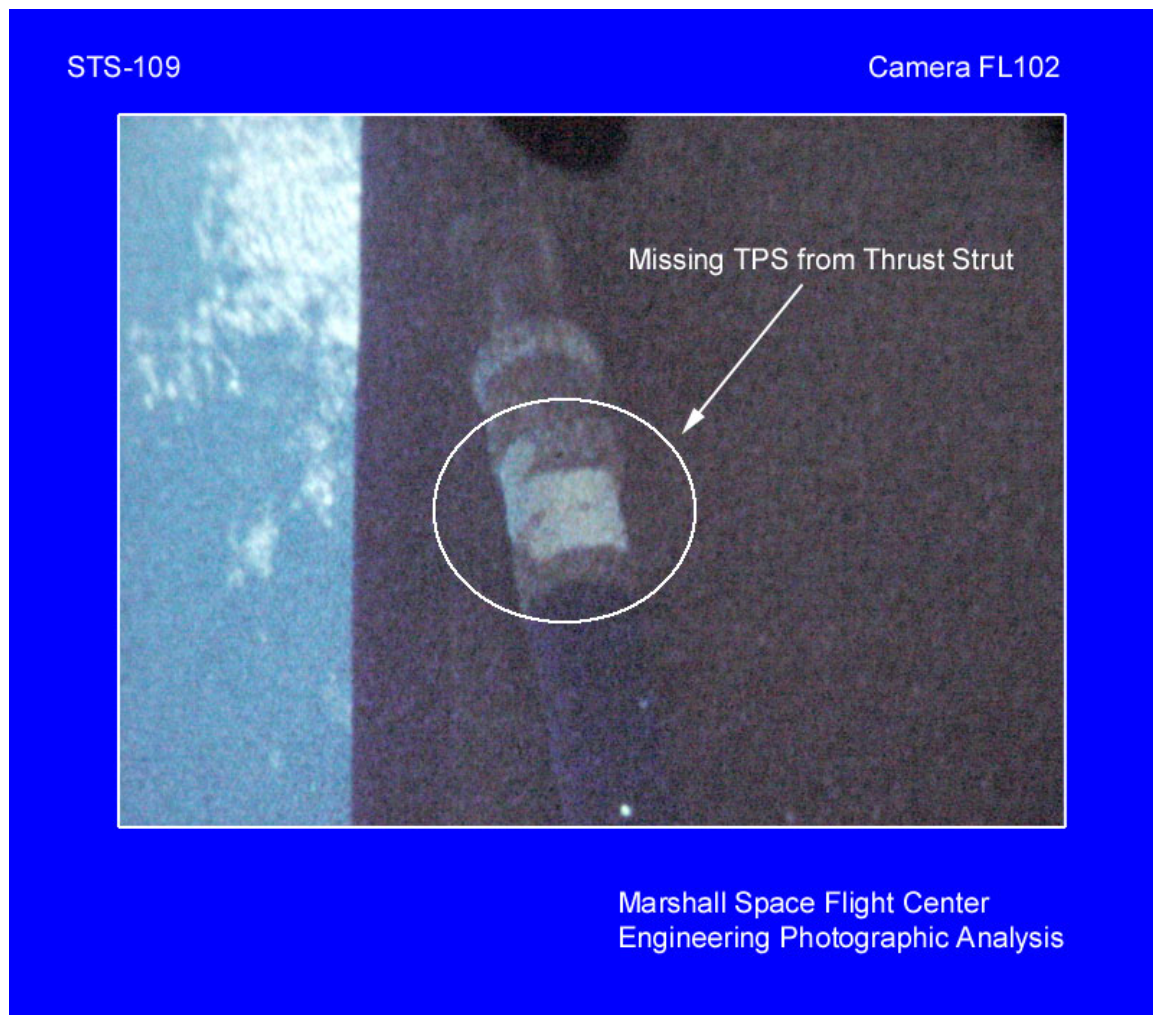
TPS was noted missing from the left aft thrust strut just after ET separation.

**Figure 22. Video Camera TV4A: Missing TPS from Thrust Strut**

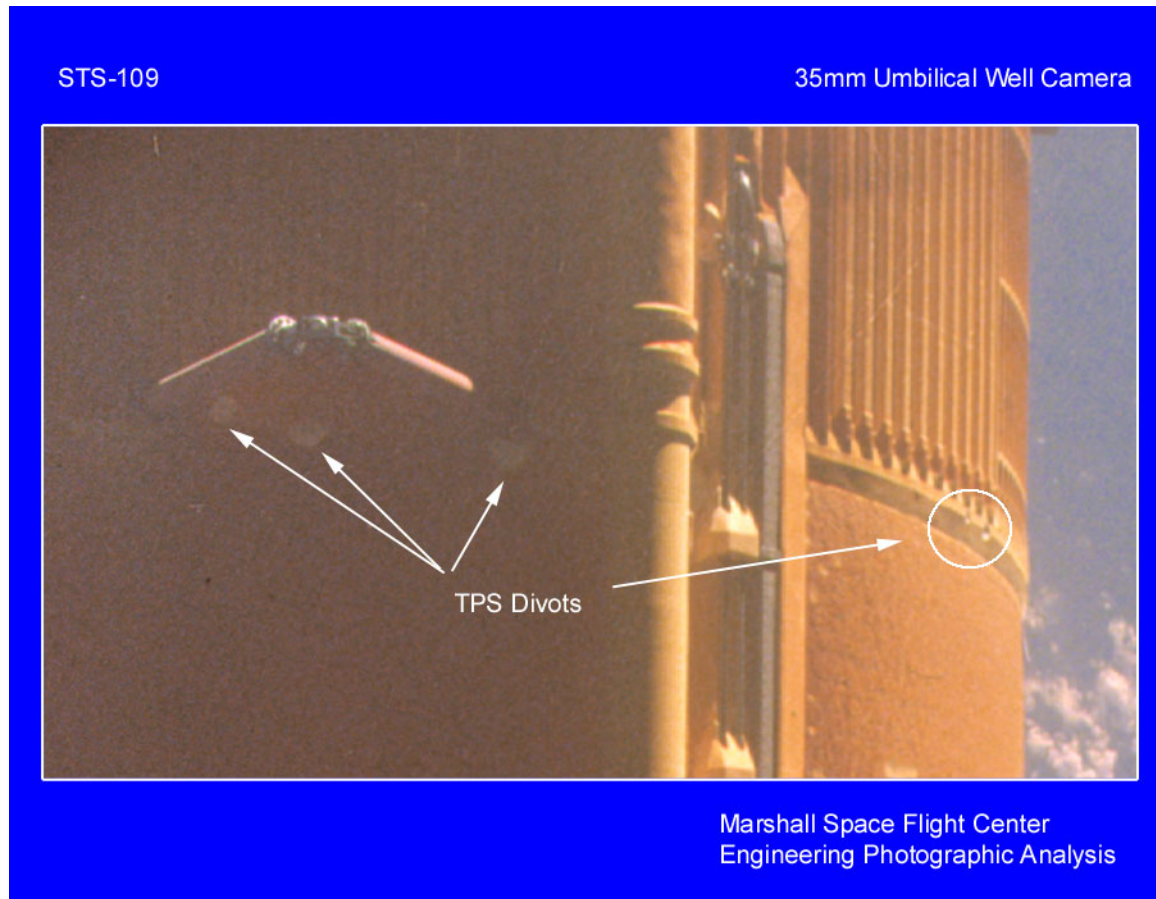
From the 35mm Umbilical camera, two large divots were observed in the ET TPS under the ET/Orbiter forward attach bipod and one divot just aft of the bipod near the LO2 Feedline. Other divots were noted on the Intertank aft flange TPS.

**Figure 23. 35mm Umbilical Well Camera: Bipod and Intertank Divoting**

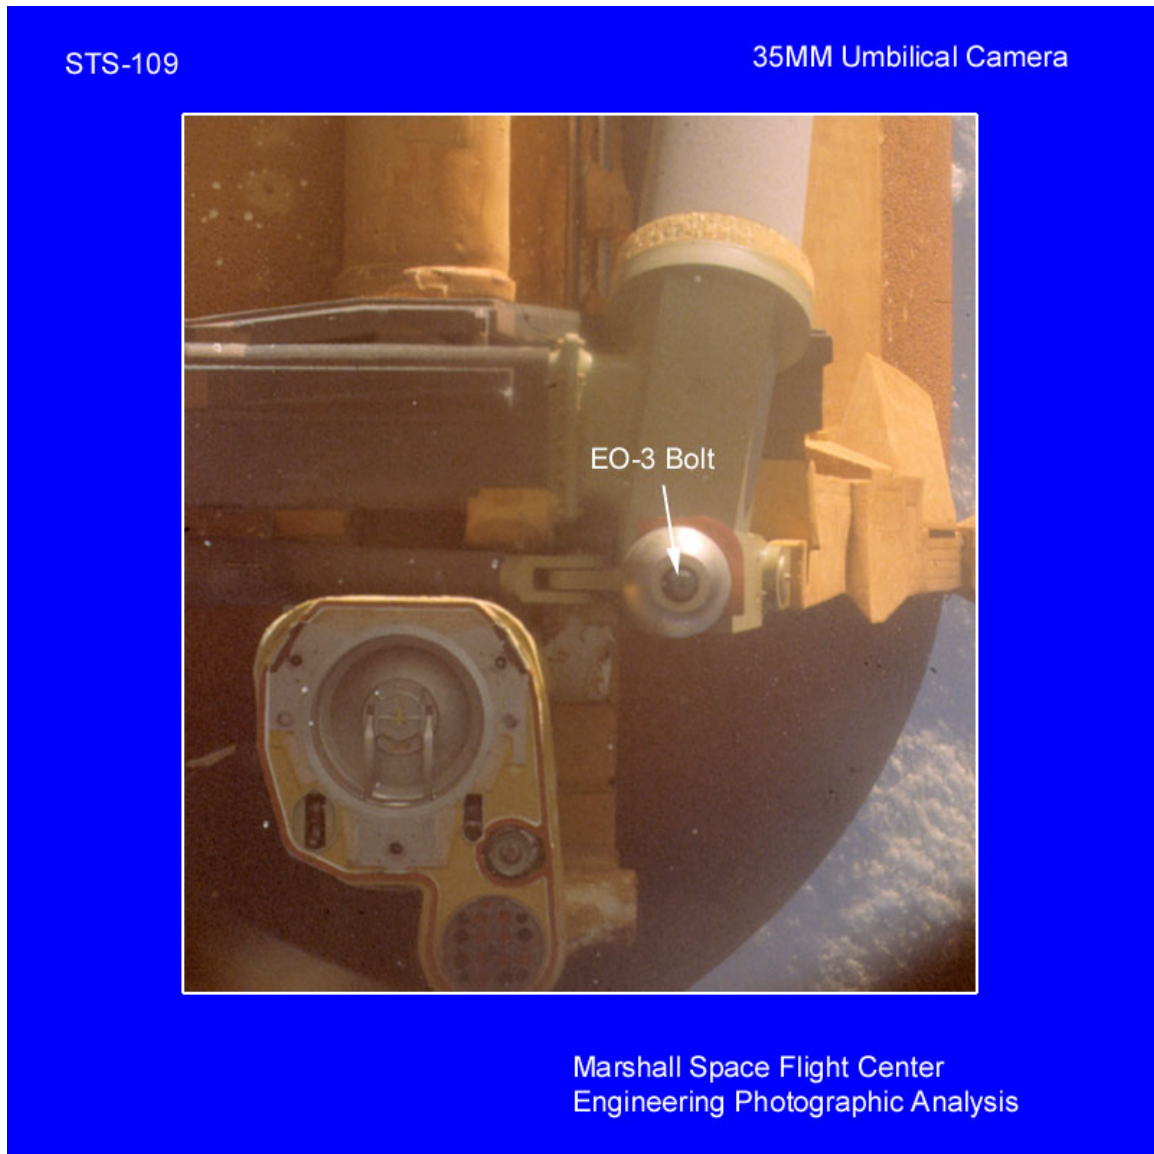
The EO-3 ET/Orbiter Interface Bolt appears to be slightly protruding after ET/Orbiter separation. Not shown are images of the EO-2 ET/Orbiter Interface Bolt which appeared to move from inside the bore to a position barely protruding from the bore.

**Figure 24. 35mm Umbilical Well Camera: EO-3 Bolt Protrusion**

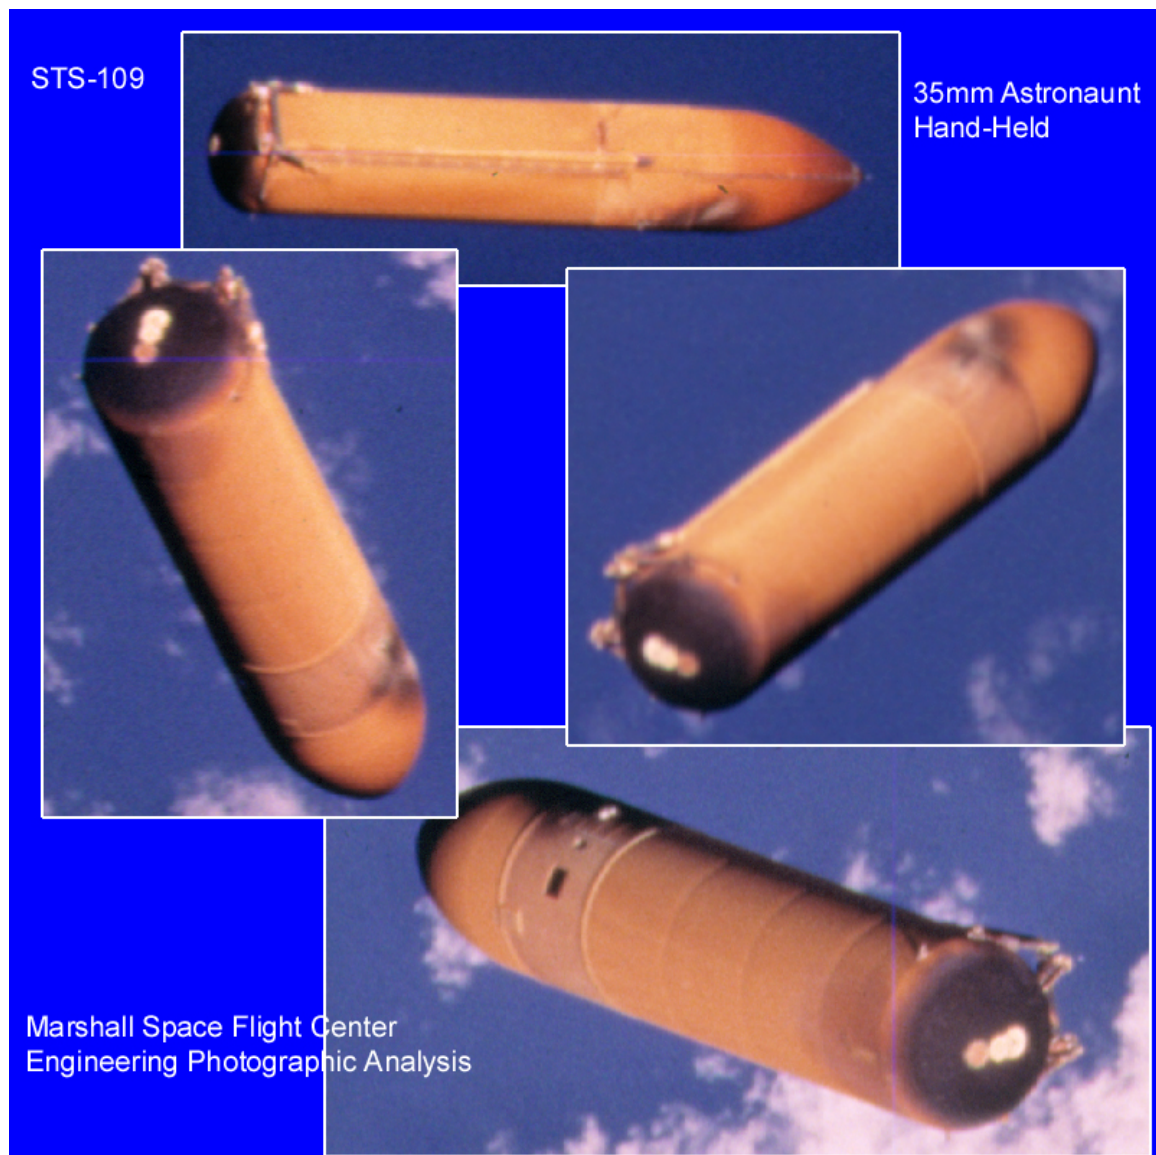
Typical BSM burn scars and aft dome charring were observed.

**Figure 25. 35mm Astronaut Handheld Camera: ET After Separation**
