Screening Li-Ion Batteries for Internal Shorts

Eric Darcy
NASA-Johnson Space Center
Houston, TX USA

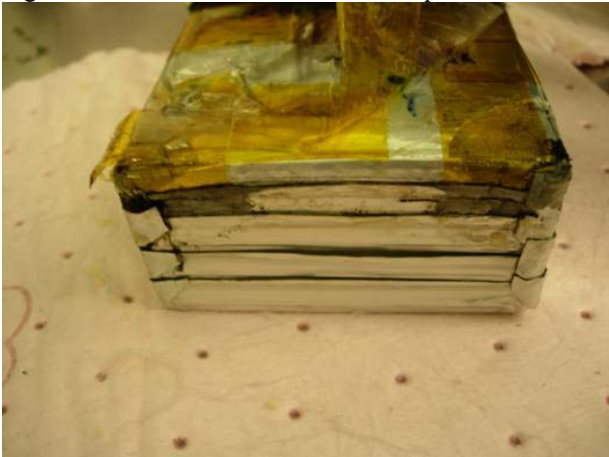
Careful, deliberate, non-destructive, and destructive physical examinations (DPA) isolated the short to one of the cell pouches within the defective cell module, specifically, the outer most cell #5 in the stack (Figs. 5 and 6). Specifically, both cell bottom corners show evidence of high heat affected zones with their centers located very near the corners (Fig. 7). There appears to be two "ground zeros" for the short, which when fed by the energy of all five cells caused intense heating, high enough to melt the copper foil (1084°C) in microscopic locations (Fig. 8). This heat damaged the bottom corners of the adjacent cell #4. No evidence of separator failure or foreign object debris (FOD) was found. This leaves electrode misalignment, native contamination, cold flow through the plastic-aluminum laminate, and pouch seal fold impingement as remaining possible root causes aggravated by the thermal cycling or/and vibration.

Figure 5. The five-cell stack of the internally shorted cell module after outer pouch was removed. Note the heat affected bottom corners of cells 4 & 5.

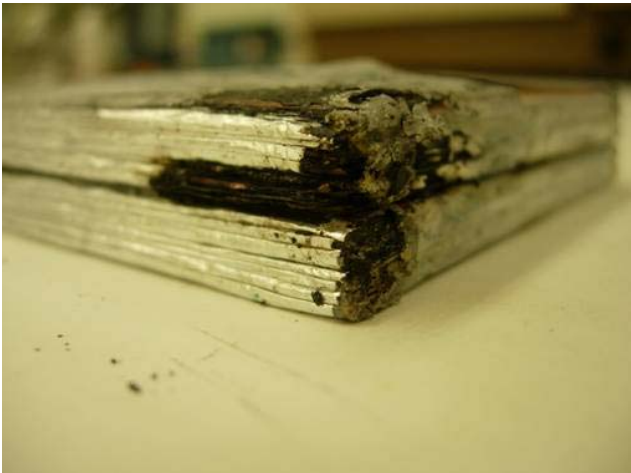
Figure 6. Damaged bottom corner of Cell #5 on top of Cell #4 with cell pouches removed.

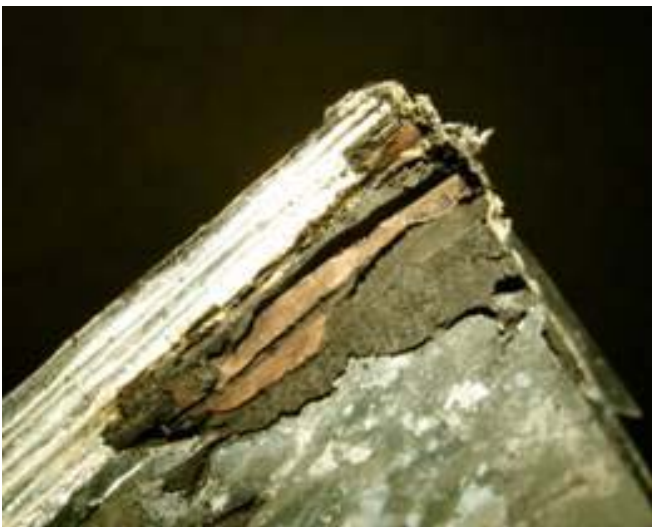
Figure 7. Torn copper substrate folds exposed on the bottom corner of cell #5.

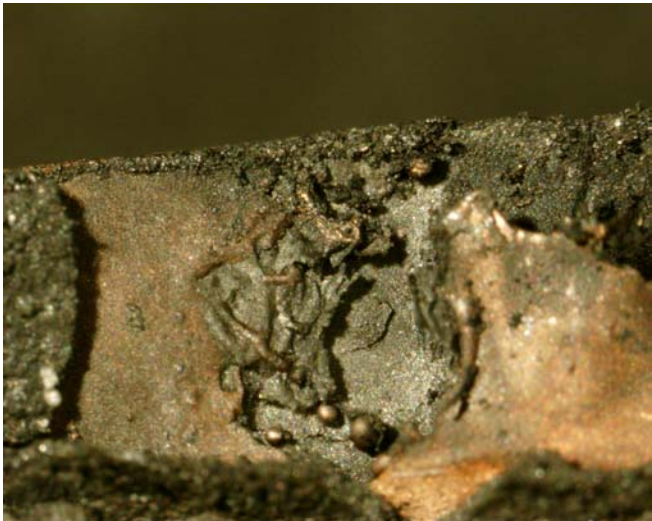
Figure 8. Ground zero arc damage on the copper foil substrate on a torn side fold near the bottom corner of cell #5.

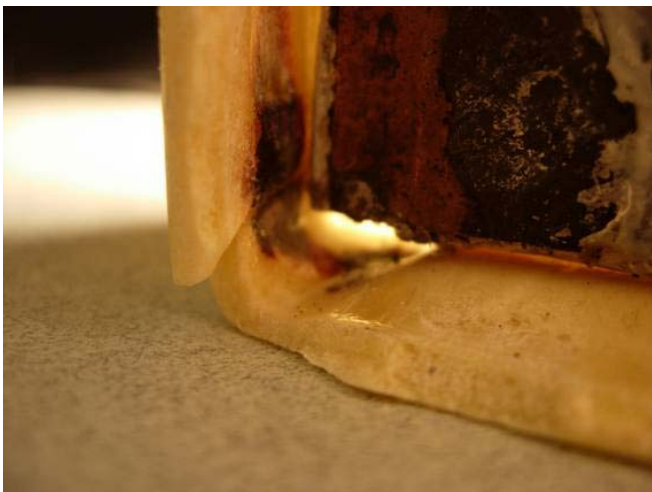
During the DPA, non-uniformities in the thickness of the urethane foam potting around the cell module were found in the layers adjacent to the affected bottom corners of cell #4 and #5 (Fig. 9). Thin and thick spots could have left the stack of pouch cells unsupported at the corners allowing relative motion during vibration. This could have aggravated to any of the four root causes mentioned earlier.

Figure 9. Cell module urethane foam with cell #4 in its position. This shows the non-uniform thickness of the foam layers near the bottom corner.

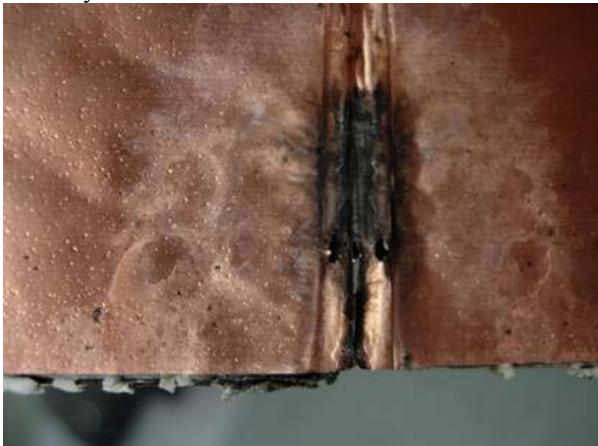
Vibration could have stressed the unsupported electrode substrate folds and cause them to tear (Fig. 10). This in turn could have damaged the separator and allowed misalignment of the electrode folds. Similarly, vibration could have caused some active electrode material to break loose and contaminate the substrate fold area, where no active material should be present. This contamination could have caused separator damage and a short. Also, impingement of the cell stack corner against the laminate pouch could have caused its plastic outer layers to cold flow until the folded cell stack made direct contact with the aluminum layer in the pouch. Alternatively, the folded pouch seal on the external edges and corners of the cells could have damaged the cell pouch laminate material at its corner where the pouch is drawn (stretched) to form a cup shape for the cell stack. This is particularly likely for cell #5, whose edge seal is doubly folded in the direction of cell #4, and its resultant corner seal fold can result in a very stiff and sharp point (Fig. 11).

Figure 10. Unfolded cell #5 stack showing the torn copper folds and ground zero of the internal short.

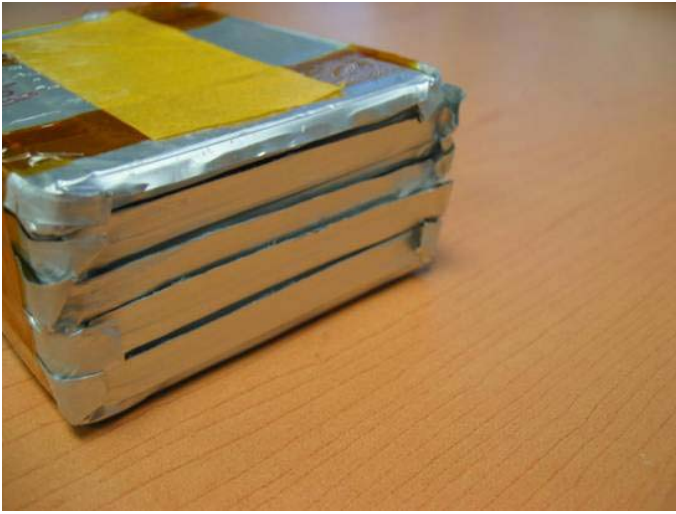
Figure 11. Bottom of a nominal 5-cell stack of a cell module, showing how the edge and corner seals are folded. Note how the edge seal of the top cell (#5) is folded differently than the seal of the other cells.
