## Tin Whiskers: A History of Documented Electrical System Failures

A Briefing Prepared for the Space Shuttle Program Office

April 2006

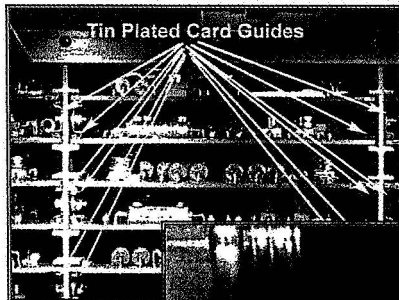
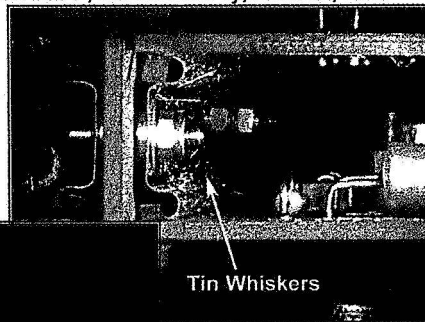
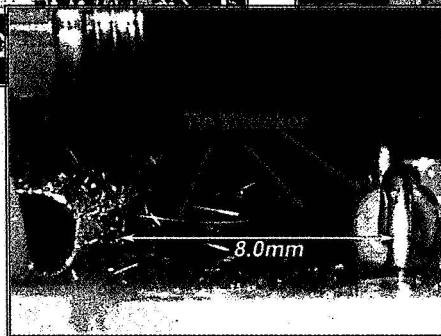
## Tin Whiskers on PCB Card Guides

Ref: "Tin Whiskers Found on ATVC S/N 0034", Don McCorvey, March 8, 2006

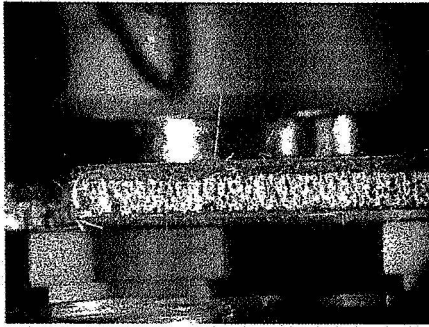
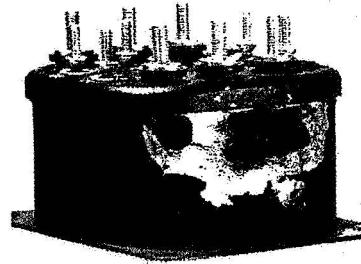
## Catastrophic Damage Due to Tin Whisker Induced Metal Vapor Arc (*In Air!!!*)

*Is your supplier reliable?  
This Electromagnetic Relay  
Was Purchased  
To MIL Spec Prohibiting  
Pure Tin Finish Inside,  
But IT WAS Pure Tin*

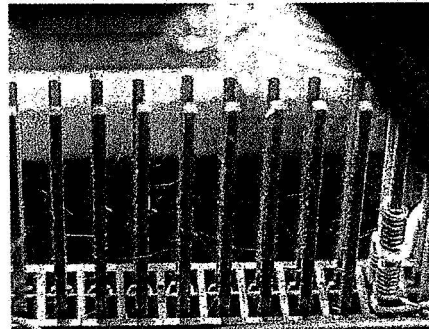
**Tin-Plated Connector Pins  
Displaying Tin Whisker Growths**

- *Tin whiskers can occur in pure electroplated tin plating.*
- *AMP rarely specifies the use of pure tin plating because of the possible whisker growth problem.*
- *AMP currently specifies (93%-7%) tin-lead alloy whenever possible to retard whisker growth and reduce lead exposure to the environment.*
- *From our experience the plating stresses in tin that cause whiskers will relieve over time, and the frequency and magnitude of new whiskers will decrease accordingly.*
- *We recommend using a nonconductive bristled brush, nylon for example, to agitate and sever the whisker from the contact and use a vacuum or compressed air to remove the whisker from the connector and the relay equipment.*
- *Although, we believe a one time cleaning to remove the whiskers will be sufficient to solve this problem, an inspection of the connectors six month to one year after the cleaning is recommended.*

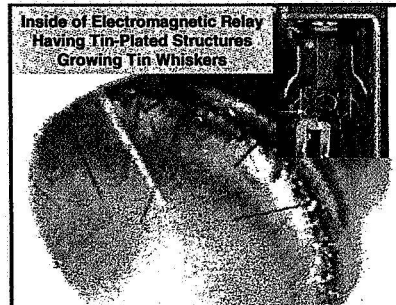
"Three relays were reported to have failed by an overseas electric power company. The customer indicated that energized relays inadvertently closed without the proper control signals. Such condition contributed to a false contact closure condition, which in turn produced unnecessary alarm protection signals initiating a plant shutdown."

- The Foxboro Company is recommending that each customer inspect for, and replace, N0152CK & C0147SS relays manufactured by Potter & Brumfield which display manufacturer's date codes between 7707 and 9352, with those replacement relays manufactured by Communications Instruments Inc.
- Inspection for those relays supplied by Potter & Brumfield will require removal of the N-2A0-L2C-R card from the nest. Visual inspection of the relay package allows easy identification of those relays manufactured by Potter & Brumfield.
- The U.S. Nuclear Regulatory Commission has been informed of this potential defect. The Foxboro Company sincerely regrets any inconvenience this potential defect may cause you and trusts that our actions will completely resolve this matter to your satisfaction.

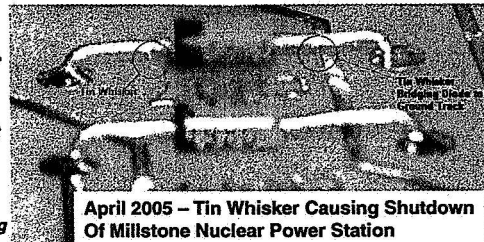
April 2005 - Tin Whisker Causing Shutdown Of Millstone Nuclear Power Station

Tin-Plated Diode Terminals Displaying Tin Whisker Growths Which Short From Terminal to Exposed Circuit Trace  
 Photo Credit: Dominion - Millstone Power Station

- Westinghouse recommends that utilities conduct periodic inspections for tin whiskers.
- In order to detect the presence of tin whiskers, the inspections should be done with a minimum of 10x magnification and directed light.
- An inspection of a 15% random sample of installed components is recommended to ensure an adequate population is inspected and to minimize the adverse affects of handling and temperature cycling. If any of the randomly selected components have tin whiskers, 100% inspection of the components installed in the system is recommended.
- Upon completion of the inspection, the components should be gently cleaned with a soft bristle, static-free brush and cleaned with either canned air or a static-free vacuum.
- Westinghouse recommends that the inspections be performed periodically at least every 5 to 6 years, depending on the operating unit's refueling cycle.

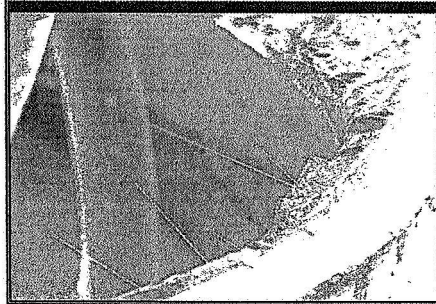
**AF114 Germanium Transistors**  
Mfr Date ~1960. Observation Date - 2005

Tin Whiskers grow **INSIDE** tin-plated transistor package, causing shorting to internal connections.

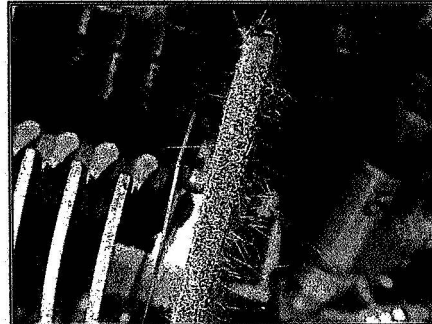
**Variable Air Capacitor**  
Mfr Date ~1959. Observation Date - 2006

Tin Whiskers grow from tin-plated housing. Some whiskers ~1cm long.

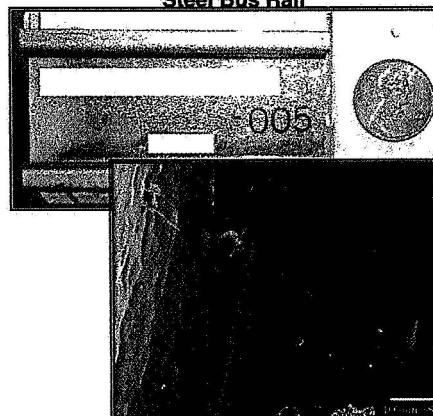
**Zinc-Plated Yellow Chromate Steel Bus Rail**

- Circa 2001 Metal Vapor Arcing was induced by zinc whiskers on a twin of this bus rail during system level thermal-vac testing at a space contractor facility:

- Whiskers bridged a 45-mil gap from the bus rail to an aluminum chassis
- The short ignited a metal vapor arc which lasted 4.7 seconds.
- Extinction of the arc occurred after interruption of 20-Amp fuse pairs on 11 separate boards within the electronics box.
- The current was sufficient to melt most of the bus rail, a portion of the aluminum housing under the rail, and some nylon.

**Don't assume "color" of the metal finish is a sufficient indicator of whiskering potential.**
