Mars Exploration Rover Potentiometer Problems, Failures and Lessons Learned

Mark Balzer*

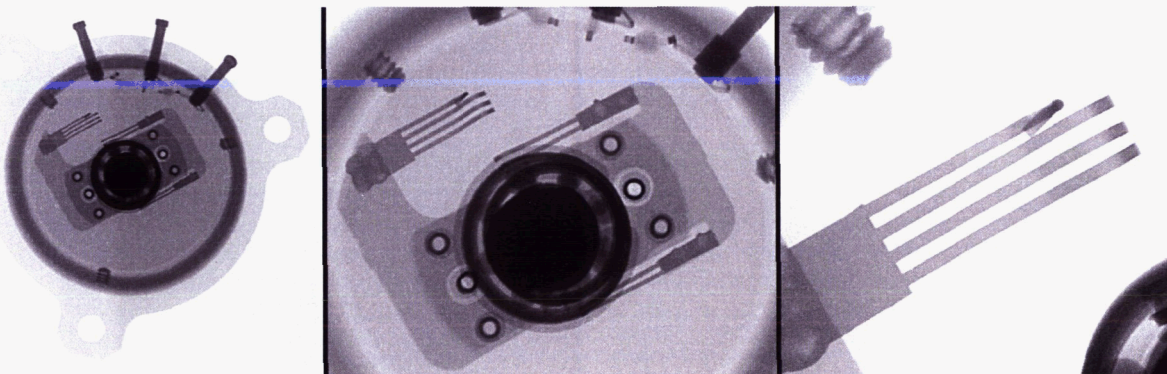
Figure 2. X-ray images of the S/N 1041 pot at increasing magnification show wiper damage

FeinFocus real-time X-ray images of the pots revealed wiper damage (Figure 2). Subsequent disassembly of S/N's 1035 and 1041 revealed that the resistance element wiper, slip-ring wiper and the conductive plastic disk were all damaged due to high current and/or arcing (Figure 3).

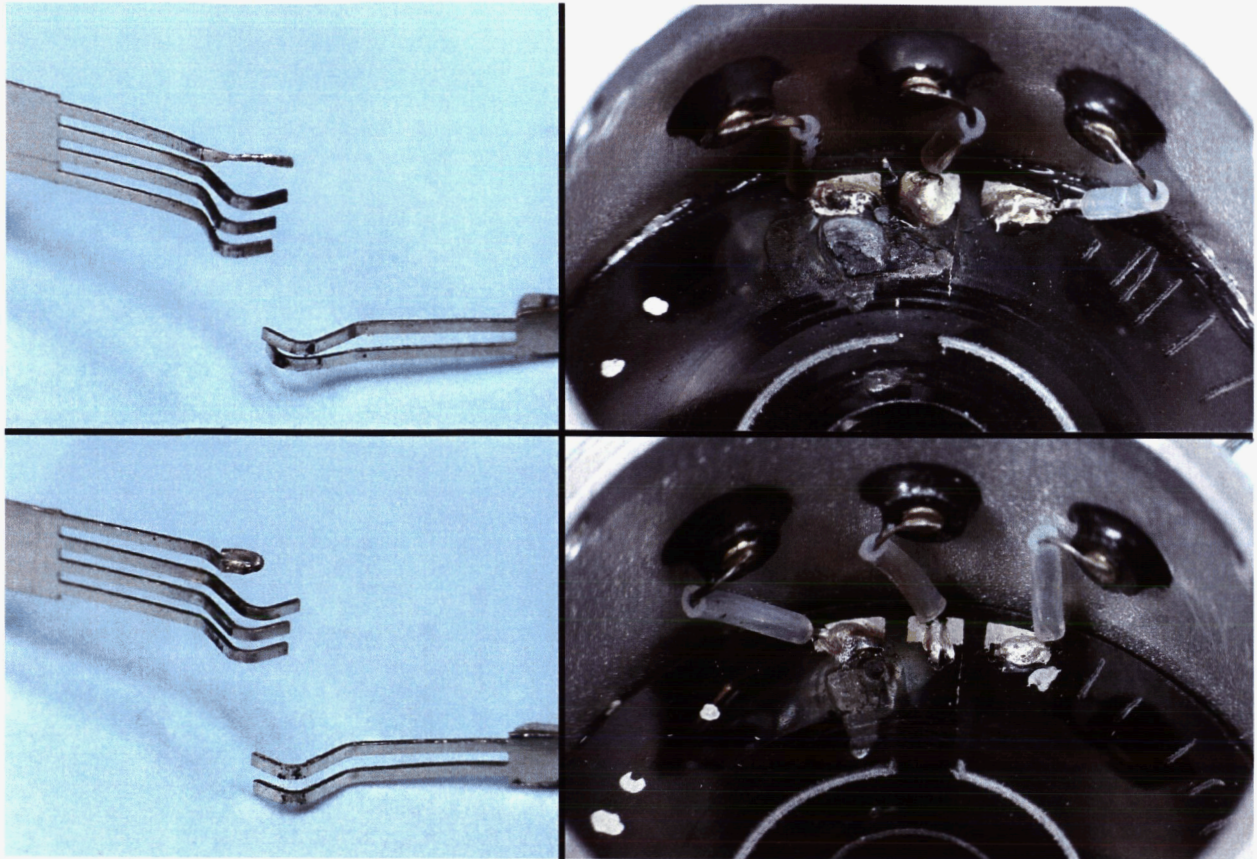
The wipers showed arc scarring: pitting coupled with discoloration and warping due to overheating (Figure 3). The end of one S/N 1035 wiper finger was burned off and embedded in its conductive plastic disk. The disks were damaged in two places: a) heavy arcing damage to the triangular shaped junction between the "CCW" end of the resistance element and the mound of conductive epoxy connecting the "CCW" terminal's flat ribbon wire, and b) light arcing damage to the slip-ring portion of the disk where one of the two slip-ring wipers was located. The carbonized shell of a "bubble" was observed across the wiper tracks on S/N 1035's conductive plastic disk where vaporized disk substrate "puffed up" the overheated top layers. There was a trough across the wiper tracks in S/N 1041's conductive plastic disk where the substrate was vaporized away.

Figure 3. Arc damage to fingers on wipers, and to conductive plastic disks on S/N 1035 and 1041

Based on the preceding failure analysis, this problem was attributed to test error due to a procedure fault. Pot S/N's 1035 and 1041 were scrapped. The pot specification and drawings were revised to include the 10 mA rating for the wiper circuit. The following lessons were learned:

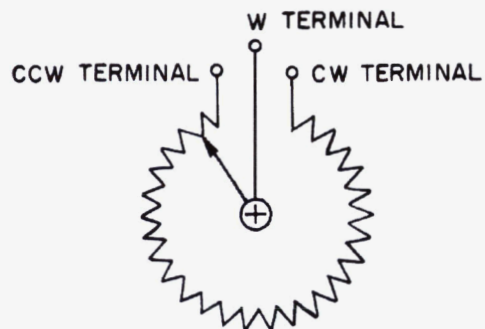
Figure 4. The wiper position shown forms a low resistance circuit between CCW and W terminals

No electrical schematic was given and no polarities were mentioned. Note that step 3 left the pot's "CCW" and "W" terminals connected to test leads and implied rather than mandated the switching of the multimeter from the "Ohms" to "DCV" range. Step 4 connected a power supply but did not specify how, and though the power supply could deliver 3 amps, there was no instruction to set a current limit. Then rotating the pot ensured that the wiper would pass over the "CCW" end of the resistance element.

LESSON 1. Be aware of low resistance circuits which exist between the "CCW" and "W" terminals when the wiper is positioned near the "CCW" end of the resistance element, as well as between the "CW" and "W" terminals when the wiper is positioned near the "CW" end of the resistance element. Warn of these conditions in the test procedure.

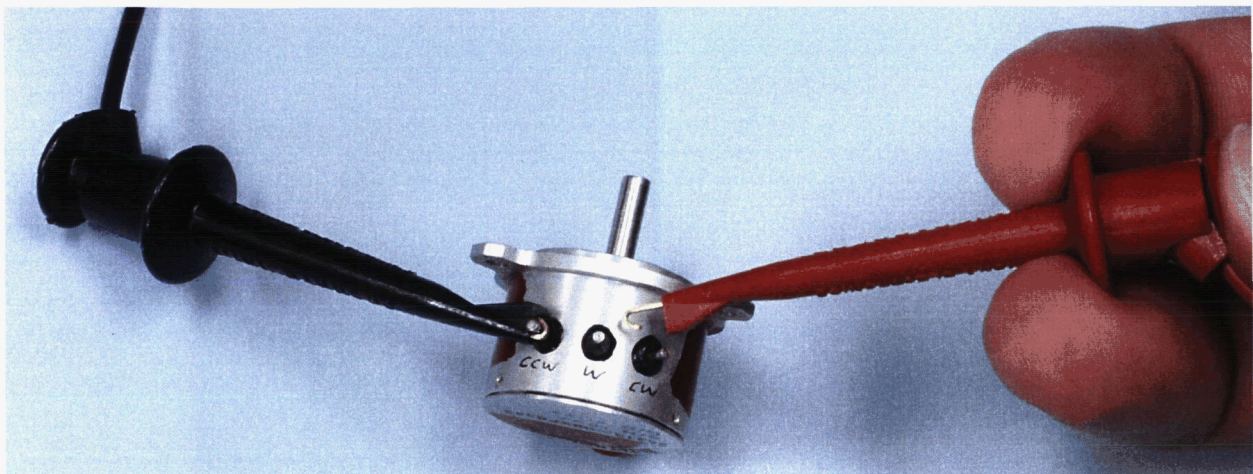
Close examination of the internal damage indicated that the wipers were stationary when the problem occurred. Note that Pomona Electronics brand "Minigrabber" test clips were used to connect to the pot terminals (Figure 5). When depressed, a beryllium-copper hook projects from the end of these test clips. As the procedure does not mention turning off the power supply outputs, the pots were likely hooked up to live (powered) test clips. The terminals on the MIL-PRF-39023 style pots are only 6mm apart. When attaching the powered clip meant for the "CW" terminal, it would have been very easy to bump the "W" terminal with the metal hook, or even clip it to the "W" terminal outright. If the wiper happened to be positioned near the "CCW" end of the resistance element, a high current could have flowed through the wiper circuit and caused the damage observed.

Figure 5. The live, exposed hook on the test clip is a danger to pots with closely spaced terminals

LESSON 5. Use insulated test clips to connect to terminals that are in close proximity to each other. Alternately, solder hook-up wires to the terminals and connect leads to the wires.

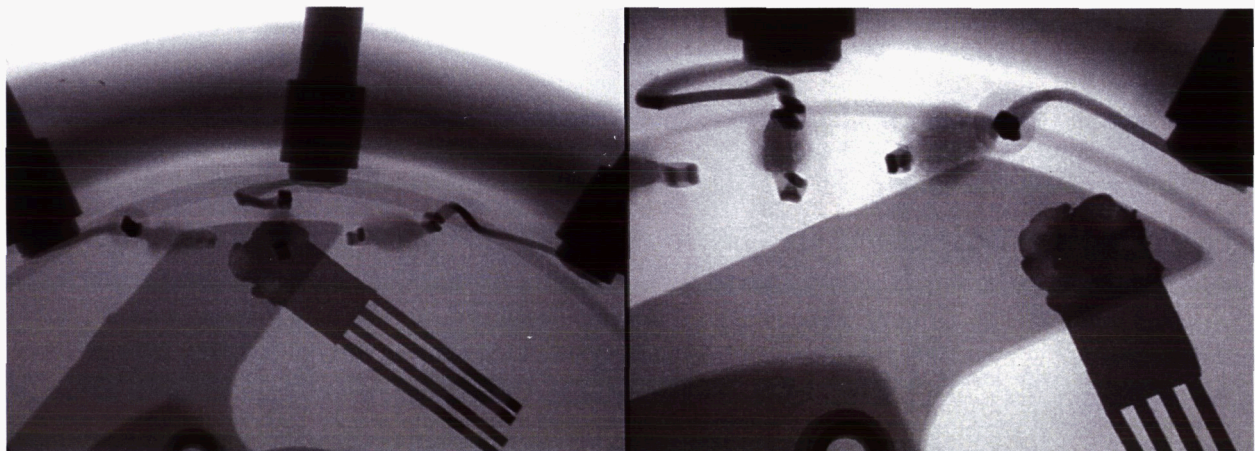
Close examination of the X-ray images showed that at the ~190 degree shaft position on S/N 1027, the wiper bracket on the shaft passed very close to the flat ribbon wire connecting the "CW" terminal to the resistance element. On most pots, the flat ribbon wires were bent towards the case immediately upon exiting the hole in the conductive plastic disk. However, on S/N 1027, the "CW" flat ribbon wire was not bent towards the case, leaving it closer to the rotating parts than usual. Careful examination of X-ray images of S/N 1027 show that the wiper bracket rubbed the insulating Teflon sleeve on this flat ribbon wire. This rubbing interference was consistent with all observations listed above, represented a new discovery, and was declared to be the cause of the detent.

Figure 7. X-ray images of pots show cause of detent: interfering Teflon sleeve on flat ribbon wire

X-ray images of S/N's 1021 and 1036 (Figure 7) also showed that their wiper brackets rubbed the insulating Teflon sleeves on their flat ribbon wires. This rubbing interference was consistent with all observations listed above, and was declared to be the source of their detents as well.

Based on the preceding failure analysis, this problem was attributed to manufacturing error due to a faulty production process. S/N's 1021, 1027 and 1036 were labeled "Limited Use (Non-Flight Part)" and were not used for flight.

- a) individually specify and inspect the angle or direction that the flat ribbon wire points as it leaves each of the three terminals. The angle should be chosen to provide a direct route to each flat ribbon wire's respective hole in the conductive plastic disk.
- b) specify and inspect that each flat ribbon wire must be bent towards the case immediately upon exiting the hole in the conductive plastic disk. This would ensure that the flat ribbon wires will be against the inner wall of the case and maximize the clearance between the rotating and stationary parts. A cutaway cover or functional gage could be designed that would permit inspection and verification of a minimum acceptable clearance.
- c) investigate a shorter wiper bracket or an alternative "lower profile" method of insulating the flat ribbon wire, to provide more clearance between the rotating and stationary parts.

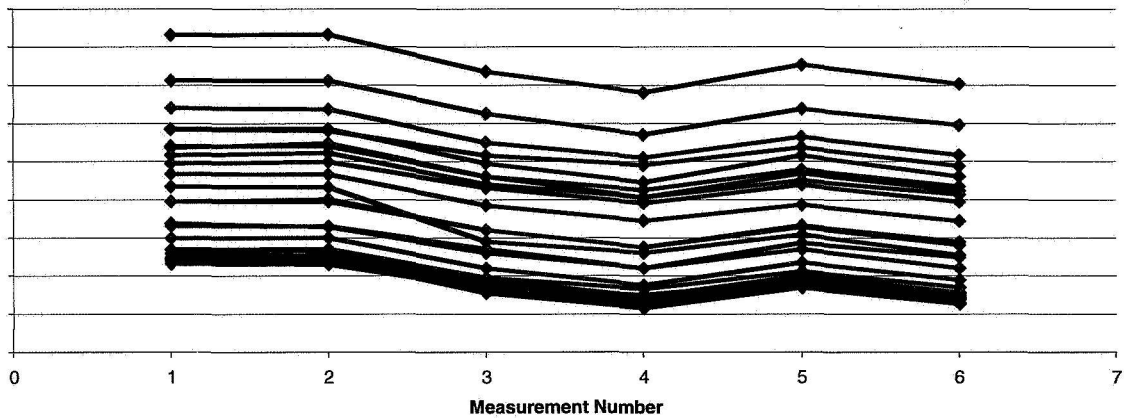
testing (measurements #1 and 2), but significant drift was measured after each JPL thermal test (measurements #3 - 6). Discussion with the original cognizant engineer responsible for measurements #3 and 4 revealed that the ohmmeter was never zeroed, which would have put a constant offset error on all values measured. If that offset had been approximately -170 Ohms, there would be a uniform downward trend across nearly all measurements. I became concerned that if this trend continued, the daily thermal cycles experienced by the Rovers might cause the total resistance of the pots to drift out of spec.

Figure 8. Total Resistance measurement history

When notified of this observation the pot manufacturer said that it was typical for the total resistance of a conductive plastic pot to change after thermal cycling. The mechanism was explained as follows: conductive plastic is made of carbon particles in an insulating matrix, co-cured at 160° C (and rated for operation up to 125° C). Thermal cycles change the insulating matrix on a microscopic level, allowing better conductivity between the carbon particles. Macroscopically these changes appear as a drop in the total resistance. The manufacturer said that as the number of thermal cycles builds, the rate at which the resistance drops will decrease and the resistance will eventually stabilize. The scratches and drops of silver paint used to linearize the pot have an effect on the rate at which the resistance stabilizes. The manufacturer assured me that the resistance changes would be uniform throughout the length of the resistance element and that the pot's linearity would not be affected by changes in the total resistance.

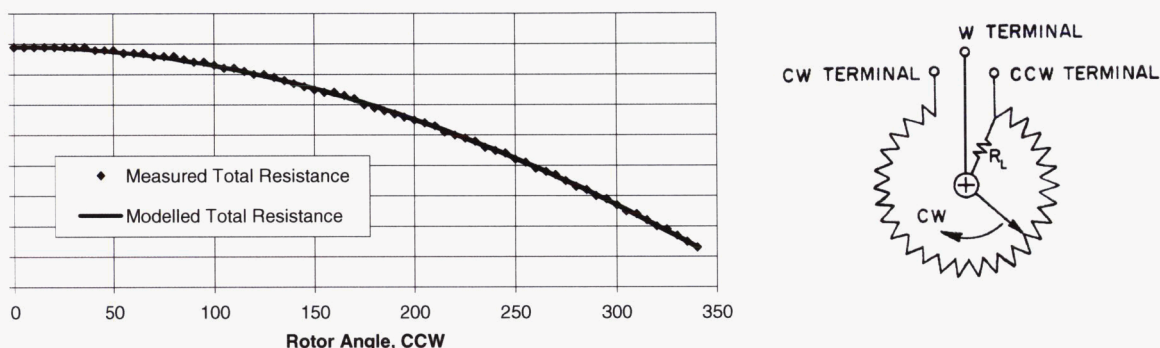
After plotting and examining the data, I hypothesized that a high resistance leakage path between the “CCW” end termination of the resistance element and the slip ring could explain the anomaly. A schematic of a pot with an internal leakage resistance was drawn (Figure 10) and an equivalent resistance equation was written as a function of shaft angle. This mathematical model was iterated with different values of leakage resistance until the model predictions matched the measured total resistance data. Note that the 51.9 kOhm leakage resistance found in this way was 8.3 times the pot's nominal total resistance.

Figure 10. Measurements match model of HGAG pot with internal leakage resistance $R_L = 51$ kOhm

The prediction of the model fits the data extremely well, supporting the hypothesis. The extremely linear output of this pot supports the conclusion that this leakage resistance was present all along but never discovered (because per a strict reading of the ATP instructions, no one was looking for it). Any non-linearity caused by the leakage resistance was likely removed by adding scratches and/or drops of silver paint when the pot's linearity was adjusted by the manufacturer.

True confirmation of the hypothesis requires direct measurement and so the pot was disassembled by removing the rotor from the stator. In this condition the leakage resistance could be accurately measured because the slip ring and the resistance element were no longer bridged by the brushes. With the pot disassembled, the leakage resistance measured 51.4 kOhms to the “CCW” lead, and 57.6 kOhms to the “CW” lead. Note that $57.6 - 51.4 = 6.2$ kOhm, the nominal total resistance.

Based on the preceding failure analysis, this problem was attributed to manufacturing error due to a faulty production process. Pot S/N 1017 was labeled "Limited Use (Non-Flight Part)" and was not used for flight.

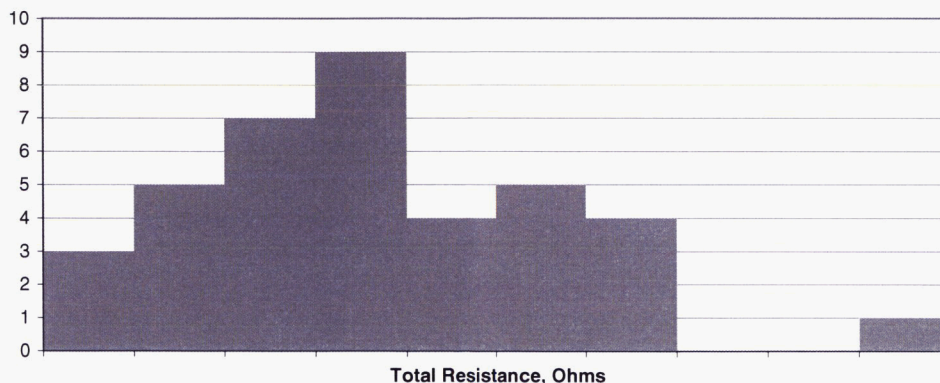
Next the build documentation was examined to see if it held any clues to this anomaly. The spec called for a total resistance of 6250 Ohms $\pm 20\%$. The in-process data sheet filled out by the pot manufacturer listed the total resistance as 7391 Ohms. After environmental testing, the in-process data sheet listed the total resistance as 7404 Ohm. While S/N 1039 was in spec, all the other WSA potentiometers supplied to JPL had much lower total resistances. A histogram of WSA total resistance values (Figure 11) clearly shows S/N 1039 to be an outlier.

Figure 11. Histogram of Total Resistance values showing the lone outlier, S/N 1039
