ISS Internal Active Thermal Control System (IATCS) Coolant Remediation Project - 2006 Update

Russell H. Morrison
The Boeing Company

Mike Holt
NASA Marshall Space Flight Center

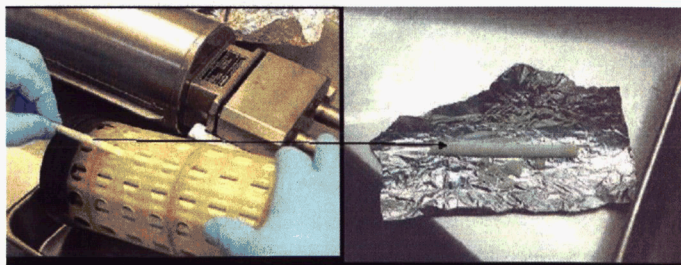
The effects of nickel precipitation were believed to be first observed in the IATCS in July 2001 when the pressure drop across a gas trap installed in the MTL had risen to 6 psid from a nominal 4.4 psid last observed in November 1999 [4]. The pressure drop across this gas trap had been rising even during ground testing of the US Lab. The last pressure drop observed on the ground before launch was 5.3 psid in September 2000. The US Lab was activated on-orbit in February 2001 and by May 2001, the gas trap pressure drop had risen to 5.7 psid. It was returned to the ground in August 2001. The hydrophilic membranes had a green appearance as illustrated in Figure 5, rather than the normal white. Tests revealed no significant microbiological contamination. Flushing with de-ionized water, isopropyl alcohol, and dilute hydrochloric acid cleaned the membrane module. At the time of its removal, the pH of the IATCS coolant was still around 9 and had never been below 9. Phosphate concentration was still in the normal range. Nickel concentration in the coolant was still below 2 ppm and was never high when the first increases in pressure drop were observed on the ground. Analysis of contamination from the membrane did reveal some nickel, phosphorus, silicon, aluminum and oxygen. It is not clear that these compounds were in large enough quantities to be responsible for the pressure drop observed. It is interesting that even in the surge of nickel phosphate precipitation that occurred over an 18 month period beginning in March 2002, it was not until one year into the process that the MTL gas trap pressure drop again reached 6 psid. Chemical modeling of the coolant and the fact that it cleaned up with dilute acid suggests that the contaminant was likely nickel hydroxide. It is not completely clear what role nickel precipitation played in the gas trap failure of July 2001, but it did alert the program to potential issues with nickel precipitates in the months to come.

Figure 5. "Green Gas Trap" - contaminated with nickel precipitates

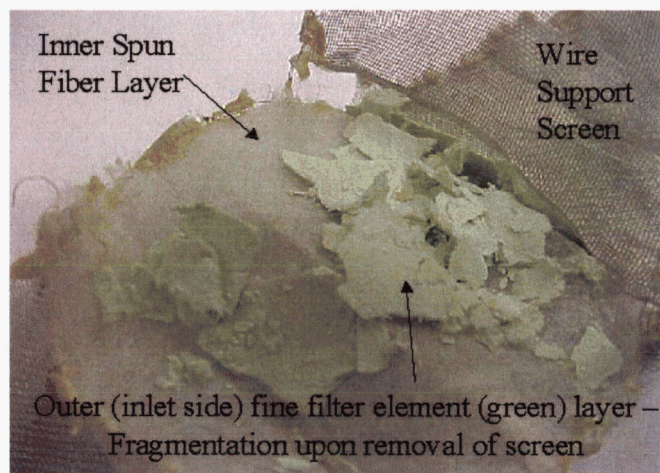
This filter was installed on the MTL in January 2002 after having been seeded with silver phosphate in an attempt to achieve some measure of microbiological control. After dissolution of the silver phosphate, pressure drop fell to the normal 1.9 psid. By October 2002, well into the main nickel phosphate precipitation event, the pressure drop in this filter had risen to 4 psid. It was replaced and returned on flight 9A. Green precipitate was quite obvious on this filter as seen in Figure 6. Scanning Electron Microscopy/Energy Dispersive X-Ray Fluorescence (SEM/EDXRF) analysis clearly showed strong nickel and phosphate peaks. Fourier Transform Infrared (FTIR) spectrum analysis also closely matched that for nickel phosphate. This filter was clearly consumed due to nickel phosphate precipitation.

Figure 6. Green Filter - contaminated with nickel precipitates, primarily phosphate

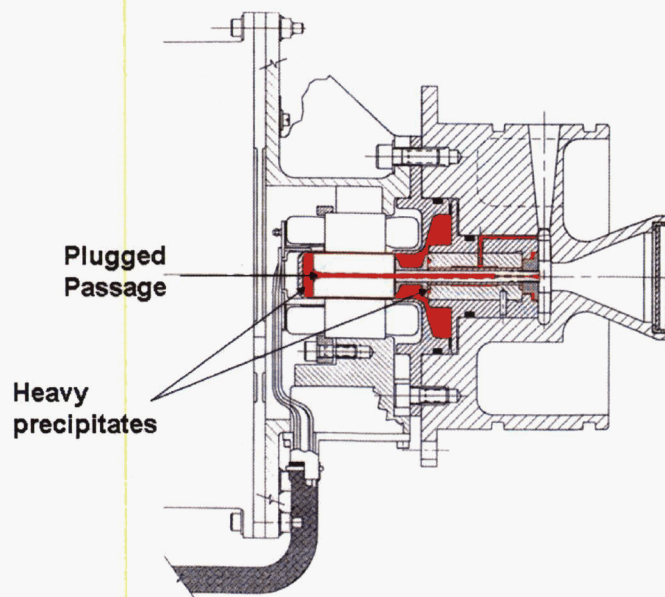
Nickel phosphate precipitates were found to have blocked passages providing flow and cooling to the hydrodynamic and hydrostatic bearings of the pump rotor assembly. Figure 7 is a cross-section of the rotating assembly with the coolant flow passages highlighted in red.

Figure 7. PPA cross-section, bearing flow passages in red

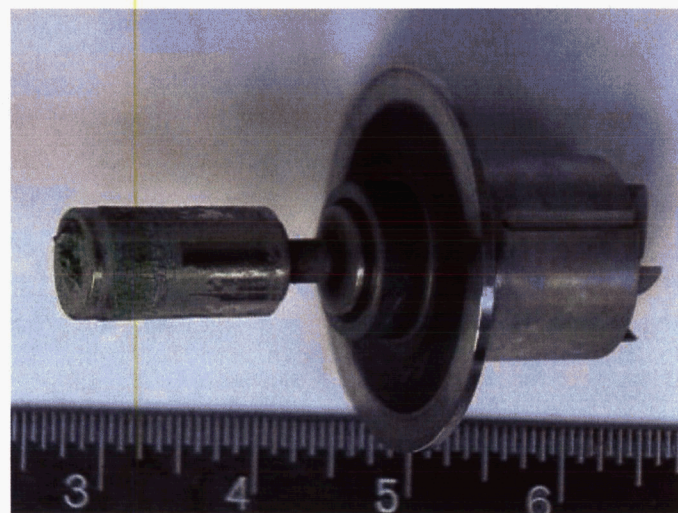
Figure 8. PPA Rotor Assembly

Figure 8 is the entire rotor assembly after removal from the PPA with visible green precipitation on the rotor OD and at the end. Figure 9 shows precipitates found in the bottom of the rotor seal in the stator and Figure 10 shows the precipitate buildup on the end of the rotor (both on left side of red area in Figure 7).

The precipitates were all positively identified as nickel phosphate by Scanning Electron Microscopy (SEM)/ Energy Dispersive Analysis X-ray (EDAX).

This failure occurred after about 9 months of rapidly decreasing phosphate concentration. The concentration was at about 75 ppm and still over a year from stabilizing at about 10 ppm, thus there had been a large quantity of phosphate forming in the IATCS at the time the PPA failed. The PPA failure mechanism was loss of flow to the hydrodynamic and hydrostatic bearings due to a buildup of precipitates in the tight flow passages. Without flow, the hydrostatic thrust bearing collapsed and rotor torque exceeded the capability of the PPA motor. These MTL flow passages are among the warmest locations in both coolant loops. Nickel precipitates have an inverse solubility relationship to temperature, i.e. they are more likely to form at higher temperatures. Thus, these passages would have been among the most likely points in the loop for precipitation to first occur. As the passages became more and more restricted, the temperature of the coolant would have increased, exacerbating the rate of precipitate formation in the passages and accelerating the demise of the PPA.

Examination of the gas trap assembly from this PPA is expected to also reveal high concentrations of nickel phosphate. The current depleted state of phosphate in the on-orbit loops mitigates the risk to the operating pumps. No additional steps, beyond coolant remediation, are necessary to protect the US Lab coolant loops from this failure in the near future. This failure illustrates the need to keep phosphate out of the remaining coolant loops of future ISS elements.

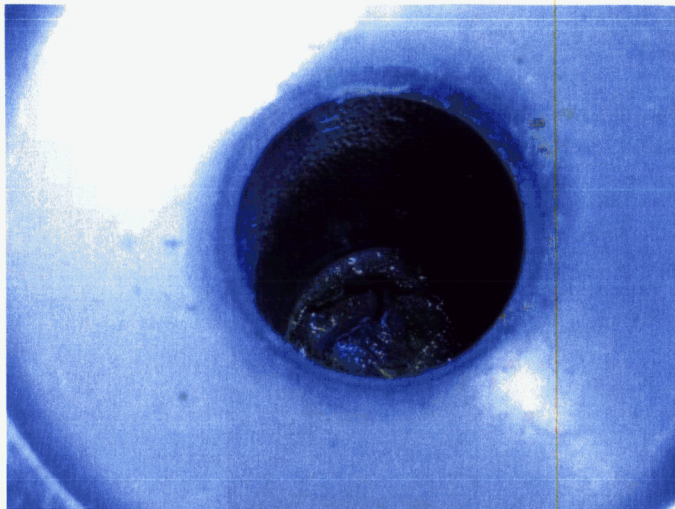
Figure 9. Precipitate in bottom of rotor cover well

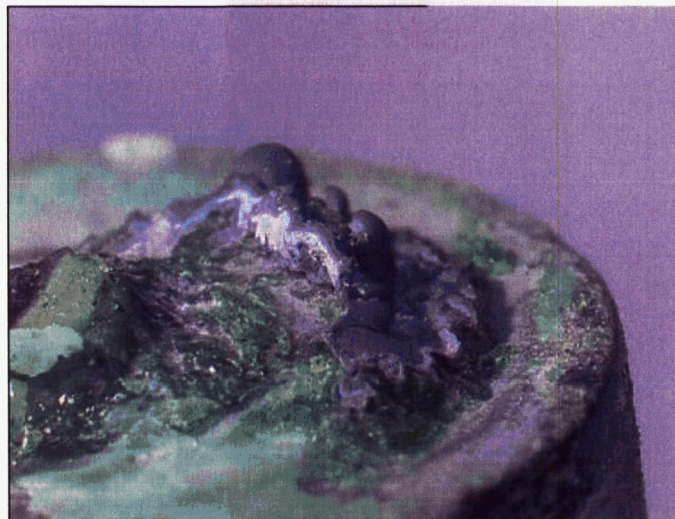
Figure 10. Precipitate on end of rotor

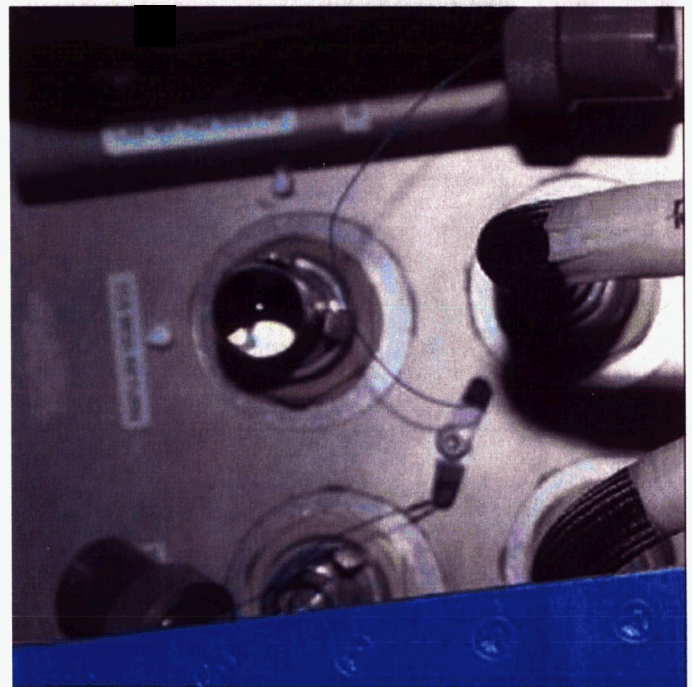
A temporary reconfiguration of the coolant loops to support Soyuz vehicle relocation on ISS left four normally mated male and female QDs in a de-mated state for a period of approximately 56 hours. Two of the QD halves, one male, one female, had water blobs on their open faces totaling approximately 100 ml just before they were re-mated. The male QD water blob is visible in Figure 11.

Figure 11. On-orbit QD leak

Procedural changes requiring the installation of caps or plugs on de-mated QD halves have been instituted. When this is not possible, the QD is cycled once before de-mating in the hopes of dislodging precipitate.

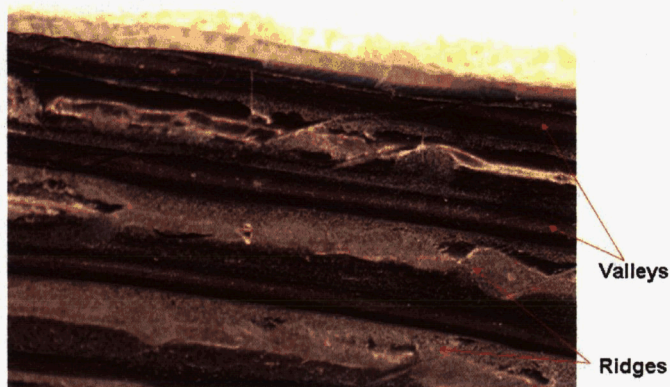
Microprobe, Time-of-Flight Secondary Ion Mass Spectrometry (TOF SIM), and X-Ray Photoelectron Spectroscopy (XPS). These tests indicated that virtually all of the precipitate in the coolant system was nickel phosphate.

Figure 12. Valleys and ridges of flexhose returned on LF-1

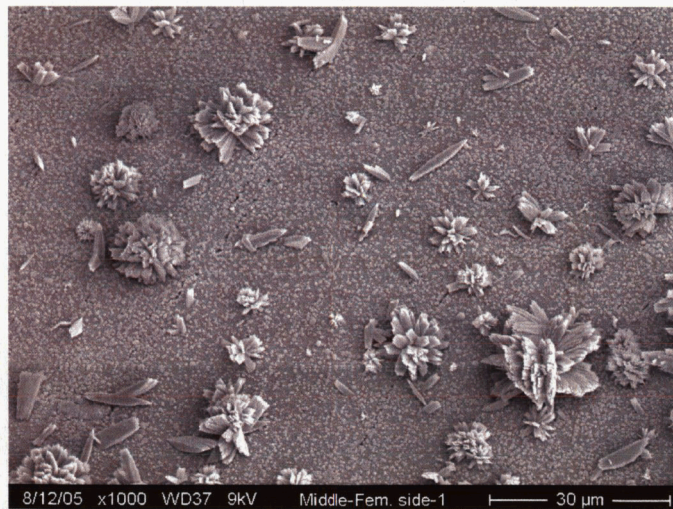
Figure 13. Heaviest distribution of precipitate, from center of teflon flexhose returned on LF-1, showing flowerettes of nickel phosphate

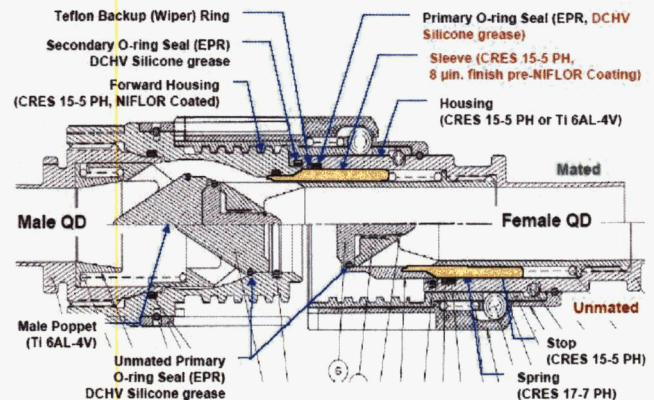
Disassembly of the female QD revealed a modest buildup of coolant residues and precipitates on the seals and sliding parts, Figures 14 and 15. There was no significant corrosion of the electroless nickel plated surfaces or any other surfaces in this QD. The cause of

leakage in the female QD is currently suspected to be low seat load at the stop plug after a de-mate cycle due to higher than normal friction between the OD of the female sleeve and the mating EPR o-ring in the housing brought on by deposition of coolant precipitates.

Figure 14. QD cross-section with sticking sleeve highlighted in yellow

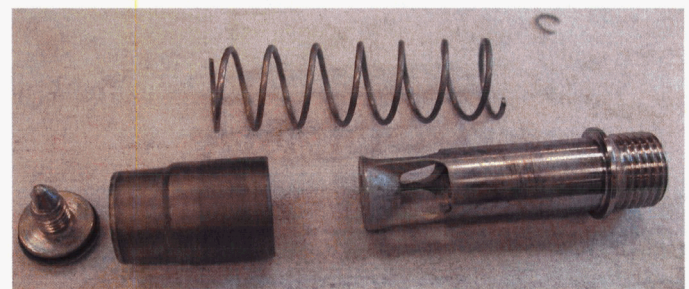
Figure 15. LF-1 female QD stop plug assembly

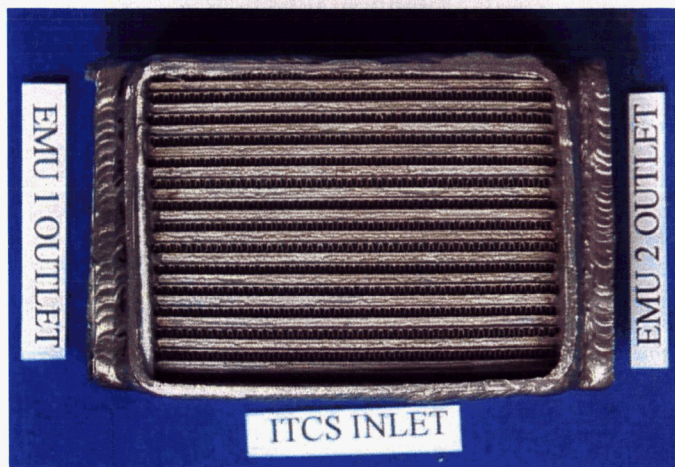
Figure 17. The ITCS passages of the dissected SPCU HX were visibly clean

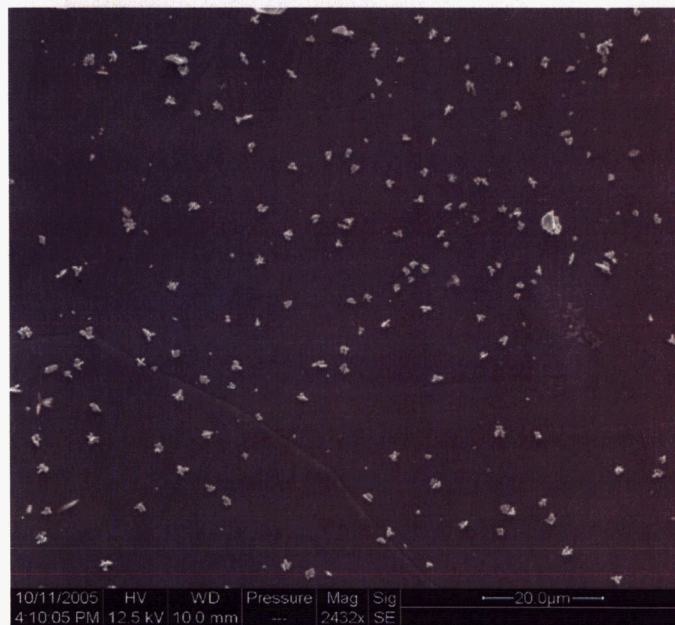
Nickel phosphate particles under magnification were smaller and less abundant than those found in the flexhose returned on flight LF-1, Figure 18.

Figure 18. SPCU HX surface distribution of nickel phosphate

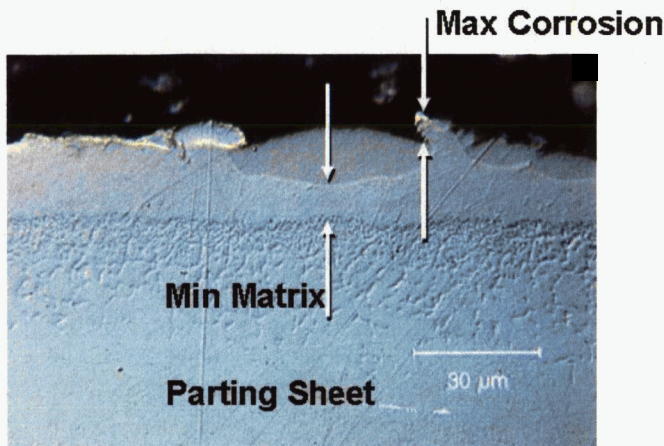
This SPCU HX had been exposed to IATCS coolant at pH less than 9.0 for 3.75 years. New life calculations were made for all single braze cycle BNi-3 components like the SPCU HX based on microscopic examination of many cross-sections of the braze layer and heat exchanger parting sheet from this unit, Figure 19. The life of such components in IATCS coolant service was extended from 4 years to 16 years. This is the predicted

Figure 19. Braze cross-section with pure nickel matrix phase and faster corroding intermetallic phase nickel
