GT2006-90833

CERAMIC MATRIX COMPOSITE VANE SUBELEMENT BURST TESTING

ABSTRACT

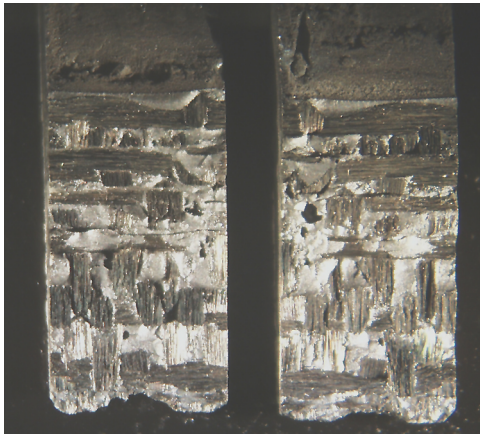
Figure 11 – Specimen 8, Trailing Edge

All vanes specimens failed in interlaminar tension, at the trailing edge, Figure 11. With the exception of one specimen, specimens remained in one piece. Specimen 8 was the only specimen to fail, in secondary mode, at the leading edge as well as the trailing edge. The leading edge failure was a result of failure to control the fixture bladder, at burst.

In a general, most specimens resisted at least 0.650 MPa internal pressure. The failure surface ran symmetrically through the trailing edge and exhibited a tortuous failure path with many broken fiber tows, Figure 11. Clearly, the failure surface was driven through the out-of-plane fibers in the Y-cloth, rather than along one single ply. The nonlinear strain records indicate that load was carried as damage proceeded through the trailing edge. This is strong evidence that the Y-cloth did the job of resisting interlaminar failure.

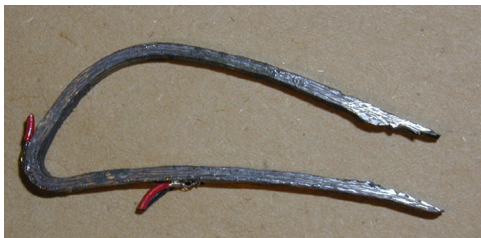
Examination of leading edge damage supports the analytical conclusion that high interlaminar stresses were present. The qualitative amount of interlaminar ply separation at the leading edge appears commensurate with the residual crack opening at the trailing edge. Specimens 2, Figures 12 and 13, and 5, Figures 14 and 15, were chosen for comparison because they display the greatest and least residual openings, respectively. Figure 13 shows extensive inter-ply cracking at the leading edge of specimen 2. There is very little obvious damage in Figure 15, specimen 5. This result is consistent with the other specimens.

Figure 12 - Specimen 2 Post Test

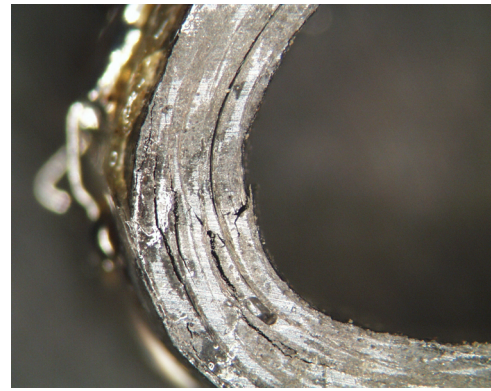
Figure 13 – Specimen 2, Leading edge damage

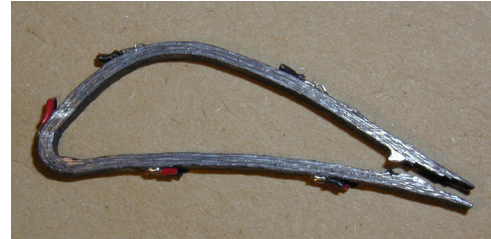
Figure 14 – Specimen 5 Post Test

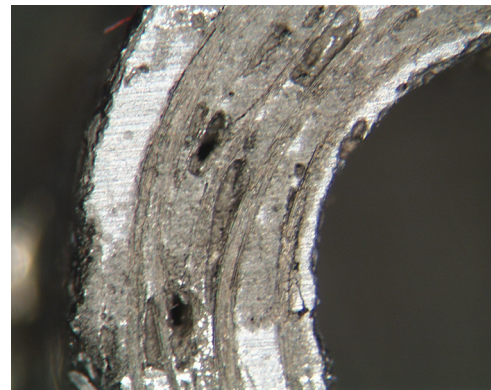
Figure 15 – Specimen 5, Leading edge damage
