# INVESTIGATIONS OF SHUTTLE MAIN LANDING GEAR DOOR ENVIRONMENTAL SEALS

Joshua Finkbeiner  
National Aeronautics and Space Administration  
Glenn Research Center  
Cleveland, Ohio

2005 Seal Workshop

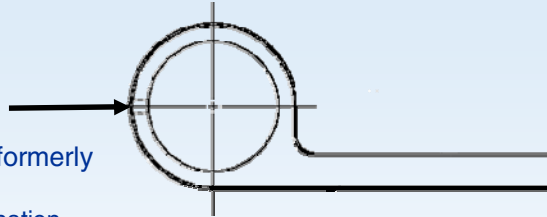
- Silicone rubber core
- Nomex fabric overwrap
- Vent holes every 6 in.
- Two revisions
  - Rev. M - old revision (formerly flown)
    - Nomex fabric impregnation
    - Higher stiffness
  - Rev. P - new revision (installed on STS-114)
    - Material slightly darker than Rev. M
    - No Nomex impregnation
    - Lower stiffness

Two revisions of the seal were tested in this study. The old type of seal, Rev. M, was removed from OV-103 during the initial investigation of the seals. It features an additional Nomex fabric impregnation of the silicone rubber material, particularly in the bulb.

The new seal revision, Rev. P, lacks the Nomex fabric impregnation of the silicone rubber. The lack of Nomex impregnation leads to a seal which is less stiff to the touch than the old Rev. M seal. The Rev. P seal material is also a slightly darker color than Rev. M, indicating a possible change in composition of the silicone rubber.

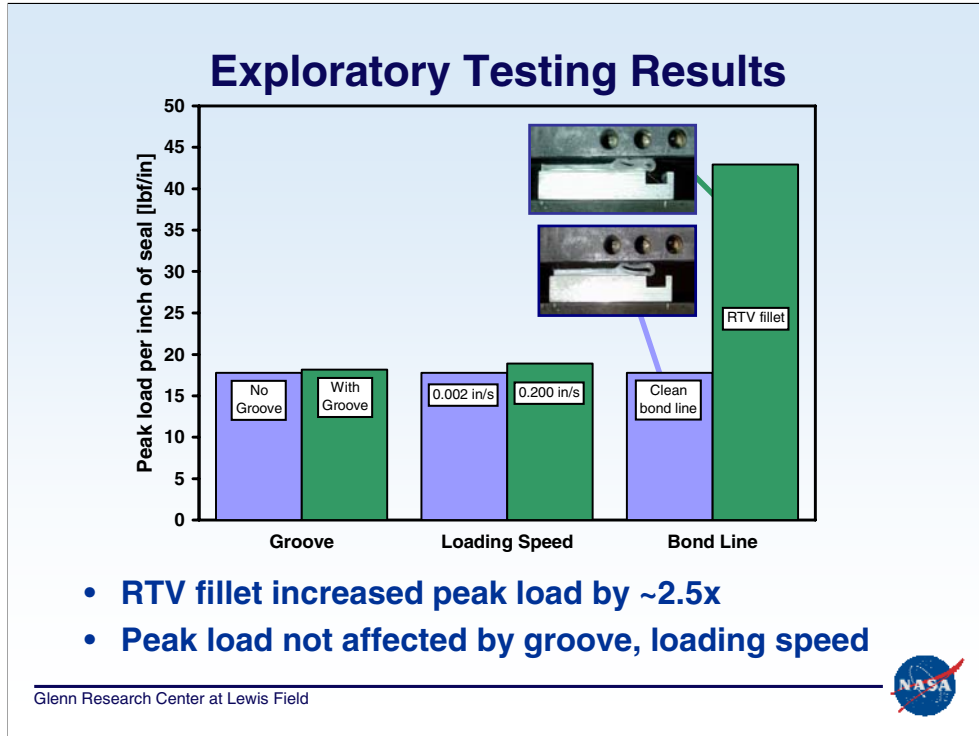
Second, the presence of an RTV fillet under the seal bulb was examined. Excess RTV was observed along the seal bulb in the newly-installed seals on OV-103.

Compression results for exploratory tests with only the first cycles of each test shown. The graph is % compression vs. load generated in the seal, and the arrows indicate the different paths for loading and unloading portions of the testing cycle. The first five tests show results which are nearly identical, demonstrating that the presence of the adjacent groove and the seal loading speed do not affect the test results. The sixth test (blue curve) demonstrates that the presence of the RTV fillet increases the load by as much as a factor of three.

GRC recommended to JSC/KSC that removal of excess RTV from under the seal bulb would reduce generated loads and possibly allow MLG door closure. The seal installation procedures were amended to include the removal of excess RTV.

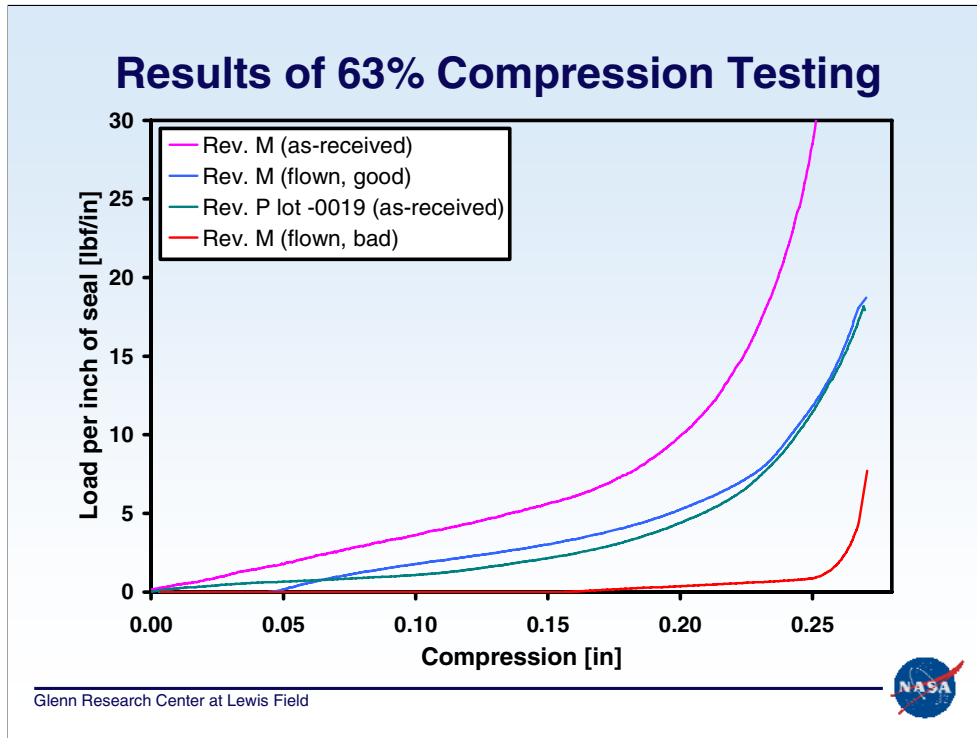
Chart shows results from four seals (two as-received, two flown) for systematic compression tests. The graph is compression distance [in] vs. generated load per inch of seal. The as-received Rev. M data is plotted twice: once in its as-measured state, and once shifted to the right (i.e. higher compression) by 0.035 in.

The as-received Rev. M specimen demonstrated the highest loads of the specimens tested, and the “bad” flown Rev. M demonstrated the lowest. With approximately 0.160 in. of permanent set, the “bad” flown specimen did not generate load until the upper platen contacted the bulb.

The as-received Rev. P data falls far below the as-received Rev. M specimen and is even lower than the “good” flown seal data. The reduction in generated load may be due to the lack of Nomex impregnation of the seal bulb. The as-received Rev. M seal generated five times the load of the as-received Rev. P seal for 63% compression.

**What does this mean?** Rev. P seals may be used as replacements for Rev. M seals without danger of overloading Shuttle structures. As-received Rev. P seals can be expected to generate lower loads (as much as five times) than as-received Rev. M seals. Permanent deformation in the seal bulb reduces the load generated by the seal.

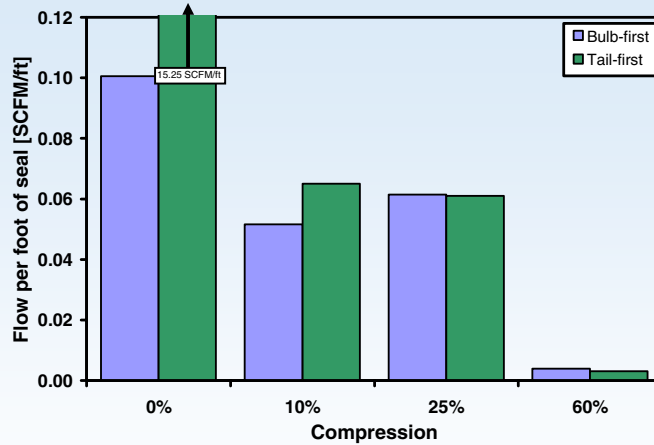
- Bulb-first (descent) flow rates below 3 SCFM/ft leakage limit
- Tail-first (ascent) flow rates much higher at low compressions
- Effect of orientation disappears by 25% compression

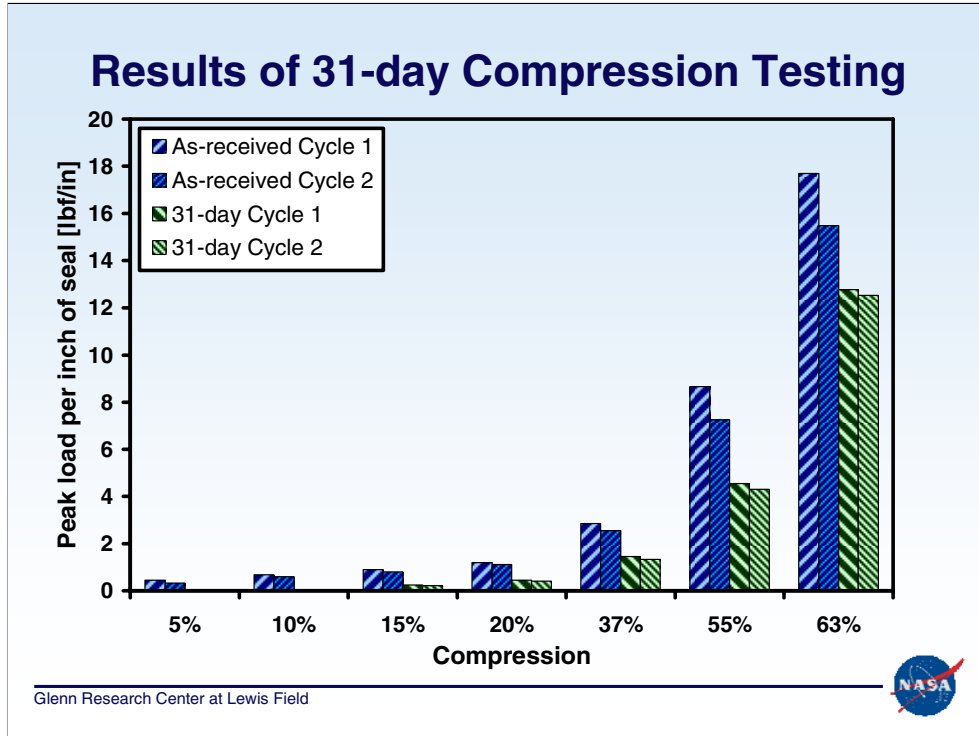
This graph shows the peak load per inch of seal vs. discrete compression levels applied to the seals for each of the two loading cycles. Both seal previously held at 63% compression for 31 days and an as-received control specimen are shown. The as-received specimen was measured to have 0.050 in. (12%) permanent deformation after release from the 31-day compression fixture.

The control specimen generated small amounts of loads immediately, while the 31-day compressed specimen did not generate any measurable load until 15% compression. Since the 31-day specimen was found to have 12% permanent deformation after the compression, the upper platen of the fixture did not contact the seal for 5% and 10% compression and generated no load for these displacements. Meanwhile, at 63% compression, the first cycle of the post-compression specimen generated 80% of the load of the as-received specimen.

Of particular interest was the drop-off in load of the as-received specimen between the first and second loading cycles and the relatively small load reduction in the compression specimen. If load drop-off is assumed to be proportional to permanent deformation, the data indicates that a seal with permanent deformation takes on new deformation more slowly than a pristine seal.

**What does this mean?** Seals held at compression for 31 days will take on some permanent deformation (0.050 in. in this test). However, the rate at which the seals take on permanent deformation appears to decrease as the seal takes on more deformation.
