NASA/CR-2007-213697

Lessons Learned From Seven Space Shuttle Missions

John Goodman
United Space Alliance
Houston, Texas 77058

January 2007

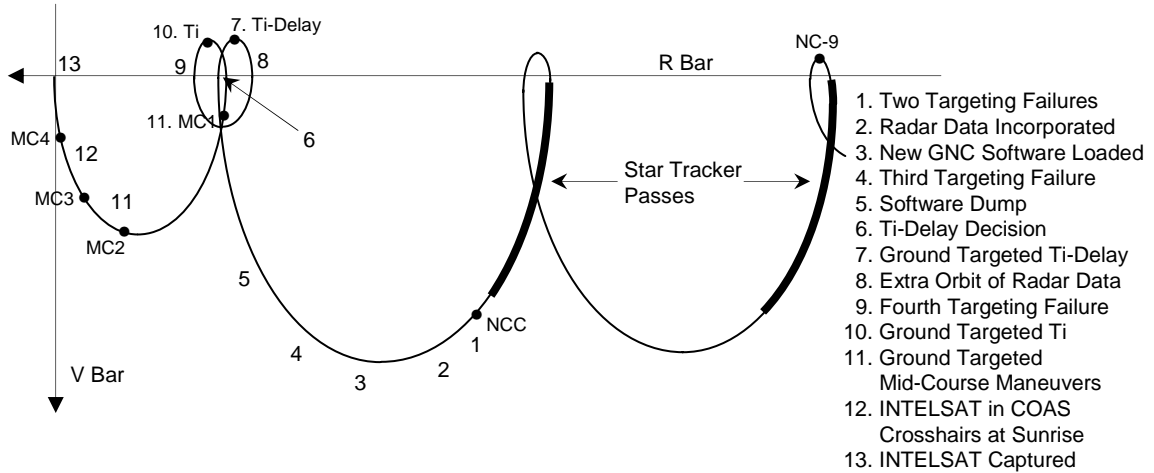
After *Endeavour* began its return to INTELSAT, two star tracker passes and a midcourse correction (NCC) maneuver were successfully performed (Figure 29). However, a targeting attempt soon after NCC for the next maneuver, Transition Initiation (Ti‡), failed to converge on a solution (item 1 in Figure 29, Figure 30).

Figure 29 Sequence of events during the third rendezvous of STS-49.

After the Mission Control computed Ti-Delay was performed (item 7 in Figure 29), two on-board troubleshooting Ti targeting attempts succeeded while another failed. The Ti and subsequent maneuvers were performed using burn solutions voiced to the crew from Mission Control. At orbital sunrise, just before the start of the proximity operations phase, the *Endeavour* commander reported that INTELSAT was in the cross hairs of the Crew Optical Alignment Sight (device on the left side of Figure 27), indicating a nominal approach trajectory for initiating proximity operations (item 12 in Figure 29, Figure 32).

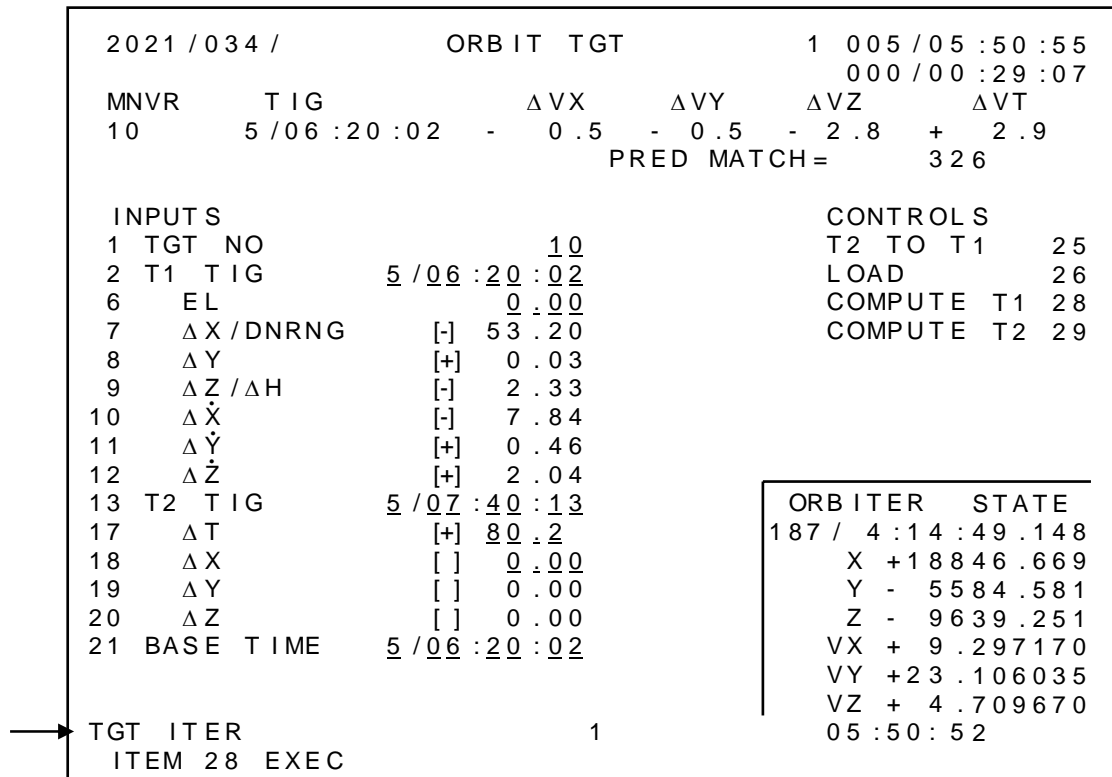
By Friday morning, the failure had been duplicated by the author in the Shuttle Software Production Facility using shuttle software and a shuttle flight computer (Figure 41).¹⁵ Data was distributed to all parties involved in the investigation that morning. By 5 pm on Saturday the 11th, the source of the failure had been identified as a rare numerical condition associated with the convergence improvement code introduced after STS-49. It was limited to rendezvous targeting, would not impact any other software functions or flight phases, and was not a constraint to the upcoming mission. Should the failure occur during the STS-51 rendezvous, a procedural work-around was developed and the STS-51 crew was briefed on the procedure the day before the launch.

Figure 41 Failed Ti targeting attempt recreated before the 1993 launch of *Discovery* on STS-51.

The STS-51 rendezvous with ORFEUS-SPAS was successfully conducted with no targeting failures occurring during the mission (Figures 42 and 43). Post flight, another investigation resulted in a software change to prevent the new anomaly from reoccurring. Analysis showed that the occurrence of this anomaly was less frequent than the STS-49 anomaly. Starting with the first rendezvous mission after STS-49 (STS-56, April 1993) through STS-114 (July-August of 2005), 45 shuttle missions have exercised the Lambert targeting software with no software anomalies occurring in flight. In addition, none have occurred in software testing and pre-mission training simulations since the fall of 1993.
