Pitting and Repair of the Space Shuttle's Inconel[®] Honeycomb Conical Seal Panel

During return to flight servicing of the rudder speed brake (RSB) for each Space Shuttle Orbiter, inspectors discovered numerous small pits on the surface of the #4 right hand side honeycomb panel that covers the rudder speed brake actuators. Shortly after detection of the problem, concurrent investigations were initiated to determine the extent of damage, the root cause, and to develop a repair plan, since fabrication of a replacement panel is impractical for cost, schedule, and sourcing considerations. This paper describes the approach, findings, conclusions and recommendations associated with the investigation of the conical seal pitting. It documents the cause and contributing factors of the pitting, the means used to isolate each contributor, and the supporting evidence for the primary cause of the pitting. Finally, the selection, development and verification of the repair procedure used to restore the conical seal panel is described with supporting process and metallurgical rationale for selection.

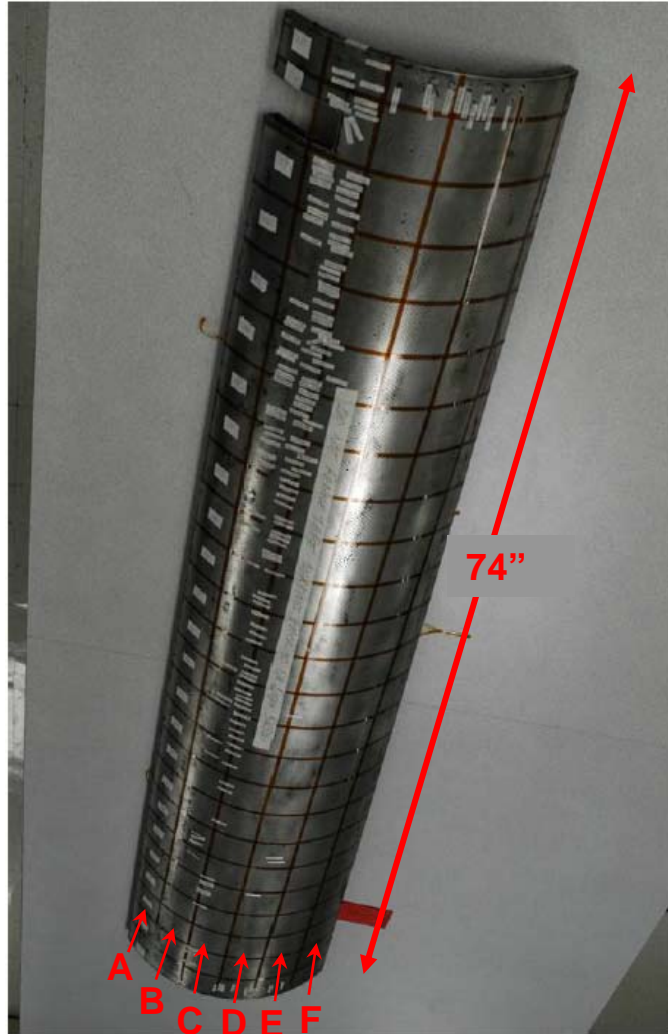
Figure 3. Photograph OV-105 RSB Conical Seal #4 Right Panel with a tape grid applied. Columns A-E parallel to the length of the panel correspond to columns A-E for the pit depth data in Fig. 9.

A grid of axial columns (A-F) and circumferential rows was overlaid on the panel with tape, as can be seen in Fig. 3. The grid location and dimensions of all pits greater than 0.003 inch in depth, as measured with an optical micrometer, were documented. The 0.003 inch threshold was selected based on a conservative structural analysis indicating that defects smaller than that depth would be inconsequential and the Material Review Board (MRB) accepted it for unrestricted use “as is.” The majority of the pits were located in the column designated as B; pitting was also clustered at the panel’s ends in columns C, D, and E (see Fig. 3). Figure 9 plots the depth of the pits as a function of grid location.

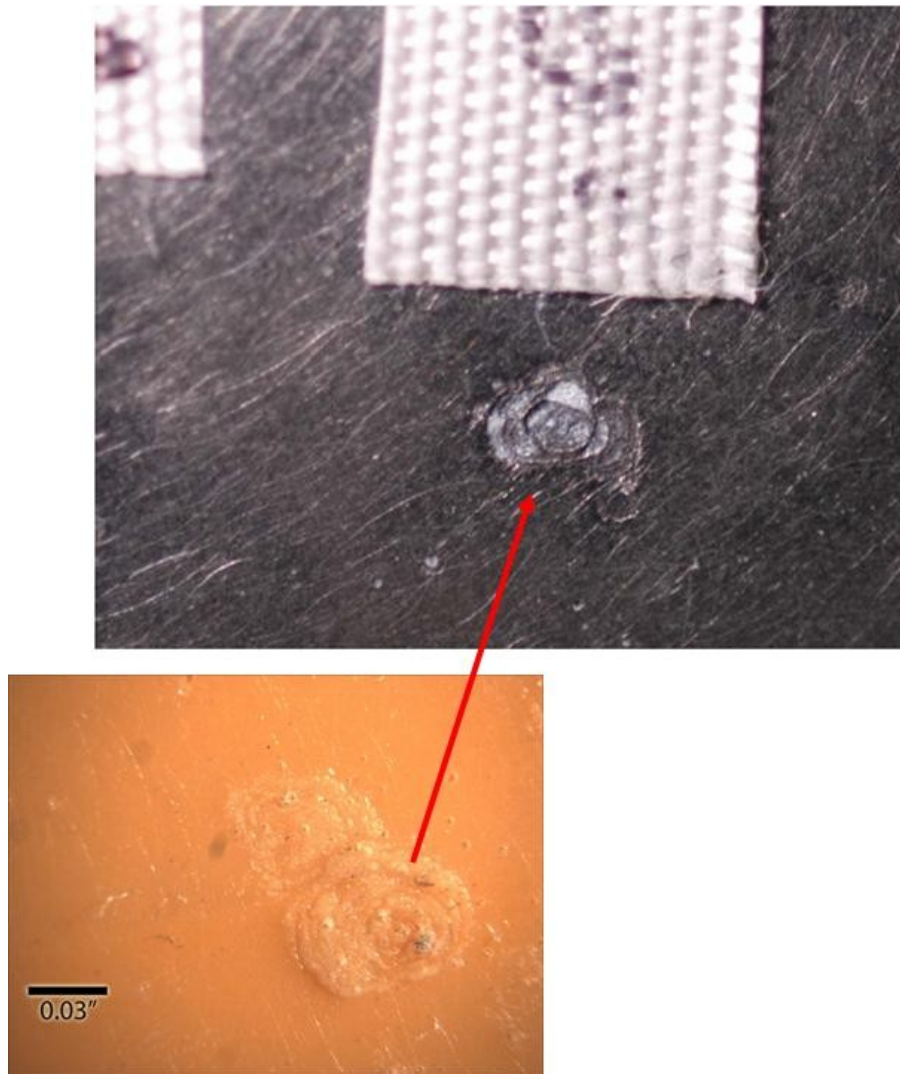
Visual inspection of the panel revealed 105 pits with a depth greater than 0.003 inch with some pits appearing to be through the thickness of the face sheet. Photographs of typical pitting and of molds from the pit interiors (replisets) are shown in Fig. 7 and Fig. 8.

Figure 8. Photograph of typical OV-105 RH #4 conical seal pit (top) and mold of pit interior (bottom).

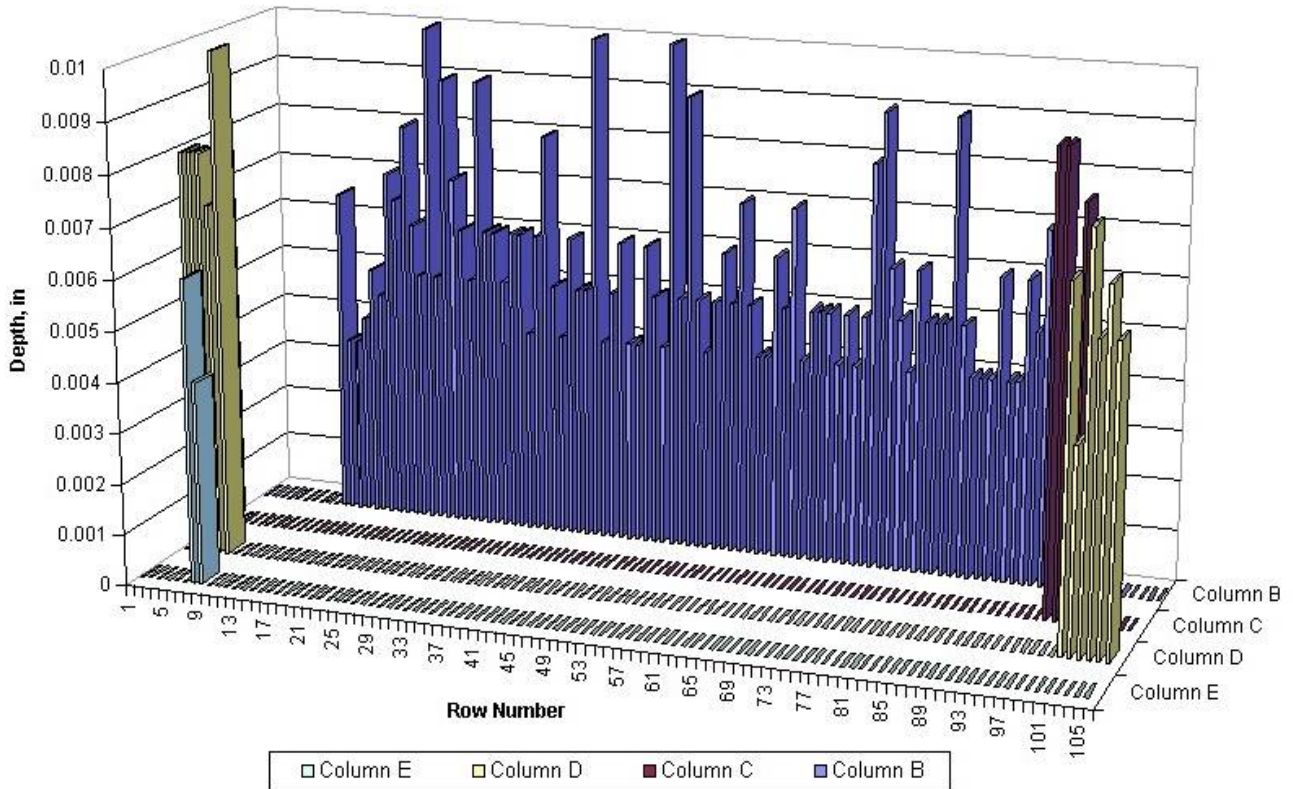
Figure 9. OV-105 RSB #4 conical seal pit depth by grid location.

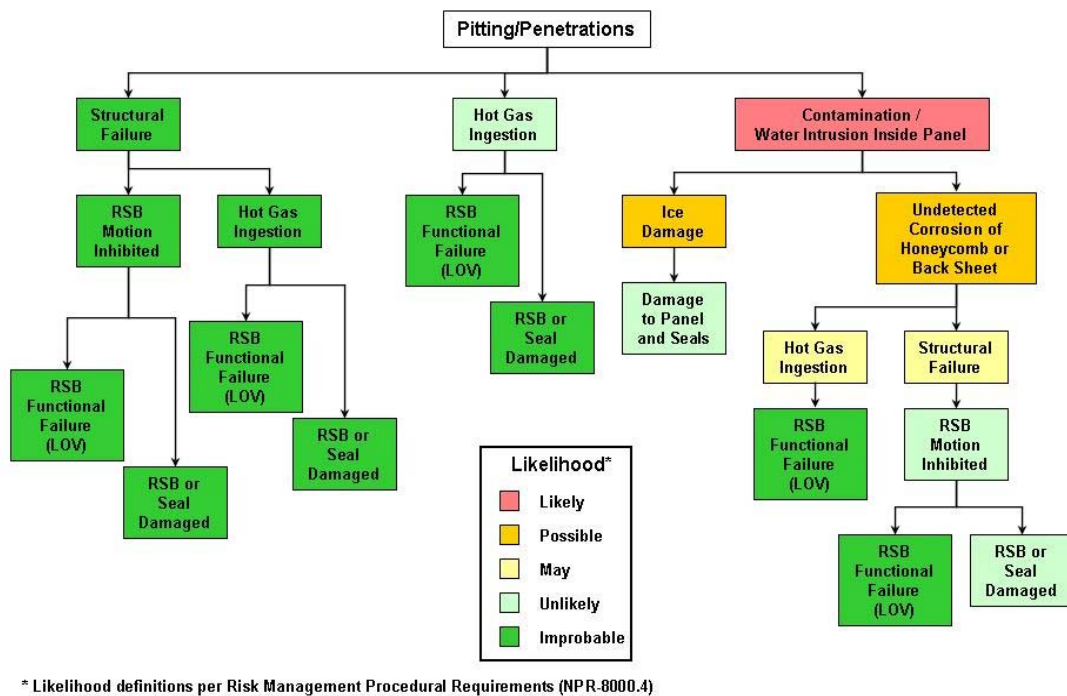
Figure 10. Simplified risk tree for OV-105 RSB RH #4 conical seal panel degradation.

The three top level primary risks considered were structural failure, ingestion of hot gasses, and contamination or water intrusion inside the honeycomb panel cells. The structural failure is applicable to new, “as is,” or repaired panel, and was addressed by structural analysis. Based on results from the analysis, structural failure is considered to be unlikely. The possibility of hot gas intrusion exists because the outboard face sheet has been penetrated in approximately 12 locations. Hot gas intrusion would occur only during reentry when vertical tail section temperatures are likely to reach 950°F. It is assumed that the inboard face sheet has not also been penetrated, although not verified except for X-rays. Thus it is unlikely that hot gas intrusion will occur through the panel due to the extent of pitting damage. Aero-thermo dynamic analyses would have to be completed to verify this assumption. It is likely that dust, water, sea spray, or other contaminants could, and may have already entered the honeycomb cells. Once contamination or water enters the cells, then a second tier of risks must be considered. Ice damage considered in this analysis is any damage resulting from the formation of ice within the cell prior to launch, and effects of the ice rapidly turning to steam during reentry in the event that the ice did not sublimate on orbit. The likelihood of this occurring is estimated somewhere between possible and may occur. The resulting damage is believed to be an unlikely flight risk, and would be observable by normal visual inspection during post flight checkout.

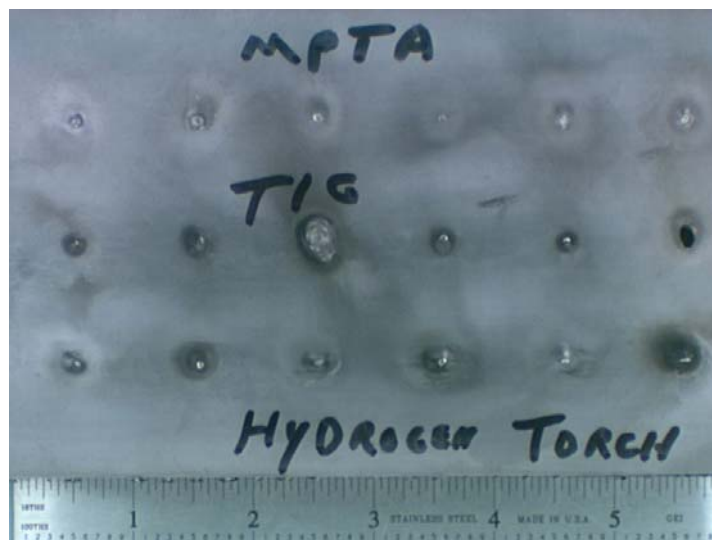
The project conducted both a welding/brazing test and a HVOF spray test and have noted preliminary results/observations. The welding test included 6 attempts at repair of through holes with gas tungsten arc welding (GTAW) – labeled as “TIG” in Fig. 12, micro plasma transfer arc (MPTA), and hydrogen torch techniques. The welds were executed by a qualified welder who has performed MPTA crack and pinhole repairs on the thin walled (0.008 inch) A286 coolant tubes of the Space Shuttle Main Engine (SSME) nozzle. The resulting welds are shown in Fig. 12. The project selected only MPTA welding/brazing for further consideration due to the level of technical maturity for similar Shuttle hardware and low heat input to the face sheet.

Figure 12. Conical seal welding test panel

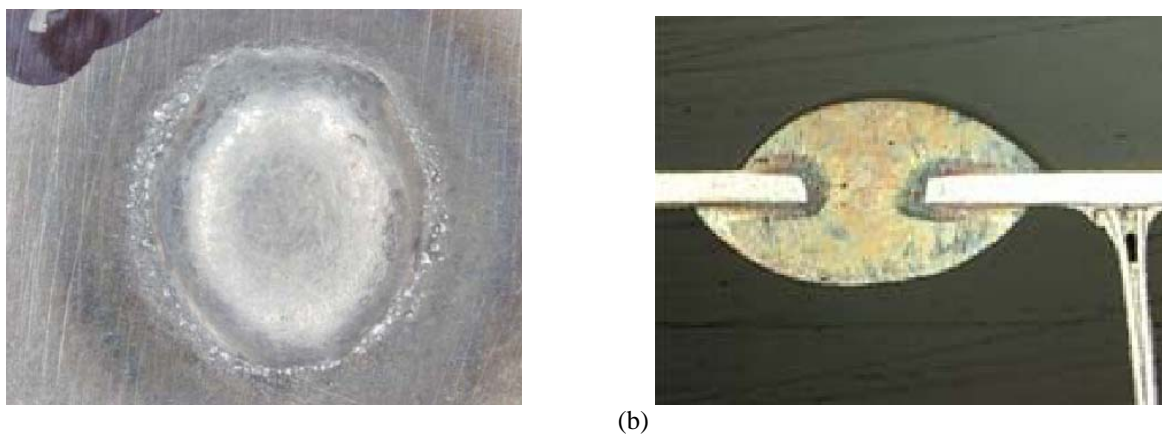
A more detailed metallographic analysis was also performed on all repair locations in the as-welded condition. Several internal defects were revealed by metallography that would have been found after grinding the deposits flush to the panel surface. Based on these results, it was decided to make additional samples that would be completed through flushing prior to metallography. Any defects visually detected after grinding would be repaired and the location re-ground. A sample containing 24 repairs was used to develop grinding and repair techniques. Grinding was accomplished using stone bits and a hand “mini-grinder”. A repair technique was developed and demonstrated on the sample. The procedure required grinding of a new through hole to remove the defect, followed by re-fill with the standard MPTA process.

Figure 17. (a) Typical MPTA repair using AMS 4777 braze alloy. (b) Micrograph of a typical cross section of MPTA braze repair.

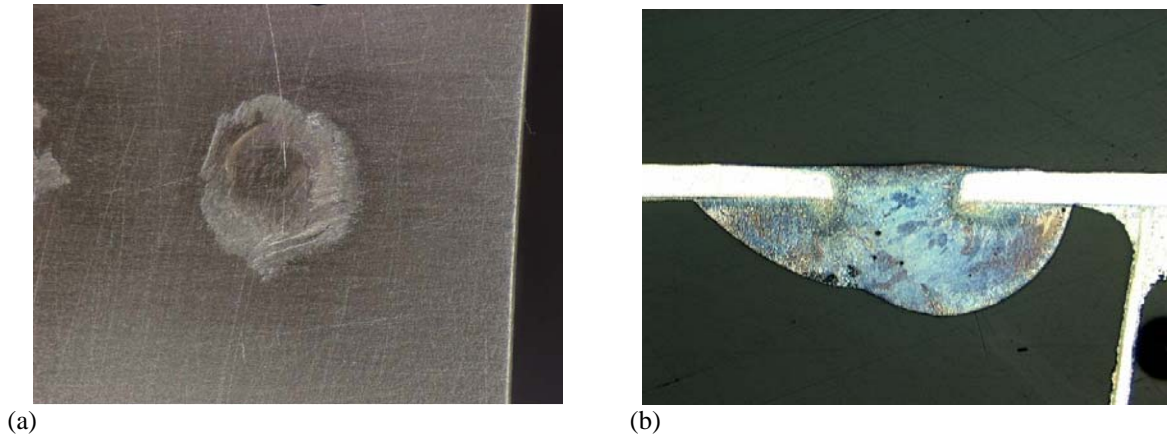
To verify the repair process on RH #4, a brazed honeycomb panel was used as a process control sample and was prepared in parallel by drilling a series of 0.040 inch diameter holes in the Inconel[®] 718 face sheet. Six locations were repaired using the same MPTA process and AMS 4777 alloy filler as RH #4. The completed welds were visually inspected with magnifications up to 30x. No cracking in the deposit or heat affected zones was noted. The six deposits were manually ground flush to the face sheet surface and were re-inspected at the same magnifications. Based on the visual inspection, all deposits appeared sound and free of rejectable defects. The six deposits were then sectioned, cold mounted, polished and etched for metallographic inspection. Figure 18 shows a typical deposit.

Figure 18. (a) Macrograph showing a typical repair location on the in-process weld sample. Repair has been manually flushed after welding. (b) Micrograph of typical cross section of a flushed repair.

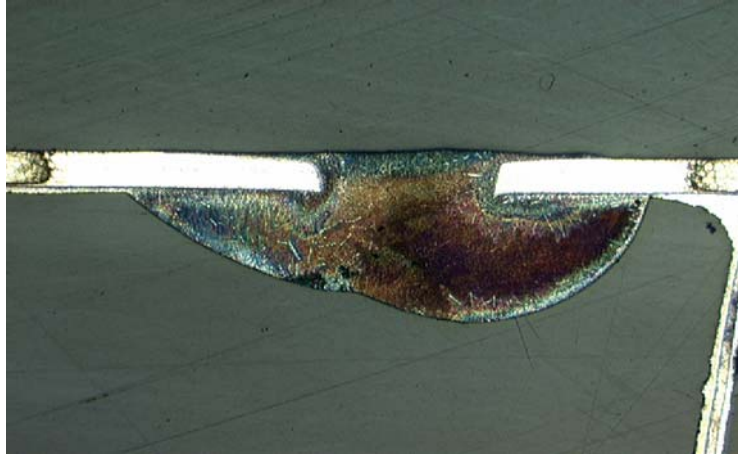
After metallographic examination each sample was re-etched with an electrolytic process using 10% oxalic acid, Fig 19. This procedure causes fully aged Inconel[®] 718 to stain while annealed areas remain shiny and unstained. The edge to edge distance observed on the etched samples was used to determine the diameter of the fusion and HAZ zones. The maximum allowable combined fusion and HAZ diameter is 0.187 inch, according to the repair work authorization. Figure 19 shows a repair cross section after oxalic acid etching.

Figure 19. Typical repair (same section as in Fig. 18b previously) after electrolytic etch with 10% oxalic acid. The area of Inconel® 718 face sheet not stained was annealed by the MPTA process. Such micrographs were used to measure the fusion zone and heat affected zone, which are required to be under a specified size.
