# Characteristics of Post-Sorbent and High Temperature Catalytic Oxidizer Beds After Long-Term On-Orbit Use

Sharon Johnson  
MEI Technologies, Inc.

David E. Williams  
National Aeronautics and Space Administration

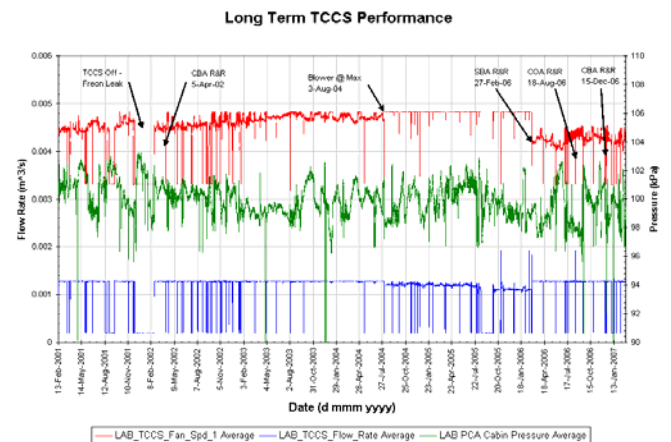
Figure 3: Long Term TCCS Performance

Analysis of on-orbit telemetry data showed a slow increase in flow resistance in the TCCS over approximately five years of operation (figure 3). From February 2001, until August 2004, the blower was able to compensate for the increased resistance. Eventually, the blower reached its maximum speed, and the flow rate through the catalytic oxidizer branch varied with changes in cabin pressure and Carbon Dioxide Removal Assembly (CDRA) operation. Examination of heater duty cycle, as shown in figure 4, shows that when the blower remained at 17.3 m<sup>3</sup>/hr (10.2 cfm), the duty cycle adjusted with the flow meter: when the flow through the flow meter decreased the duty cycle decreased, and when the flow throughout the flow meter increased the duty cycle increased. This indicates a functional flow meter, since a lower flow through the catalytic oxidizer flow branch would require less heating to maintain the catalyst bed temperature. In addition to analyzing telemetry data, ground testing and on-orbit troubleshooting was performed. Results from this

additional testing indicated that the increased resistance was due to one or more of the beds in the catalytic oxidizer flow branch.

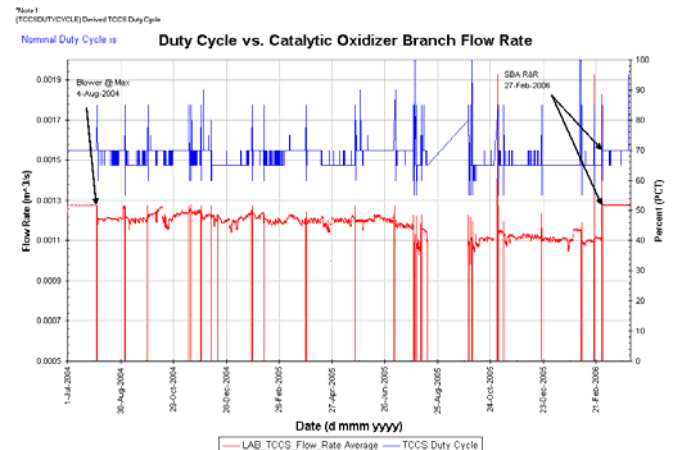
Figure 4: TCCS Duty Cycle

The regenerative heat exchanger in the COA maintains the catalyst temperature by cycling the heater at a specific duty cycle. Any changes in the flow through the COA will change the heater duty cycle. When the flow rate decreases, the heater duty cycle is reduced since less heating is required to maintain the catalyst bed temperature. Monitoring the heater duty cycle along with the flow rate through the flow meter ensures that the flow rate through the catalytic oxidizer flow branch is being maintained. It is also a check to see if the flow meter is functioning properly.
