Space Shuttle Program Tin Whisker Mitigation

Keith Nishimi - United Space Alliance, LLC

International Symposium on Tin Whiskers
University of Maryland - CALCE
April 24-25, 2007

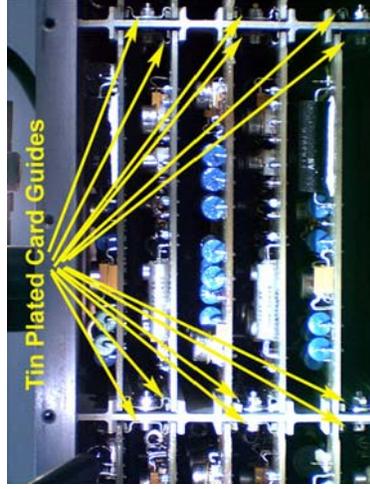
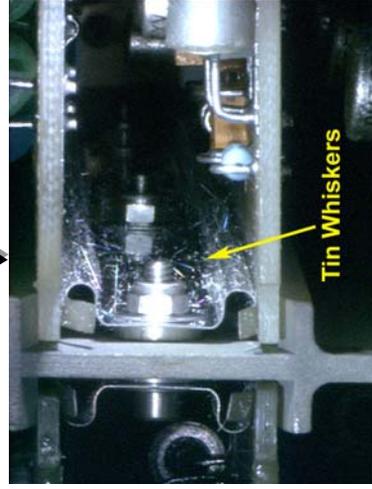
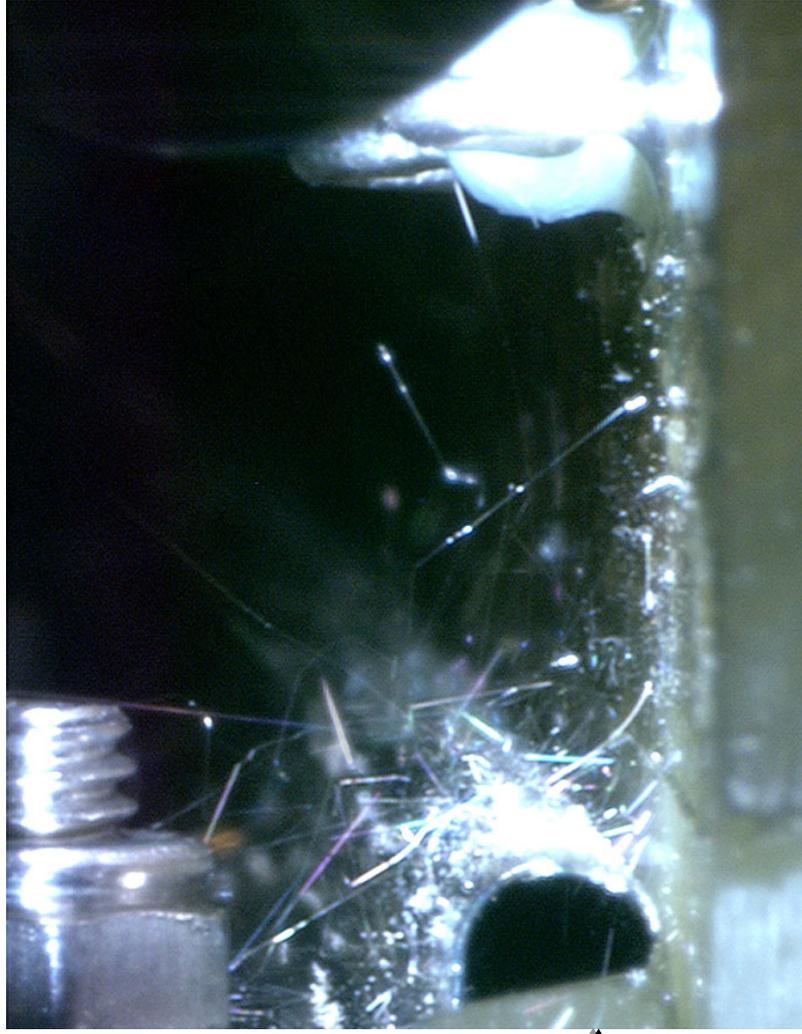
Internal Photos of TW Growth

- **Whiskers grew from pure tin plated circuit card retainers, not from electrical components**
 - Intent of tin plating in original design was for corrosion protection of BeCu retainers
- **Immediate Concerns:**
 - All FCS avionics boxes in the same family were similarly designed and could fail because of TW
 - Whiskers could either grow into conformal coating, or touch electrical components having inadequate coating
 - Active concern for July 2006 launch; particularly if no clean spares exist to rotate into vehicle
 - How can the Program ensure that other Space Shuttle hardware isn't at high risk for TW failures?

Box with cover removed illustrates progressively progressively finer detail
