The Dangers of Failure Masking in Fault-Tolerant Software: Aspects of a Recent In-Flight Upset Event

C. W. Johnson^{*}, C. M. Holloway[†]

Keywords: accident, software, fault-tolerance, maintenance

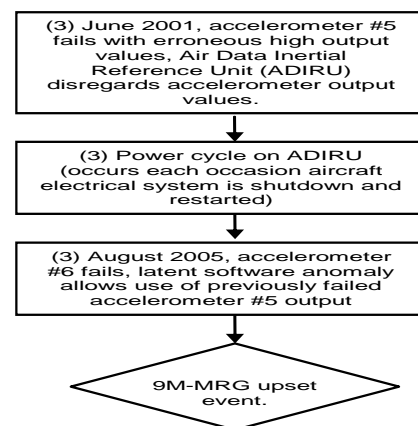
Figure 1: High-Level Overview of the Case Study Incident

Figure 1 illustrates the immediate events that contributed to the case study incident. The focus here is not on identifying a cause

for the accident but simply on establishing a more detailed timeline for the sketch that was presented in the introduction. The number that is used to label each box in the ECF diagram refers to the page on which that event is described in the Australian Transport Safety Bureau's official report [1]. This enables readers to use these diagrams to support the more detailed analyses of the textual documentation. The diamond indicates the eventual outcome of the events that lead to it.

As can be seen, the initial events may be traced back more than four years before the mishap. Accelerometer number 5 failed with erroneous high output values. The Air Data Inertial Reference Unit (ADIRU) software was programmed to disregard such output from the accelerometer and, instead, to rely on values from backup systems. The initial failure was, however, masked following a restart of the ADIRU. This created a vulnerability that was compounded by a latent software error – or bug. Following the failure of another accelerometer the ADIRU could revert to accepting input from the accelerometer that had initially failed and been excluded from its computations. This scenario contributed to the failure that is described in the opening sections of the paper.

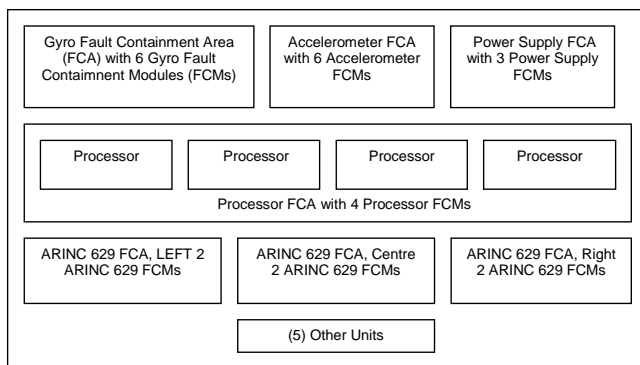
Figure 2: Air Data Inertial Reference Unit (ADIRU) Architecture (ATSB, 2007, p.5)

Figure 2 provides an overview of the architecture that supports the Air Data Inertial Reference Unit (ADIRU) on the B777. A core concept was to exploit redundancy as a means of achieving fault tolerance. The unit was divided into seven fault containment modules or areas. Each of these was physically and electrically isolated from the others. The intention was that the aircraft could have a fault in any of the modules and still remain serviceable. This feature would enable operators to continue flying until the number of fault-free modules fell below a minimum specified by the component manufacturer. This fault tolerance supported lower operating costs, for instance, by reducing the potential disruption to aircraft operations from unscheduled maintenance. In particular, the ADIRU used a fault containment module to analyze data from accelerometers and gyros before passing them through the ARINC 629 units to navigation and flight control systems.

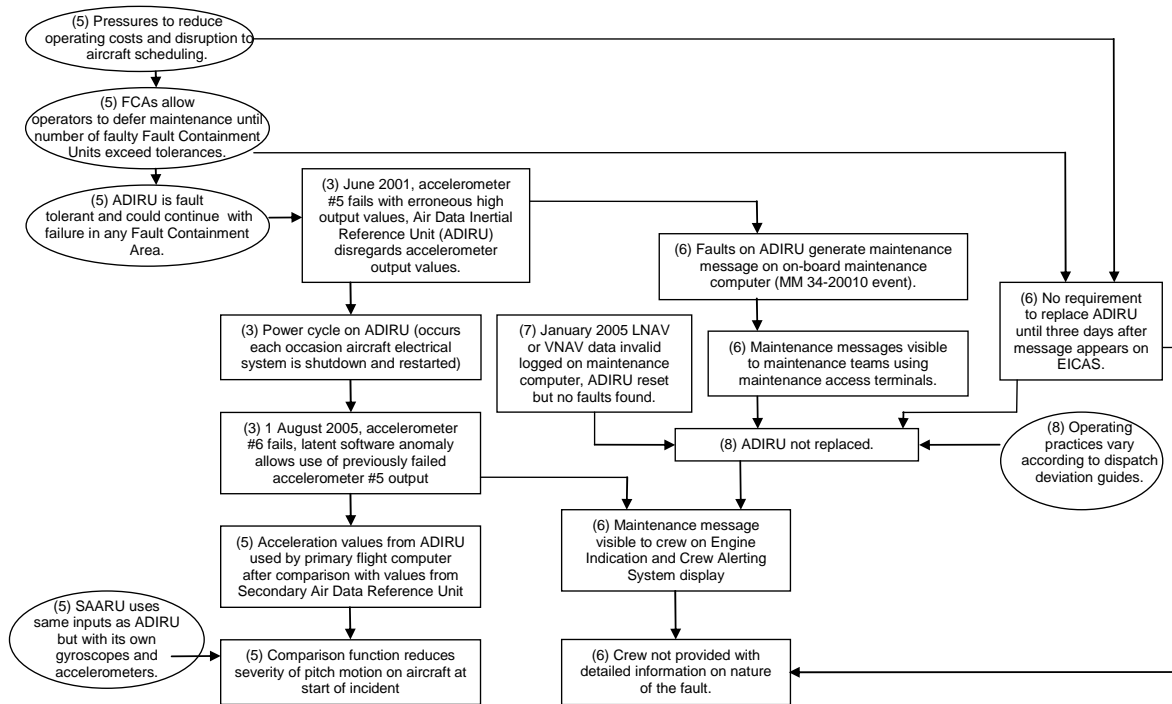
Figure 3: Maintenance Not Required to Replace Fault Tolerant ADIRU

Figure 3 builds on the previous analysis and illustrates how the architecture and design objectives for the ADIRU software contributed to the case study incident. As in Figure 1, the rectangles represent events leading to the mishap and page numbers in the ATSB report are indicated in parentheses. The ovals denote contributory factors. These provide a short-hand representation for many individual events that together create the preconditions for an incident. For example, many aspects of this mishap can be traced back to the initial aim of reducing operating costs and disruption to aircraft scheduling. This created a condition in which designers developed fault containment areas or modules that enabled operators to defer maintenance until the number of faulty Fault Containment Units exceeded specified tolerances.

The left-hand chain of events captures elements of the ECF diagram shown in Figure 1; including the initial failure of accelerometer number 5 in 2001 and the subsequent failure of number 6 in 2005 that triggered the mishap. As can be seen, however, Figure 3 significantly extends the analysis in the previous diagram. For example, it refers to the Secondary Attitude Air Data Reference Unit (SAARU). This extends the concepts of redundancy and of defence in depth by providing an alternate source of attitude, heading and air data to the ADIRU. A comparison was made between the output of the ADIRU and the SAARU during the mishap and this helped to mitigate the impact of the incorrect values from the ADIRU. This illustrates an important point in this paper – the aim is not to undermine the use of fault tolerance and redundancy but instead to demonstrate the particular dangers of software masking component failures both to operational crews and maintenance teams. In this case, it can be argued that the redundant SAARU provided sufficient control for the pilot to avert more serious consequences from the ADIRU faults.

The right side of Figure 3 looks more closely at maintenance issues in the case study incident. The initial failure of accelerometer number 5 in 2001 triggered a maintenance message on the on-board maintenance computer; this was known as an ADIRU MM 34-20010 event. Such messages could be read by maintenance teams using a ground-based terminal but were not directly visible to the crew. Some ADIRU events can, however, be displayed in-flight on the Engine Indication and Crew Alerting System (EICAS). If such an in-flight warning occurs, then the ADIRU must be replaced with a serviceable unit within three days. As can be seen in Figure 3, the crew did not receive such a warning following the 2001 accelerometer failure and so the ADIRU was not replaced. However, the ECF diagram also denotes that different operators implemented different practices and risk mitigation strategies following such MM events. The aircraft manufacturer noted that: “the ADIRU can be dispatched with MM 34-20010 present until such time that the operator deems it prudent to remove the ADIRU to avoid a schedule interruption due to occurrence of the ADIRU Status message. The decision to remove the ADIRU based on the presence of MM 34-20010 only is made by the operators on an economic basis, not a safety basis” [1, p.8].

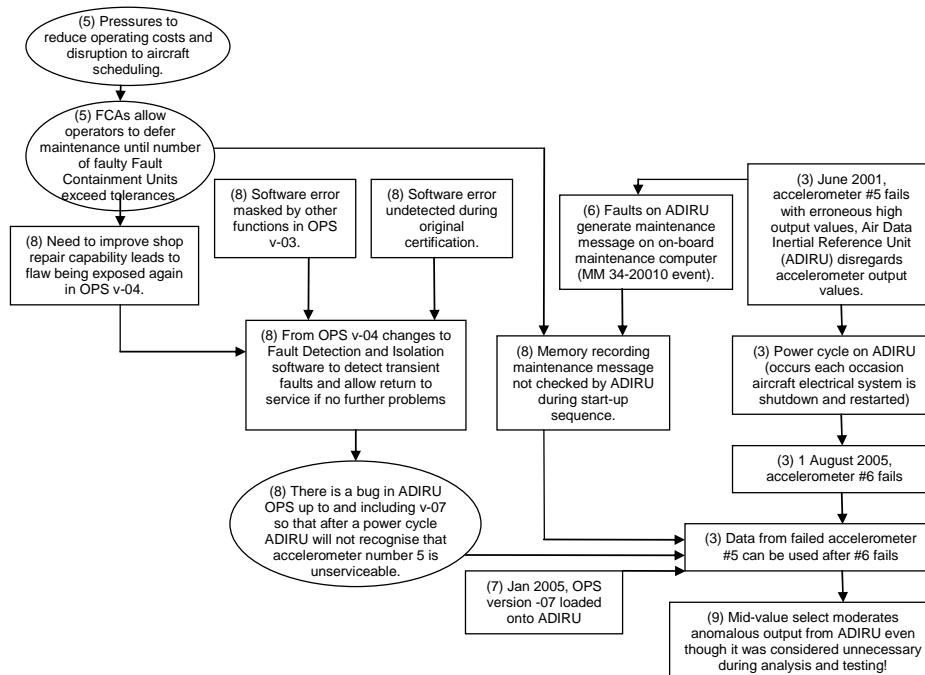
Figure 4: Software Propagates Failure and Mitigates Adverse Effects

Figure 4 focuses on the software issues that contributed to the in-flight mishap. As before, many of the particular events can be traced back to pressures to reduce operating costs and avoid disruption to aircraft scheduling. This created the Fault

Containment Area architecture that enabled maintenance to be deferred. It also led to software requirements for the ADIRU so that the system would check the status of critical components but allow the unit to continue operation if minimum criteria for the availability of FCAs were met. The implementation of this software requirement was flawed in early versions of the OPS –

software. However, up to version v-03 this problem was mitigated by additional checks in other areas of the application. A renewed requirement to improve shop repair capability led to the flaw being exposed again in OPS v-04. The OPS software up to and including v-07, therefore, contained a bug such that after a power cycle the ADIRU would not recognise that accelerometer number 5 was unserviceable.

Figure 4 also denotes how a maintenance message was generated following the 2001 fault on accelerometer number 5. However, the fault status was not checked by the ADIRU following a power up for the reasons presented previously. This

combination of events led to use of data from the failed accelerometer when a further fault was detected in 2005 with accelerometer number 6. Again, however, this incident reveals how the ‘defence in depth’ techniques of modern avionics helped to mitigate the potential consequences of this bug. The ADIRU software had been designed to pass on mid-range values if components provided data that varied between two implausible extremes. It is important to stress that designers may underestimate the value of the defences they create. The bottom event in Figure 4 records that this additional safety feature was considered to be superfluous during testing and analysis of the ADIRU.

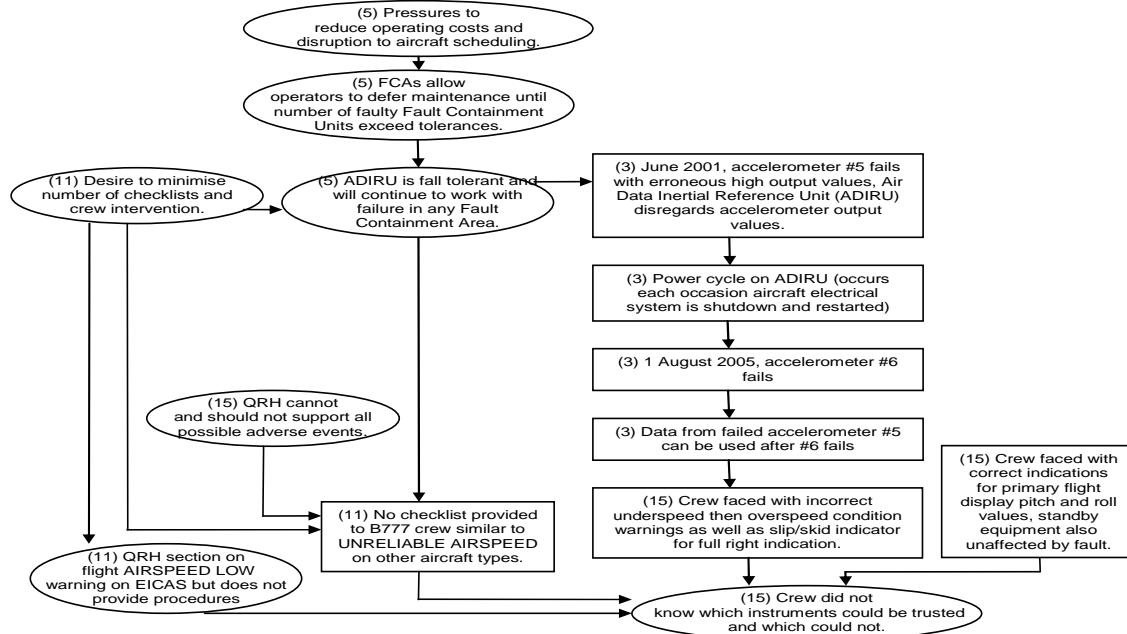
Figure 5: Fault-Masking Undermines Crew Interaction

Figure 5 illustrates how the impact of software bugs propagates beyond the embedded systems of modern avionics to affect crew interaction. The ECF diagram illustrates how the silent masking of redundant failures undermined the ability of human operators to diagnose and respond to the problems that confronted them. Page 15 of the ATSB report describes how the crew was faced with incorrect underspeed warnings, followed by overspeed warnings, as well as a full right slip/skid indication following the failure of accelerometer number 6. At the same time, correct indications were presented for the pitch and roll values on the primary flight display. Standby equipment was also unaffected by the fault. The crew were, therefore, unsure which of the instruments to trust. Their uncertainty was exacerbated by design decisions that stemmed from the underlying philosophy of masking redundant failures during continued operations, mentioned in previous sections. Figure 5 records that previous aircraft types had provided checklists for UNRELIABLE AIRSPEED in the crews’ Quick Reference Handbooks (QRH). However, the redundancy implemented by the B777 software systems implied that the crew should never be faced with such an indication. The system was designed to ensure that unreliable input from key components should automatically

trigger a transition to redundant systems without any intervention from the crew. It was reasonable, therefore, to argue that this section should be dropped from the QRH. Crews often complain when documentation is unnecessarily verbose or difficult to navigate. It was possible for multiple failures to trigger a NAV AIR DATA SYS message on the EICAS. The QRH then referred the crew to an unreliable airspeed table. However, this particular warning was not triggered during the case study incident. The key point here is that the problems facing the crew were exacerbated by the decision to mask information that designers did not consider would be needed by the crew. However, the circumstances of this mishap reiterate the importance of providing some degree of visibility to the crew when it is difficult or impossible to guarantee the resilience of fault tolerant systems [6].

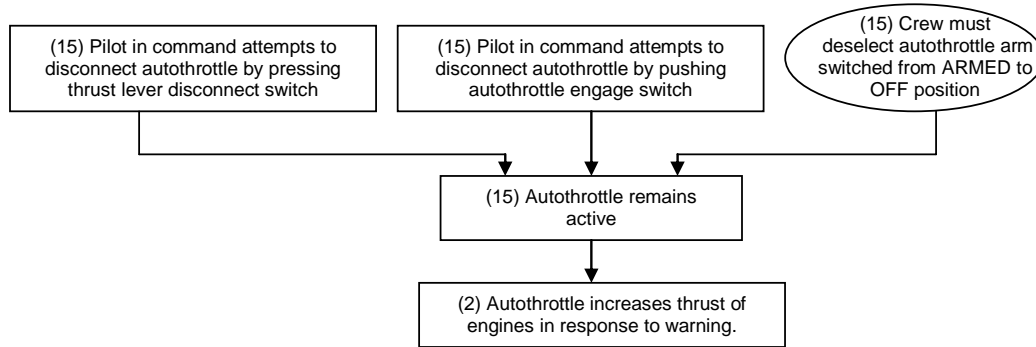
Figure 6: Auto Throttle Uncertainty Further Undermines Situation Awareness

Figure 6 continues the analysis of crew interaction in the aftermath of the 2005 auto throttle failure. As mentioned, the pilot was faced with a situation that designers had not considered to be possible. The auto throttle system remained active and the underspeed/overspeed warnings suggested that the malfunction may have been related to these functions. In consequence, the pilot attempted to disconnect the autothrottle by pressing the thrust lever disconnect switch and pushing the autothrottle

engage switch to toggle it off. However, these attempts were ineffective because the crew failed to switch the autothrottle arm switch from ARMED to OFF. In consequence, the autothrottle continued to increase thrust in response to the low-speed data that was erroneously being supplied from the ADIRU and the fault accelerometer. The interaction difficulties faced by the aircrew when attempting to disarm the autothrottle are typical of the ways in which the stress imposed on a human operator by an initial failure can trigger further mistakes. These errors serve to

compound the problems created by an initial mishap. Figure 6 illustrates how the crew now not only had to understand the reasons for the erroneous and inconsistent readings from their instrumentation, they now had to find an explanation for their failure to disarm the auto throttle. Without additional support from documentation, such as the QRH, it can be difficult for any crew to avoid a gradual loss of situational awareness through apparent interactions between such compound failures.

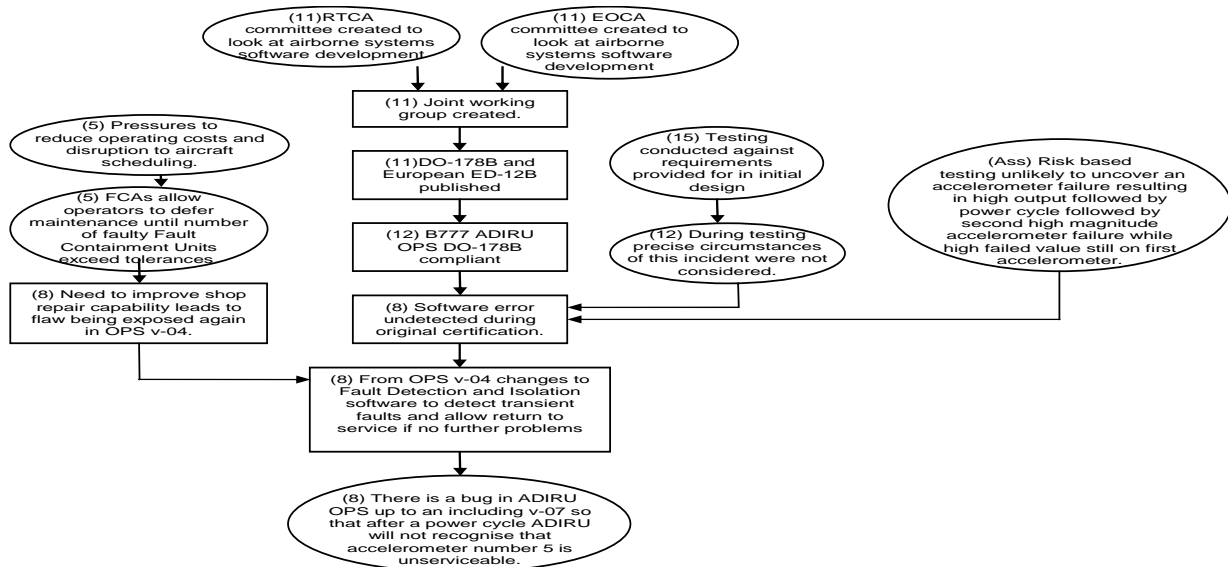
Figure 7: Process-Based Certification and the Selection of Test Cases

Figure 7 illustrates some of the certification-related issues that were raised by the case study incident. It notes that DO-178B [7] and the European ED-12B equivalent were derived from joint working groups within the RTCA and the predecessor of the European Organisation for Civil Aviation Equipment. It also shows that the ADIRU OPS software was DO-178B compliant. Even so, testing failed to consider the precise circumstances of the failure that was revealed in this incident. The diagram also records an assumption that risk-based testing was unlikely to uncover an accelerometer failure resulting in high output, followed by power cycle, followed by a second high magnitude

accelerometer failure while the high failed value was still on first accelerometer. Although the consequences of such a scenario were potentially severe, such a contingency might arguably have been considered too unlikely to be considered in detail during system testing. It is, however, difficult for the ATSB and other investigatory organisations to confirm such analyses without access to detailed design process information that is likely to be commercially sensitive.
