THE POTENTIAL FOR IMAGING IN SITU DAMAGE IN INFLATABLE SPACE STRUCTURES

Eric I. Madaras¹, Robert F. Anastasi², Jeffrey P. Seebo³, George Studor⁴, Douglas L. McMakin⁵, Robert Nellums⁶, and William P. Winfree¹

34th Annual Review of Progress in Quantitative NDE,
July 22-27, 2007
Golden, Colorado

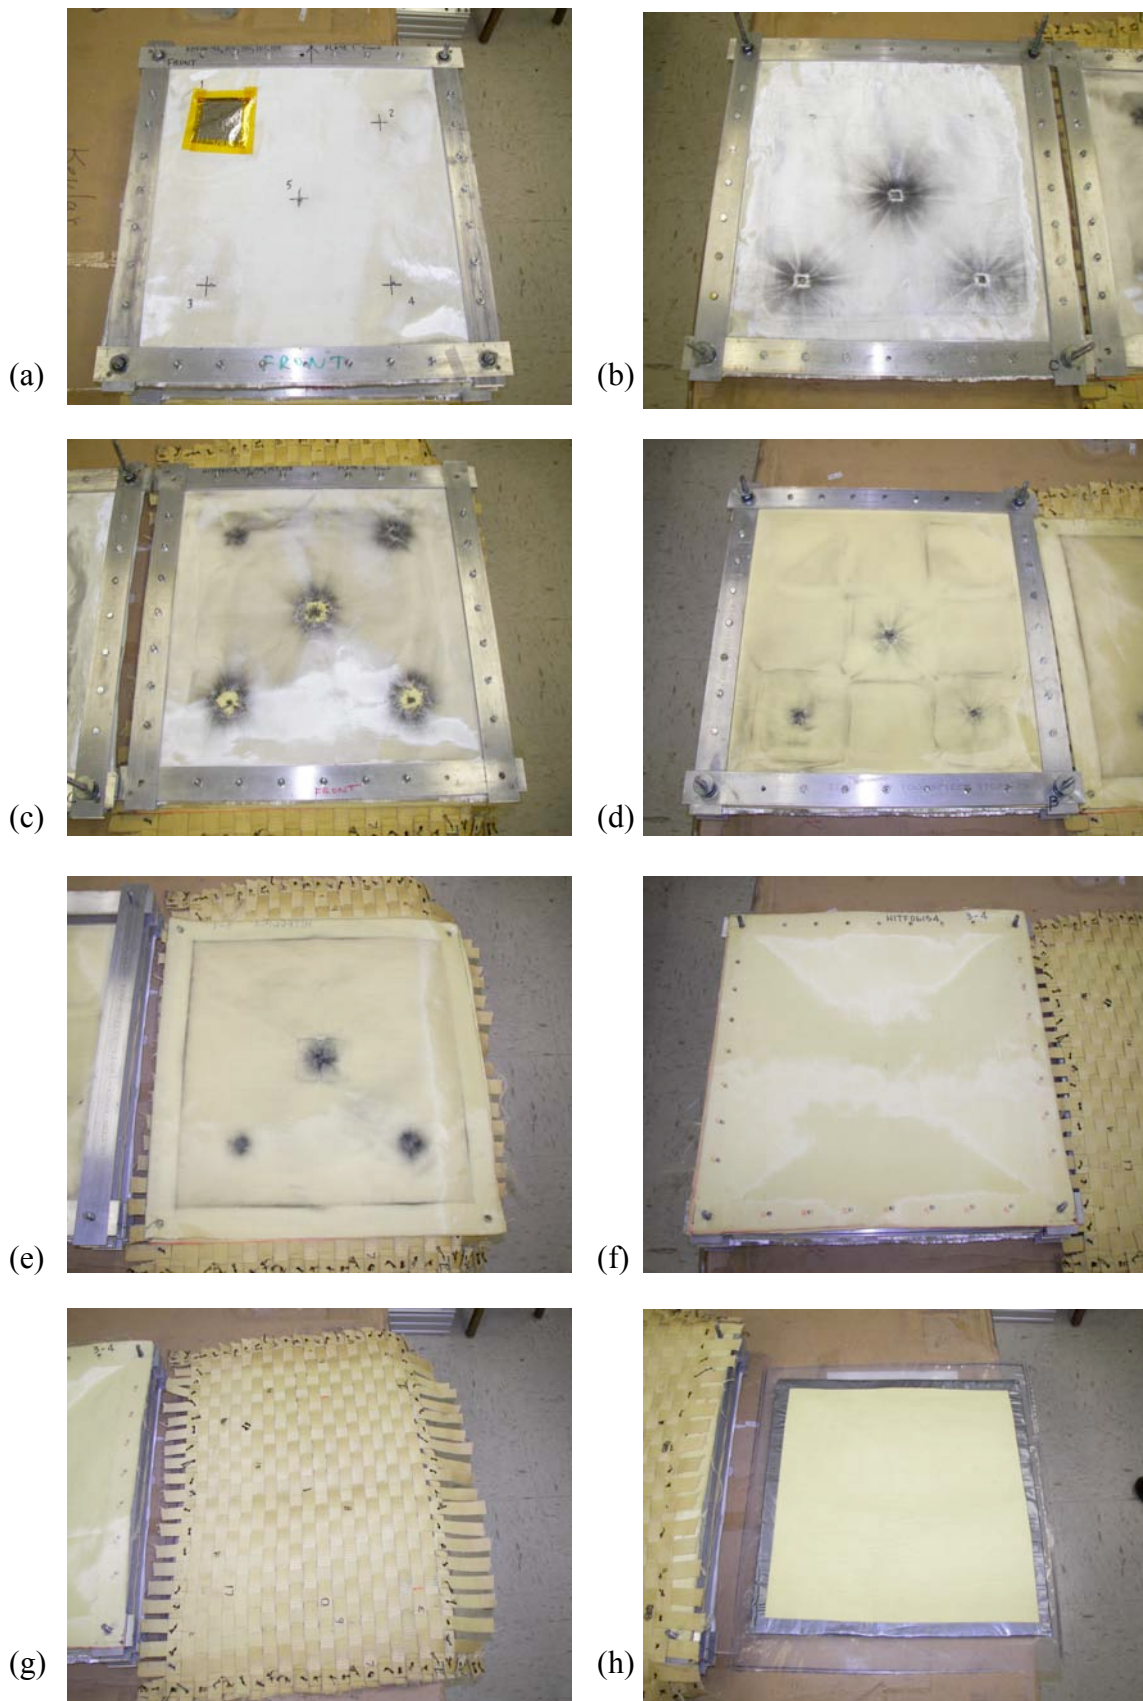
Figure 4 shows a series of photographs that document the hypervelocity impact damage. All of the impacts were predicted to penetrate no further than the third MMOD shield layer. The five impact locations are visible in Figure 4a on the outer layer as small perforations. Fig. 4b shows the obverse side where the damage is highlighted by a spray of debris on the larger three impacts. Fig. 4c is the impact side of the middle MMOD shield. The debris spray from the impacts again highlights the five impact sites. Fig. 4d shows the obverse side of the middle MMOD shield. The two impact sites at the top of the target did not penetrate through the second layer, while the other three sites show damage. Fig. 4e

shows the inner layer where three impacts penetrated. Fig. 4f shows the inner layer's obverse side where no impact damage is readily visible. In fact, there is a region in the center where there is a small amount of damage to the fabric. Fig. 4g shows the Kevlar restraint layer. There was no impact damage to the restraint layer. Fig. 4h shows the combined interior surface layers.

Figure 4. The various layers of the test article. (a) and (b): Front and back of the outer MMOD shield. (c) and (d): Front and back of the middle MMOD layer. (e) and (f): Front and back of the inner MMOD layer. (g) The Kevlar restraint layer. (h) The interior layers.

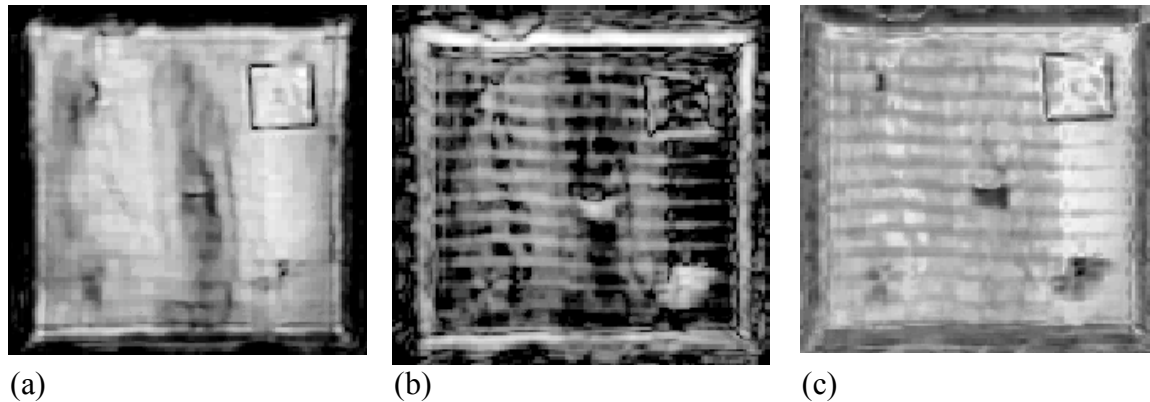
Fig. 6. 10-20 GHz Microwave images of the outer MMOD shield layer. (a) Image represents a R-L polarized image. (b) Image represents a R-R polarized image. (c) Image represents the difference image between (a) and (b).

represents microwaves that are directly reflected from the target. Fig. 6b is an image made with R-R polarized microwaves on transmit and received, which represents indirect or multiple reflections. Fig 6c is a difference image made from Fig. 6a and 6b. The five impact damaged regions at the back layer are visible. The difference image helped to remove some of the artifacts caused by the unevenness of the layers. All the images show some effects from the overlying layers, including the Kevlar restraint layer.

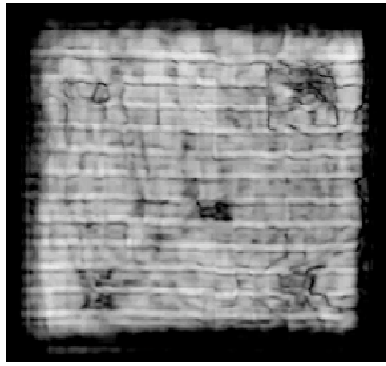
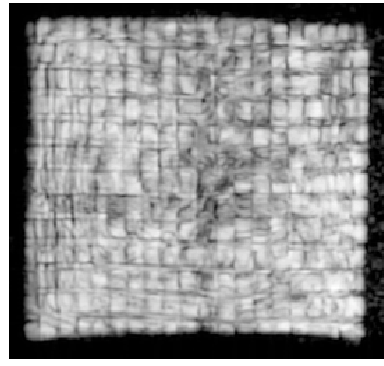
Two regions of the habitat module that are of the more concern are the interior layers of the Kevlar restraint layer and the bladder layers. The integrity of the structure depends on the Kevlar restraint layer. This layer is under a significant level of stress at atmospheric pressure. Significant damage to this layer, which is not visible from the interior, could lead to rupture of the wall. In addition, the integrity of the bladder layers is important, as even a small breach in those layers will allow the loss of air from the module. The terahertz imaging system at NASA Langley Research Center, which operates in the 100 GHz to 2 THz frequency range, was used to scan these layers. For these scans, the layers were placed under a plastic sheet and the air was evacuated to produce an atmosphere pressure difference against the wall to simulate the wall being under pressure and compression. Fig. 8a shows a photograph of the scan setup with the wall being compressed. Fig. 8b shows an image of the scanned region. In the scan image of Fig. 8b the warp and welt weaving of the Kevlar are well resolved. It is evident that there is a transition in the Kevlar layer on the

Fig. 7. 40-60 GHz millimeter wave images of the target layers. (a) Image represents an H-H linearly polarized image of the outer MMOD shield. (b) Image represents an H-H polarized image of the interior MMOD shield with the Kevlar restraint layer.

right side of the image. This transition results from the use of thinner Kevlar belts (0.035" thick vs. 0.090" thick).

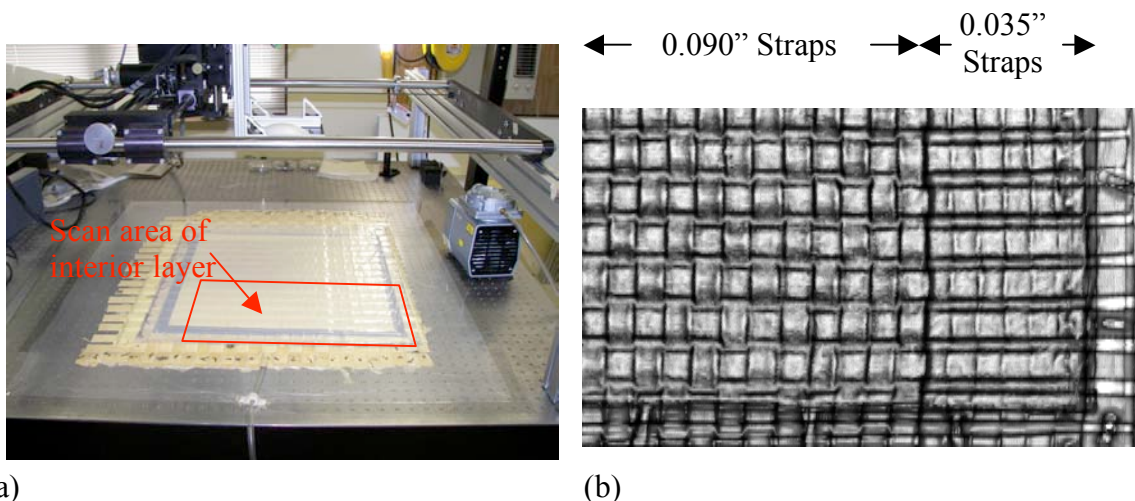
Figure 8. (a) Photograph of the terahertz scanning system at NASA Langley Research Center with the Kevlar restraint layer and the interior wall layers in place for scanning. (b) A terahertz scan of the interior layers.

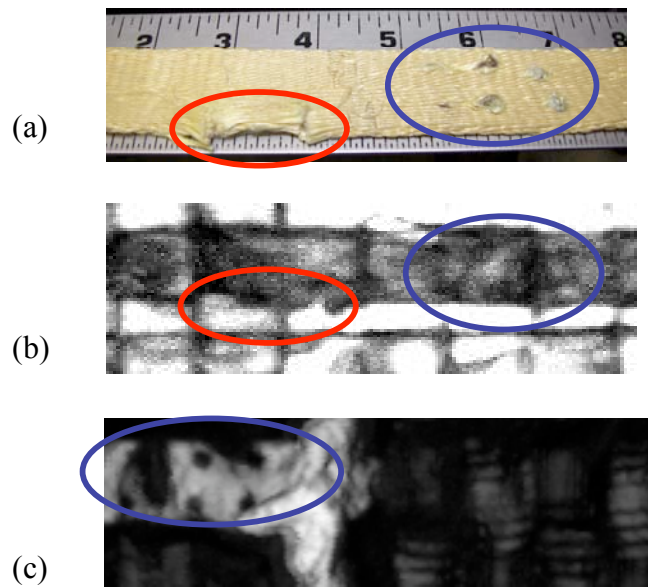
To investigate the capability of the system to detect damage in the Kevlar belts, one of the warp belts was extracted and another belt with holes and cuts was reinstalled. Fig. 9a shows a photograph of the damaged belt. Fig. 9b shows the results of scanning that belt within the restraint layer. The cuts on the edge are evident in the image as marks on the side of the belt in the image. The holes did not produce large contrast, but they were detectable as dark spots in the image. Fig. 9c shows an image where plastic material similar to the bladder material was inserted in between the front layers. This layer had numerous holes punched through the plastic. The holes in this material are easily detected in the image.

Figure 9. (a) A photograph of a Kevlar belt with induced damage (circled). (b) Scan image of the belt after it was reinserted into the restraint layer showing the damaged regions (circled). (c) Scan image of damaged bladder material inserted into the front layer (circled).

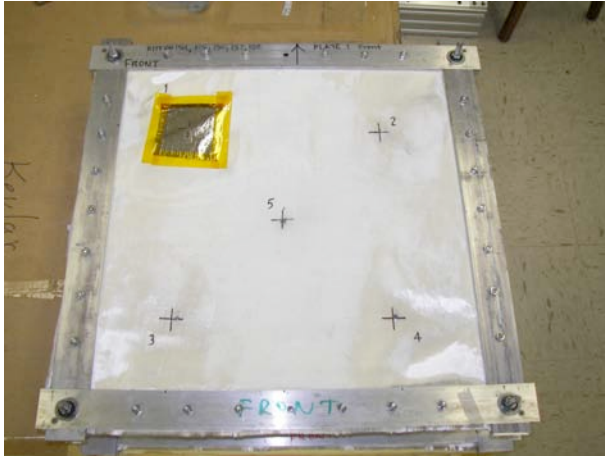
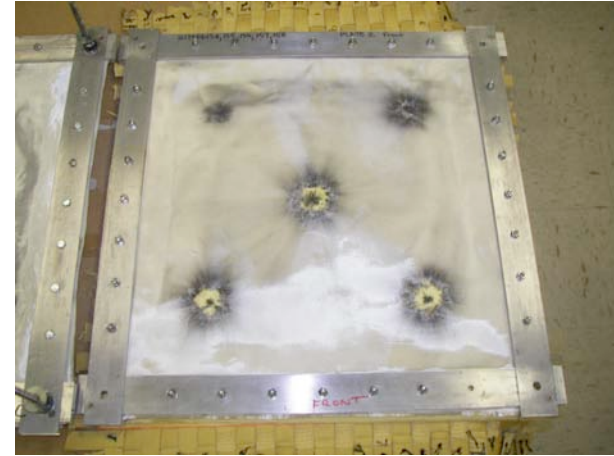
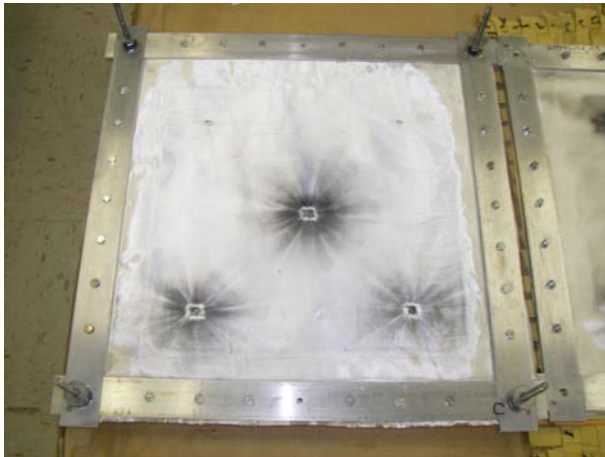
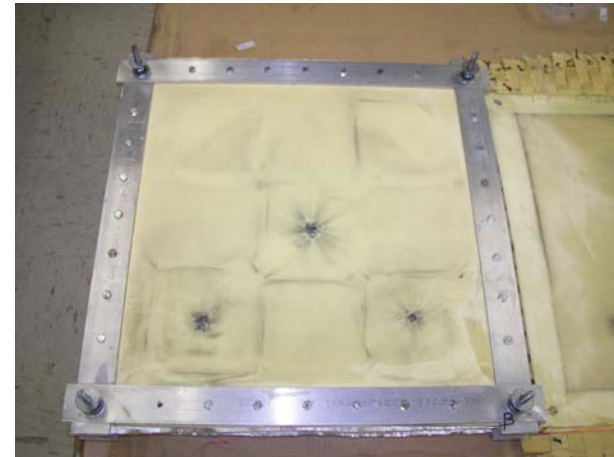
Exterior layers
Top Image: Outside
Bottom Image: Obverse

Middle layers
Top: Outside
Bottom: Obverse

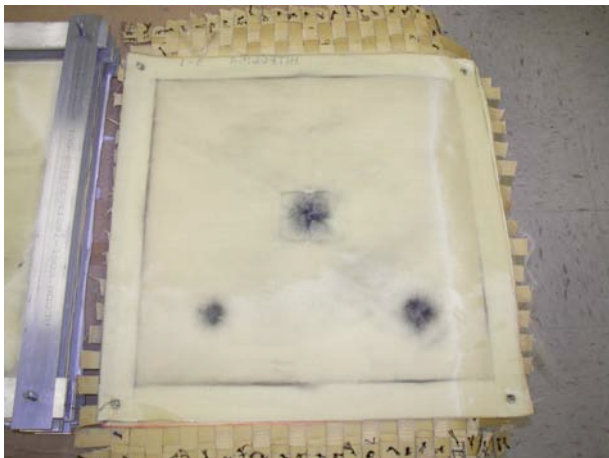
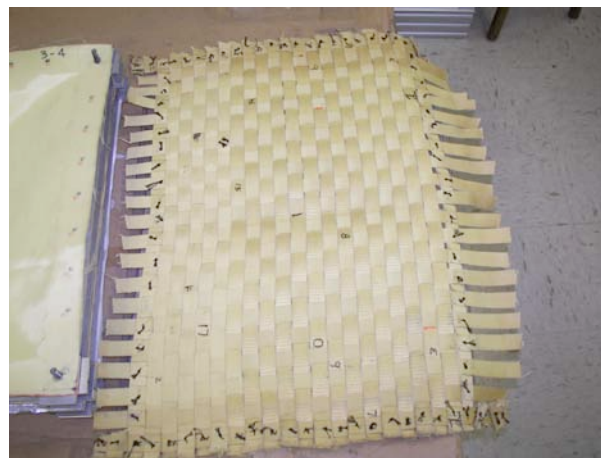
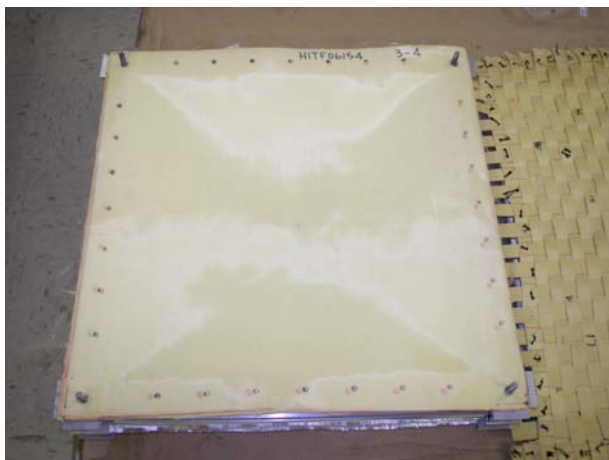
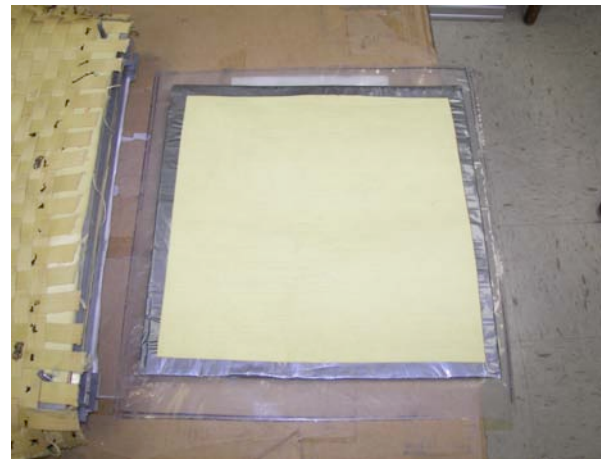
Interior layers (w/MMOD damage)
Top: Backside of wall
Bottom: Inside of shield fabrics

Interior layers (No MMOD damage)
Top: Structural Kevlar webbing
Bottom: Inside of wall

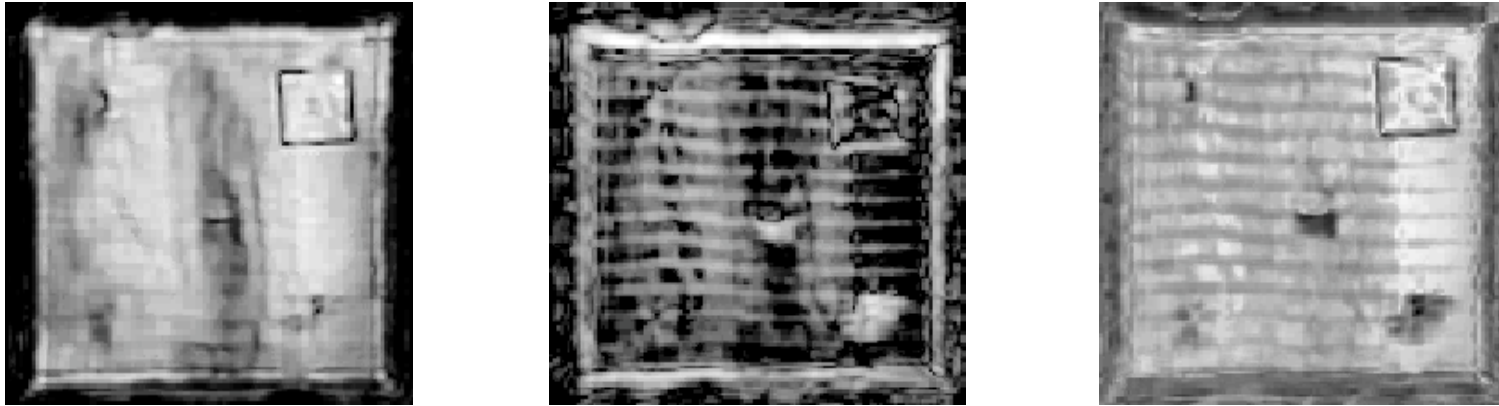
10-20 GHz Images of Exterior Damage

- 10-20 GHz images of damaged region of test target, nearest the outside layer of MLI and copper screen.
- The image at left is R-L polarization associated with direct return.
- The image at center is R-R polarization associated with multiple scattering. The image at right is difference.

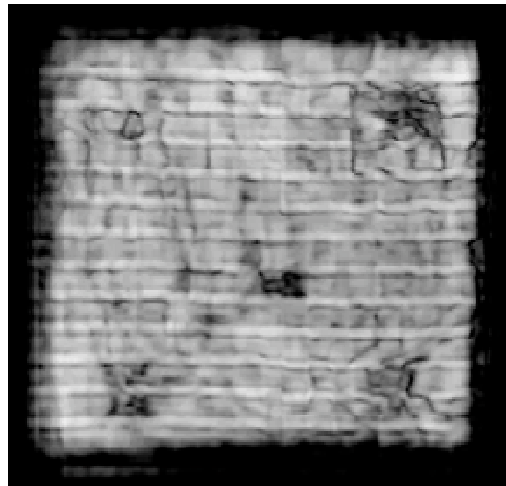
Back Wall Image

- H-H polarized images of test target.
- At left is return from reflecting aluminum and MLI at rear of target.
(With a reflecting aluminum layer at the back wall, the image creates a shadow pattern detailing the MMOD incursions even though the imaging system is set up in a reflective mode.)
- At right is direct return from Kevlar web layer.
