# STS-118 Radiator Impact Damage

D. LEAR, J. HYDE, E. CHRISTIANSEN, J. HERRIN, F. LYONS

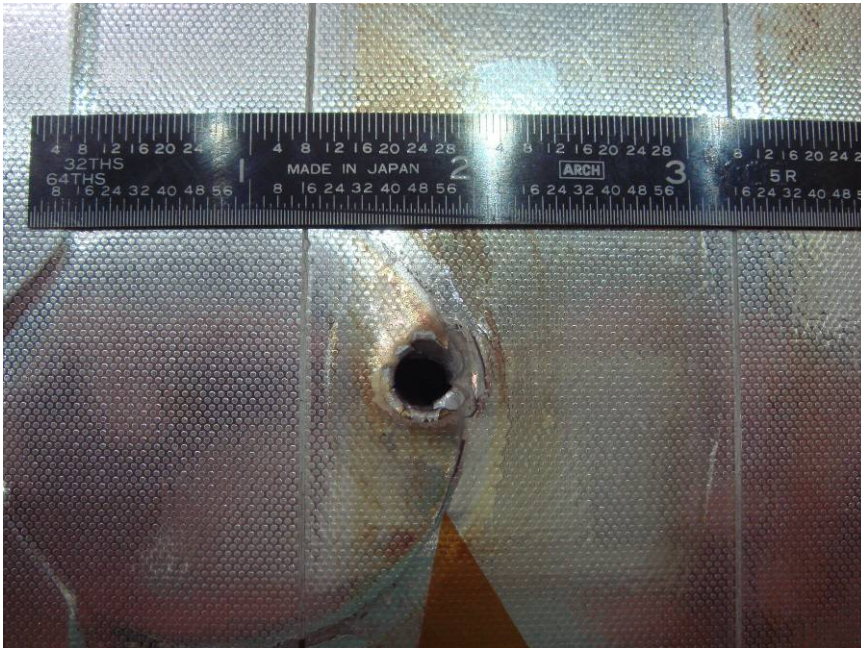
A close-up photograph of the radiator impact entry hole is shown in Figure 1, and the location of the impact on Endeavour's left-side aft-most radiator panel is shown in Figure 2. The aft radiator panel is 0.5-inches thick and consists of 0.011 inch thick aluminum facesheets on the front and back of an aluminum honeycomb core. The front facesheet is additionally covered by a 0.005 inch thick layer of silver-Teflon thermal tape. The entry hole in the silver-Teflon tape measured 8.1 mm by 6.4 mm (0.32 inches by 0.25 inches). The entry hole in the outer facesheet measured 7.4 mm by 5.3 mm (0.29 inches by 0.21 inches) (0.23 inches). The impactor also perforated an existing 0.012 inch doubler that had been bonded over the facesheet to repair previous impact damage (an example that lightning can strike the same place twice, even for MMOD impact). The peeled-back edge around the entry hole, or "lip", is a characteristic of many hypervelocity impacts. High velocity impact with the front facesheet fragmented the impacting particle and caused it to spread out into a "debris cloud." The debris cloud caused considerable damage to the internal honeycomb core with 23 honeycomb cells over a region of 28 mm by 26 mm (1.1 inches by 1.0 inches) having either been completely destroyed or partially damaged. Figure 3 is a view of the exit hole in the rear facesheet, and partially shows the extent of the honeycomb core damage and clearly shows the jagged "petaled" exit hole through the backside facesheet. The rear facesheet exit hole damage including cracks in the facesheet measures 14 mm by 14 mm (0.55 inches by 0.55 inches). The remnants of the impacting particle and radiator panel material blown through the rear facesheet hole also created two penetrations in the TCS blanket 115 mm (4.5 inches) behind the rear facesheet. Figure 4 shows these two impacts, which are located 75 mm (3 inches) apart. Some deposits of material were found on the payload bay door beneath the TCS blanket, but no additional damage occurred to the door.

**Figure 1:** Entry-hole damage (5.5mm diameter hole) to Endeavour's left-side aft-most radiator panel observed during post-flight inspection.

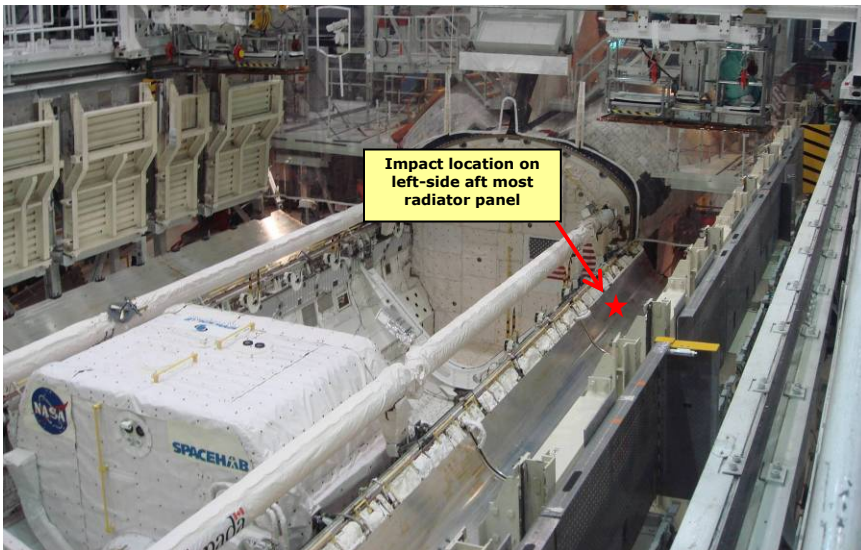
**Figure 2:** Impact damage location on Endeavour's left-side radiator panel # 4 (LH4)

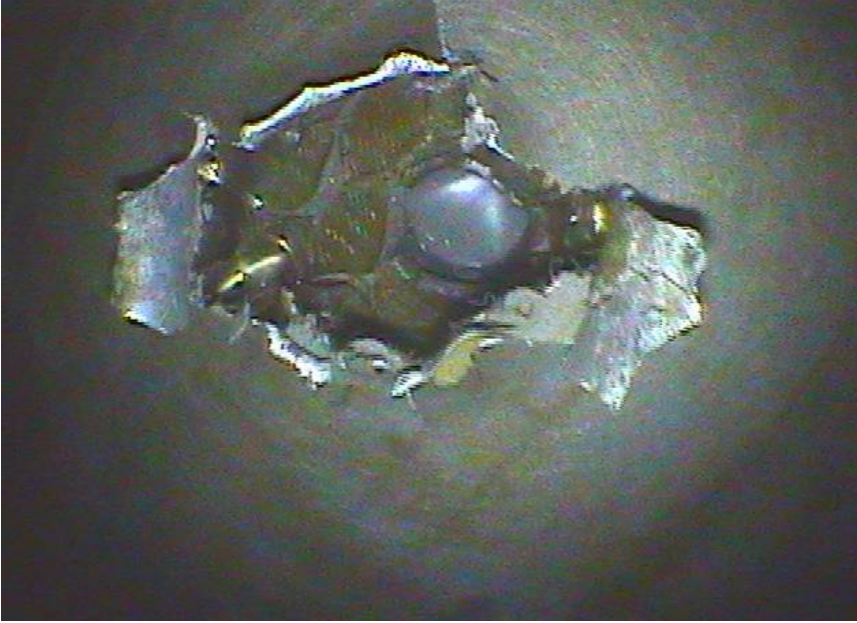
**Figure 3:** 12mm by 19mm hole in the rear facesheet of the radiator panel

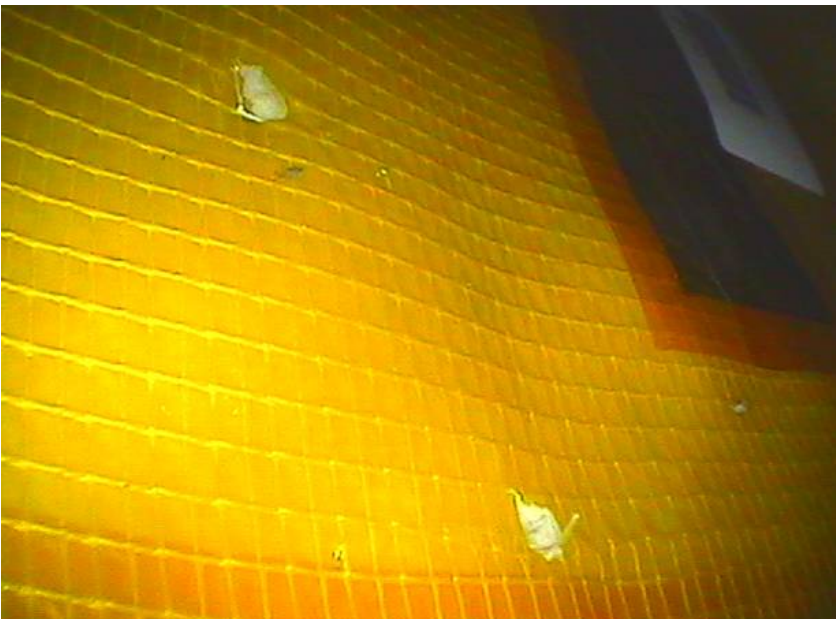
**Figure 4:** Damage to thermal control system blanket (two impact locations)

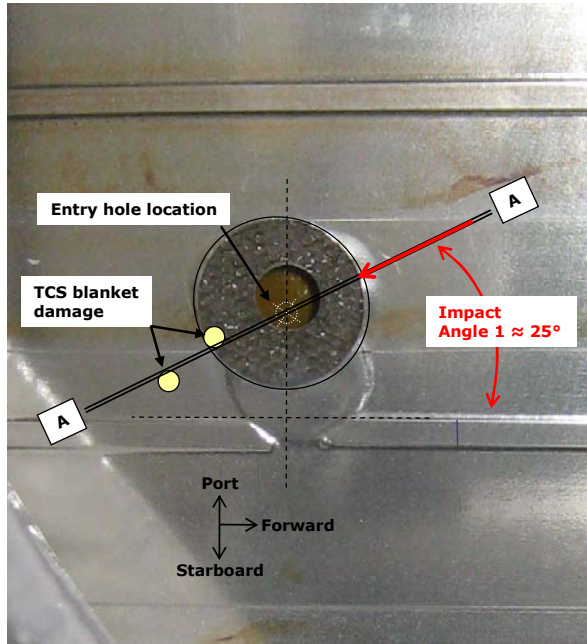
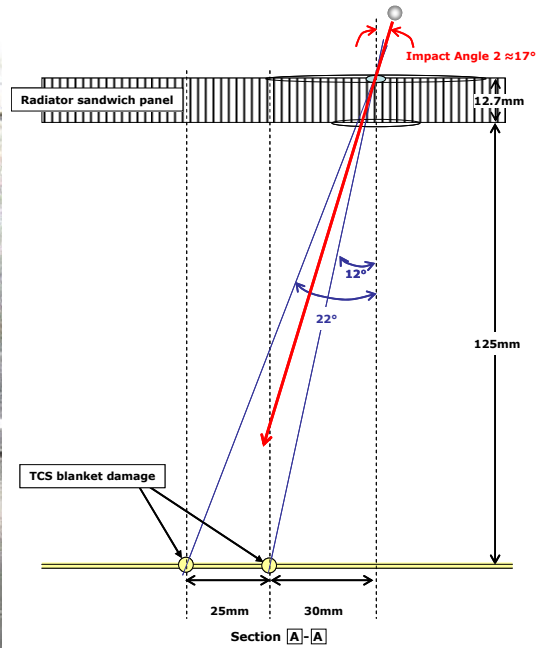
Figure 5 illustrates the relationship of the facesheet entry hole to the TCS blanket damage, which may indicate the direction of the impacting particle. The image on the left side of Figure 5 shows an overhead view of the damaged radiator after the facesheet holes were cored out of the panel. The entry hole location and the two underlying TCS blanket damage sites are annotated on the image. Section A-A, running through the entry hole and TCS blanket damage locations, describes a 25° angle from the longitudinal axis of the shuttle. The 2<sup>nd</sup> impact angle can be seen in section A-A on the right side of Figure 5. An average 17° angle of impact to the surface normal was derived by measuring the angles of the two damage sites in TCS blanket to the entry hole.

Figure 5: Estimated orientation of MMOD impactor
