Moisture-Induced Delamination Video of an Oxidized Thermal Barrier Coating

James L. Smialek, Dongming Zhu, and Michael D. Cuy
National Aeronautics and Space Administration
Glenn Research Center
Cleveland, Ohio 44135

Abstract

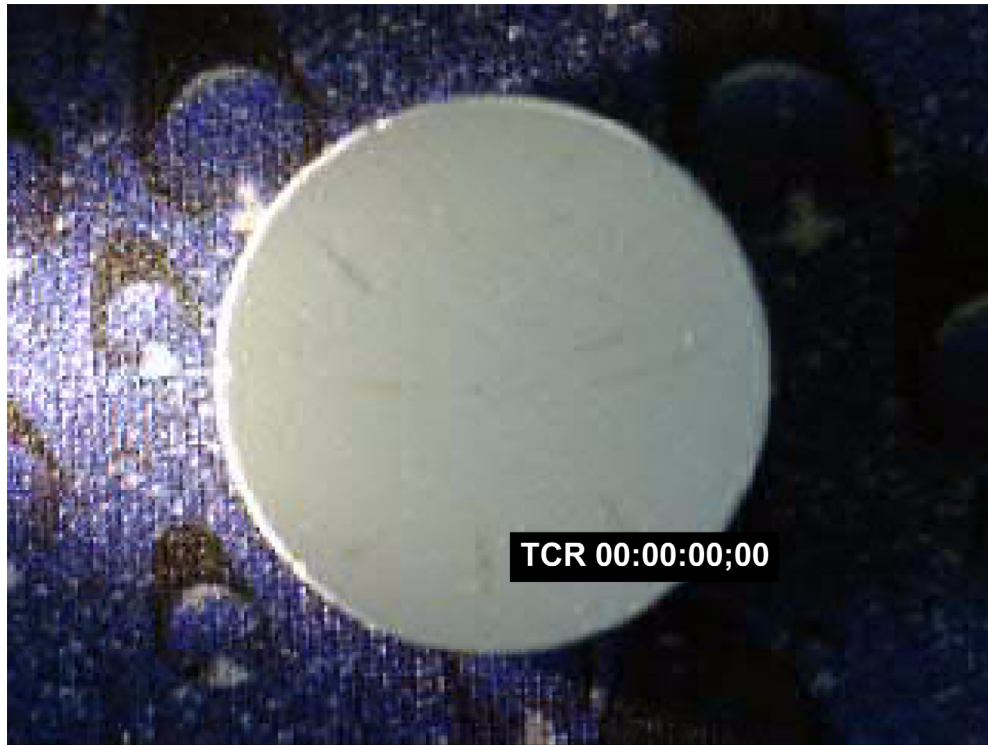
The TBC was seen to be intact after 100 hr, with essentially no distinguishing features, despite additional handling for photography. Similarly, figure 2 shows an intact TBC of the same sample (210 μm of EB-PVD (Y-Gd-Yb)₂O₃ stabilized ZrO₂, Ni(Pt)Al bond coat on Rene'N5), after cooldown from 300 1-hr furnace oxidation cycles at 1150 °C. A video clip (30 sec) showing real-time failure of this sample due to moisture can be viewed by clicking on figure 2 in the online version of this report which can be found at <http://gltrs.grc.nasa.gov>. Two water drops were applied from a water bottle, showing a large meniscus for the first 3 sec. After about 6 sec, a north-south edge crack begins at the 12 o'clock position, then propagates and branches out over the entire surface. The coating is completely delaminated within 3 sec after the appearance of this first crack. Figure 3 presents images captured from the video in figure 2, allowing examination of crack structure at times labeled on each macrograph, in seconds.

Figure 2.—Video file of water-induced TBC failure. Moisture-induced delayed failure, EB-PVD RE-YSZ, Ni(Pt)Al, Rene'N5, 1150 °C, 300 cycles.

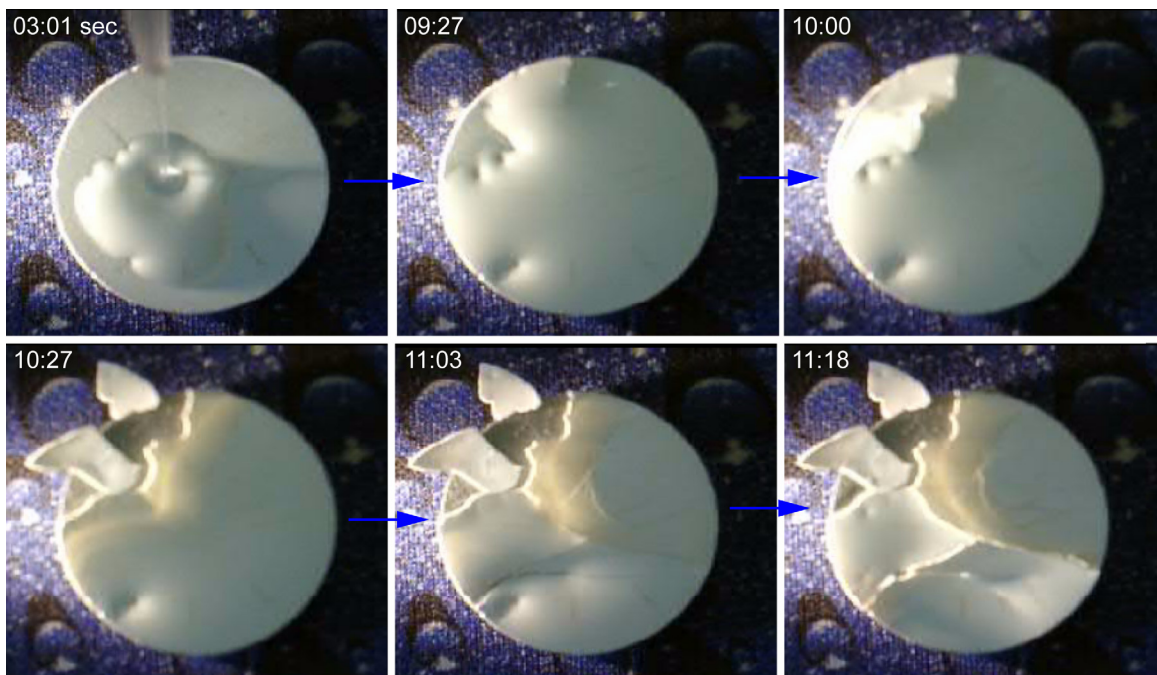
Figure 3.—Still frames from video sequence listing start times of water application and complete delamination in 9 sec. (EB-PVD TBC, pre-oxidized 300 hr at 1150 °C).

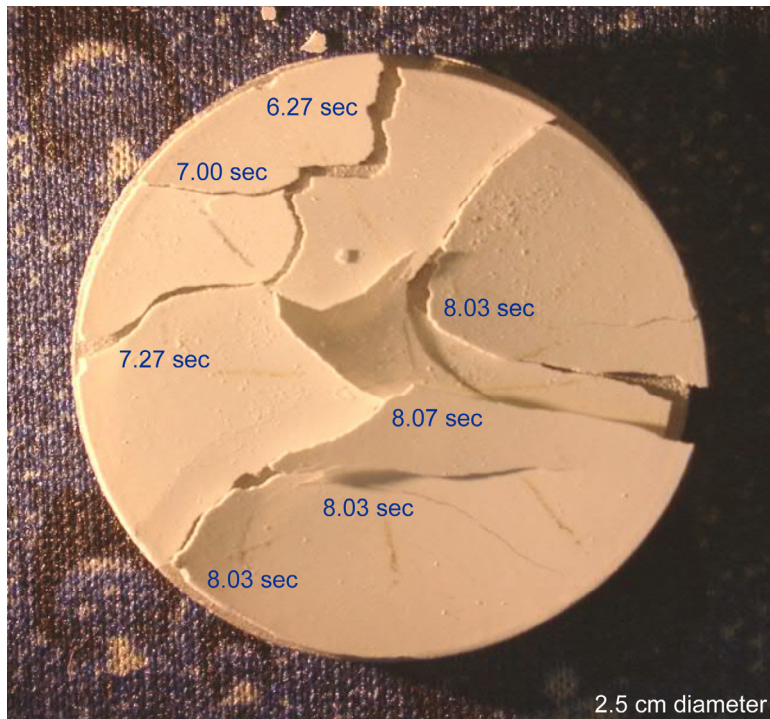
The time from the first application of water until a specific crack was formed is labeled on the final still photo of figure 4. Here about 6 sec elapsed before the first crack appeared, and approximately 3 more sec were required to fail the entire surface. These time intervals refer primarily to the incubation of a crack rather than propagation. The actual crack velocity was much faster, as viewed in real time.

Figure 4.—Final appearance of failed TBC after water drop experiment; incubation times for specific cracks range from 6 to 8 sec.

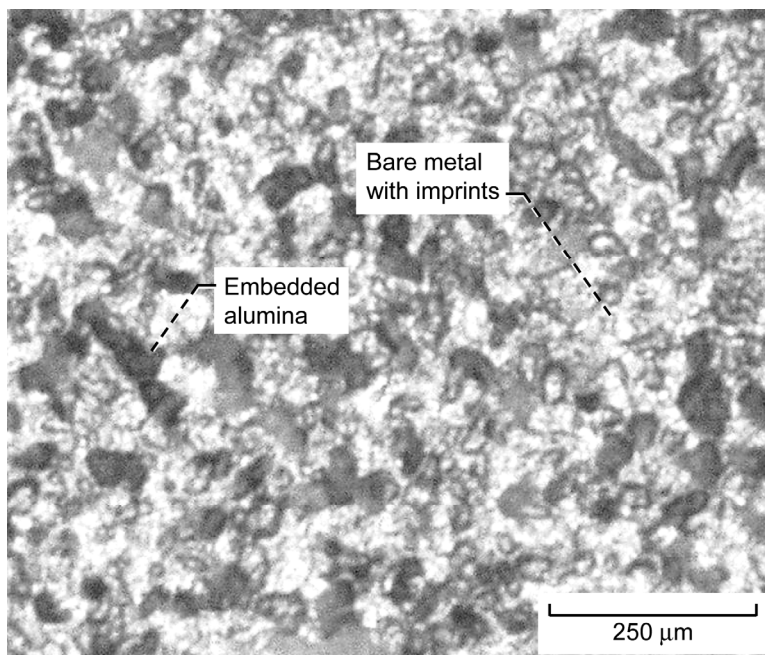
Preliminary observation via optical microscopy revealed very little retained TBC material, islands of alumina scale embedded into the bond coat, and a continuous sea of bare metal. The latter featured the tell-tale interfacial imprints of the previously adjacent alumina grains and a fair degree of surface undulation. Some of these features can be discerned in the low magnification macrograph of figure 5.

From the data above, one can conclude that failure of the TBC was commensurate with, and probably caused by, failure of the alumina scale at the scale-metal interface. Little evidence existed, either from surface morphology or weight change, to indicate any precursor to this massive catastrophic TBC delamination failure. The primary source of suspicion was the failure

Figure 5.—Macrograph of exposed bond coat metal after TBC failure, indicating Al_2O_3 spallation to bare metal and trapped Al_2O_3 oxide intrusions.
