# Space Shuttle Orbiter Atlantis Liquid Oxygen Pre-Valve Detent Roller Cracking Investigation

## Abstract

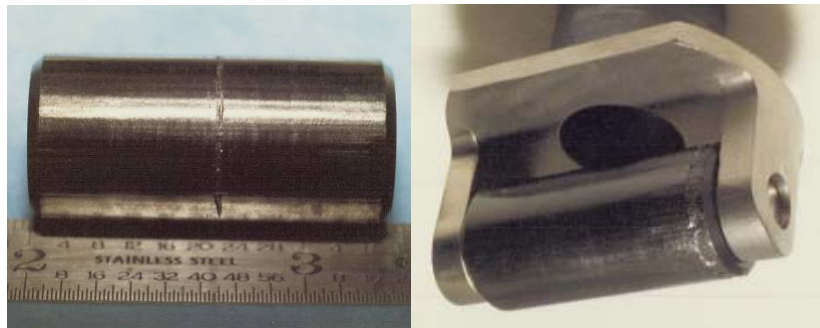
Some rollers within the fleet are specially machined to have a smaller diameter in specific locations. The purpose of this process is to reduce the effect of rough or high spots on that specific valve's visor. During inspections after the initial flights of the OV-103 and OV-104, several rollers in the LH<sub>2</sub> and LO<sub>2</sub> systems were found with rough gouges at specific distances along their lengths. Borescope and visual inspections concluded these instances of damage were due to wear associated with the high spots on each visor. Two rollers showing this type of damage are shown in Figure 6. Examples of specially machined rollers with gaps to avoid a high spot on a discrepant visor are shown in Figure 7.

**Figure 6: Rollers Exhibiting Wear due to High or Rough Spots on the Visor**

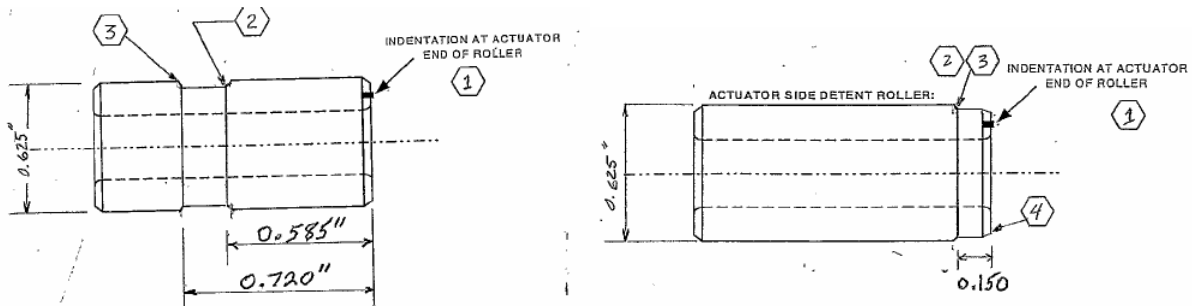
**Figure 7: Drawings showing how these rollers are machined to avoid discrepant areas on valve visors**

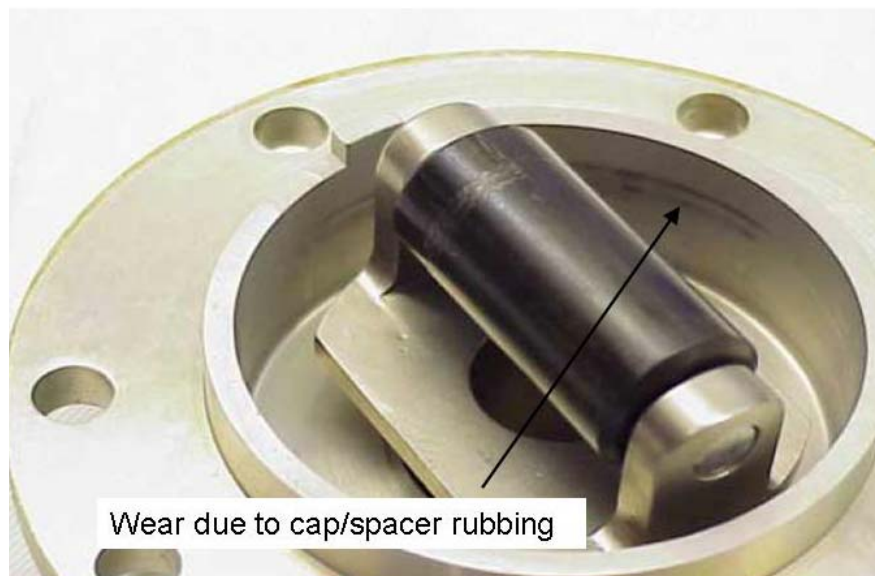
In addition to roller wear, the retainers also show signs of wear due to contact from the side of the follower. Deposits of the retainer material have been found on the pin and follower, which further supports the theory that the retainer is being damaged by these components. The cap also shows signs of wear due to the sliding contact of the four spring spacers. Example of nominal wear associated with spacer travel in the cap can be seen in Figure 8. All parts of the assembly are inspected thoroughly and replaced if the wear is considered significant. Minor wear to metal parts may be treated with Chem-film which is an acceptable practice for Shuttle LO<sub>2</sub> and LH<sub>2</sub> systems.

**Figure 8: Cap showing signs of nominal wear due to spacer rubbing**

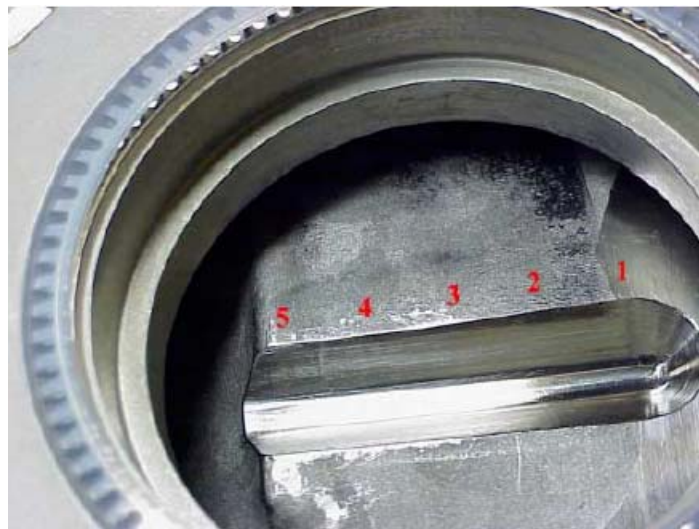
Molds of the visor detent groove were made so that measurements of the key dimensions of the visor could be taken. It was determined that the radius of the lip of the leading edge of the detent groove was sharper for this particular valve visor than drawings for the part allowed. The edge radius underwent a grinding and polishing process with the valve installed on the vehicle. Prior to machining, the radius was found to vary between 0.13 to 0.51 mm (0.005 to 0.020 inch) at various points along the length of the detent groove. The drawing requirement for this radius was 0.38 to 0.76 mm (0.015 to 0.030 inch). After the procedure, the sharpest dimension found along the length of the detent leading edge was 0.48 mm (0.019 inch). The polishing process was performed between the second and third rollers.

It was also noted from the mold impressions that the one end (labeled as "5" in Figure 9) of the leading edge was slightly higher than the other. This resulted in an unparallelism between the roller and visor interface. This unparallelism resulted in one side of the leading edge being approximately 0.64 mm (0.025 inch) higher than the other. This meant that one end, the horseshoe shaped end, compressed the detent roller more than the open end. All three cracks initiated on the end corresponding to the higher compression.

**Figure 9: Pre-valve Visor Detent Groove**

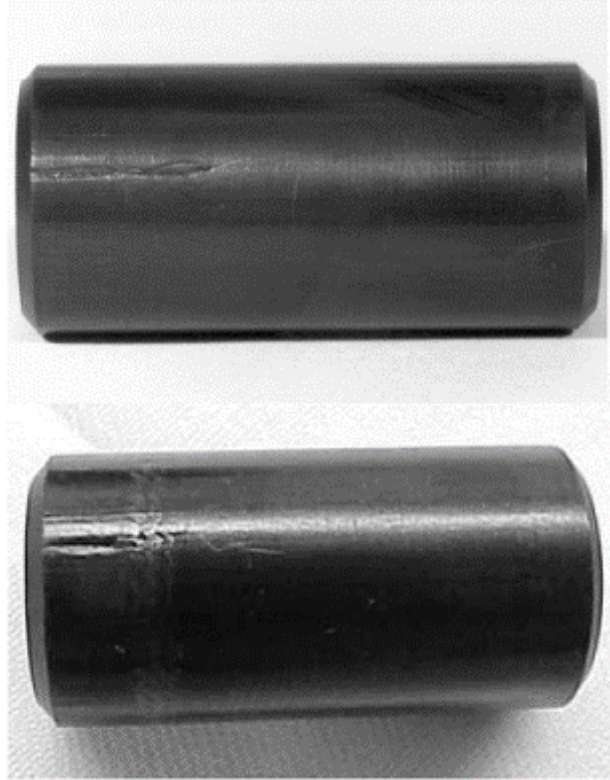
To date, three cracked rollers have been found through inspection. All 3 rollers were in the OV-104 Engine 3 LO<sub>2</sub> pre-valve. The first cracked roller was found after the second flight of OV-104, which led to the inspections discussed above. During OMDP for OV-104 after Flight 26, the second cracked roller was discovered. Following this investigation, every-flight inspections were instituted for the specific Engine 3 LO<sub>2</sub> pre-valve. During these inspections, the third cracked roller was discovered. Unlike the prior two cracked rollers, this roller cracked after only one flight. This raised concerns that a cracked roller that remains in service may degrade further and cause a serious failure in the LO<sub>2</sub> system.

Rationale to fly after finding the second cracked roller was based primarily on the conclusion that the sharp leading edge of the detent groove was the root cause of the cracking. However, after the detent groove leading edge was returned to print, the third roller cracked after only one flight. The second and third cracked rollers can be seen in Figure 10. In each case, the crack was observed to run through the LO<sub>2</sub> compatibility testing mark and completely through the thickness of the roller. This can be seen in Figure 11.

Figure 10: The second and third cracked rollers

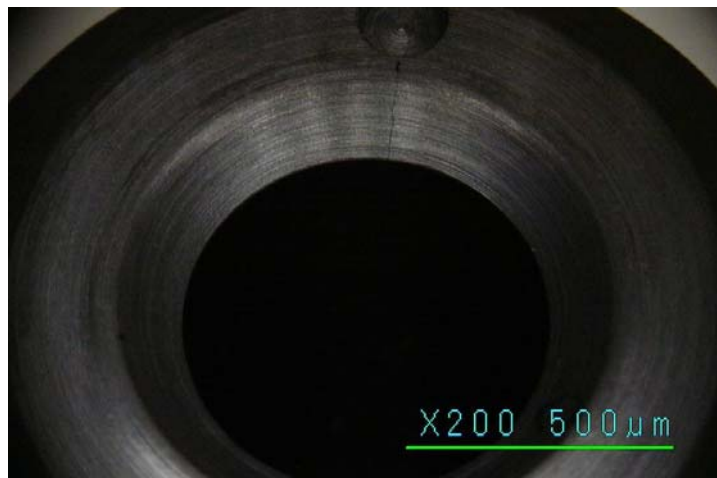
After the second failure was discovered, two likely causes were identified: roller material LO<sub>2</sub> compatibility testing marks, and detent groove leading edge sharpness. Before a soft good or non-metallic material is used in Space Shuttle LO<sub>2</sub> systems, each batch of the material must be compatibility tested. The Vespel SP21 used for the roller requires this testing. To ensure that rollers that aren't batch tested are not installed in the vehicle, a small dimple is machined into the end of the roller to indicate that the material successfully completed the required testing. The depth and diameter of the dimple are drawing controlled. The mark is to be no more than 0.76-mm (0.030-inch) deep and 1.57 mm (0.062 inch) in diameter. It was noted that the crack observed on the second and third cracked rollers initiated at the dimple and propagated through the thickness of the roller. The dimple was identified as a stress riser and a contributor to the cracked rollers. However, it was also noted that the first cracked roller did not have a dimple, so there is likely an additional cause.

Figure 11: Crack can be seen through the compatibility testing mark and from the inner to outer diameters

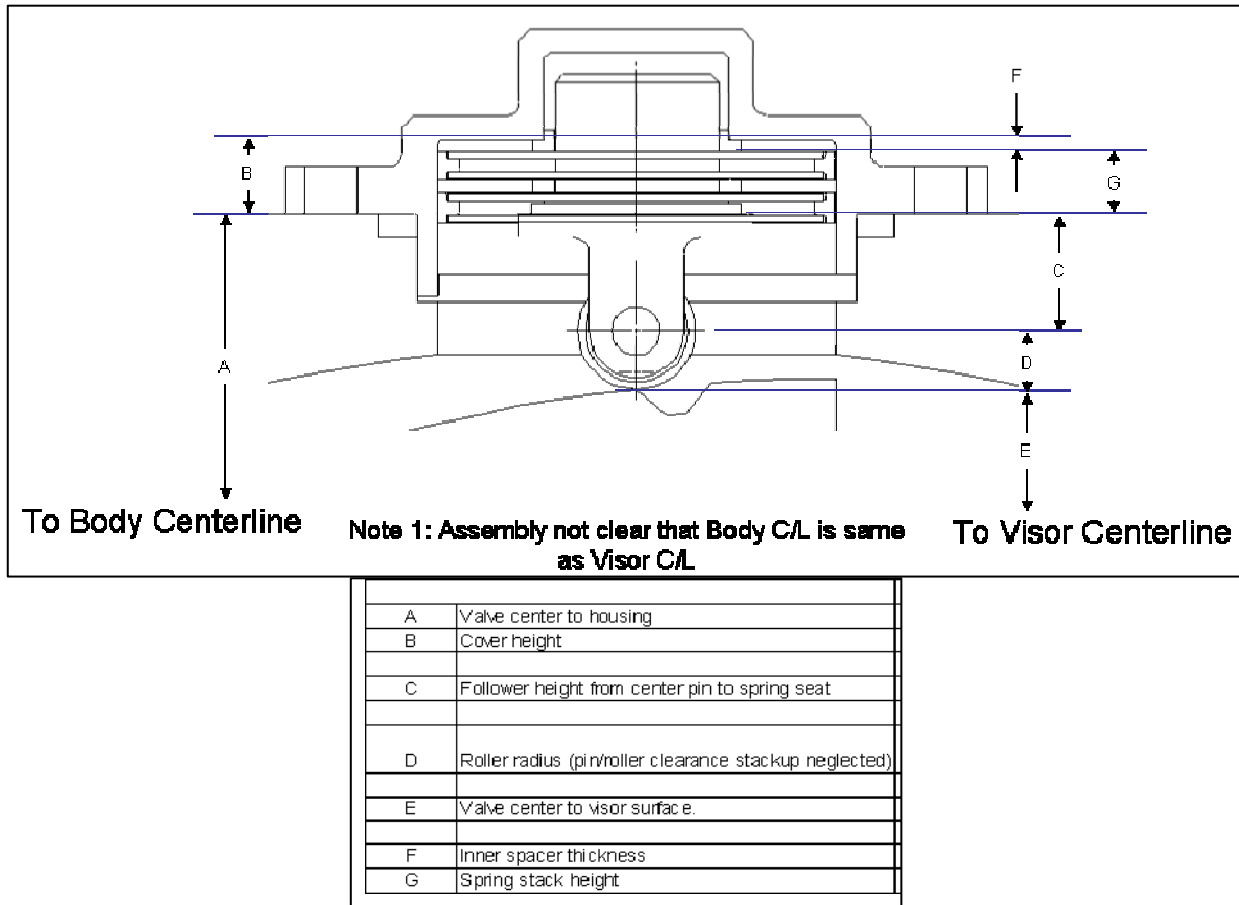
The out-of-specification measurement of the visor height prompted the tolerance stack-up investigation. The measured distance of the visor from the valve body was used as a basis for a tolerance stack-up analysis. Actual measurements of the installed detent mechanism components were used, including a force-deflection curve of the Belleville spring stack set-up. The stack up of the individual components was subtracted from the visor height to determine if interference was possible. Interference would result in the spring stack reaching its solid height and imparting unexpected high loads on the roller. It was determined that combinations of nominal piece parts tolerances could result in deflections that caused the Belleville spring stack to go flat and introduce the high loads onto the roller. An illustration of the mechanism and the measurements used in the analysis are shown in Figure 12. As a solution, piece parts were carefully selected to produce an acceptable assembly on the low side of the tolerance band. This should preclude the spring stack from reaching a solid deflection height. Further mitigation was to machine an angle in the retainer surface that contacts the follower. The surface was angled to 2 degrees based on the marks left by the roller on the retainer. These marks indicated the angle at which the roller was moving when in contact with the visor. The modified retainer allows additional movement of the follower and prevents binding at the follower-retainer interface. This reduction in binding also reduces the load being applied to roller.

Figure 12: Detent Mechanism Tolerance Stackup
