# The Mars Climate Sounder In-Flight Positioning Anomaly

Bruno M. Jau\* and David Kass\*

## Abstract

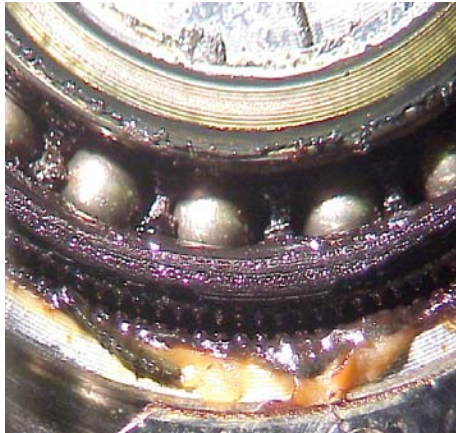
**Figure 7: Close up View of Mechanical Components after the Life Test**

Figure 7 shows a close up picture of the harmonic drive, taken after the life test: No mechanical wear could be detected at any mechanical parts, nor was there any graceful degradation evident, which would have expressed itself, for instance, by substantial increases in backlash. But the lube's color had changed from brown to black in the engagement zones between gear teeth and in the bearings. Chemical analyses, however, revealed that lube samples taken from inside the engagement zone had retained their lubricating capabilities. The joint thus maintains its full capabilities.

The overall conclusion based on life test results (for life test conditions), is that the joint demonstrated its capability to survive the required mission error free, pointing away from a mechanical cause for the anomaly: The life test joint is still being used on occasion today, proving its mechanical integrity and the lube's lubrication capabilities time and time again. It runs error free, provided it receives the proper electrical input signal and current.

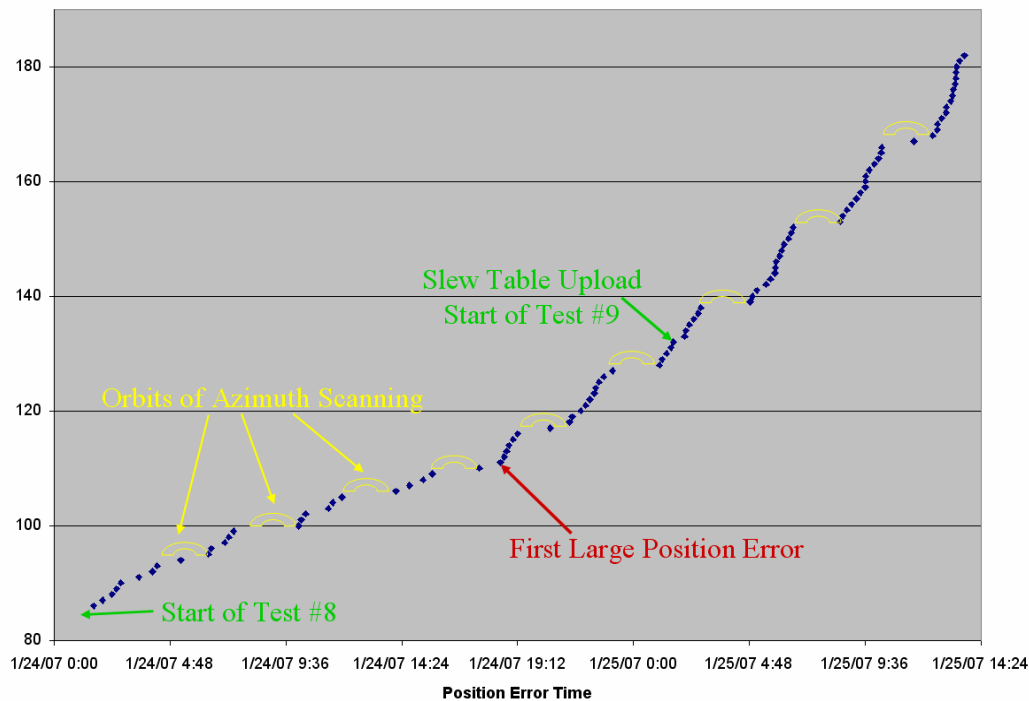
**Figure 10: Error Rate in Late January Testing**

The results are shown in Fig. 10, plotting the time of the error versus error number. The yellow crescents are the orbits with azimuth scanning. All of the errors during the azimuth orbits are associated with elevation scans. Part way through, it was decided to proceed with the next test (test #9) and remove the last difference between the two actuators by overwriting the elevation slew table with the azimuth table.

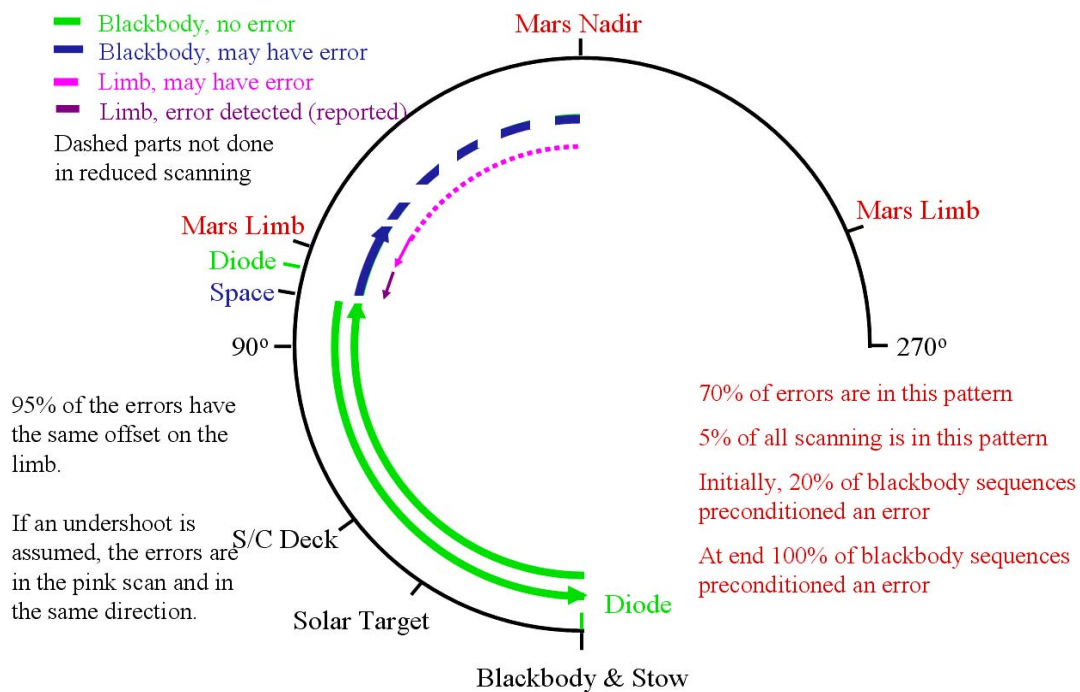
**Figure 11: Blackbody then Limb Error Pattern**

The cause of this preconditioning is not understood. Initially, 20% of the black body sequences preconditioned an error. When the errors were the most frequent, all black body sequences preconditioned a position error. Extensive analysis of the MCS software, electronics and mechanical assembly, has failed to point out any reason for such a preconditioning to occur.
