Failure of the Trailing Umbilical System Disconnect Actuator on the International Space Station

Abstract

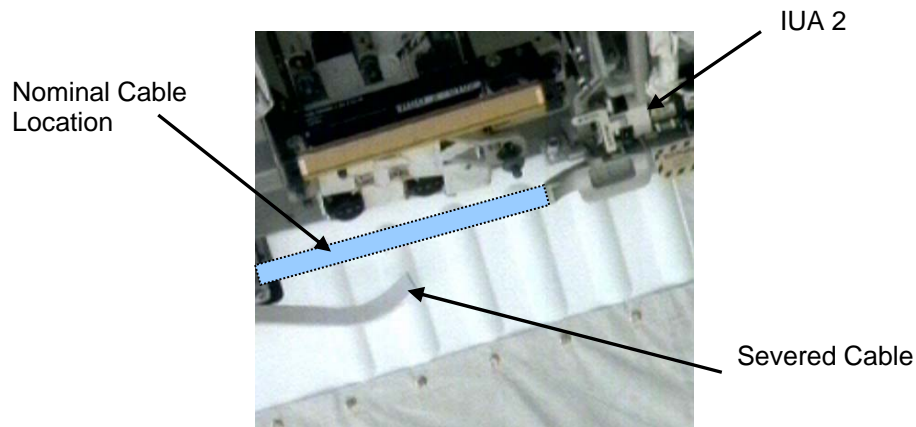
On December 16, 2005, a power switch on the ISS was tripped by a short circuit. Video of the MT and Trailing Umbilical System (TUS) cable revealed the cable routed to Interface Umbilical Assembly (IUA) 2 on the nadir side of the MT had been inadvertently severed (see Figure 1). When the cable was severed the live wire tips contacted metal causing a short, leading to a tripped power switch. Commanded actuation requires three independent power switch closures to the TUS Disconnect Actuator (TDA), and telemetry analysis indicated no possible electrical cause. The only remaining cause of the severed cable was a mechanical failure of the TDA.

Figure 1. Severed TUS Cable on IUA 2

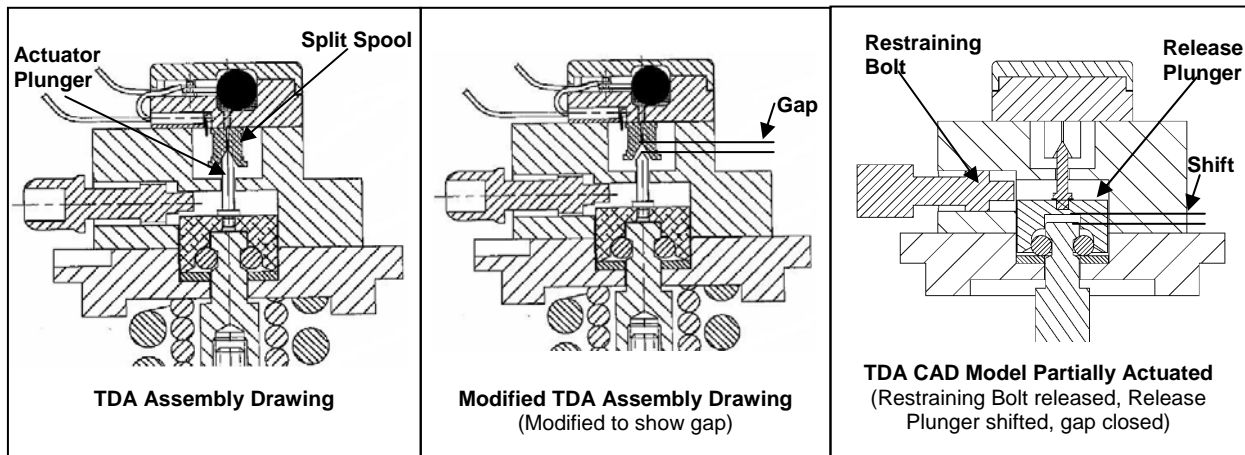
An assessment of the design was performed to determine what effects the as-built hardware could have on the position of the components within the mechanism. The results of the assessment indicated that when the components were built to the nominal drawing dimensions a gap would exist between the Actuator Plunger and Split Spool. If the as-built components were biased to one side this could increase that gap. The TDA assembly drawing omits this gap (see Figure 5).

During assembly of the flight units, the top portion of the T-plunger is installed and the Release Plunger with Retaining Pins is compressed. Next, the Restraining Bolt is engaged to hold the Release Plunger in place and preclude release of the top portion of the T-plunger. The Primary Compression Springs are then mechanically compressed, and the bottom portion of the T-plunger is installed and fastened to the top portion with a single bolt. The final step installs the TDA Cover with Split Spool to the Housing. After reviewing the assembly process it was clear that any gap between the Actuator Plunger and Split Spool would go undetected during final assembly of the flight unit. That gap is maintained by the Restraining Bolt until the unit is activated on-orbit. During on-orbit activation the Restraining Bolt is removed and the Release Plunger would move to close the gap (see Figure 5).

Figure 5. Gap Illustrations

Cross sections of the TDA assembly drawing show a close fit between the Split Spool and the Actuator Plunger and a gap between the Restraining Bolt and Release Plunger. As-built assembly indicated a gap at the Split Spool and a closed gap at the Restraining Bolt to Release Plunger interface, as seen in Figure 5, leaving the TDA partially actuated and changing the load path.

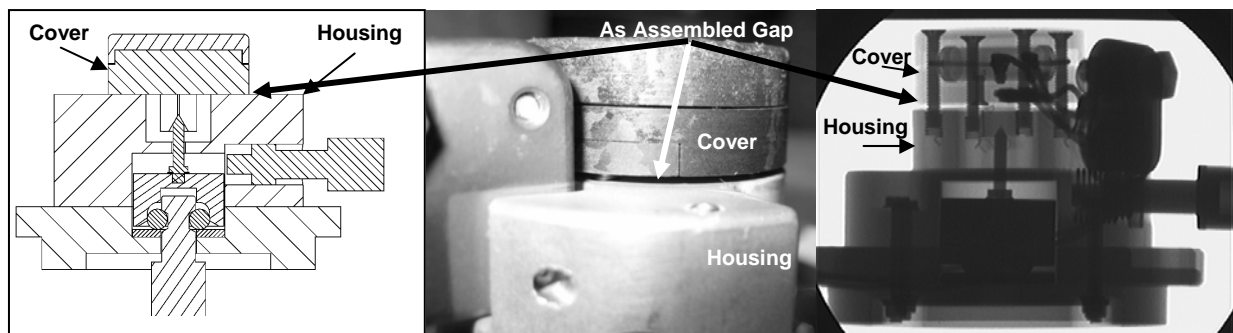
Upon return of the failed TDA, disassembly and non-destructive evaluations were performed. The first was an x-ray of the TDA Housing and internal components to determine whether or not the Restraining Wire and Fuse Wire were still intact. In addition, a detailed survey was performed of the exterior of the TDA Housing and Cover. Since the TDA mechanism was actuated and disassembled from the IUA on-orbit, the T-plunger and spring dimensions and surfaces could also be inspected. The x-ray of the TDA Housing clearly showed the Restraining Wire and Fuse Wire were still intact and did not cause the failure. When the outer covering tape was removed from the top portion of the TDA Cover, a non-uniform gap nearly 1.02 mm (0.04 in) tall was found between the Cover and Housing, indicating an assembly error. This gap was also confirmed by a subsequent review of the x-ray. The markings on the removed tape were consistent with a gap that had been present from initial Cover installation.

Figure 6. Failed TDA External View (tape removed) & X-Ray

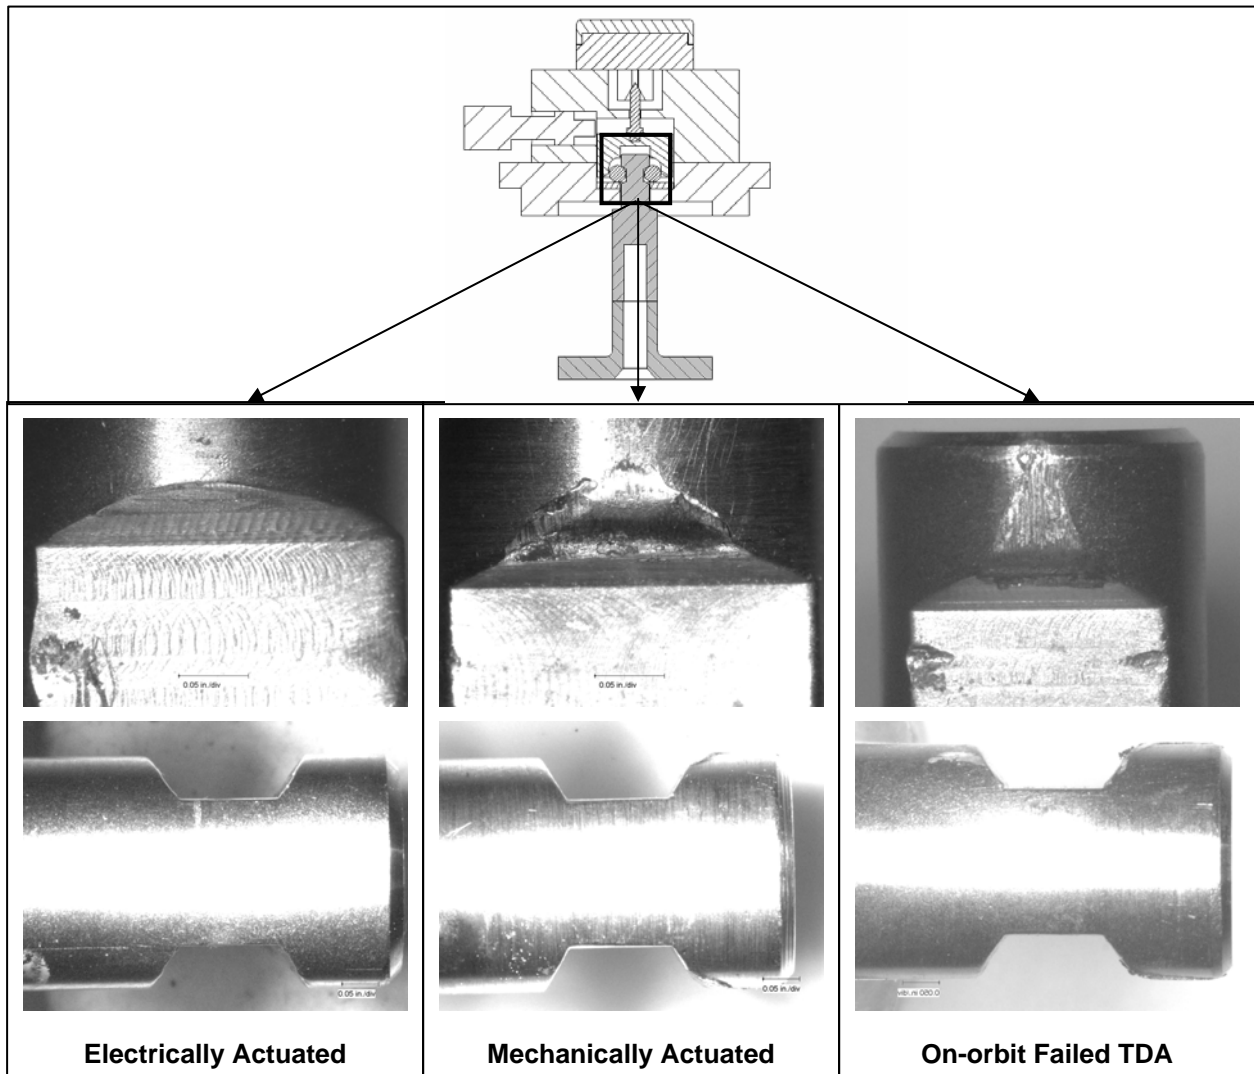
Upon inspection of the T-plunger, yielding was found where it contacted the Retaining Pins. Prior to obtaining the failed TDA, a series of ground tests were performed to support the planned on-orbit repair strategy. These tests included both a slow mechanical release of the Actuator Plunger and a near instantaneous release of the Actuator Plunger. Mechanical actuation was achieved by slowly backing out the fasteners that hold the Cover and Split Spool to the Housing, thus allowing the Release Plunger to shift and release the T-plunger. This test resulted in three findings that were significant to the failure investigation: 1) The T-plunger release required significantly less travel than expected (~0.965 mm (0.038 in) actual vs. ~4.75 mm (0.187 in) expected), 2) The edge of the T-plunger notch was mechanically yielded at the Release Pin interface, 3) The Split Spool was damaged at the Actuator Plunger interface. Post flight inspection of the failed TDA T-plunger indicated similar notch yielding at the Retaining Pin interface. The travel required to mechanically actuate the TDA was similar to the gap that was seen between the Cover and the Housing on the failed TDA. This indicates the TDA was very close to actuating when the Restraining Bolt was first removed on-orbit.

Figure 7. T-Plungers Post Actuation

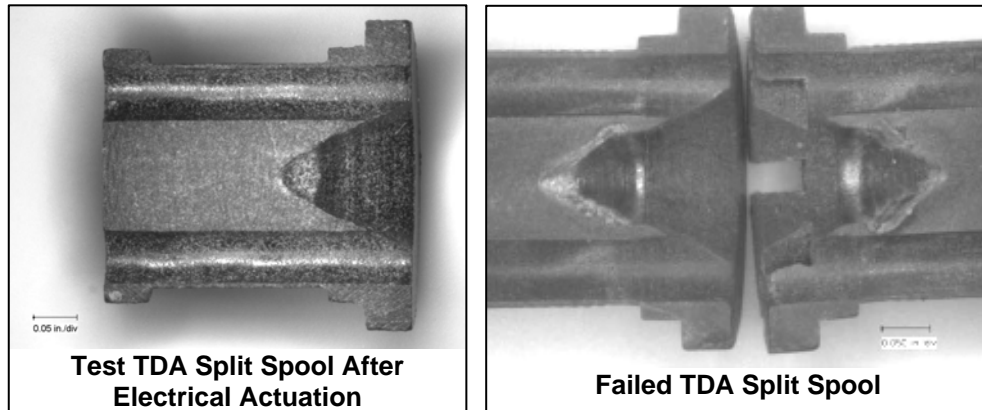
The Split Spool and Restraining Wire were inspected via x-ray and visually after initial disassembly. The Restraining Wire was intact and did not allow the Split Spool to separate. The Split Spool was then separated by removing the Restraining Wire to allow a detailed inspection of the Split Spool halves. The inspection revealed the Release Plunger had compressively yielded the interior of the Split Spool. This finding was consistent with the damage seen during the mechanically actuated ground test. This damage is caused by an increased force transferred to the Actuator Plunger from the Primary Compression Springs during a slow release actuation. As the Release Plunger travels upward the Primary Compression Springs force the Restraining Pins outward. This outward force is then transmitted to the Release Plunger and subsequently to the Split Spool. When the TDA is electrically actuated the Split Spool is free to separate and thus does not compressively yield (see Figure 8).

Figure 8. Split Spool Details

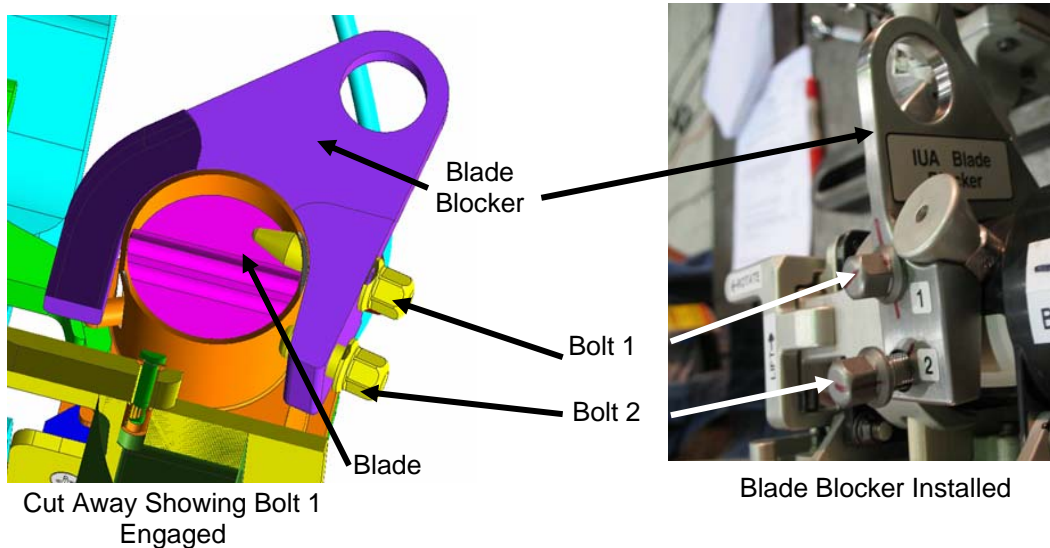
Figure 9. Blade Blocker Details

In the weeks after the TUS 2 cable sever, the team was concerned with the possibility of a second TDA failure on IUA 1 leading to a TUS 1 cable sever. In early February 2006 during Russian Extravehicular Activity (EVA) 15, the TUS 1 cable was routed outside of the TDA to prevent it from being cut until a long term repair could be implemented. The configuration of the MT leading up to the removal of the failed system was the TUS 1 cable was severed (IUA 1 failed) and the TUS 2 cable was routed outside of the TDA. The team prepared a repair to regain full MT redundancy in one Shuttle Flight, STS-121 (ISS Mission ULF1.1), in July of 2006. One requirement was to fly a spare TUS Reel containing a fully intact cable with connectors. In addition, the blade blocker (see Figure 9) was designed and tested on the ground to be installed EVA onto IUA 1 to prevent the TDA from cutting the cable in the case it too mechanically failed. The repair allowed for IUA 1 to be fixed in place in one short EVA task.

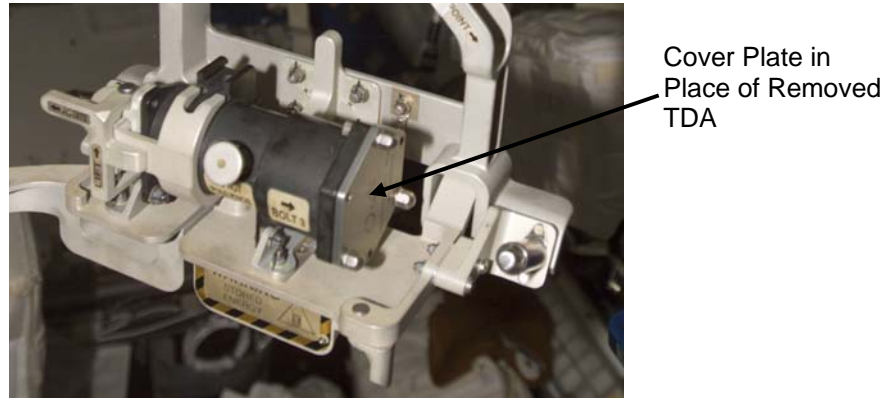
Figure 10. New IUA Configuration

Next was to address both the ground spare and the failed IUA 2 on-orbit. For the ground spare the TDA hardware was removed to prevent inadvertent actuation once in service. The IUA itself is still required for power conditioning, TUS cable to MT interface connections, and cable strain relief. This modified spare unit was installed in place of the failed IUA 2 during the STS-121/ ISS ULF1.1 mission. With the removal and replacement (R&R) of the TUS 2 Reel, installation of the blade blocker onto the IUA 1, and R&R of IUA 2 with the newly configured spare, the MT System was left with full redundancy at the end of the mission. In a subsequent decision, the ISS Mission Management Team decided the crew would disassemble the failed TDA on-orbit and only return that small portion to the ground for failure investigation. The failed IUA 2 was re-configured much like the spare unit during the mission and now serves as a fully operational IUA spare on-orbit without any ground re-processing required. Figure 10 illustrates the configuration of a newly configured IUA.

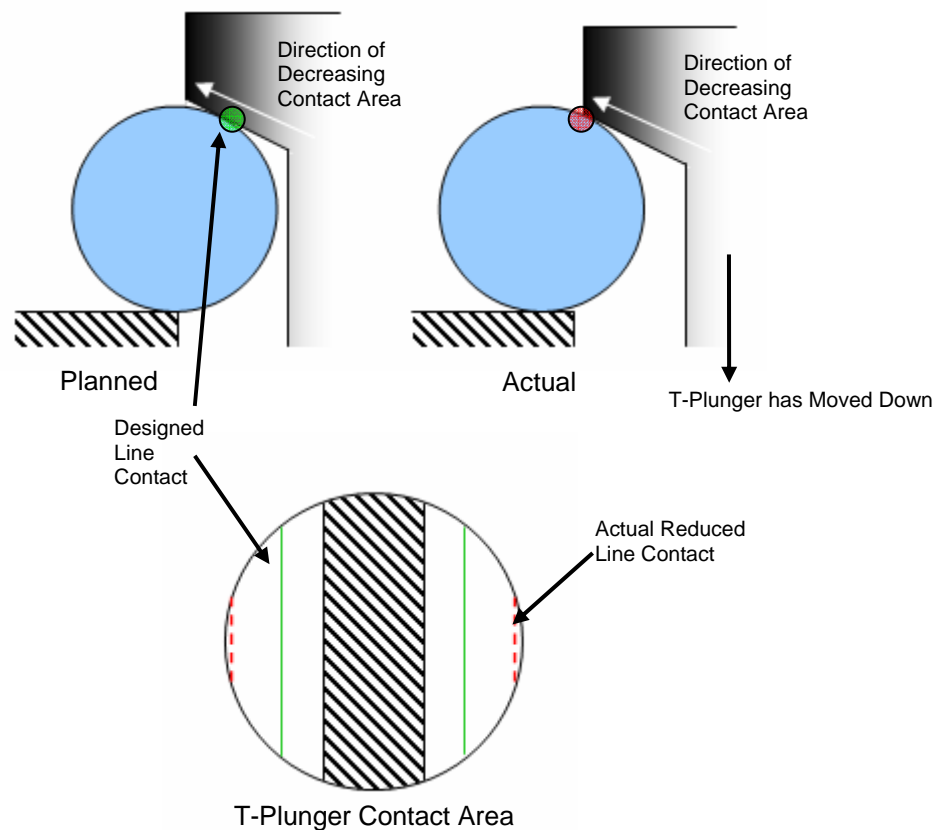
Creating a gap between the Actuator Plunger and the Split Spool allows a partial actuation of the TDA when the Restraining Bolt is removed. The effect of creating that gap is movement of the Retaining Pins along the slope of the T-plunger, as shown in Figure 10. When this loading condition is created, the high force from the Primary Compression Springs is concentrated on a significantly smaller area within the TDA. The designed line contact reduces greatly as it approaches a point contact as shown in Figure 10. Any yielding at that point exacerbates the problem and further actuates the TDA.

Figure 10. Change in Load Condition at Retaining Pin

A detailed design study and resting state review considering the impacts of spring forces would point out the possibility of these issues and their impact to loading within the mechanism. Defining critical dimensions for Split Spool and Actuator Plunger height to ensure the Restraining Pins would remain fully seated could prevent a gap and the associated high loading condition.

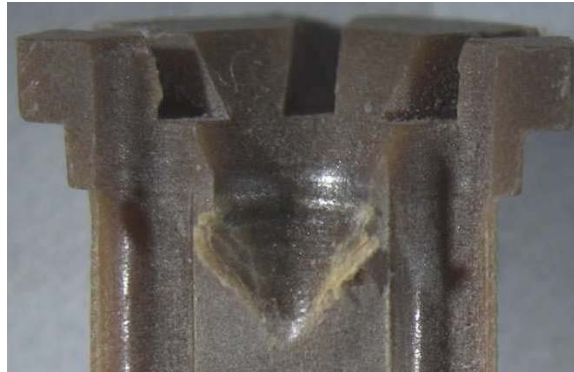
Disassembly of the Cover portion of the TDA assembly revealed deformation and yielding of the Split Spool (see Figure 11). Torlon Split Spools of this type had been used previously in switches for power systems.

Figure 11. Split Spool Deformation

In other applications, Torlon was highly desirable because of its electrical insulating properties. For the TDA, electrical properties were irrelevant. Structure focused requirements for this portion of the TDA would have weighted strength as far more important than electrical resistance. Torlon would not be as robust as steel for this application. Since electrical resistance was irrelevant, a steel Split Spool would be a more desirable choice for a compressively loaded structural member.

Where mechanical and strength properties are the main requirement, they should be weighted more heavily than flight history or other concerns. If the Split Spool was never overloaded, polymer selection would not have been a problem. In this case, other issues led to structural members experiencing loads in excess of design loads and failed by yielding. Caution should be used whenever adapting heritage designs that were developed for other applications.
