Space Shuttle Orbiter Atlantis Liquid Oxygen Prevalve Detent Roller Cracking Investigation

Abstract

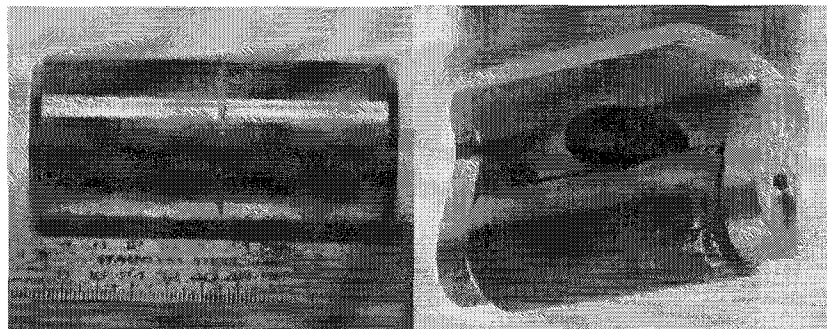
Figure 6 Rollers Exhibiting Wear due to High or Rough Spots on the Visor

Some rollers within the fleet are specially machine to have a smaller diameter in specific locations. The purpose of this process is to reduce the effect of rough or high spots on that specific valve's visor. During inspections after the initial flights of the OV-103 and OV-104, several rollers in the LH₂ and LO₂ systems were found with rough gouges at specific distances along their lengths. Borescope and visual inspections concluded these instances of damage were due to wear associated with the high spots on each visor. Two rollers showing this type of damage are shown in Figure 6. Examples of specially machined rollers with gaps to avoid a high spot on a discrepant visor are shown in Figure 7.

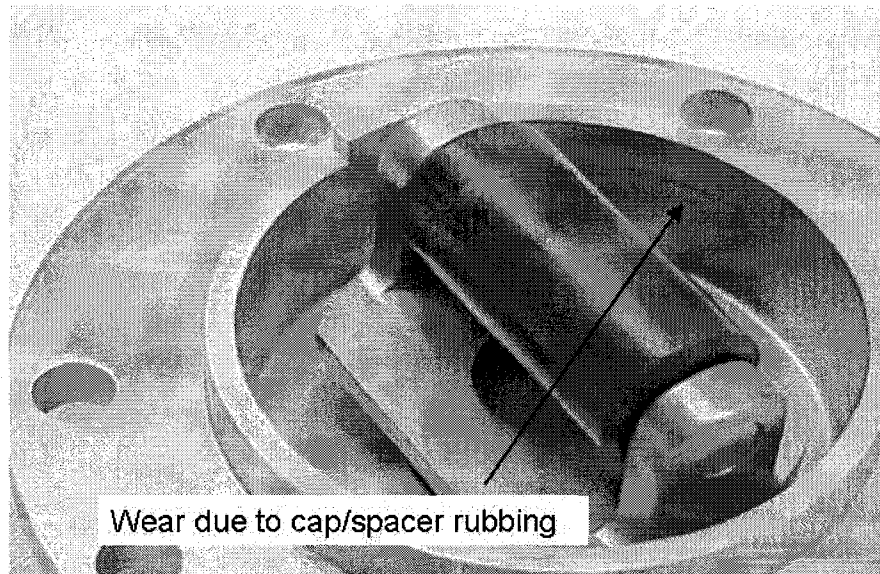
Figure 8 Cap showing signs of nominal wear due to spacer rubbing

In addition to roller wear, the retainers also show signs of wear due to contact from the side of the follower. Deposits of the retainer material have been found on the pin and follower which further supports the theory that the retainer is being damaged by these components. The cap also shows signs of wear due to the sliding contact of the four spring spacers. Example of nominal wear associated with spacer travel in the cap can be seen in Figure 8. All parts of the assembly are inspected thoroughly and replaced if the wear is considered significant. Minor wear to metal parts may be treated with Chem-film which is an acceptable practice for Shuttle LO₂ and LH₂ systems.

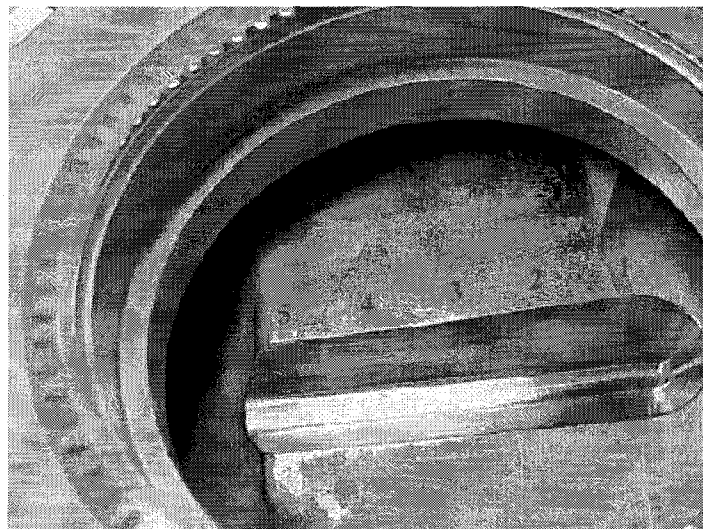
Figure 9: Pre-valve Visor Detent Groove

Molds of the visor detent groove were made so that measurements of the key dimensions of the visor could be taken. It was determined that the radius of the lip of the leading edge of the detent groove was sharper for this particular valve visor than drawings for the part allowed. The edge radius underwent a grinding and polishing process with the valve installed on the vehicle. Prior to machining, the radius was found to vary between 0.005 to 0.020 inches at various points along the length of the detent groove. The drawing requirement for this radius was 0.015 to 0.030 inches. After the procedure, the sharpest dimension found along the length of the detent leading edge was 0.019 inch. The polishing process was performed between the second and third rollers.

It was also noted from the mold impressions that the one end (labeled as "5" in Figure 9) of the leading edge was slightly higher than the other. This resulted in an unparallelism between the roller and visor interface. This unparallelism resulted in one side of the leading edge being approximately 0.025 inches higher than the other. This meant that one end, the horseshoe shaped end, compressed the detent roller more than the open end. All three cracks initiated on the end corresponding to the higher compression.

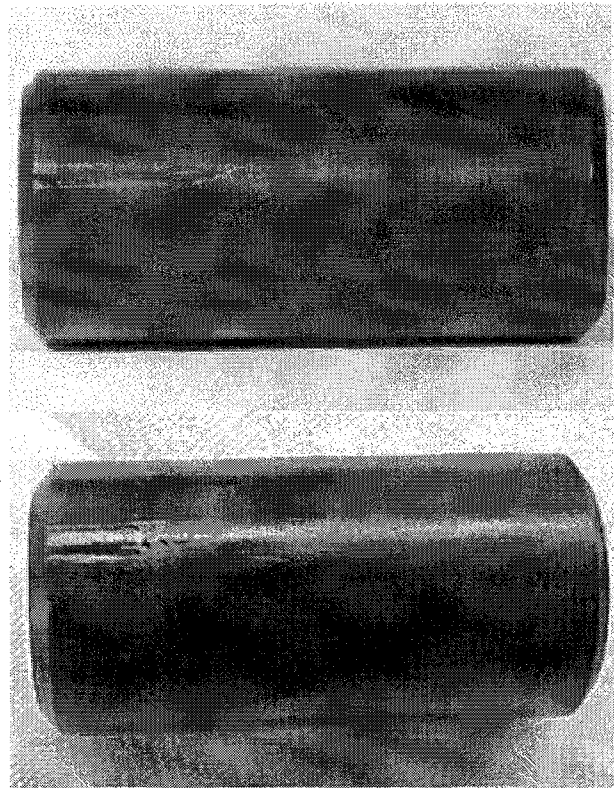
Figure 10 The second and third cracked rollers

Rationale to fly after finding the second cracked roller was based primarily on the conclusion that the sharp leading edge of the detent groove was the root cause of the cracking. However, after the detent groove leading edge was returned to print, the third roller cracked after only one flight. The second and third cracked rollers can be seen in Figure 10. In each case, the crack was observed to run through the LO₂ compatibility testing mark and completely through the thickness of the roller. This can be seen in Figure 11.

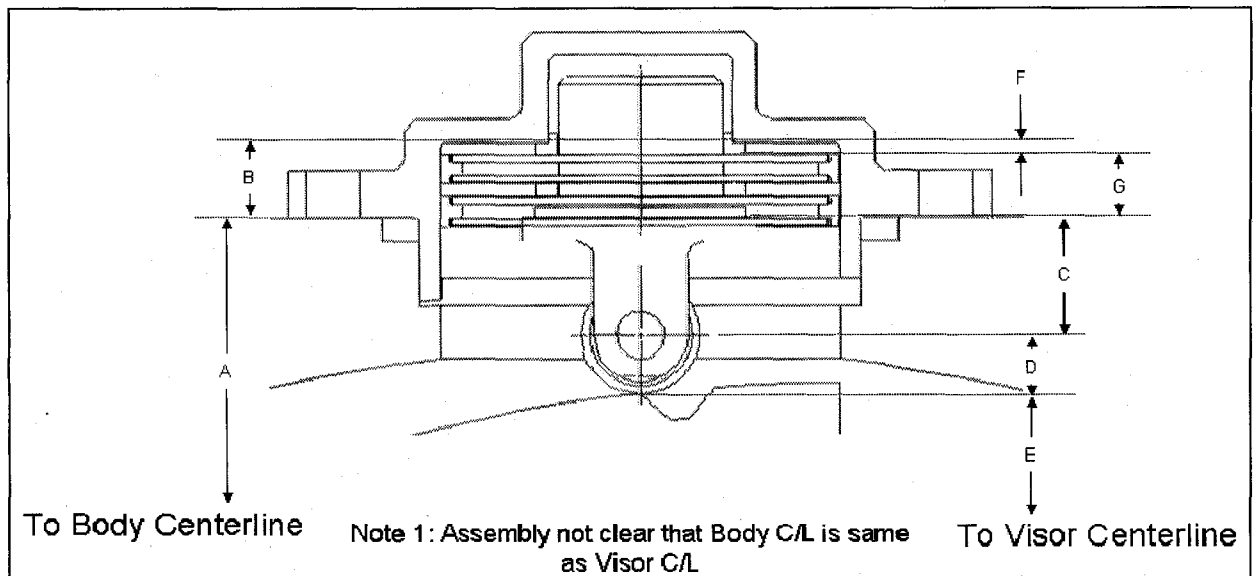
Figure 12 Detent Mechanism Tolerance Stackup

The out of specification measurement of the visor height prompted the tolerance stack-up investigation. The measured distance of the visor from the valve body was used as a basis for a tolerance stack-up analysis. Actual measurements of the installed detent mechanism components were used, including a force-deflection curve of the Belleville spring stack set-up. The stack up of the individual components was subtracted from the visor height to determine if interference was possible. Interference would result in the spring stack reaching its solid height and imparting unexpected high loads on the roller. It was determined that combinations of nominal piece parts tolerances could result in deflections that caused the Belleville spring stack to go flat and introduce the high loads onto the roller. An illustration of the mechanism and the measurements used in the analysis are shown in Figure 12. As a solution, piece parts were carefully selected to produce an acceptable assembly on the low side of the tolerance band. This should preclude the spring stack from reaching a solid deflection height. Further mitigation was to machine an angle in the retainer surface that contacts the follower. The surface was angled to 2 degrees based on the marks left by the roller on the retainer. These marks indicated the angle at which the roller was moving when in contact with the visor. The modified retainer allows additional movement of the follower and prevents binding at the follower-retainer interface. This reduction in binding also reduces the load being applied to roller.
