Title of Presentation: Apollo 13 Case Study part 1 & 2

Apollo 13 Case Study (part 1 of 2)

Apollo 13 Case Study (part 2 of 2)

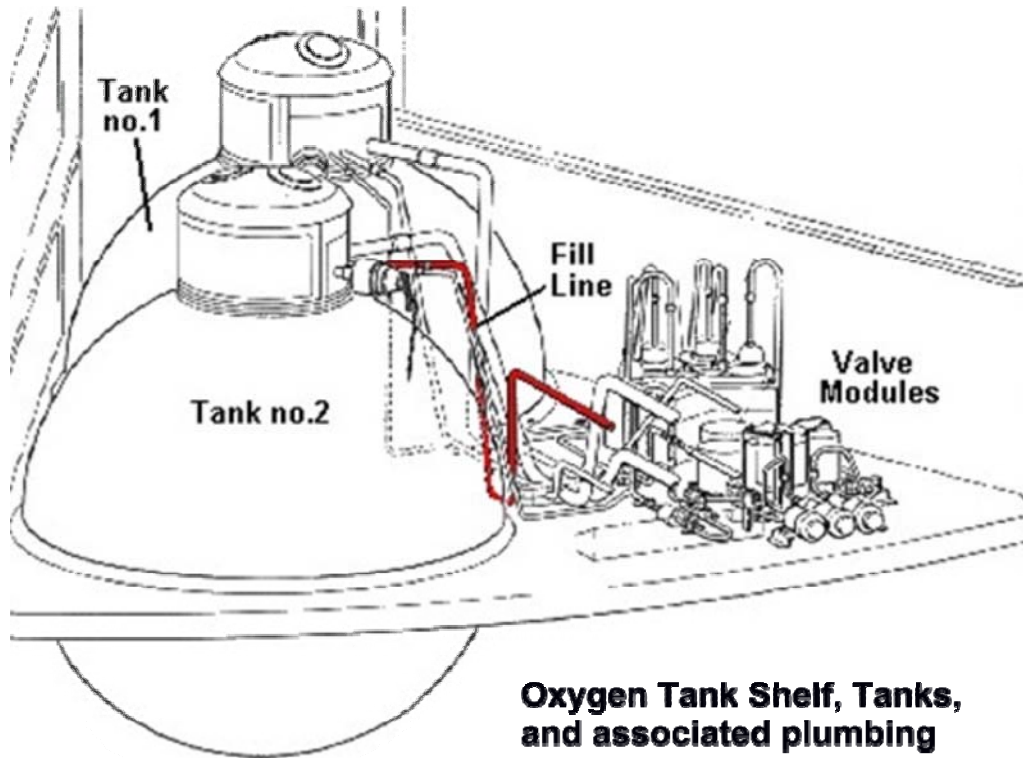
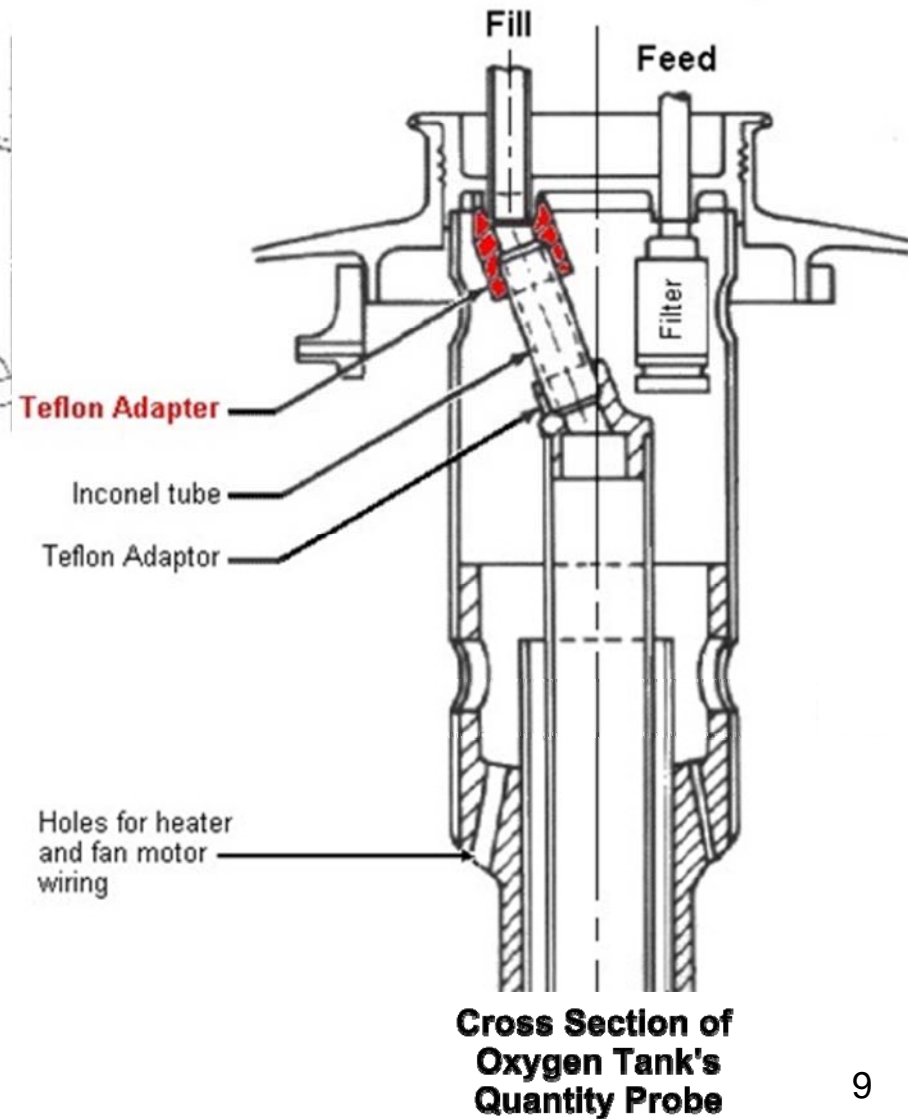
Displaced Fill Line

- ❑ October 1968, North American Rockwell
 - Tank removed from Apollo 10's SM for mods
 - During removal, tank shelf was accidentally dropped 2"
 - Passed all tests, but fill line probably displaced by 0.1"

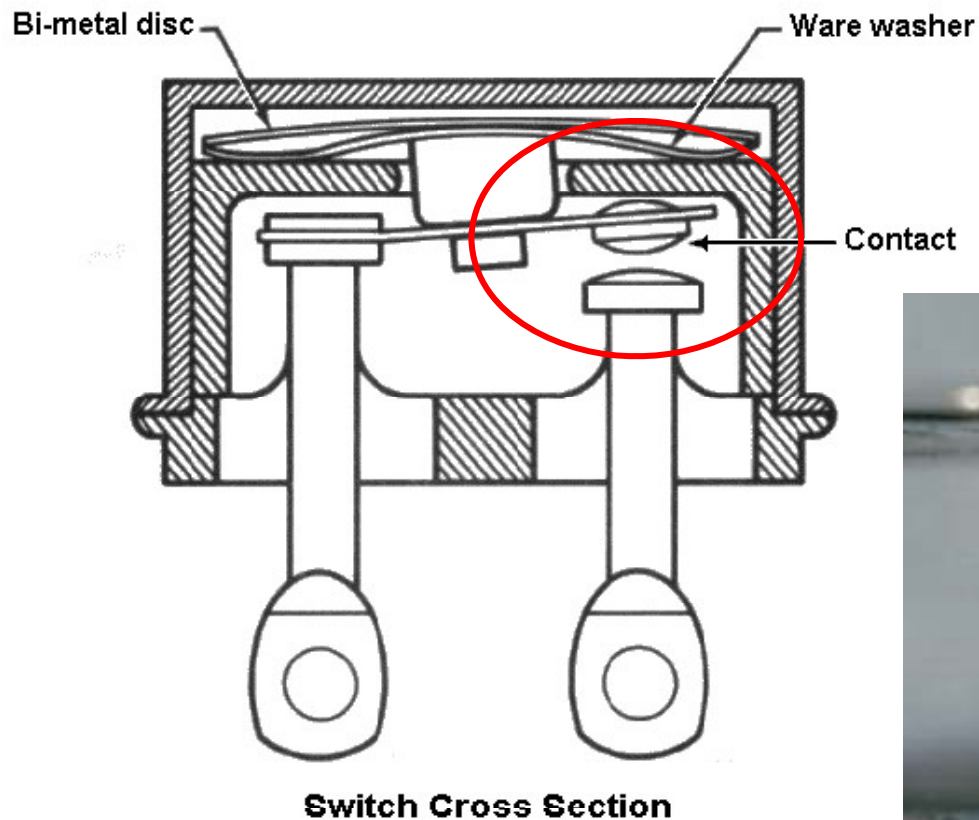
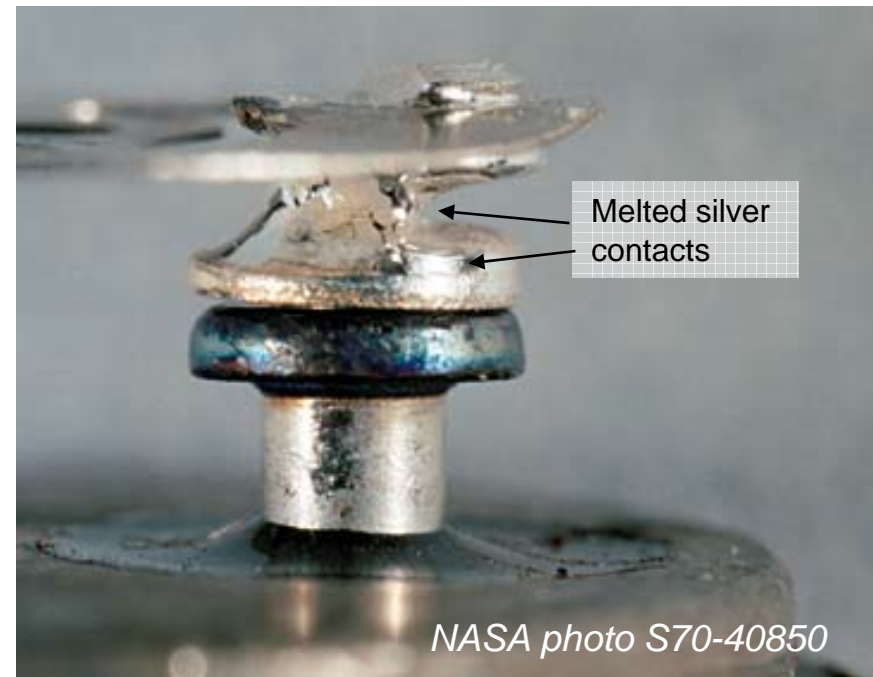
Heater Relay

- ❑ Postflight testing showed that heater thermostats did not work properly at 65 volts (KSC GSE power)
 - Originally designed for 28 V, never redesigned to be compatible with 65 V as required in a 1965 spec change
 - Thermostats supposed to cut off at 80° F (27° C), but high voltage welded the relays shut when opened under load
 - Heaters stayed on and temps rose to ~1000° F (538° C) inside the tank
 - Teflon insulation severely damaged
- ❑ Loose fill tube by itself wasn't a problem

- What happens when you put 65 V through a relay designed to handle 28 V?

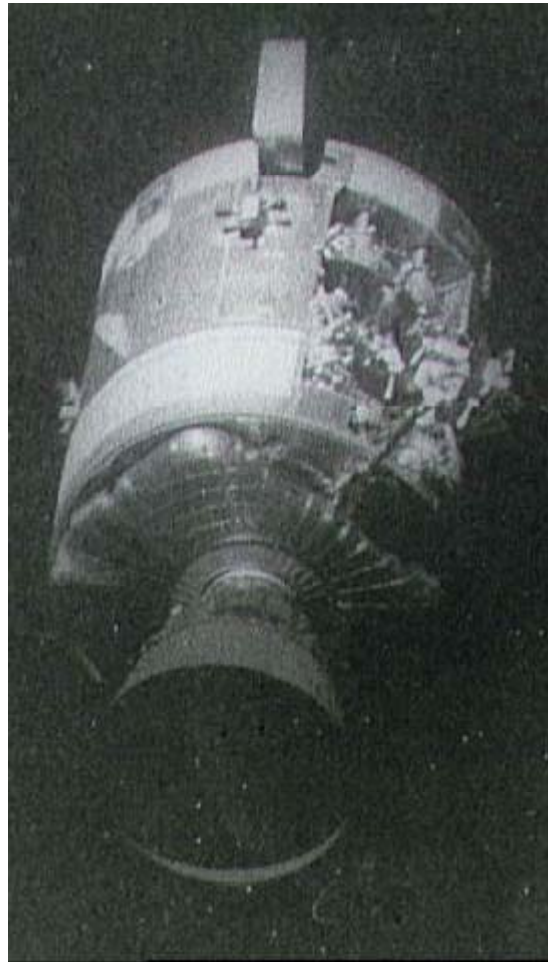
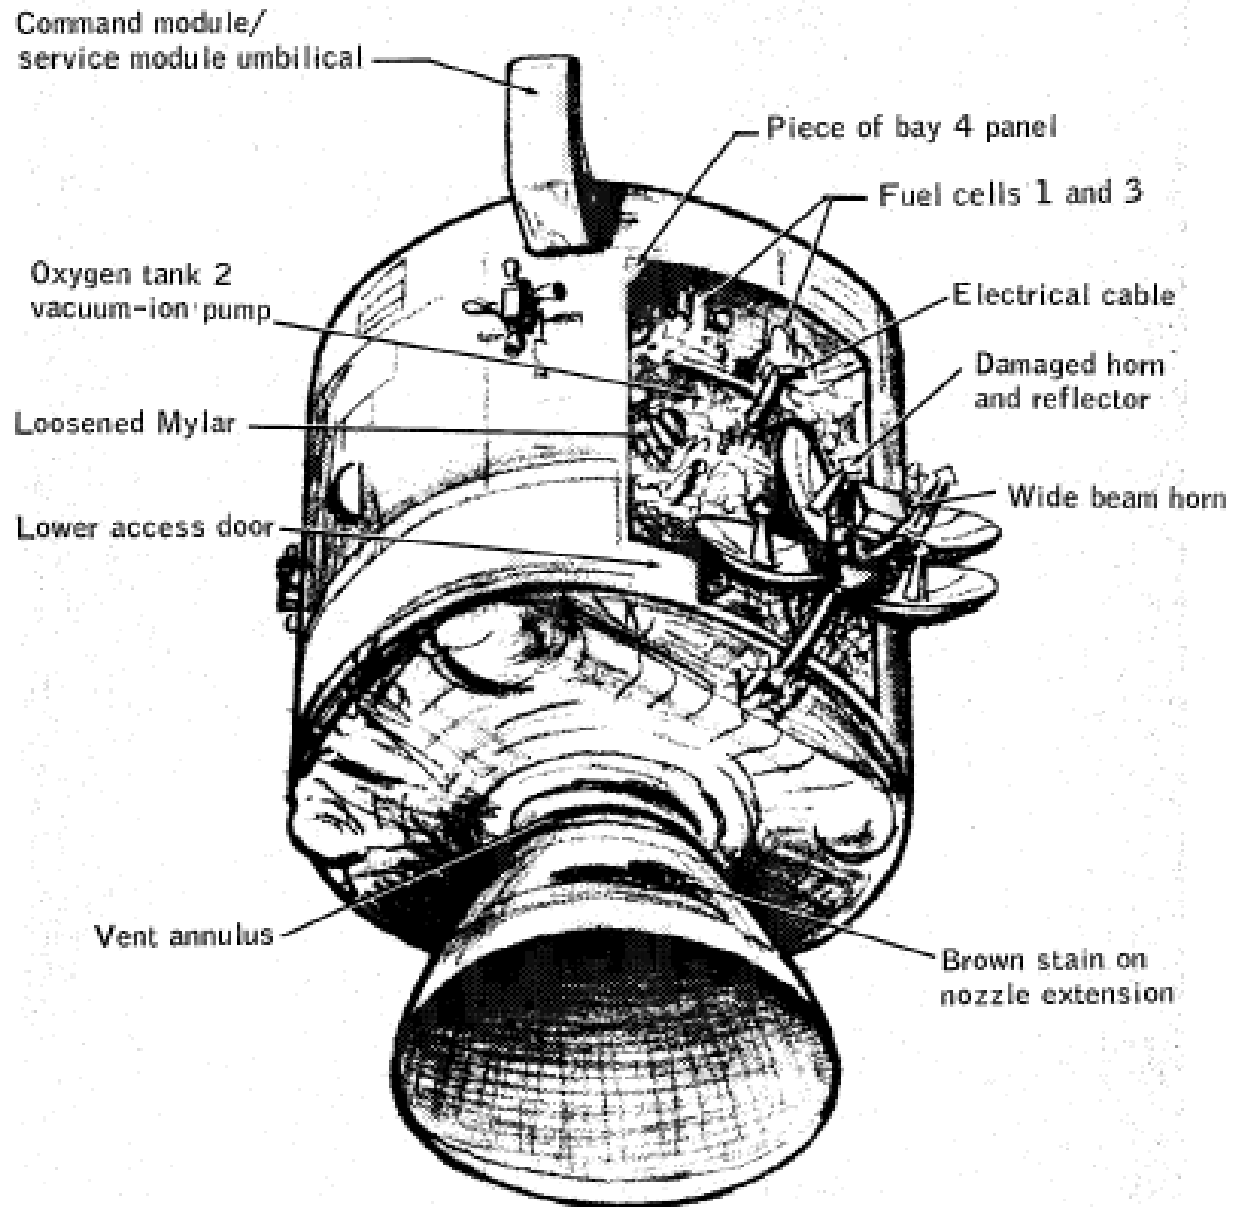
NASA photo AS13-59-8500

- O₂ tank 2 exploded, blowing off a panel cover on the SM, changed spacecraft delta-v by 0.5 fps
- Panel struck and damaged High-Gain Antenna
- Explosion shocked several RCS valves closed
- Explosion shocked fuel cells 1 & 3 reactant valves closed
- O₂ tank 1 started leaking (would be empty in ~2.5 hrs)
- Venting produced forces that were eventually counteracted by Automatic Stabilization System
- Many sensors failed off-scale high or low, or static, so flight controllers not sure they can trust their data

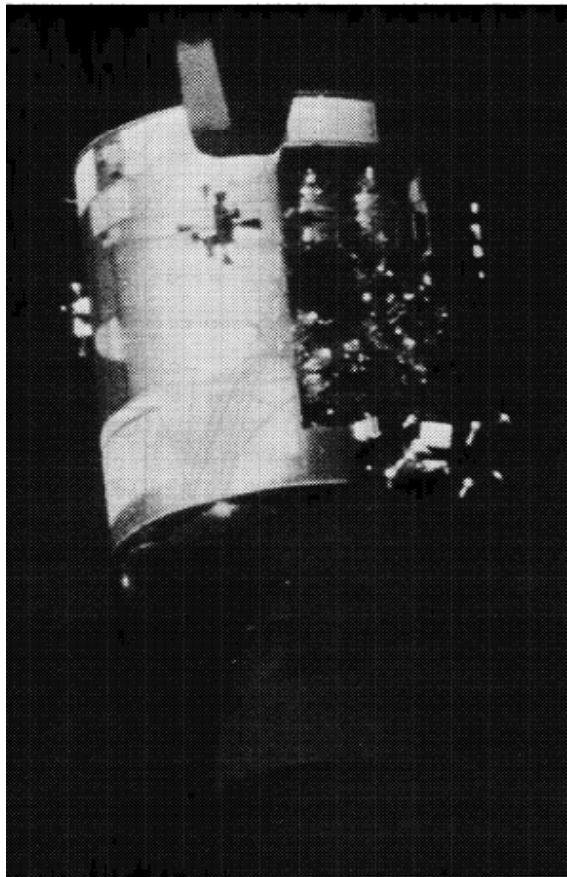
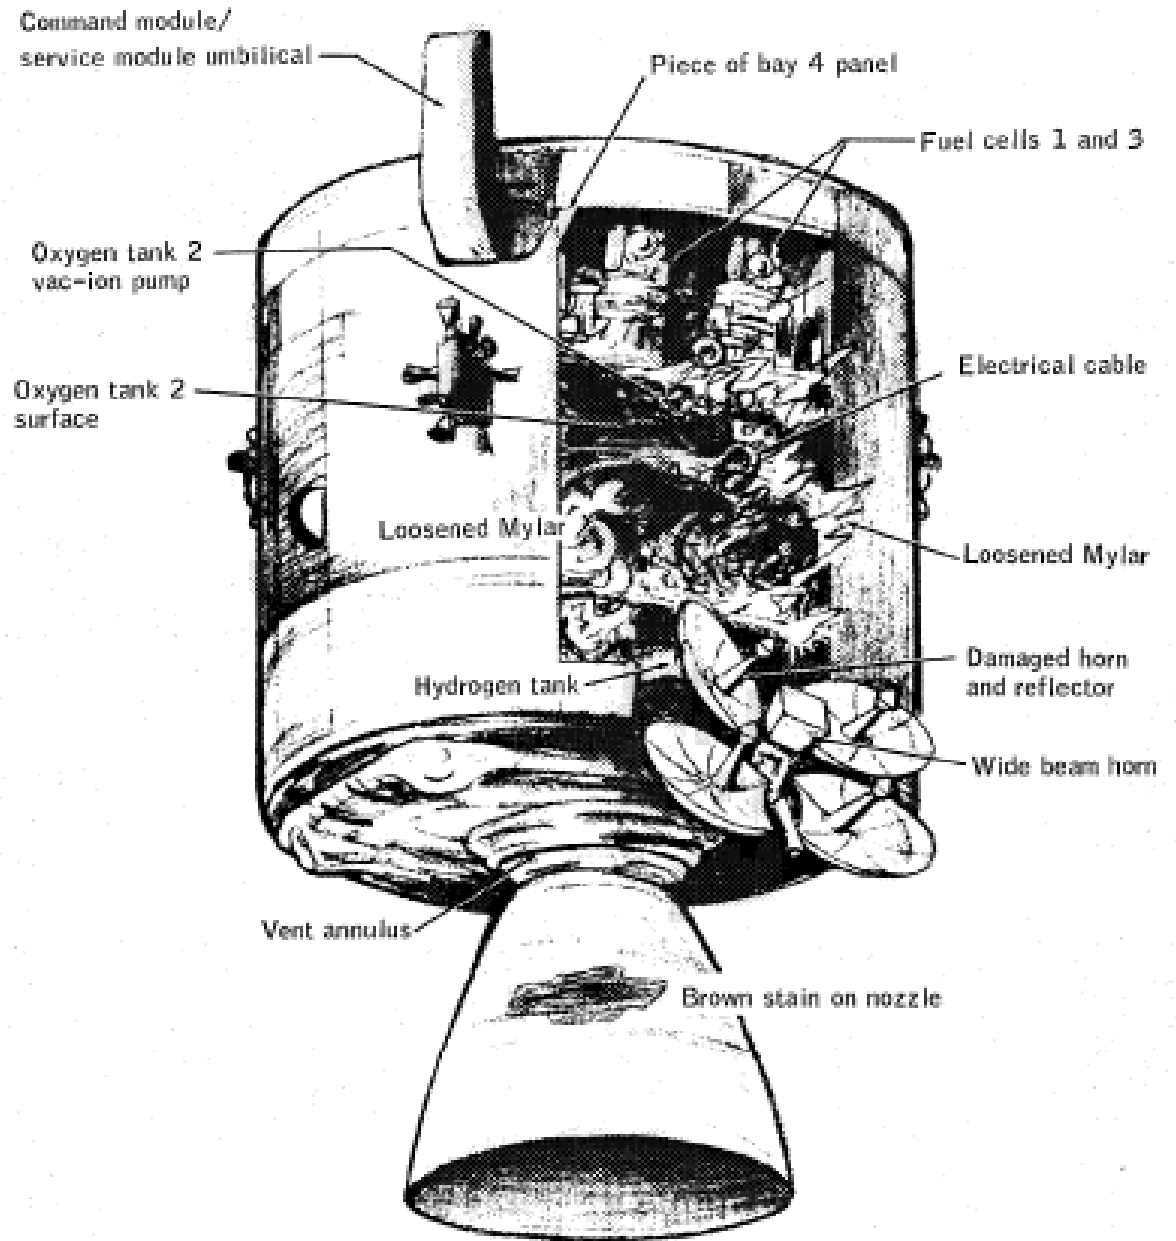
Figure 4-18.- 70-mm color film frame 8464.

(a) Onboard camera view.

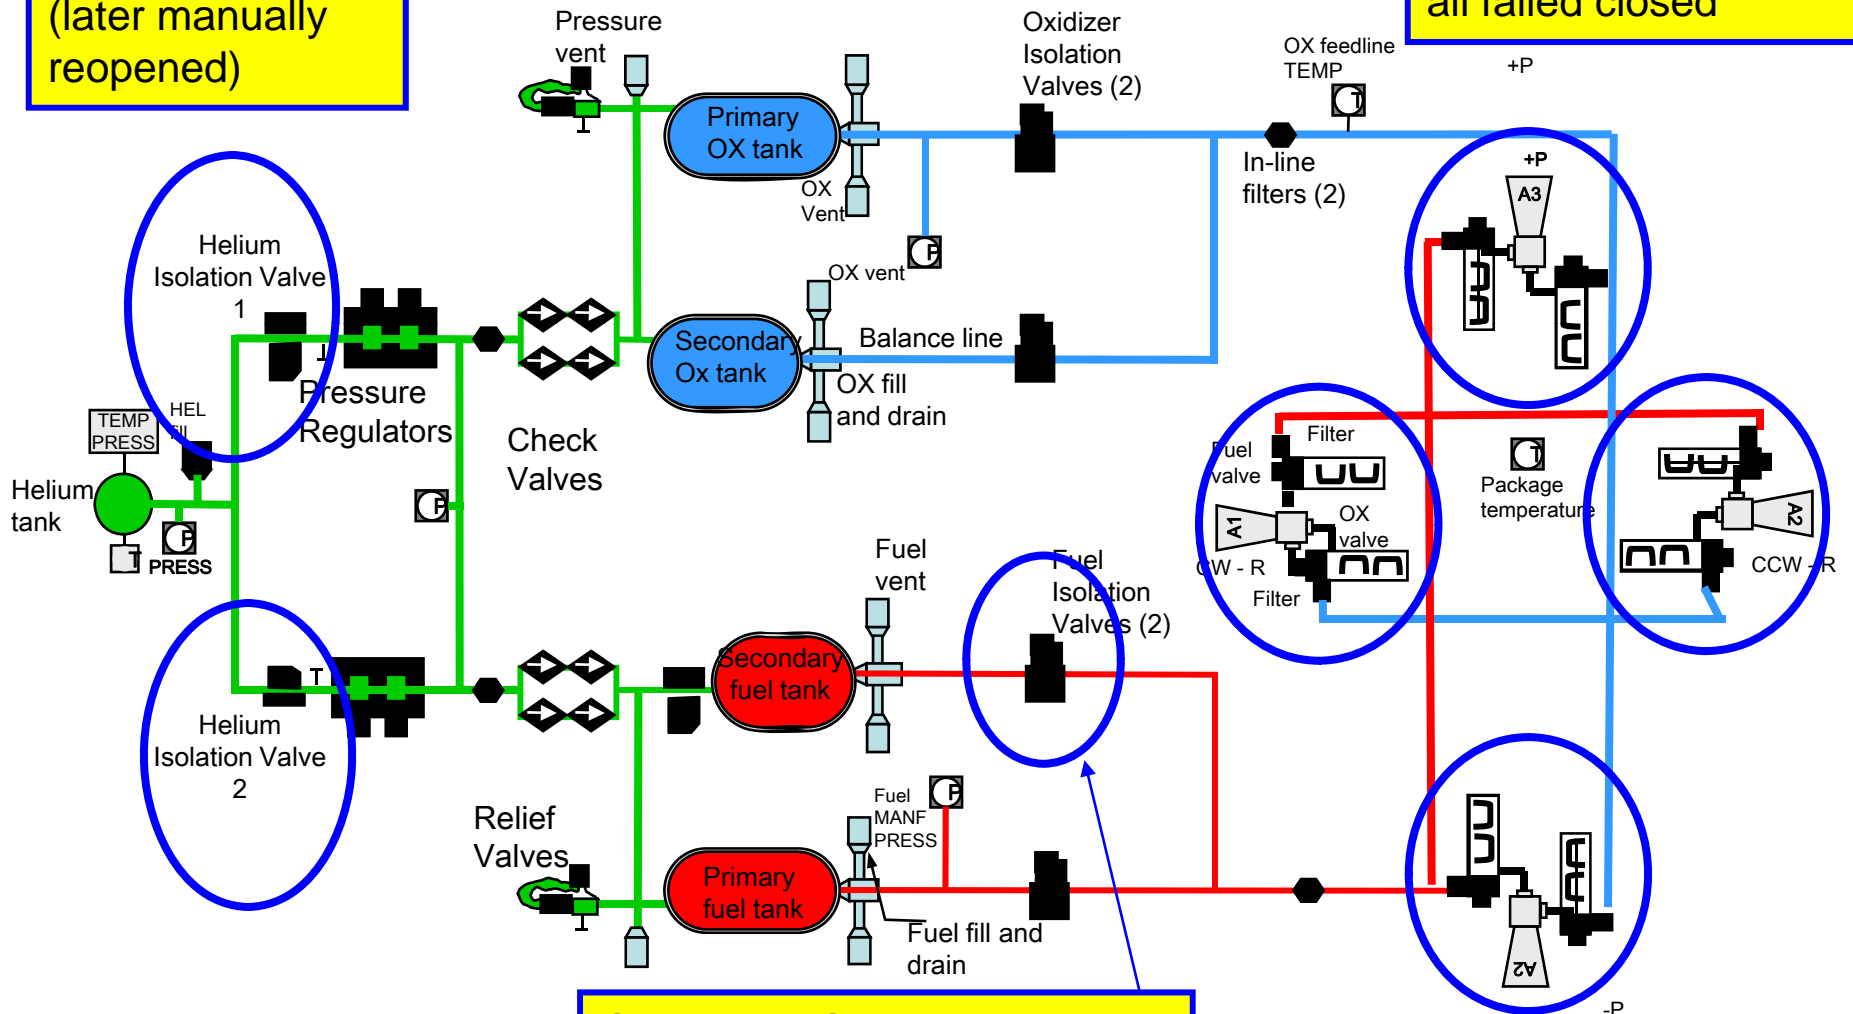
Quads B&D:
Helium isols
shocked closed
(later manually
reopened)

Quad C: inlet valves
all failed closed

Quads A&C: Secondary fuel
isols shocked closed

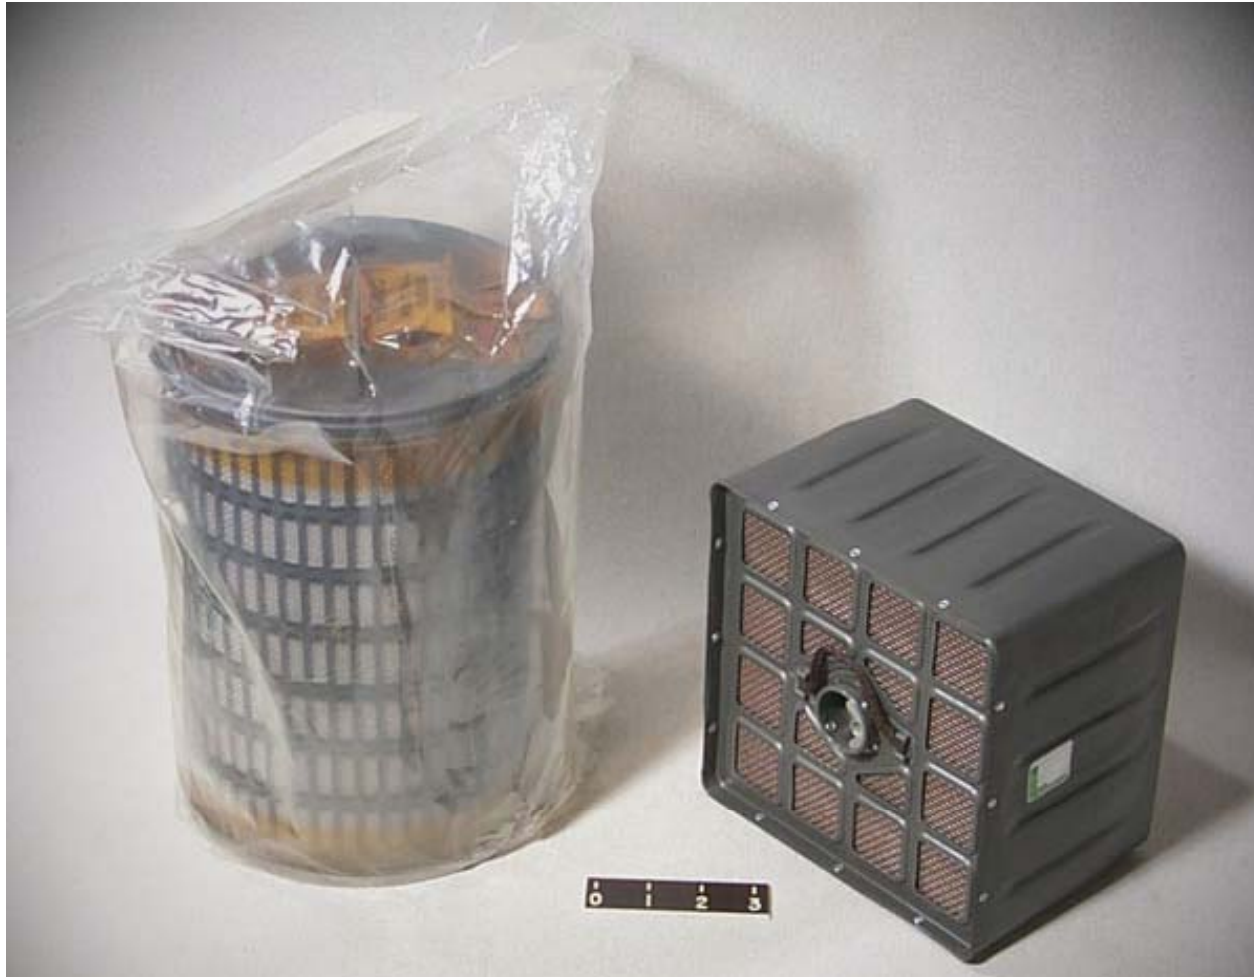
- ❑ Square LiOH cans from CM (to remove CO₂) not compatible with round LiOH slots in LM
 - Only 53 hrs of capability with LM alone, needed another 85 hrs
 - In-flight maintenance (IFM) to adapt the LM cans using plastic Flight Data File covers, plastic bags, and lots of gray tape
- ❑ Some O₂ left in CM surge tank and repress tanks
 - Normally used to repress the cabin after venting
- ❑ Powerdowns also reduce heat loads, so less water required for cooling

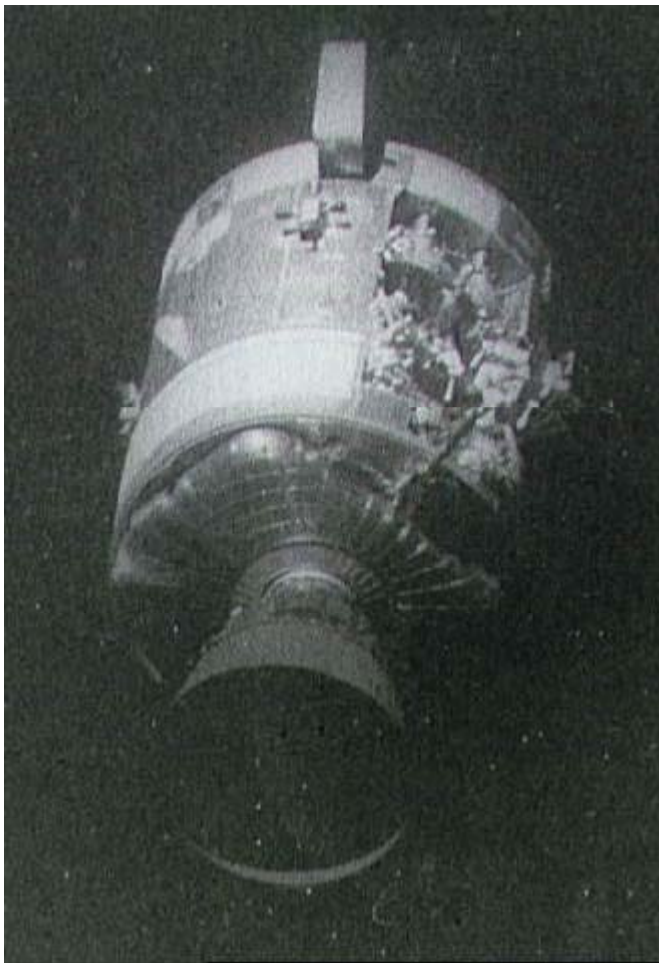
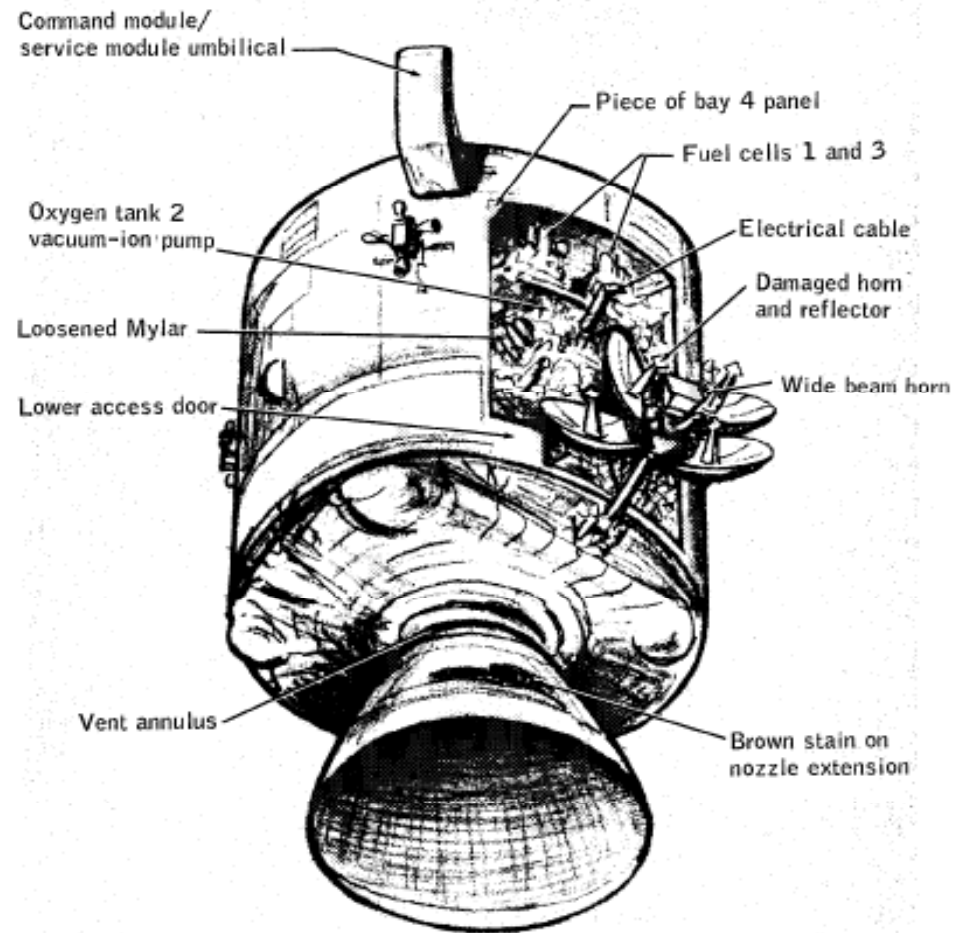
NASA photo AS13-59-8500

- ❑ Crew took photos/video of the SM after jettison, the first time anyone had seen the damage.
