NASA/TM—2009—000000

# Mitigation of EMU Glove Cut Hazard by MMOD Impact Craters on Exposed ISS Handrails

*Shannon Ryan  
Lunar and Planetary Institute  
Johnson Space Center, Houston, Texas*

*Eric L. Christiansen  
Johnson Space Center, Houston, Texas*

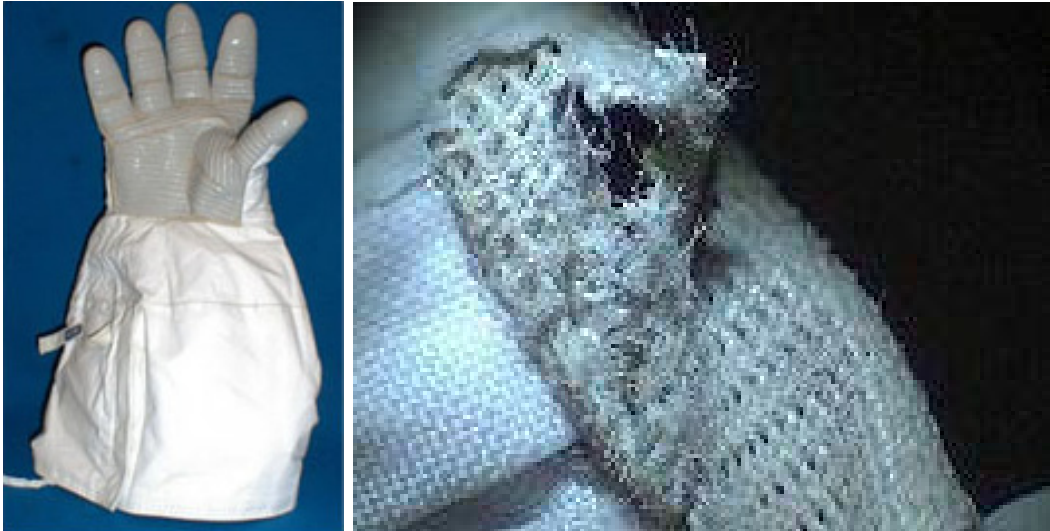
**Figure 1:** Damage to crewmember Curbeam's Phase VI glove following EVA 3 of STS-116.

Evaluation of glove damage showed that the outer Vectran fibers were sliced as a result of contact with a sharp edge or pinch point rather than general wear or abrasion (commonly observed on the RTV pads). Damage to gloves was also noted on STS-118 [2] and STS-120 [3].

Redesign efforts are currently underway to increase the resilience of EMU gloves. For example, during STS-124 a modified EMU glove was used that incorporated Vectran TurtleSkin® patches on areas of high wear (lower part of thumb and upper part of index finger). TurtleSkin is a protective fabric material commonly used in protective vests for knife protection given its extremely tight weave, providing superior protection against cuts and penetration than common woven fabrics. The modified glove is shown in Figure 4. Preliminary analysis of glove damage suggested that the modification was successful in reducing glove damage.

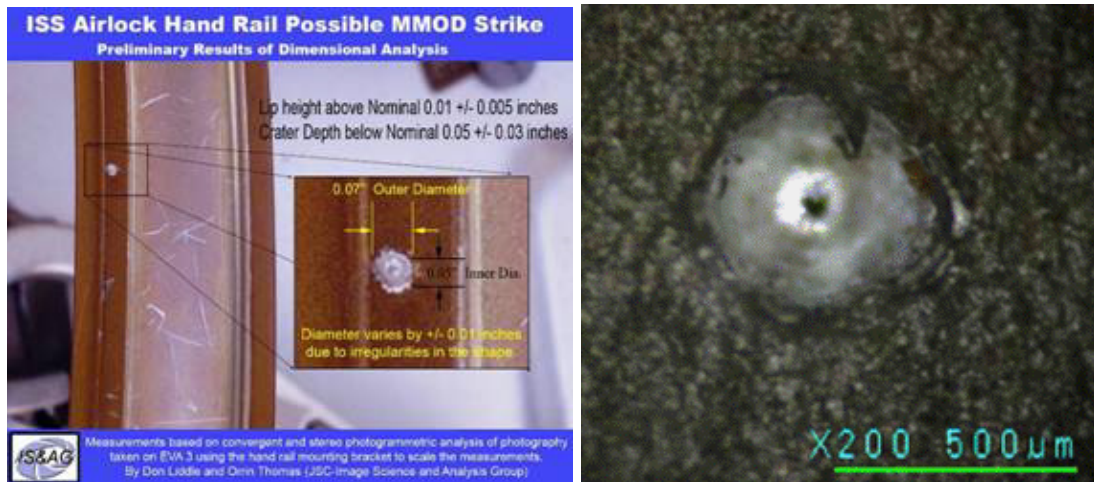
One potential source of Extravehicular Mobility Unit (EMU) glove damage are sharp crater lips on external ISS handrails. Hundreds of handrails are installed on the external surface of the ISS and are therefore subject to impact from micrometeoroid and orbital debris (MMOD) particles. Returned flight hardware has demonstrated the susceptibility of these structures to regular MMOD impacts, examples of which are shown in Figure 2 (ISS Airlock, S-band Antenna Structural Assembly (SASA)) and Figure 3 (Nitrogen Tank Assembly (NTA)).

**Figure 2:** Damage to returned handrail surfaces by possible MMOD impacts. Left: ISS Airlock handrail (~1.8 mm outer diameter crater); Right: SASA handrail (~0.5 mm diameter crater).

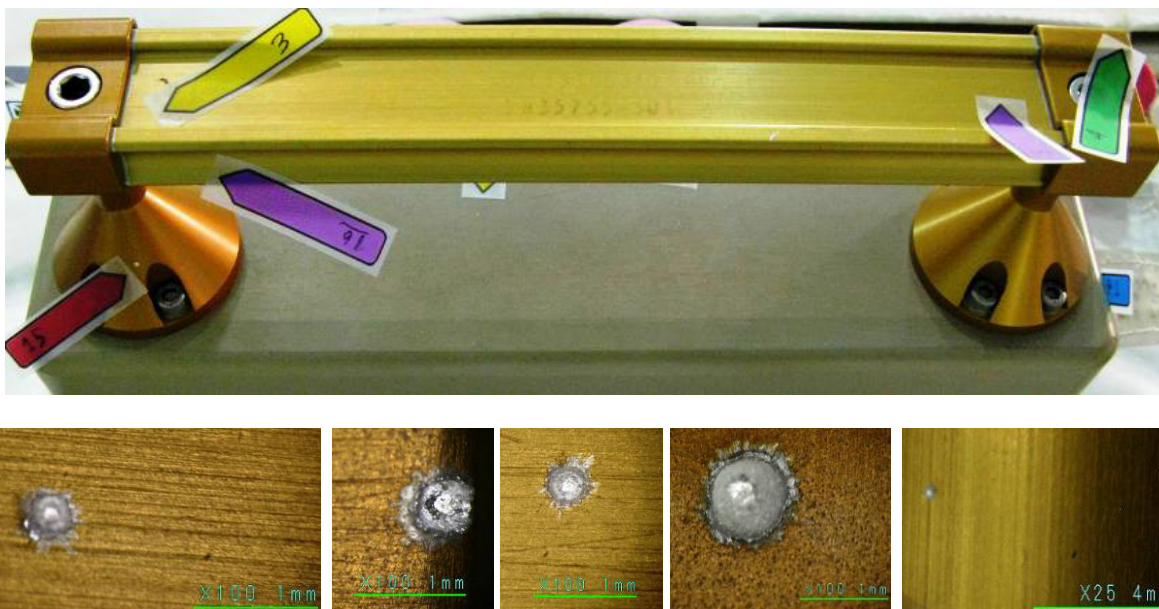
**Figure 3:** MMOD impacts on the returned NTA handrail. Top: Location of impacts; Below: Close-up of impact craters (from left-to-right: impacts 3, 4, 5, 15, 16).

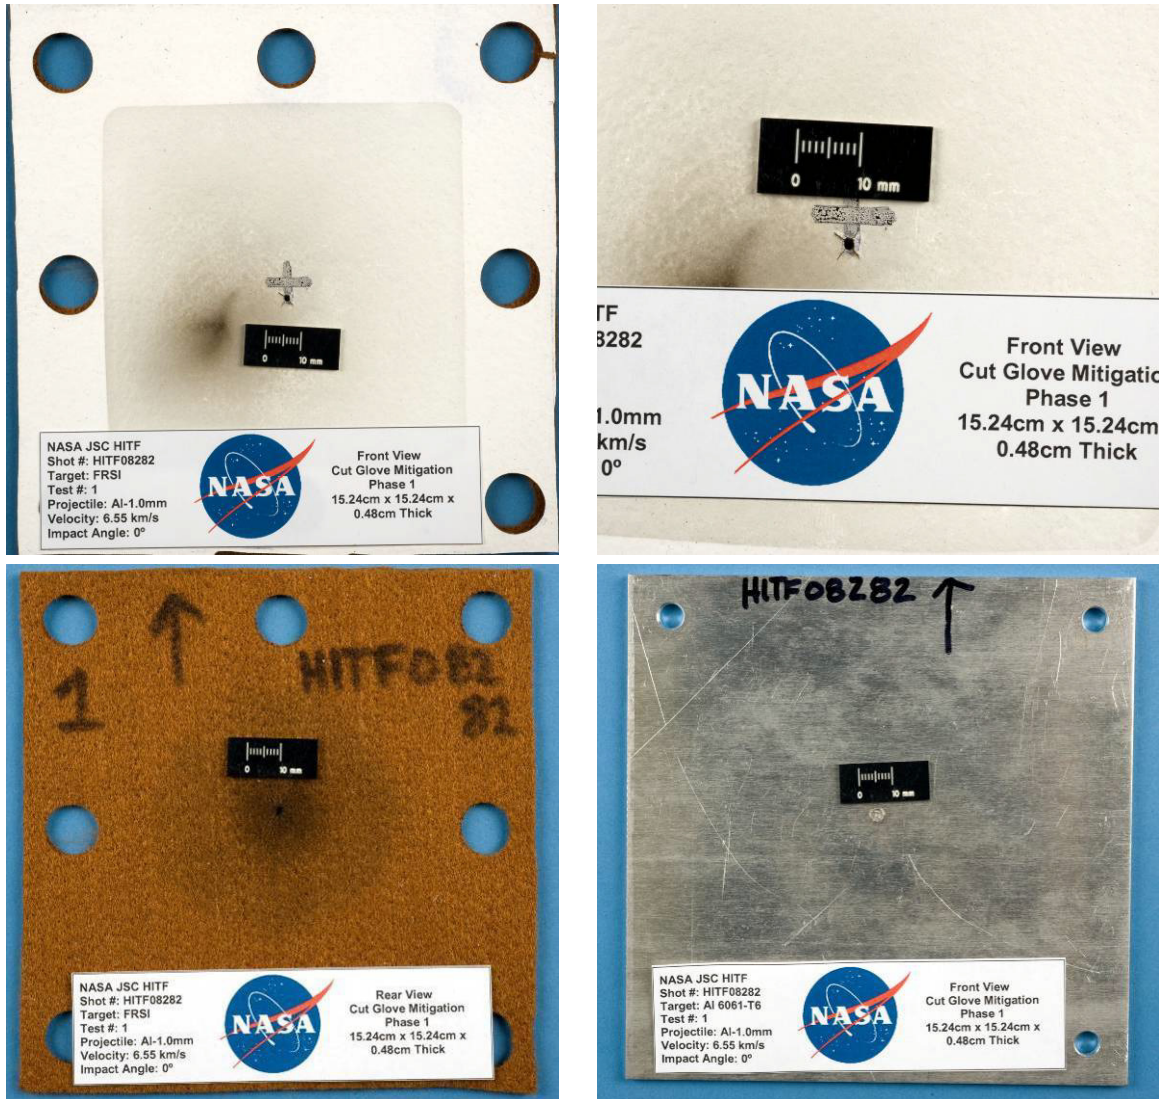
**Figure 1:** HITF08282 post-test damage photographs. Top left to bottom right: overwrap front side, overwrap front side (zoom), overwrap rear side, target plate front side.

Test #1 of Phase 1 (HITF08282) investigated a 1.0 mm diameter Al 2017-T4 sphere impacting at a velocity of 6.55 km/s with normal incidence (0°) on a 4.826mm thick Al6061-T6 plate covered by a Felt Reusable Surface Insulation (FRSI) overwrap. Impact of the projectile generated a roughly circular entry hole in the overwrap, with four radial cracks (length  $\approx$  3mm) propagating from each corner of the hole. On the rear side, the exit hole was centered in a zone of dark discoloration (diameter  $\approx$  19mm). The crater on the target plate was clearly formed with a roughly hemispherical shape and a protruding crater lip. There was no noticeable damage on the rear side of the target.

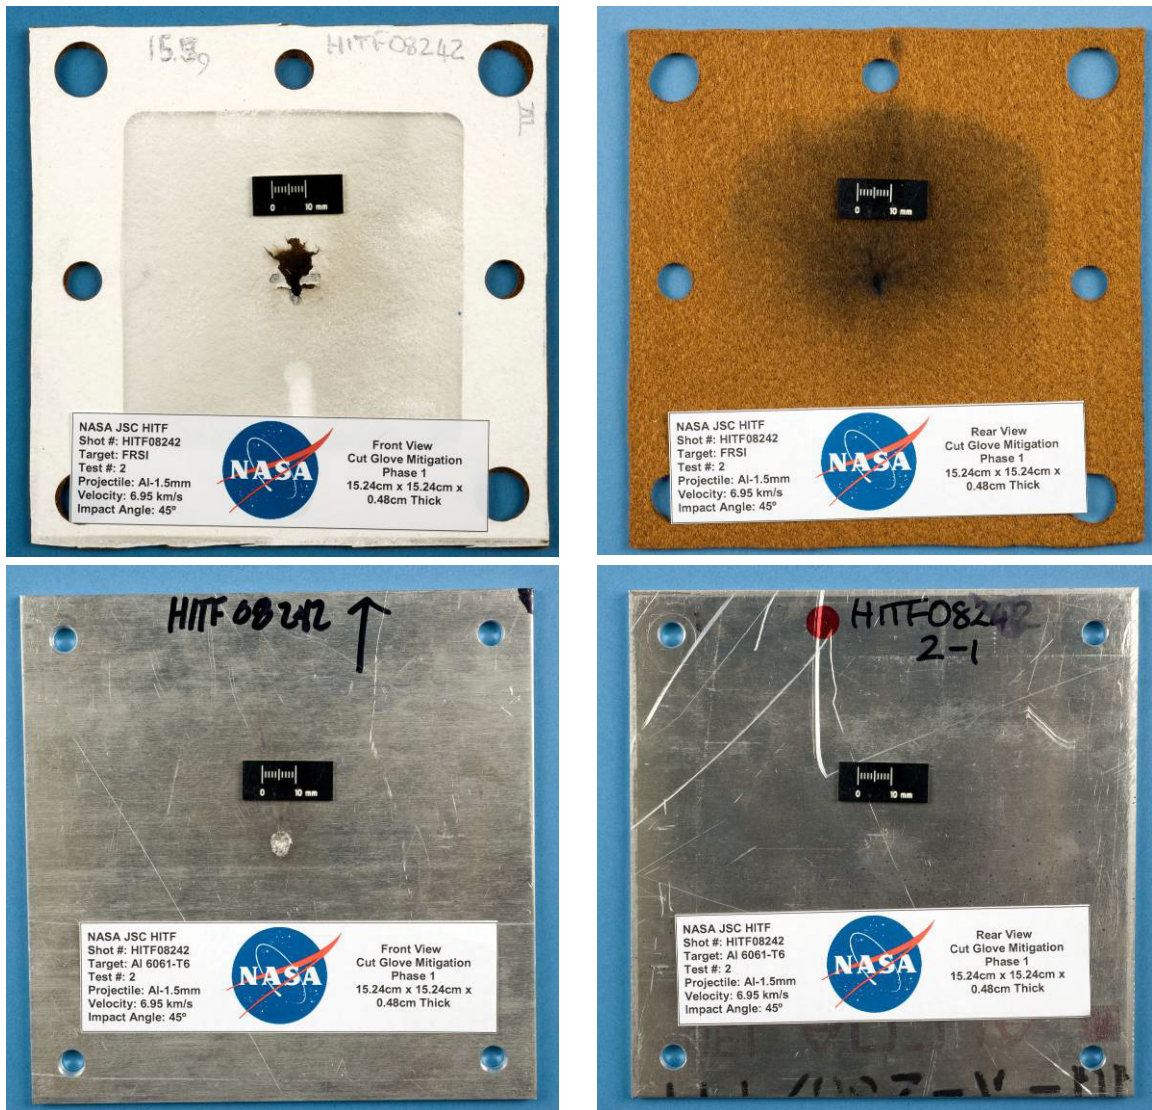
**Figure 3:** HITF08242 post-test damage photographs. Top left to bottom right: overwrap front side, overwrap rear side, target plate front side, target plate rear side.

Test #2 of Phase 1 (HITF08242) investigated a 1.5 mm diameter Al 2017-T4 sphere impacting obliquely ( $45^\circ$ ) with a velocity of 6.95 km/s on a 4.826 mm thick Al6061-T6 plate covered by a FRSI overwrap. Impact of the projectile generated an elliptical entry hole in the overwrap, which was surrounded by a number of cracks (~8) and frayed felt. The rear side of the overwrap showed a semi circular region of discoloration (radius  $\approx 52$ mm) about the elliptical exit hole, with the darkest region located above the clear hole. The crater on the target plate was clearly formed, slightly elliptical in shape with a sharply protruding crater lip (max height = 0.7 mm). The rear side of the target showed a minimal amount of bulging.

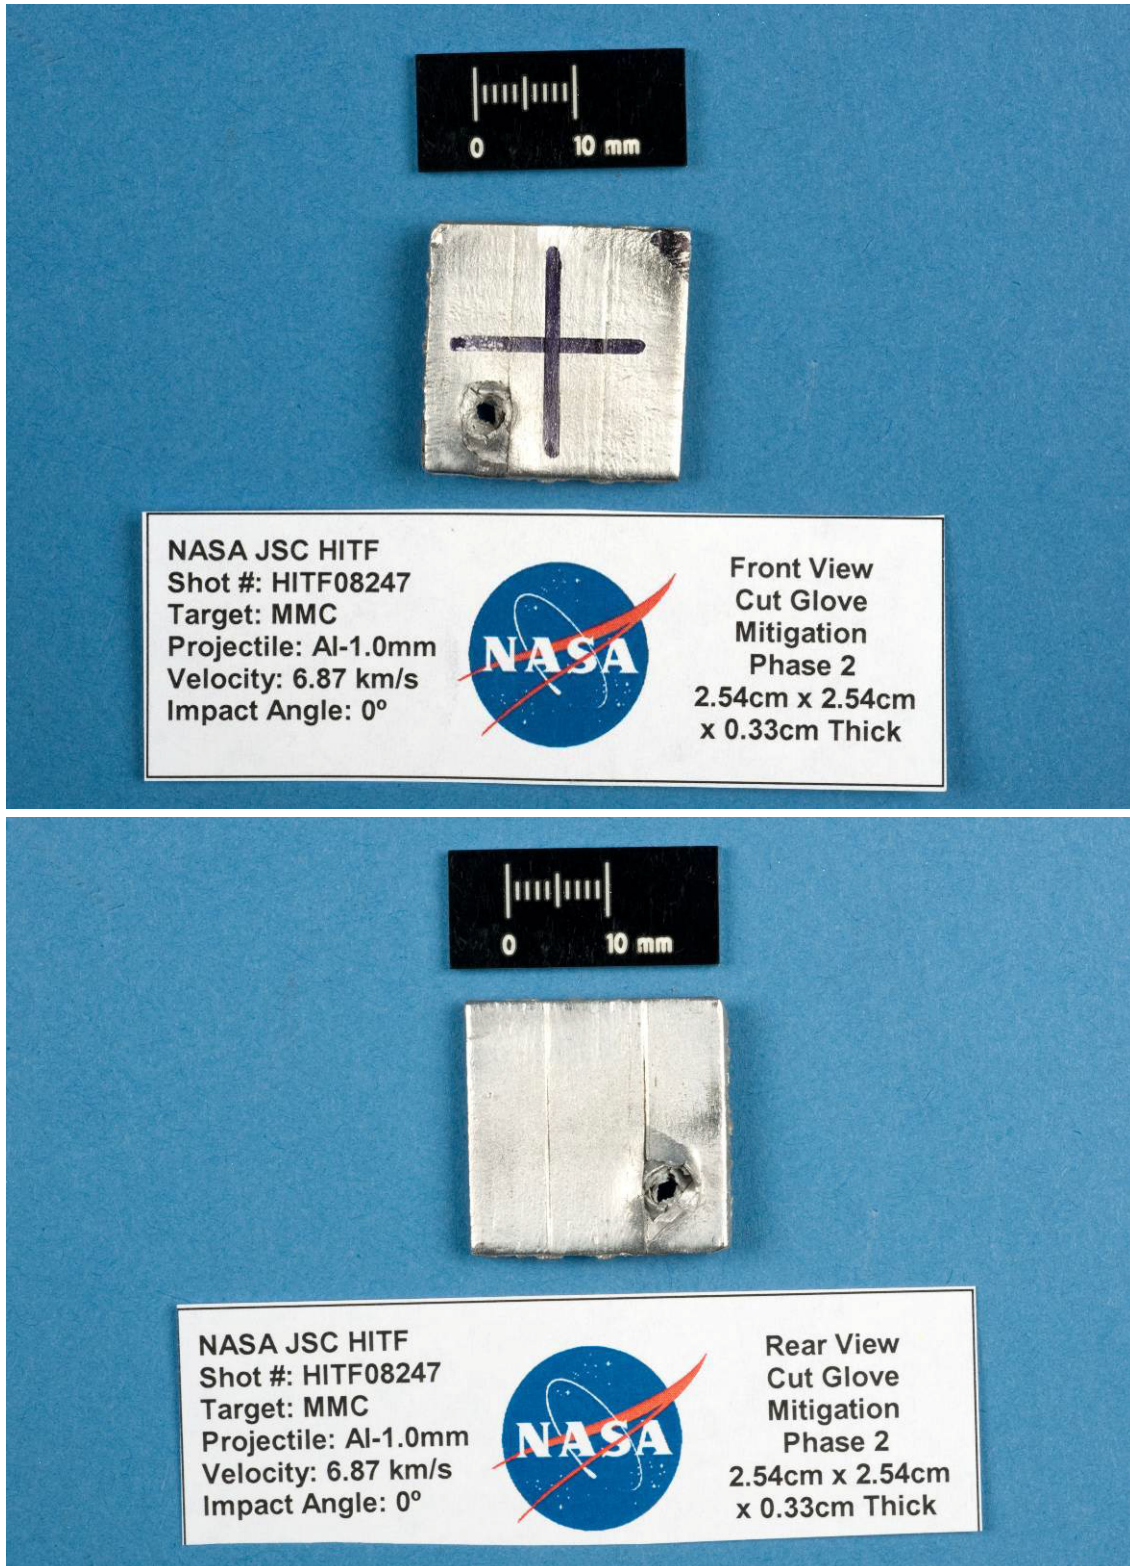
Figure 17: HITF08247 post-test damage photographs. Top to bottom: front side damage (entry hole), rear side damage (exit hole).

Test #1 of Phase 2 (HITF08247) investigated a 1.0 mm diameter Al 2017-T4 sphere impacting at a velocity of 6.87 km/s with normal incidence ( $0^\circ$ ) on a 3.3mm thick Nextel 610 fiber reinforced aluminum composite. The projectile clearly perforated the target, generating a circular entry hole. The upper lamina of the MMC shows brittle failure of the crater lip, resulting in the maximum lip height being measured on the 2<sup>nd</sup> composite lamina. The rear of target shows an elliptical clear hole with surface spallation of the outer ply. There is some cracking on the top edge of exit hole as well as some slight petalling about the lower edge of the hole.

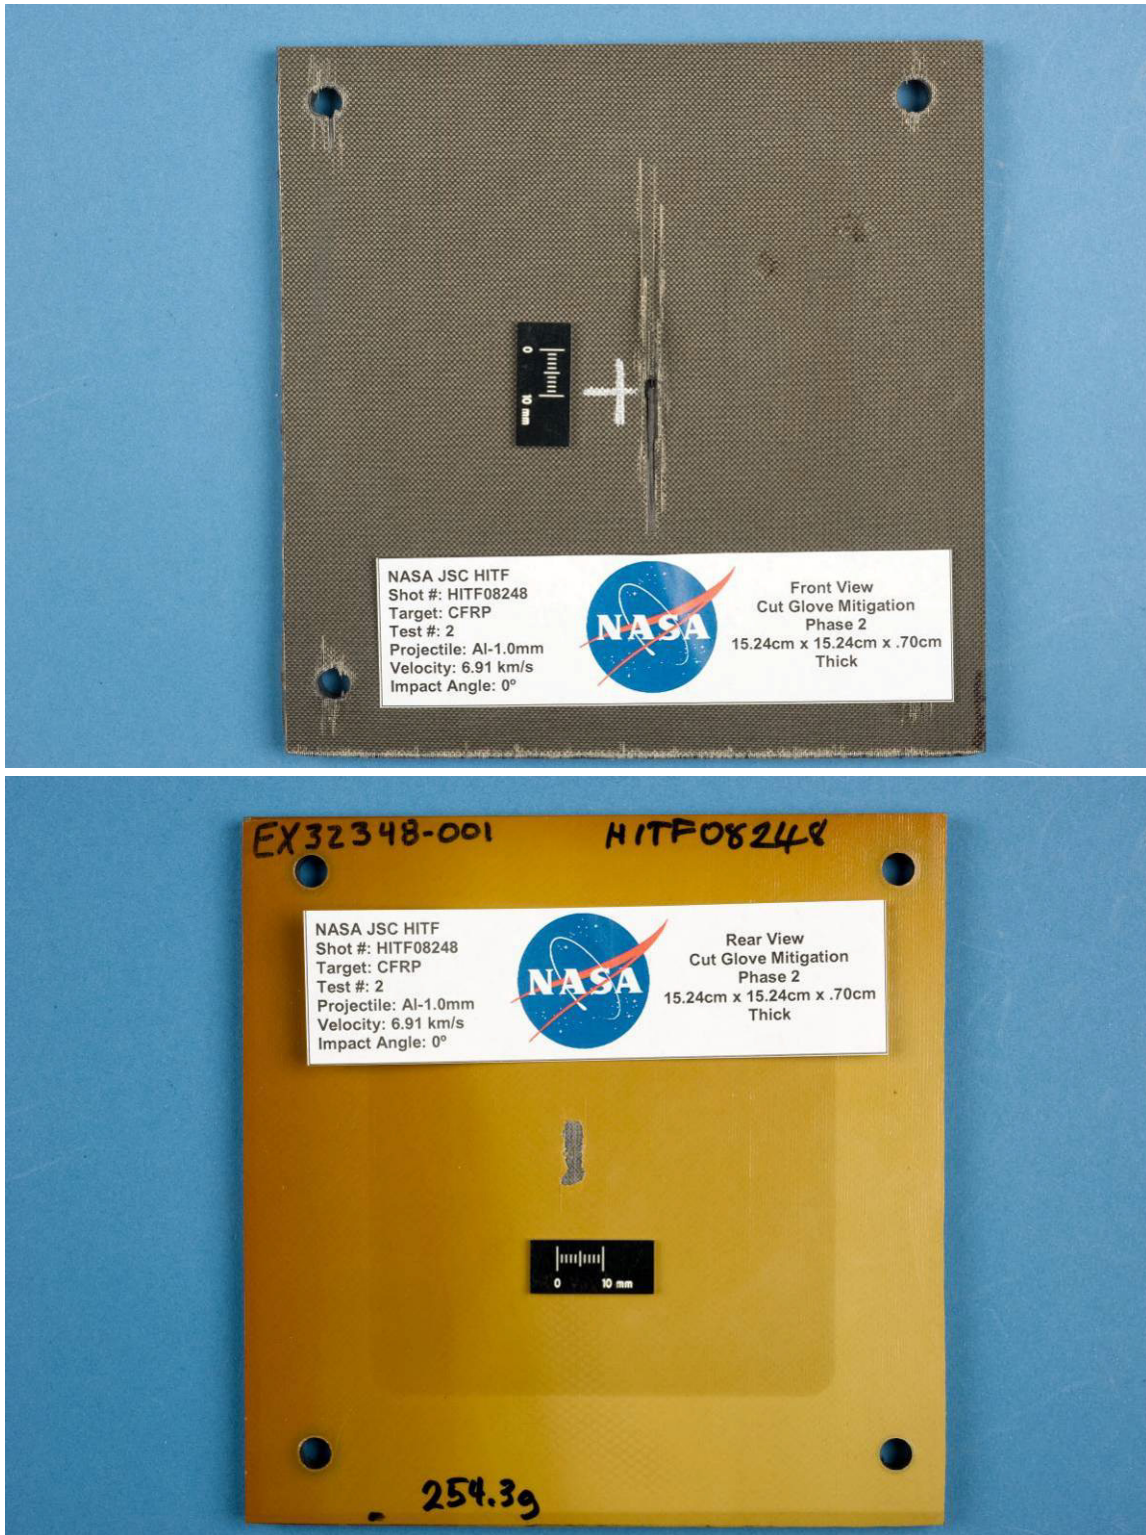
Figure 19: HITF08248 post-test damage photographs. Top to bottom: front side damage (entry hole), rear side damage (surface spallation).

Test #2 of Phase 2 (HITF08248) investigated a 1.0 mm diameter Al 2017-T4 sphere impacting at a velocity of 6.91 km/s with normal incidence on a 7.03 mm thick CFRP panel. Impact from the projectile generated a circular entry hole with significant surface spallation and cracking along the target vertical axis. Although the entry hole does not have any visible lip, the spalled fibers protrude significantly from the face of the laminate. An area ( $\approx 4\text{ mm} \times 14\text{ mm}$ ) of adhesive (AF191) was spalled from the rear side of the target, however this is not considered as damage to the test article as the CFRP rear side was undamaged.

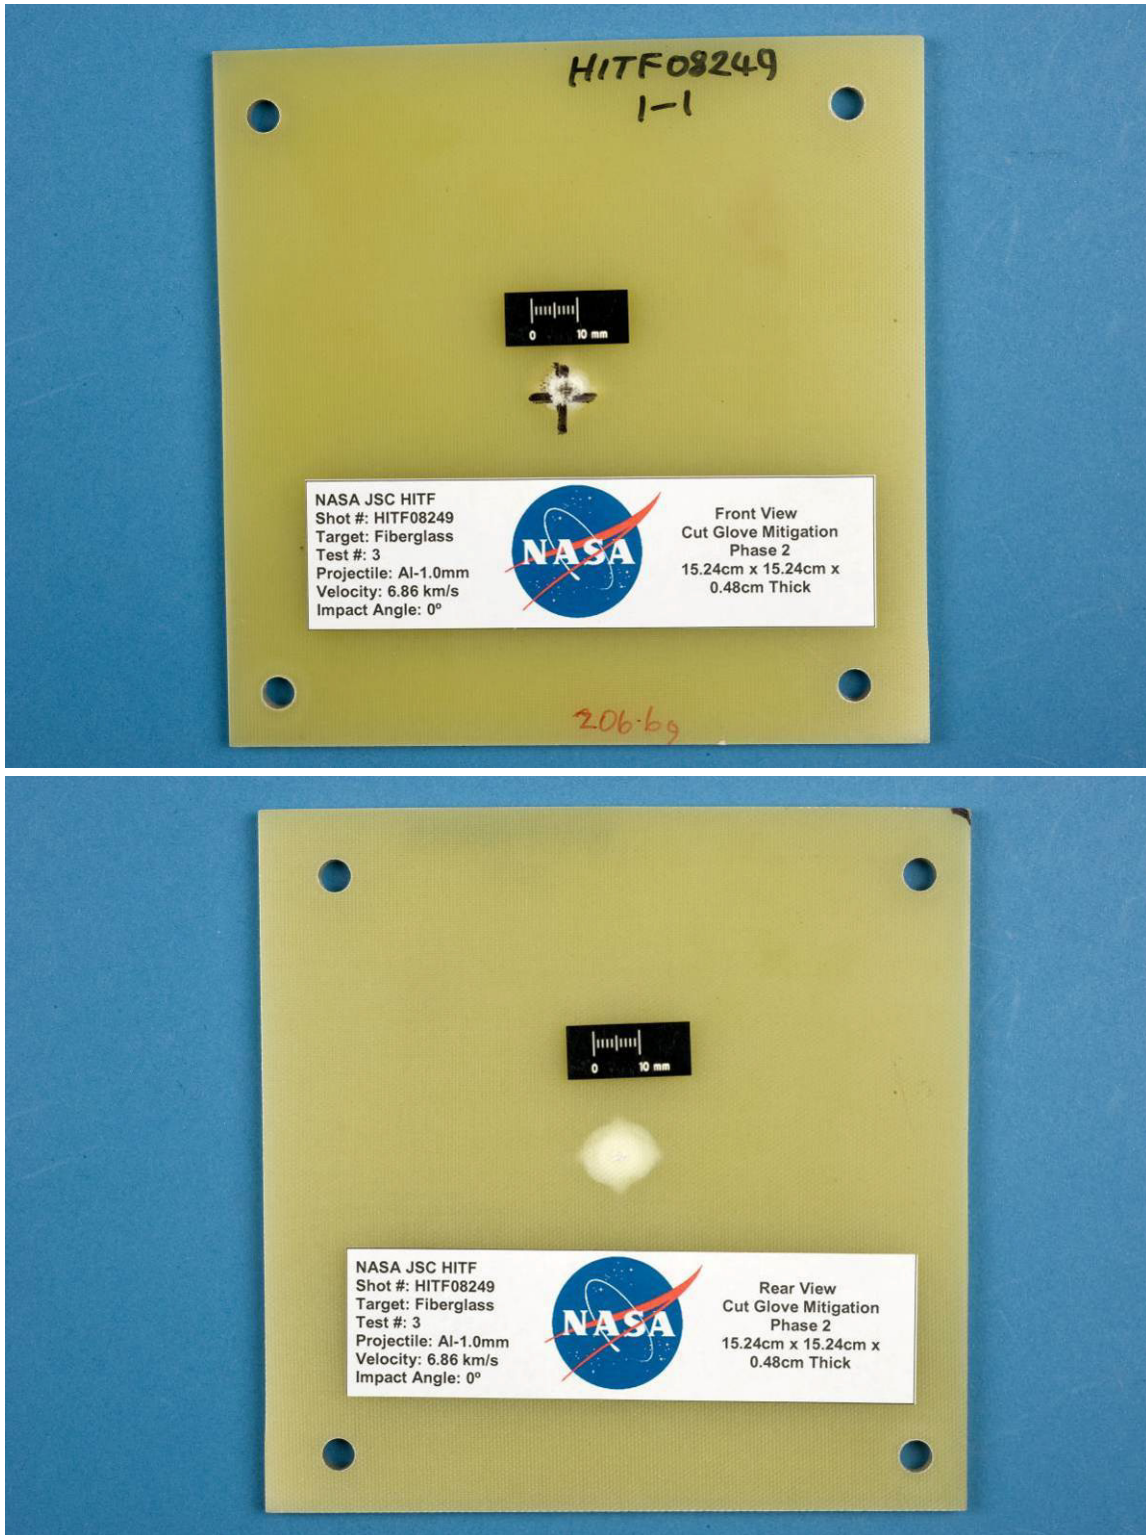
**Figure 21:** HITF08249 post-test damage photographs. Top to bottom: front side damage (entry hole), rear side damage (white area is internal damage and delamination).

Test #3 of Phase 2 (HITF08249) investigated a 1.0 mm diameter Al 2017-T4 sphere impacting at a velocity of 6.86 km/s with normal incidence ( $0^\circ$ ) on a 4.826mm thick NP500CR fiberglass composite panel. There is a roughly circular entry hole, about which frayed and broken glass fibers are observable. There is clear internal delamination, identified as a white area about the clear hole, which measures  $\sim 11$ mm in diameter. The rear of target shows a small area of surface damage (considerably smaller than the extent of internal delamination), which is slightly bulged from the plane of the target rear side. There is noticeable bias of the delamination along the fiberglass primary in-plane directions.

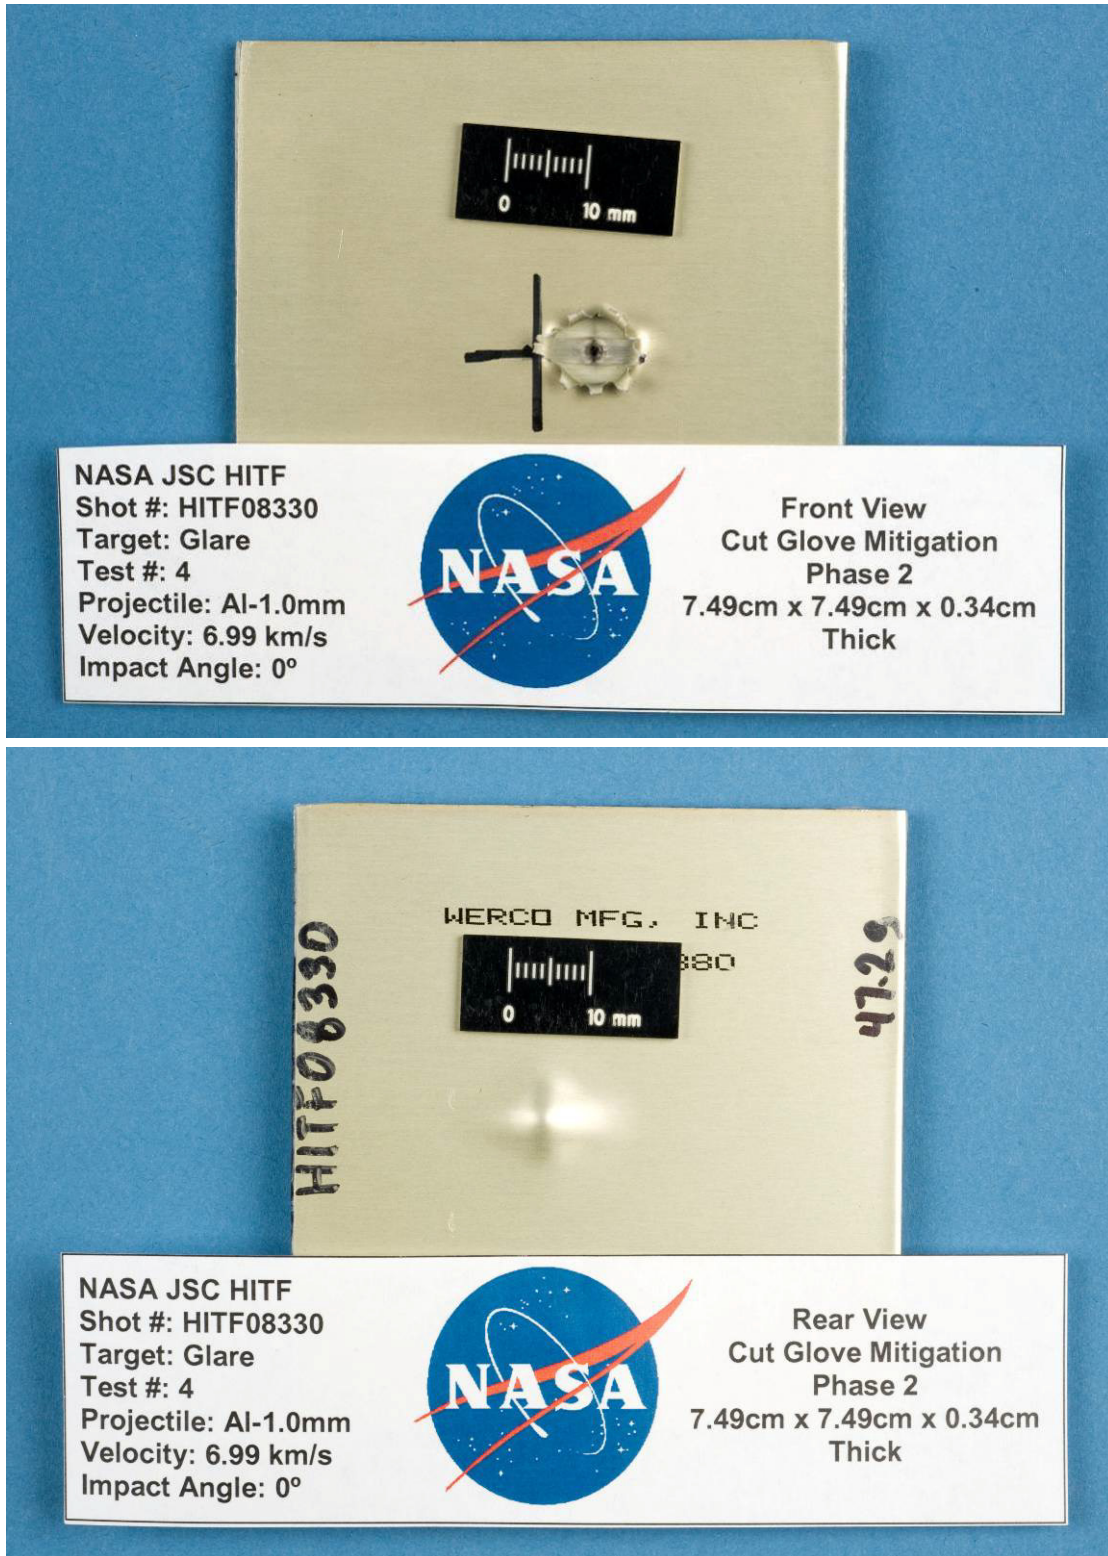
**Figure 23:** HITF08330 post-test damage photographs. Top to bottom: front side damage (entry hole), rear side damage (rear surface bulge).

Test #4 of Phase 2 (HITF08330) investigated a 1.0 mm diameter Al 2017-T4 sphere impacting at a velocity of 6.99 km/s with normal incidence ( $0^\circ$ ) on a 3.4mm thick glass-reinforced Fiber Metal Laminate (Glare). Impact from the projectile generated an entry hole into the target which was circular in shape with petalling of the crater lip (seven petals, height = 3.5mm). The petals are formed from the upper aluminum layer in the FML. The rear of target shows a steep bulge, however there is no spallation of any material.
