MITIGATION OF EMU CUT GLOVE HAZARD FROM MICROMETEOROID AND ORBITAL DEBRIS IMPACTS ON ISS HANDRAILS

ABSTRACT

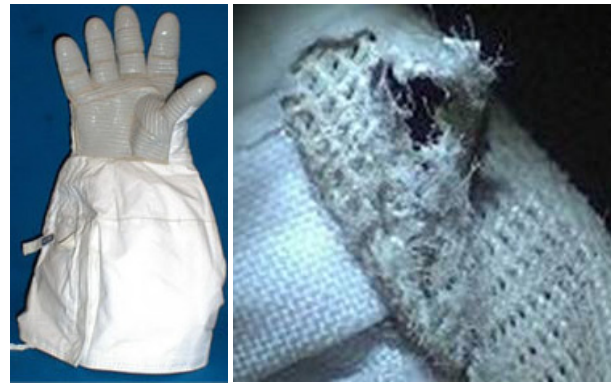
During post-flight processing of STS-116, damage to crewmember Robert Curbeam's Phase VI Glove Thermal Micrometeoroid Garment was discovered (shown in Figure 1). This damage consisted of: loss of RTV-157 palm pads on the thumb area on the right glove and a 0.75 inch cut in the Vectran adjacent to the seam and thumb pad (single event cut), constituting the worst glove damage ever recorded in "the history of going EVA for the U.S. program" [1]. The underlying bladder and restraint were found not be damaged. Evaluation of glove damage showed that the outer Vectran fibers were sliced as a result of contact with a sharp edge or pinch point rather than general wear or abrasion (commonly observed on the RTV pads). Damage to gloves was also noted on STS-118 [2] and STS-120 [3]. A potential source of EMU glove cut hazard is micrometeoroid and orbital debris (MMOD) impact craters on ISS handrails. Returned flight surfaces (see e.g. nitrogen tank assembly handrail in Figure 2) have demonstrated the susceptibility of these structures to regular MMOD impacts.

Figure 1. Damage to crewmember Curbeam's Phase IV glove following EVA 3 of STS-116

Redesign efforts are currently underway to enhance the resiliency of EMU gloves to cut hazards. In the meantime, temporary reinforcements (TurtleSkin® patches) have been added to high wear areas (lower part of thumb and upper part of index finger). Parallel efforts have been made to characterize MMOD impact damage profiles on representative and actual ISS flight hardware and mitigate the cut hazard posed by these profiles on crewmember EMU gloves. In this paper, the results of these characterization and mitigation impact test studies are presented and suggestions for modifications to ground equipment yet to be flown are made.

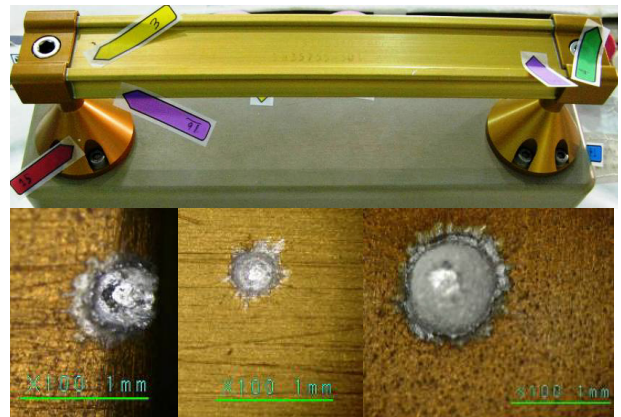
Figure 2. MMOD impacts on the returned nitrogen tank assembly handrail. Top: location of impacts; Below: impact craters 4, 5, 15 (left-to-right)

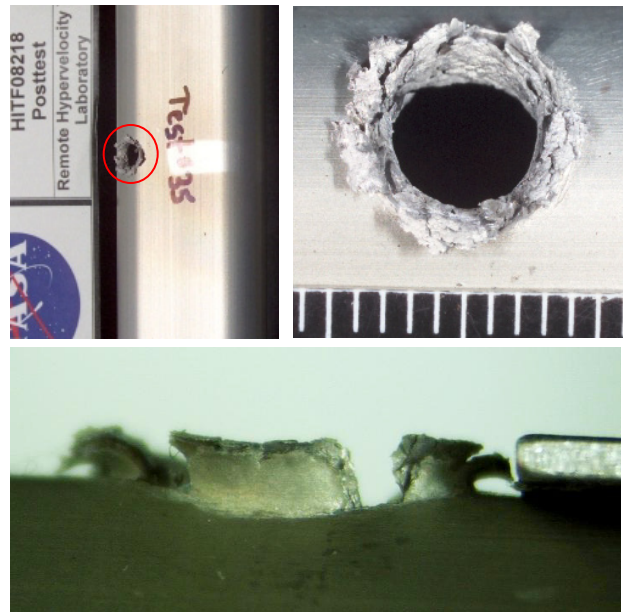
Figure 6: Impact damage on a tubular ISS handrail induced by impact of a 0.15 cm diameter Al2017-T4 sphere at 6.95 km/s with normal (0°) incidence

For the tubular handrail configuration, entry hole diameters were also commonly 3-4 times the diameter of the projectile. However, impact crater lips did not protrude above the handrail surface as much as on the rectangular configuration. The more hazardous crater profiles on the rectangular handrail were found upon the thicker sections. Thus, damage profiles on the thin tubular handrails were not expected to protrude as significantly as on the reinforced sections of their rectangular counterparts. A maximum raised crater lip of 1.9 mm was measured for the tubular handrail, induced by impact of a 1.5 mm diameter Al2017-T4 sphere at 6.95 km/s with normal incidence. None of the 12 impact tests on the tubular handrail resulted in ejection of material from the rear side of the handrail target.
