Helios High Altitude Long Endurance Mission Mishap

Photos Taken of HP03-2 26 June 2003

Photos Taken of HP03-2 Following Mishap

The Helios Mishap Root Causes

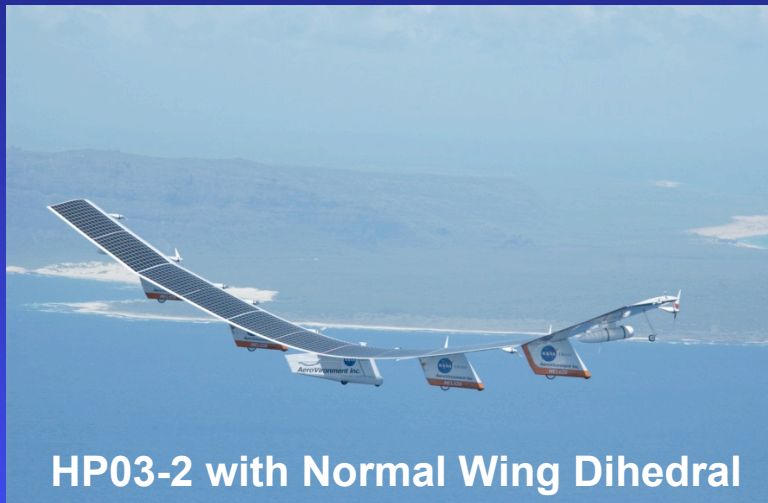
HP03-2 with Normal Wing Dihedral

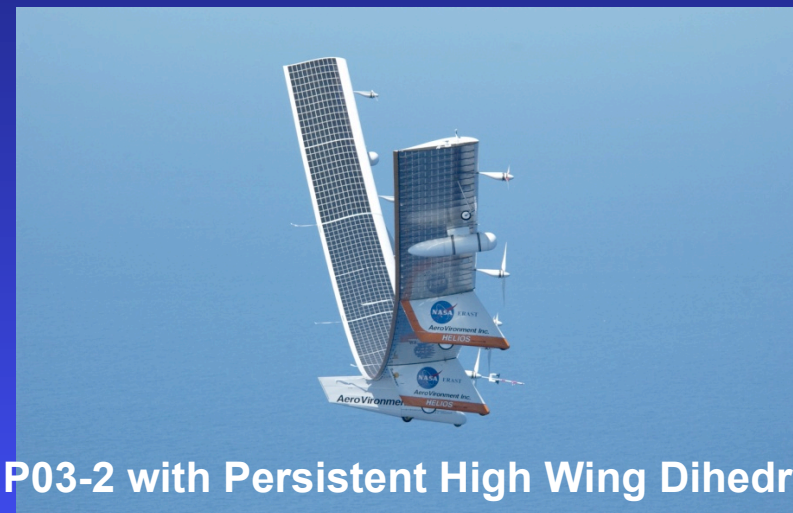
HP03-2 with Persistent High Wing Dihedral

- Lack of adequate analysis methods led to an inaccurate risk assessment of the effects of configuration changes leading to an inappropriate decision to fly an aircraft configuration highly sensitive to disturbances.
- Configuration changes to the aircraft, driven by programmatic and technological constraints, altered the aircraft from a spanloader to a highly point-loaded mass distribution on the same structure significantly reducing design robustness and margins of safety.

- ◆ Develop more advanced, multidisciplinary (structures, aeroelastic, aerodynamics, atmospheric, materials, propulsion, controls, etc) “time-domain” analysis methods appropriate to highly flexible, “morphing” vehicles.
- ◆ Develop ground-test procedures and techniques appropriate to this class of vehicle to validate new analysis methods and predictions.
- ◆ For highly complex projects, improve the technical insight using expertise available from all NASA Centers.
- ◆ Develop multidisciplinary (structures, aerodynamic, controls, etc) models, which can describe the nonlinear dynamic behavior of aircraft modifications or perform incremental flight-testing.
- ◆ Provide adequate resources to future programs for more incremental flight-testing when large configuration changes significantly deviate from the initial design concept.

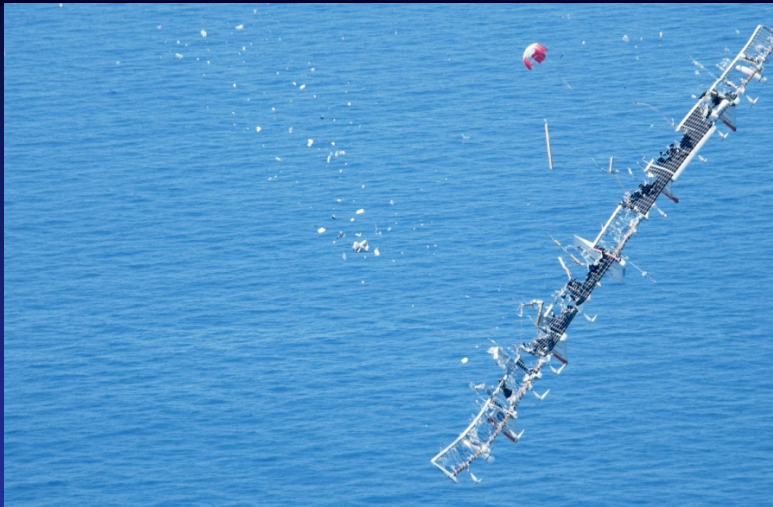
- The aircraft entered a series of severe pitch oscillations, resulting in some failure of the secondary structure, and could no longer generate lift
- The aircraft impacted the water within the confines of the Pacific Missile Range Facility, approximately 10 miles west of the island of Kauai
- Except for loss of the aircraft, no property damage, environmental hazard, or personnel injury resulted from the mishap
- Approximately 70% of the aircraft (by weight) was recovered, including the two hydrogen fuel tanks

Falling to the Pacific

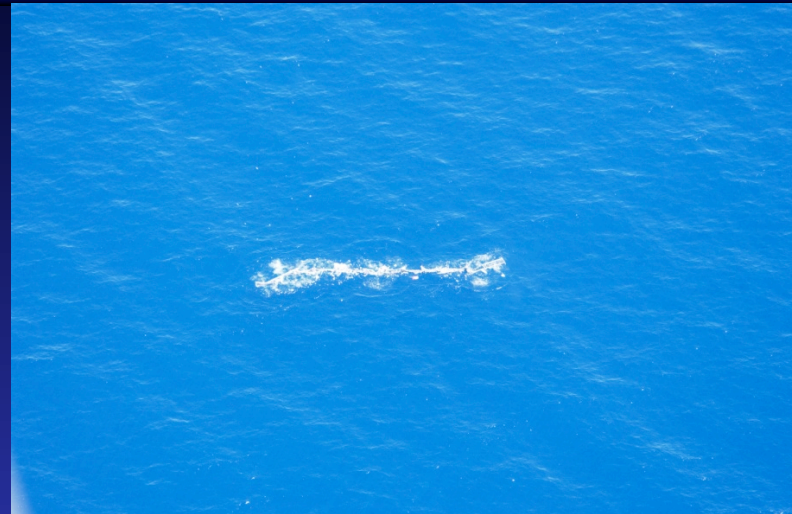
Helios Upon Impact with the Ocean

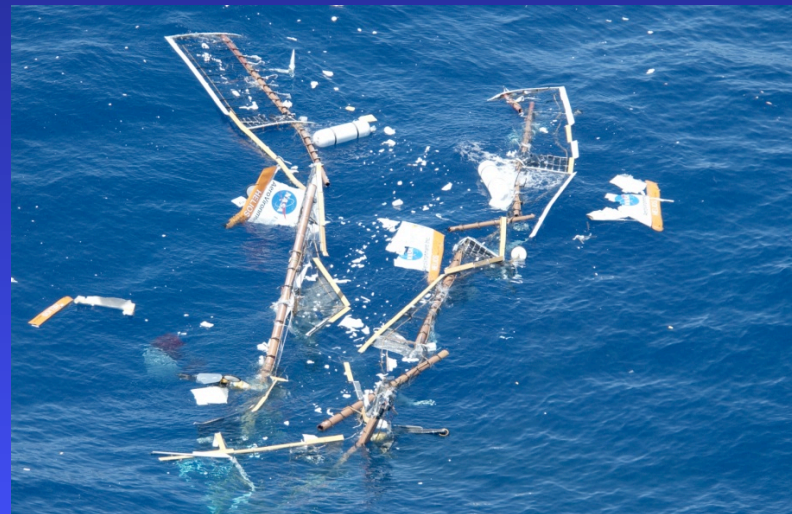
Close-Up of Floating Debris
