NASA/TP-2009-214769

A Summary of NASA and USAF Hypergolic Propellant Related Spills and Fires

B. M. Nufer
Kennedy Space Center, Florida

June 2009

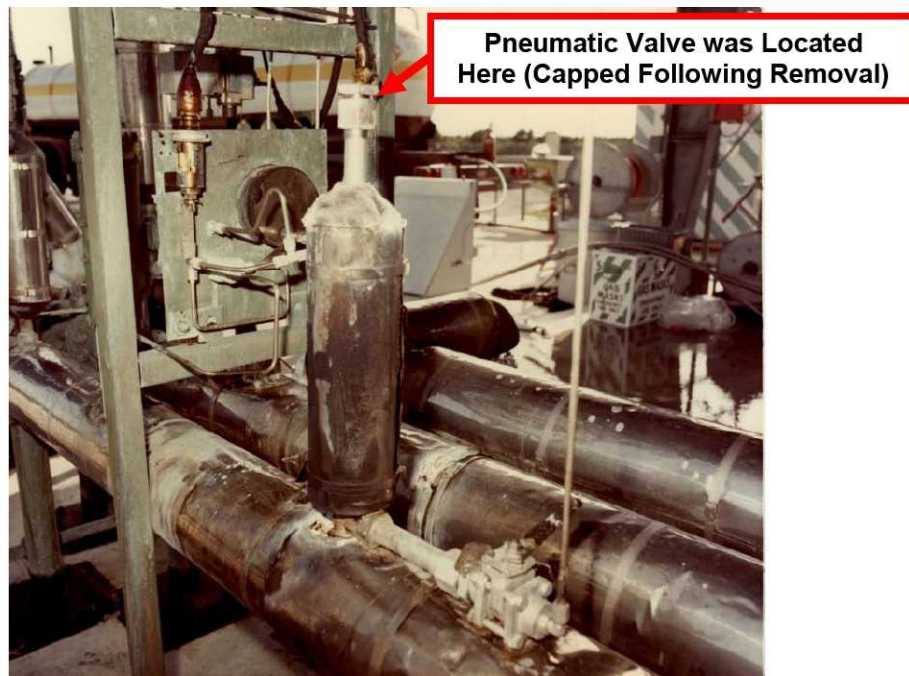
Figure 12-1: Photograph of Fuel Farm Following Fire

- The procedure was not written or reviewed by an experienced engineer prior to the task
- The engineer on console was making changes to the procedure real-time while monitoring another task in parallel
 - Improper adherence to the procedure and the procedure approval process are also root causes of this incident
- There was only one engineer on console supporting the hazardous operation
 - The engineer had to leave the communications channel to talk to the test conductor and in doing this missed some reports from the personnel at the fuel farm
- There was not a charged water line nearby when the fire occurred

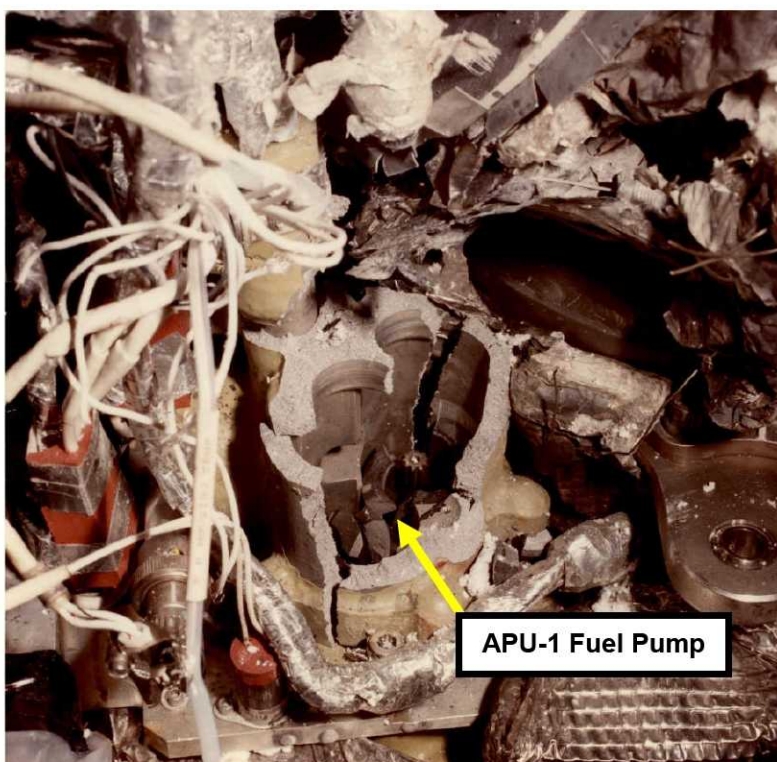
Figure 15-1: APU 1 Fuel Pump Explosion Following STS-9

The APU failures most probably resulted from a crack in the injector stem caused by corrosion of the sensitized inside diameter surface. The corrodant is probably carbazic acid or some similar substance which can be derived from air, moisture, CO₂, hydrazine and/or ammonia. The corrosion is time dependent and the crack progressed under sustained stress levels from the inner diameter surface toward the outer diameter surface until mechanical or thermal fatigue conditions could [complete] the crack rupture."

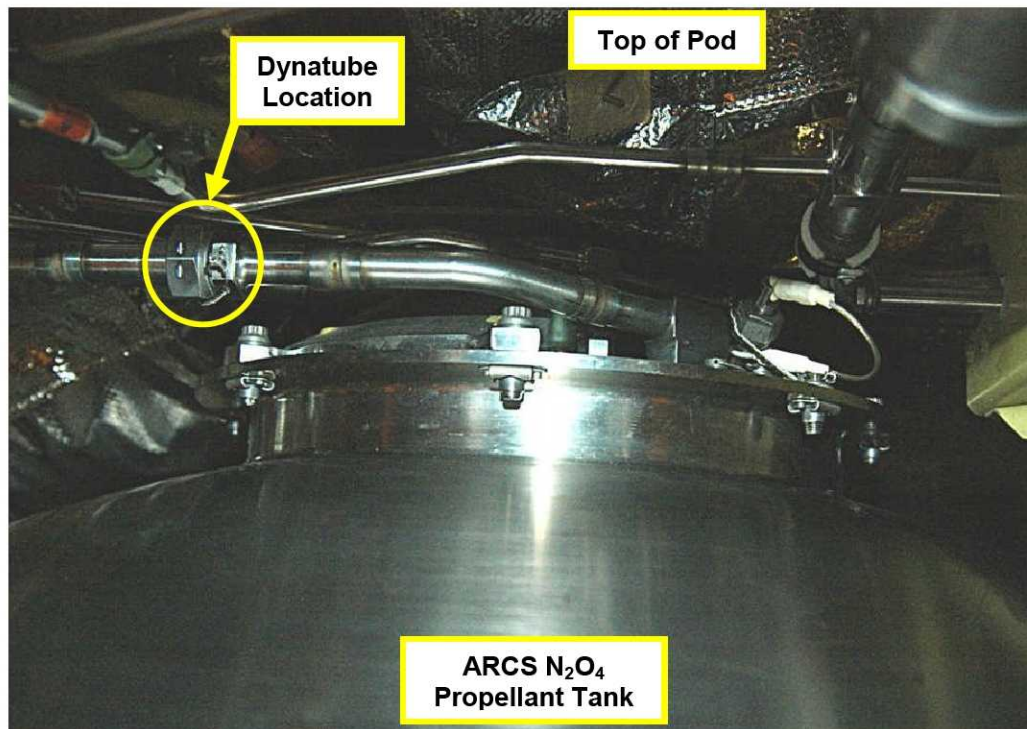
Figure 24-3: Dynatube Location on ARCS N₂O₄ Tank

First, the exact location of the leak within the pod had to be found (a cutaway view of the Space Shuttle OMS pod can be seen in Figure 24-1). This was difficult because the internals of the aft pods and forward module are not meant to be accessed while the vehicle is at the launch pad. The location of the leak had been isolated to the LRCS N_2O_4 system or the associated tubing through monitoring of the instrumentation in the LCC. The leak was measured to be 0.26 psi per hour (about 800 standard cubic centimeters per hour) and a TVC found the concentration of NO_2 vapor to be 15 ppm at the vehicle vent door. This later decreased to 3 ppm. An access door was removed on the pod's outer skin and several internal thermal blankets were removed. A long section of PVC pipe was then inserted into the pod to function as a guide for a borescope. Using a borescope, the leak was finally isolated (after a six hour search) to a ½-inch dynatube fitting on the MD224 leg (the N_2O_4 propellant tank ullage vent). A cross-section view of a dynatube is shown in Figure 24-2 and a photograph of the leak location can be seen in Figure 24-3.

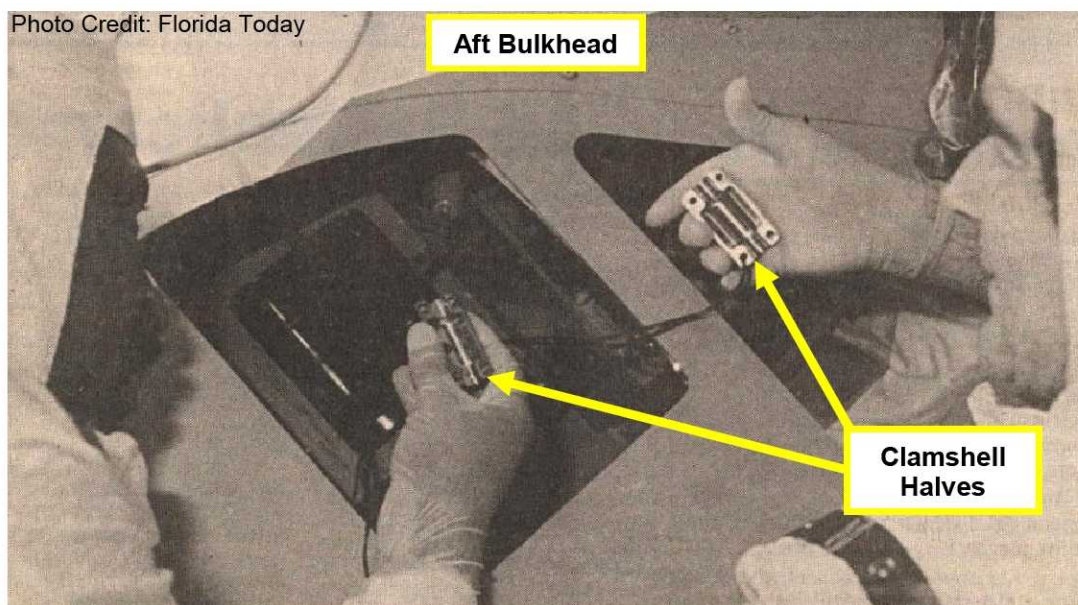
Figure 24-5: Technicians Repairing STS-26R Leak at the 1307 Bulkhead

After a week of deliberation, the “clamshell” was selected as it was the least invasive method to stop the leak prior to launch and it could be completed at the launch pad. Furmanite FSC-6B was used as the sealing compound as a result of it having the best compatibility characteristics with N_2O_4 . The FRF was finally completed on August 10, 1988 following a few hardware-related delays. The repair of the oxidizer vapor leak began on August 17, 1988 with the cutting of two holes in the aft 1307 bulkhead (the bottom of the payload bay with the orbiter in the vertical orientation) and the top of the pod beneath the bulkhead. The dynatube’s safety wire was removed and a “clamshell” (shown in Figure 24-5) was placed over the leak. The Furmanite sealing compound was then injected. The leak was eliminated; therefore, the Space Shuttle Program cleared Discovery for launch, which successfully occurred on September 29, 1988, a few weeks later than the original launch date of September 6, 1988. The delay was a result of multiple items including the FRF test delays, return to flight SRB testing delays in Utah, and the N_2O_4 leak on LP04.

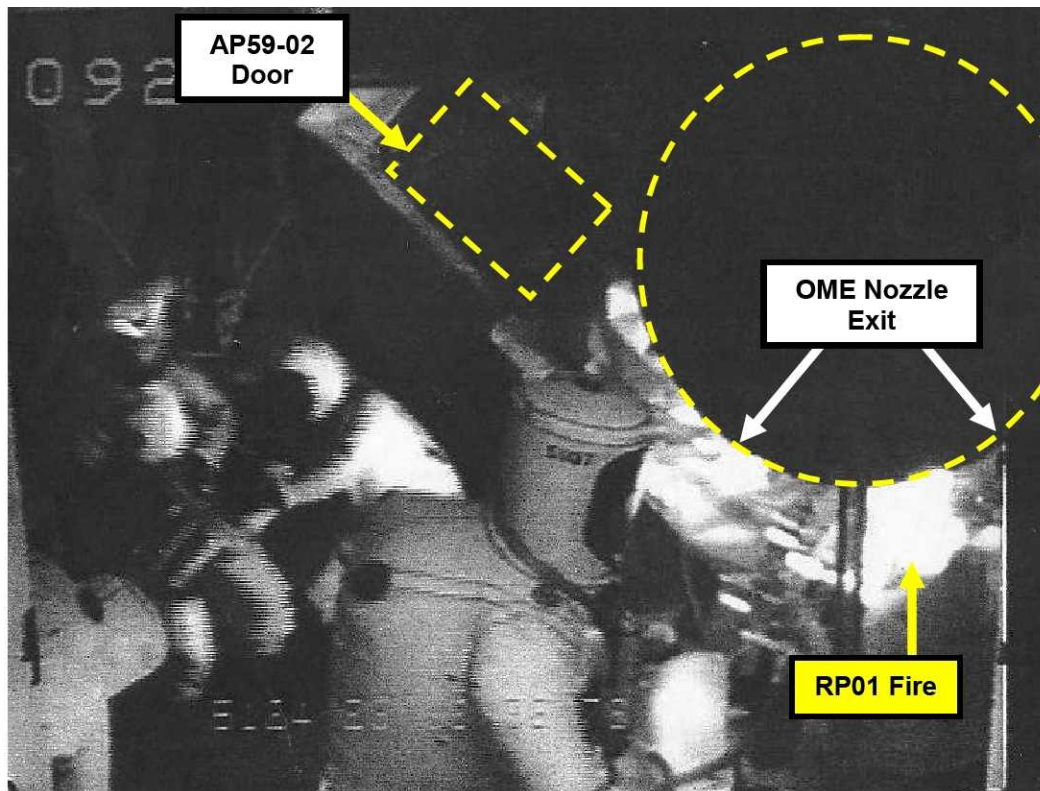
Figure 33-1: Still Photograph from Video of RP01 Fire

During the STS-69 OV-105 flow, while performing a thruster R1A removal and replacement, a fire broke out in the Space Shuttle right OMS pod stinger area. The fire burned strongly for about 30 seconds and a smaller flame burned for about one minute and 45 seconds. The size of the flame was estimated to be approximately 15 inches x 11 inches x 11 inches with a damage region of approximately 22 inches x 14 inches x 14 inches in the stinger. The materials that burned included several ounces of fuel, a shop light, and the Orcofilm spill protection (flame retardant covering films). Figure 32-1 is a still image from the video recording during the fire and Figure 33-2 is a clearer color photograph of the same area for reference.

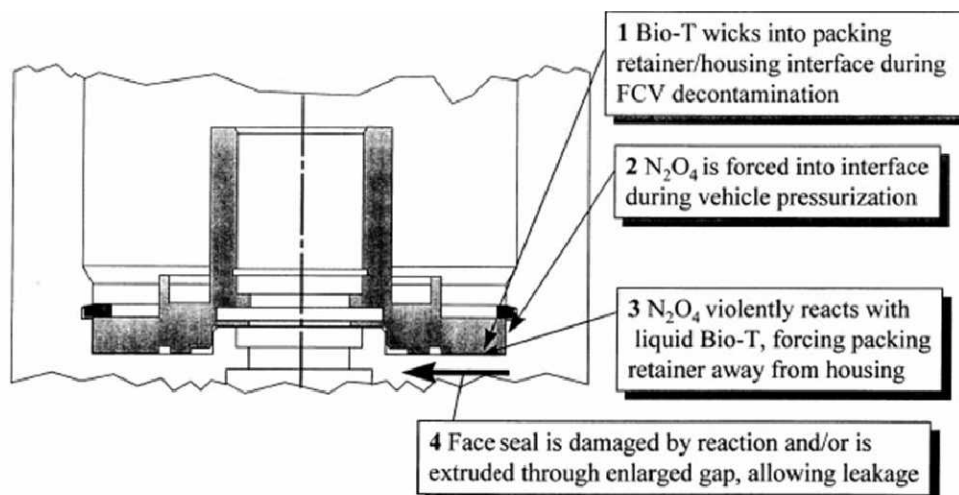
Figure 37-4: Titan IV A FCV Failure Description

1. By the completion of the TVC N_2O_4 propellant tank loading, the cavity adjacent to the packing retainer filled with liquid N_2O_4
2. The liquid N_2O_4 vaporized and migrated into the packing retainer crevice
3. During the tanks' pressurization, the trapped N_2O_4 vapor re-condensed into a liquid and reacted with the residual Bio T-200A in the packing retainer crevice (see Figure 37-4)
 - The energy of this reaction damaged the packing seal
 - The force of the increased system pressure overcame the remaining, compromised integrity of the seal components and thus flowed past the seals to atmosphere.
