NASA/TM—2009-215802

Failure Analysis of Sapphire Refractive Secondary Concentrators

Jonathan A. Salem
Glenn Research Center, Cleveland, Ohio

George D. Quinn
National Institute of Standards and Testing, Gaithersburg, Maryland

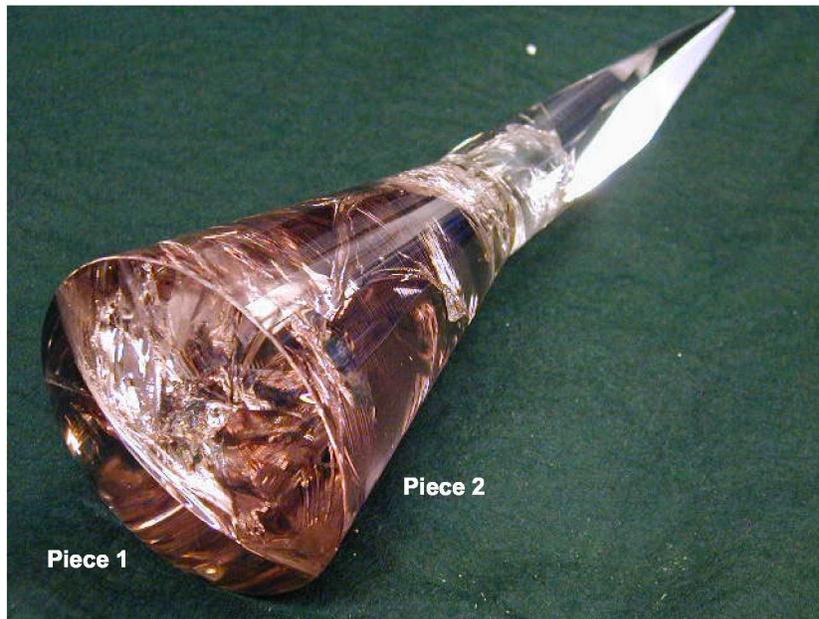
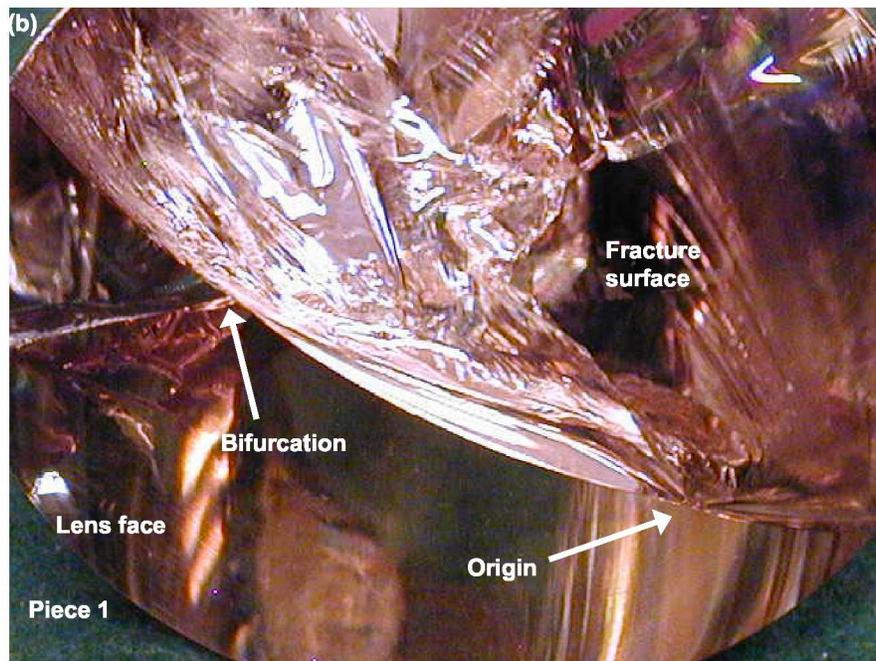
Figure 5.—(a) Overall view of RSC no. 1, the first solar concentrator, after testing. The lens diameter is 89 mm (3.5 in.) and the overall length is 284 mm (11.2 in.). (b) View of the fracture surface face of the bottom half (piece 1) showing the fracture origin and bifurcation that is located 44 mm away from the origin.

On August 30, 2001, two tests were run with the rigid primary concentrator—one at lower temperatures without the Re receiver and one at higher temperatures with the Re receiver. The high temperature test had an approximate maximum receiver temperature of 1300 °C (1573 °K) and an approximate front shoe temperature of 532 °C (805 °K), with a peak shoe temperature of 582 °C (855 °K) after shut down. The first indication of performance problems was an unexpected decrease in temperature as shown in the temperature—time profile in Figure 4. The test was shut down and cracks in the lens could be seen once the temperature cooled to ~982 °C. Upon inspection the crystal was observed to be cracked as shown in Figure 5.

As shown in Figure 5(a), the lens face and cone are fractured near the mid-plane of the lens face and downward into the body to the extractor. There is a mixture of cleavage and conchoidal fracture and some crack bifurcations. As will be shown later, fracture started on the face of the lens and propagated downward into the cone body and extractor.

Besides the severe cracking, Figure 5(a) also shows that the cone region of the lens exhibits a rose hue when viewed on the cone sides, with thicker regions appearing darker than thinner regions. When viewed down the lens axis, a light-brown hue is exhibited in the uncracked regions, and rose hues in the severely cracked regions, probably from side light being reflected out the lens face. The rod region and a heavily cracked region of the cone are still clear.

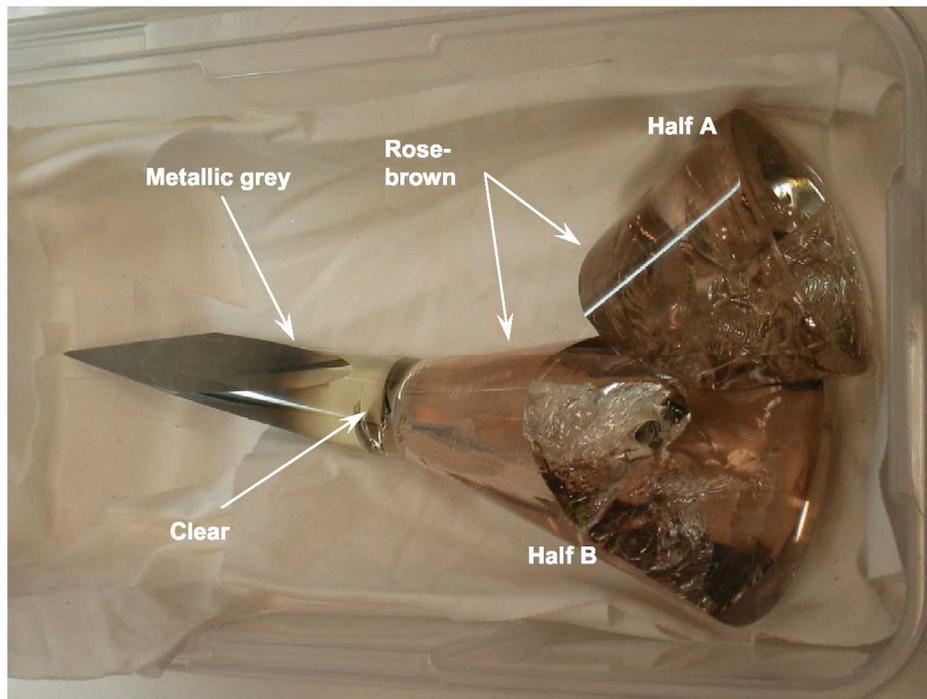
Figure 6.—RSC no. 2 after removal from the test rig. It has broken into two pieces. Cracks at the neck are also visible. The cracks in the neck and extractor are extensions of the main fracture in the cone body. The lens diameter is 89 mm (3.5 in.) and the overall length is 284 mm (11.2 in.).

As shown in Figure 6, the fracture started on the face of the lens and propagated downward into the cone body and extractor. The primary crack split the lens face and cone body near the mid-plane down to the extractor. Several *r*-plane bifurcations branch from the cone sides. The main crack rotated onto the *c*-plane after traveling ~15 mm into the extractor.

Besides being severely cracked, the cone region of the lens exhibits a translucent, lighter rose-grey hue as compared to the first RSC, with thicker regions appearing darker than thinner regions. The lighter color is likely a result of the lower temperature (and power) level. The end of the cone and the rod region just after the cone are clear whereas the remaining portion of the rod is an opaque dark gray.

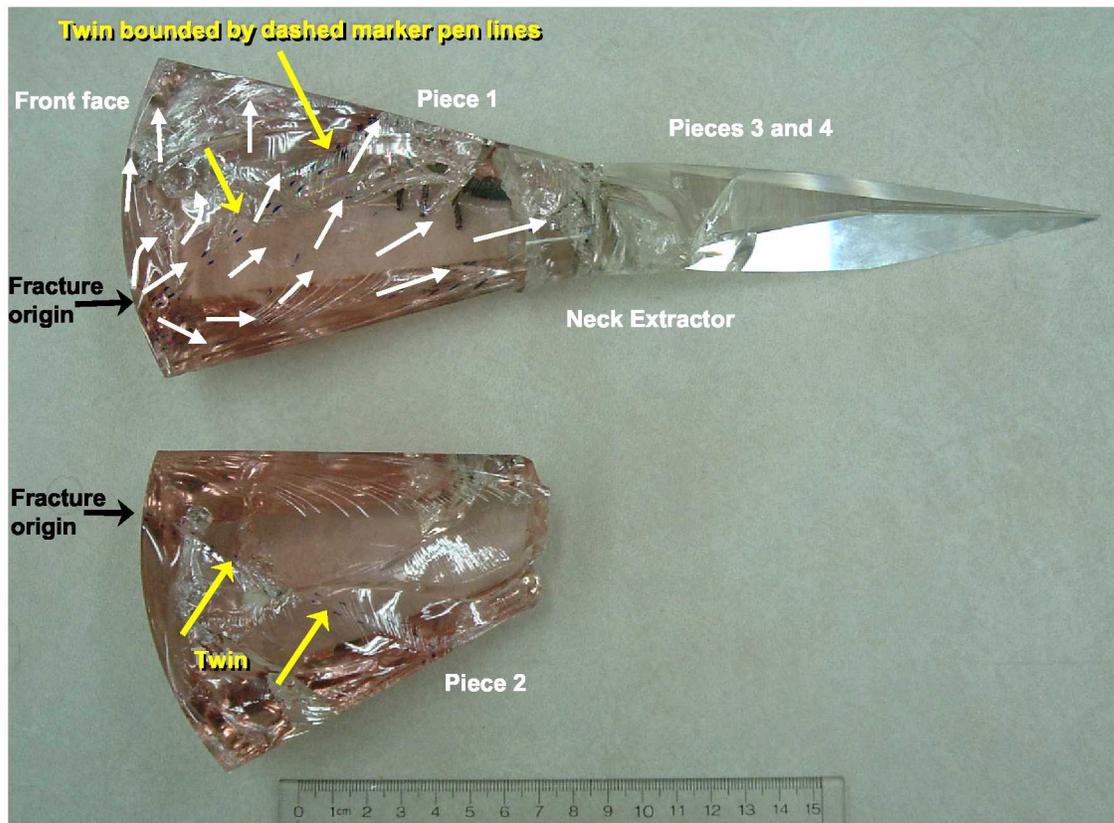
Figure 7 shows the four main pieces that concentrator no. 1 broke into after removal and some subsequent handling for the fractographic analysis. The origin is on the curved front face, about 20 mm away from the rim. There also is a large twin that extends diagonally all the way through piece 1 and which penetrates partially through piece 2. This twin was incidental and did not cause fracture.

Figure 7.—Concentrator RSC no. 1 fractographic analysis. Fracture started from the fracture origin on the front face and propagated (white arrows) into the cone body and onwards to the neck and extractor. The initial main fracture was almost perfectly radial and close to the m -plane in orientation. All the cracking in the neck and cone body can be backtracked to the one fracture origin. An incidental twin ran entirely through piece 1 from the lens front face through to the cone side and out the back of the cone. One end was close to but not exactly at the fracture origin site (2.3 mm away). There were minor perturbations in the main crack when it reached the twin plane indicating that the twin was in the RSC before the crack ran through it. The twin was very shallow in piece 2. It ran from the lens face right through the side of the cone, but did not extend very far below the fractured surface. The insert shows how subsequent handling caused the extractor to split into two pieces that separated from the cone body.

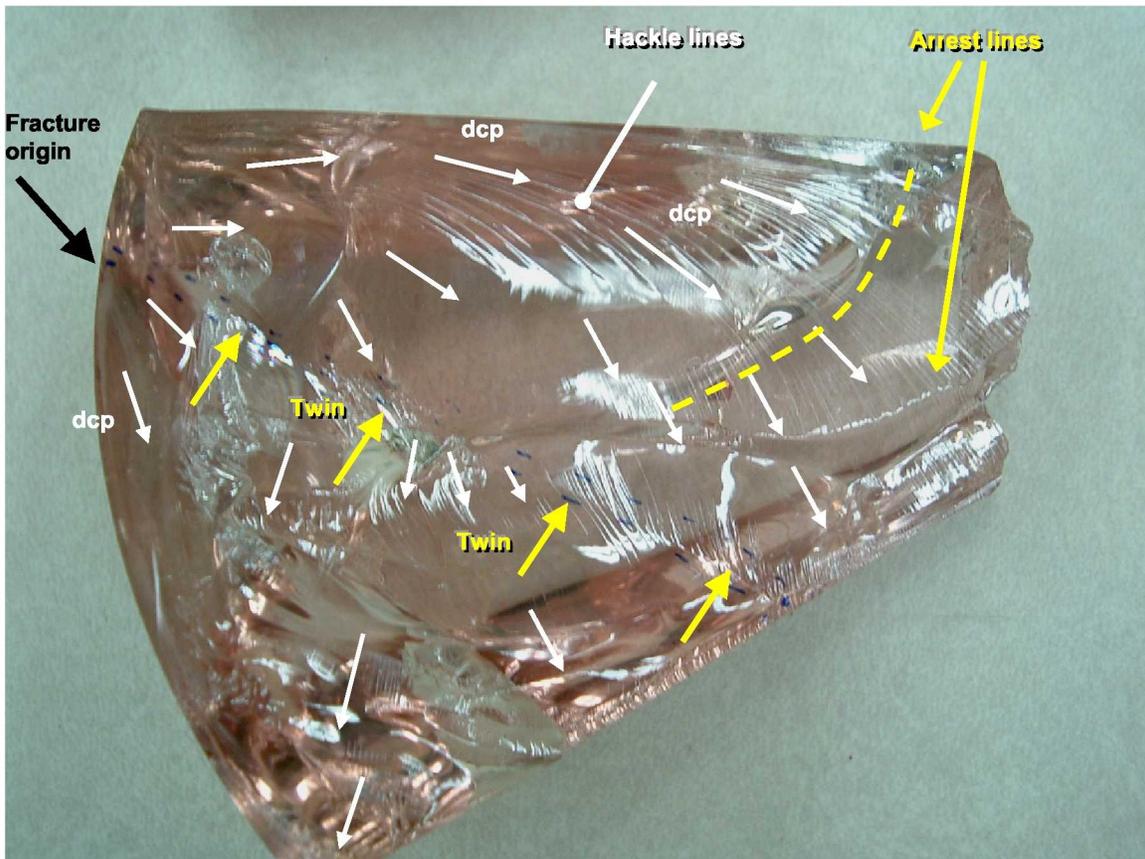
Figure 8 shows a close-up of piece 2 revealing some of the classic fracture surface markings such as twist hackle, cleavage step hackle, Wallner and arrest lines. The fractographic analysis of single crystals is covered in detail in Reference (Ref. 7). It should be borne in mind when viewing this and the following figures that reflections and translucency make photographing single crystals difficult. In the examples below, some regions are shown with several views with different lighting to bring out various details. Failure occurred from the fracture origin site and extended parallel to the m -plane. The main crack plane emanating from the origin contains hackle lines that extend from the lens face to the extractor on one side. This is a distance of ~ 5 in., and the crack nearly cleaves the cone into two segments that attached at the extractor rod. On the other side of the origin, the crack cleaved the lens cone only to a depth of ~ 2 mm along the lens before splitting, moving off the m -plane and forming a confluence of cracks at a variety of angles.

Figure 8.—Piece 2 of RSC no. 1. The small white arrows show the local direction of crack propagation (dcp) as identified by hackle lines, Wallner lines (not labeled), and arrest lines. These facilitate the determination of the crack propagation direction and the fracture origin. The twin runs diagonally across this view as marked by yellow arrows. Its left end comes very close to but is not coincident with the fracture origin. The main crack was perturbed slightly when it traversed across the preexisting twin.

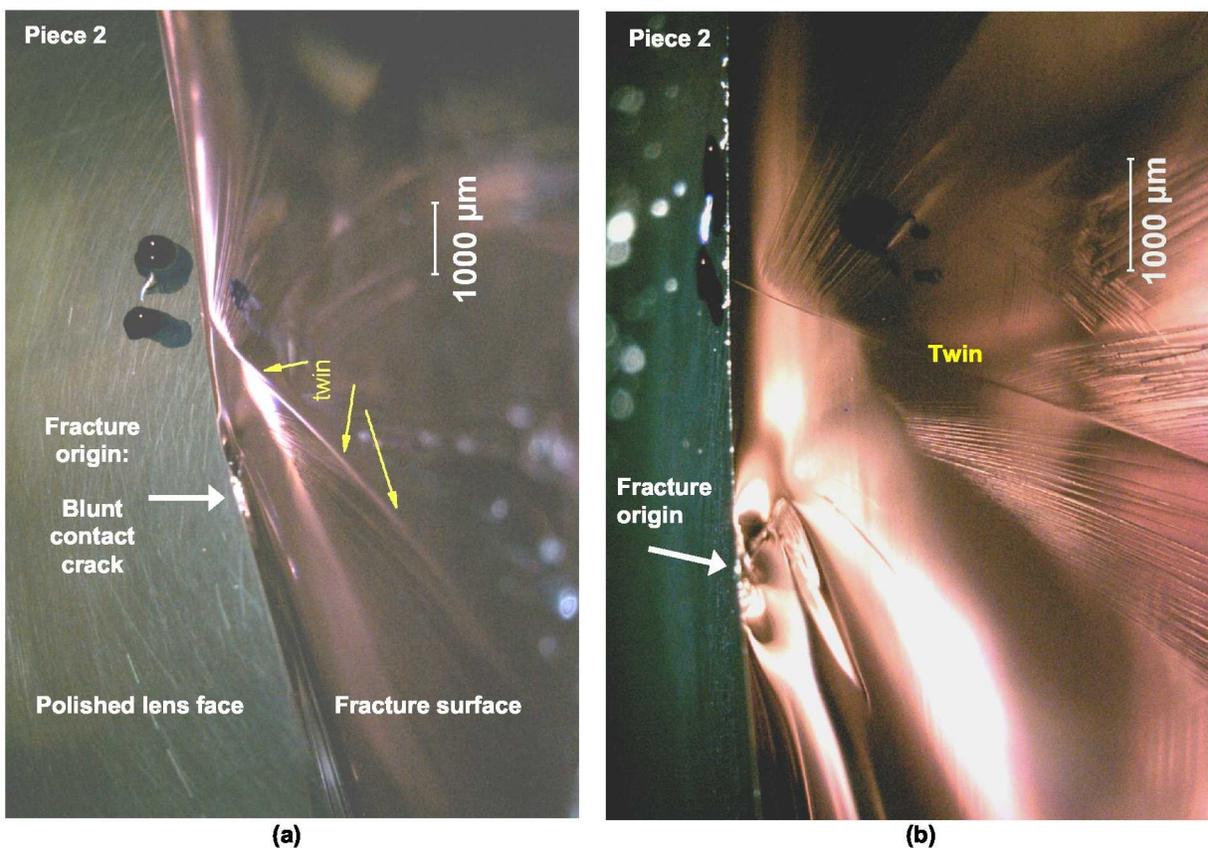
Figures 9 to 12 show that the failure origin is on the lens face, about 20 mm away from the rim. These views were taken with different lighting at different angles. The origin is a large, partially formed Hertzian cone crack, that extended from one of two partially polished impact divots or “bruises” measuring ~ 0.1 and ~ 0.2 mm in diameter, as shown in Figure 12. The cracks associated with the bruises are quite large, ~ 0.5 mm, and the damaged region can be seen with the unaided eye. Contact damage usually has two forms depending upon the sharpness or bluntness of the offending impactor (Ref. 7). Sharp impactor contact damage usually has a small concentrated damage crater with a star like array of cracks radiating outwards. Blunt impactor damage has a conical or ring shape. Often it may be a partial ring shape such as shown in Figures 10 and 11. From the size of the ring crack, it may be deduced that the impact object had a diameter greater than 0.5 mm.

Figure 9.—Close-up views of piece no. 2 of RSC no. 1 with about the same orientation as in Figures 7 and 8. Minor polishing scratches are revealed by the lighting in (a). (b) is a close up of (a).

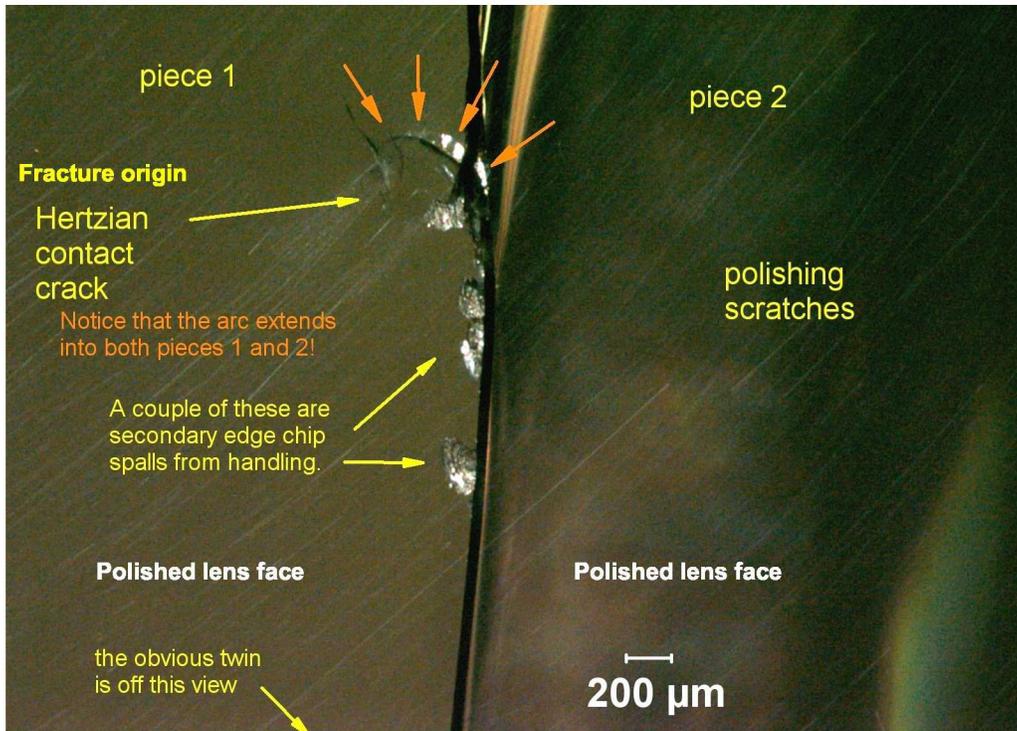
The Hertzian crack likely formed due to impact with a hard blunt object during the grinding or early polishing steps. As Figure 12 shows, final polishing created some microscratches around the bruises. These would not have been present if the impact had occurred *after* the final polishing phase. Better care would have eliminated this failure source.

Figure 10.—This view shows the curved polished face of pieces 1 and 2 of RSC no. 1 held together at the origin site. The orange arrows highlight the Hertzian (blunt impactor) contact crack.

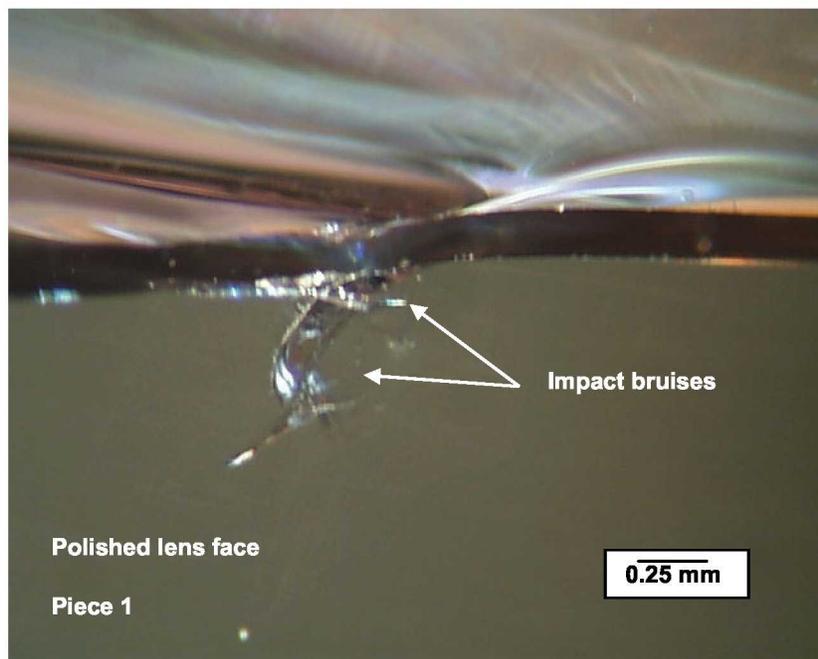
Figure 11.—View of piece 1 of RSC no. 1 showing cracks extending from bruises on the lens face. The sites of the impact bruises are marked in this view, but they are more obvious in the next figure which has different lighting.

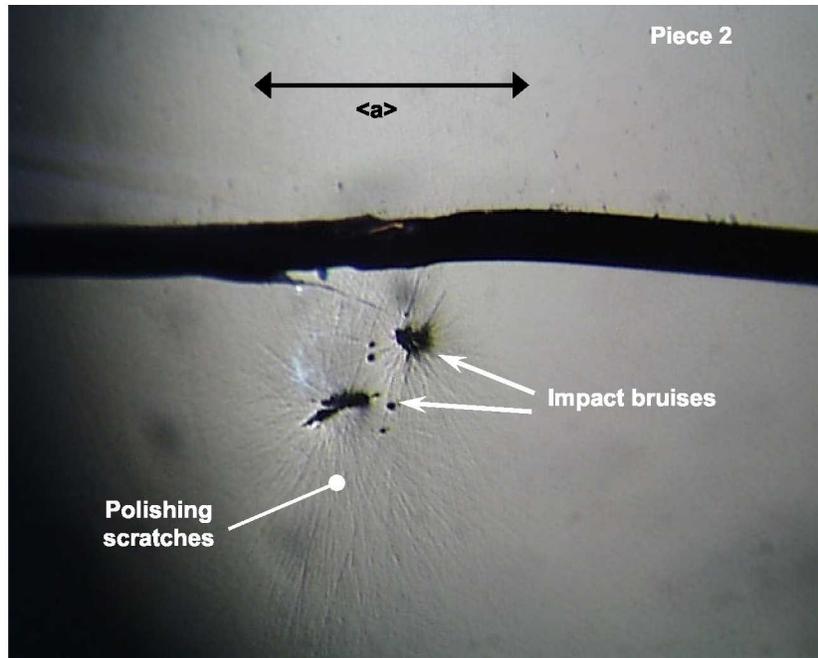
Figure 12.—Surface lighting of the bruises revealing polish scratches in the polished face of RSC no. 1. The residual scratches that radiate from the contact sites imply that the impacts occurred prior to the final polishing of the face. Final polishing caused micro scratches to radiate outward from the damage sites.

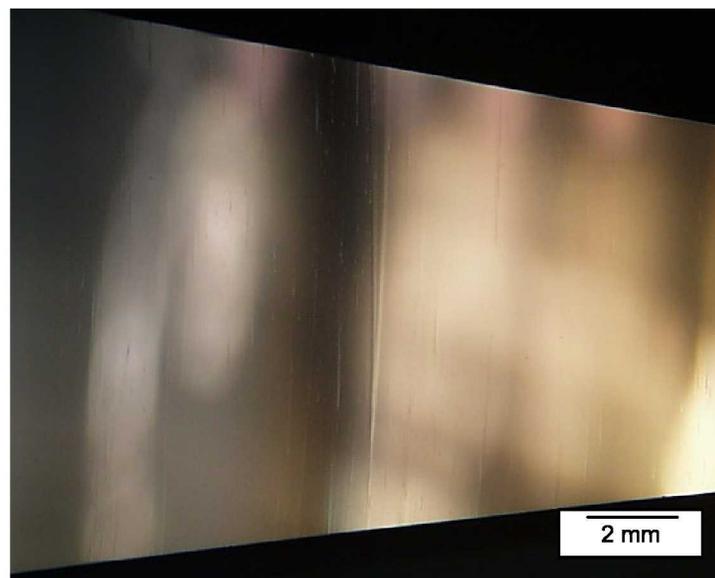
In addition to the bruises, large remnant scratches from the rough machining were noted on the lens faces, Figures 10 and 11, but also on the shaft, Figure 13. Another scratch approximately 2.3 mm from the rim on the lens face extends along nearly $\frac{3}{4}$ of the perimeter and can easily be seen with the unaided eye, Figure 14. Also apparent are some semi-polished chips on the edge between the lens face and the cone, as shown in Figure 15. Ideally, better machining and polishing should be performed. Poor polishing, such as that observed, is referred to as a “short finish” and generally results in a very large variation in the measured strength (Ref. 8).

Figure 13.—Grinding marks along extractor shaft of RSC no. 1.

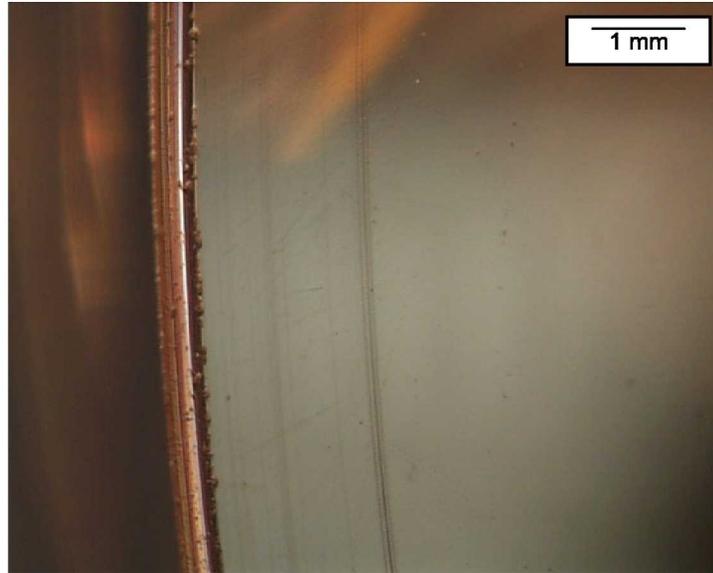
Figure 14.—Grinding damage and scratches on the lens face near the rim of RSC no. 1.

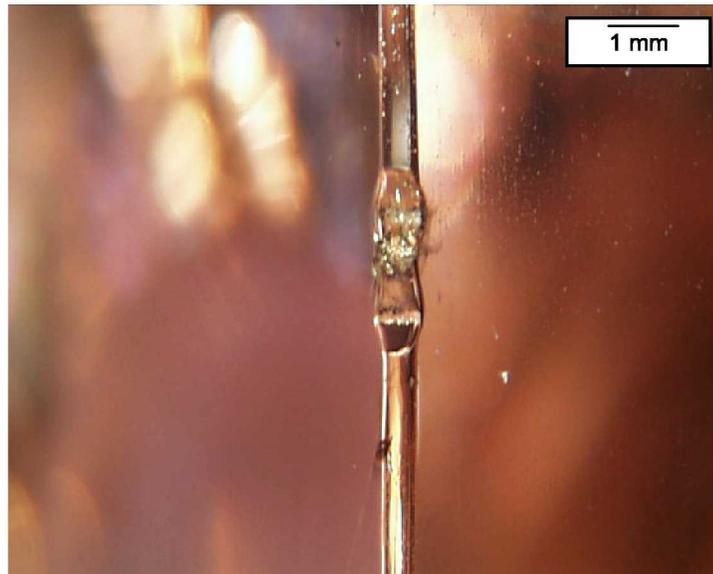
Figure 15.—Chips on the rim of the lens of RSC no. 1.

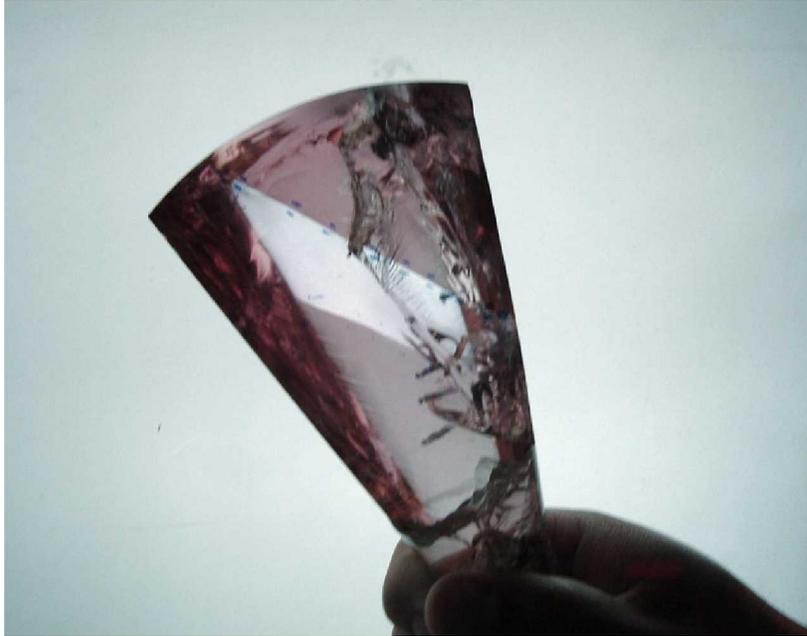
The twin that was observed running through RSC no. 1 is shown in Figures 7, 8 and 16, but it appeared to have been incidental. It could not be determined where it initiated. It was more obvious in piece 1 and it penetrated completely through the piece. It was seen over all surfaces with the naked eye. It extends only partially into piece 2. It is also visible on piece 2 primarily by how it affected the main crack propagation. Additional twins that were detected in the front face of piece no. 1 are shown in the Appendix.

Figure 16.—A prominent twin (the light colored band) ran through the body of piece 1 of RSC no. 1. This is a view of the piece through crossed polarizers.

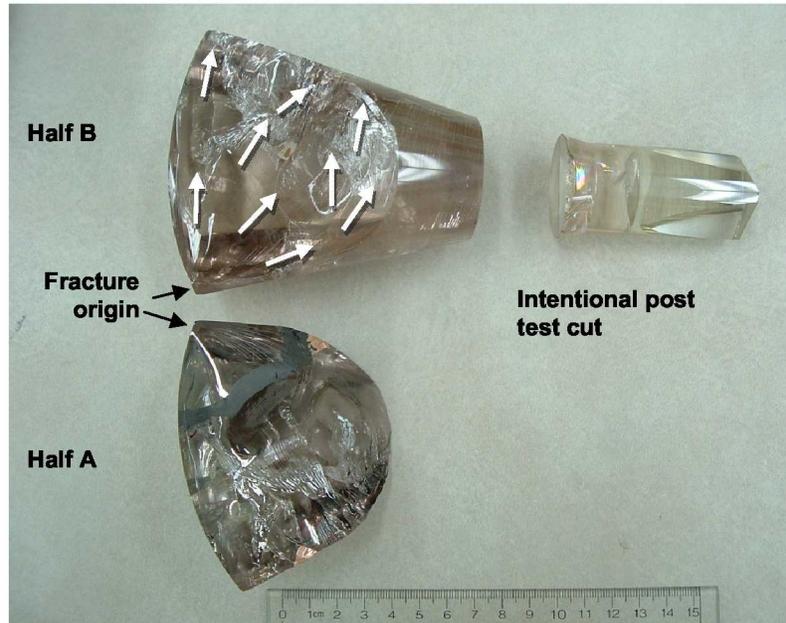
Figure 17 shows fractured RSC no. 2, which was intentionally sliced after the test in order to facilitate chemical analysis and fractographic examination. Hereafter the two halves of the conical body are referred to as half A or half B as shown in the figure. The main crack plane emanating from the origin contains twist hackle and cleavage step hackle that extend from the lens face to the rod neck and extractor. Once entering the rod extractor, the crack turned onto the c -plane, nearly cleaving the rod.

Figure 17.—Concentrator 2. The white arrows show the direction of crack propagation.

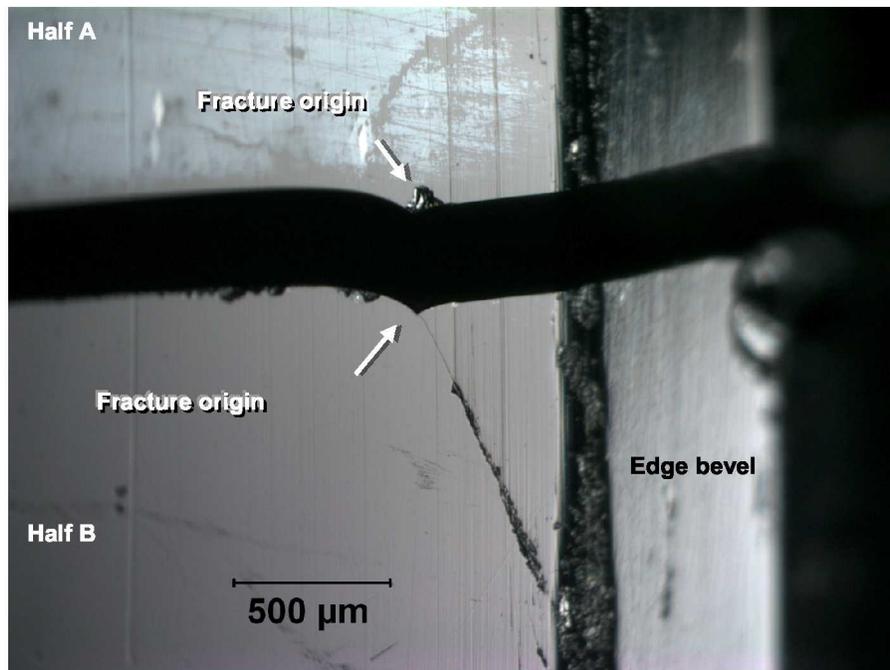
There was a single fracture origin on the lens face that was located only 0.5 mm away from the rim bevel and 1.3 mm away from the cone side wall as shown in Figures 17 and 18. It is not known whether this site was coincident with a shoe contact site as shown in Figures 2 and 3. On half B the origin is clearly identified as a large curved scratch. Close up views of half B are in Figures 19 and 20 which show the curved scratch in more detail.

Figure 18.—View of curved forward face of RSC no. 2. Fracture started from a curved scratch best seen on half B on the bottom. Note the secondary chipping on both halves along the main fracture plane.

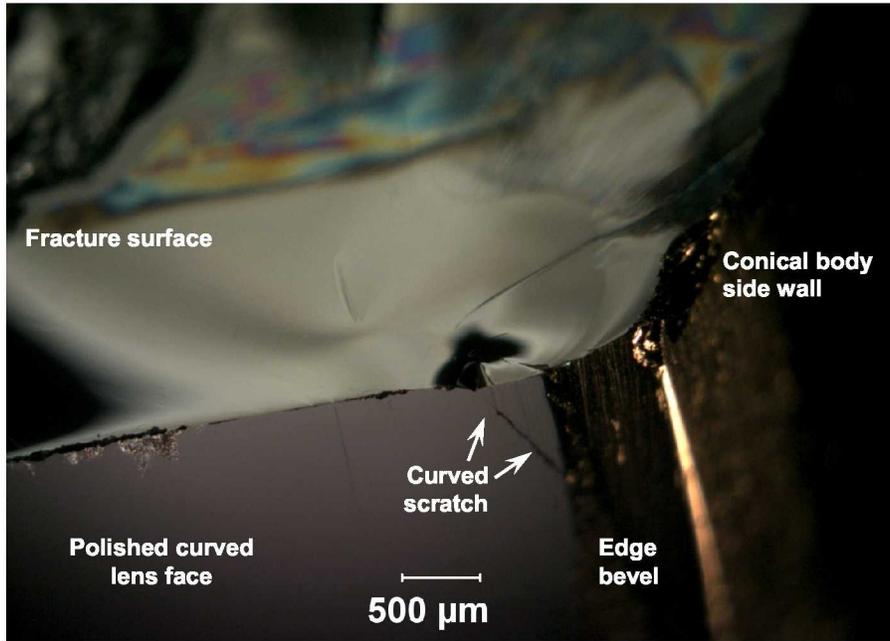
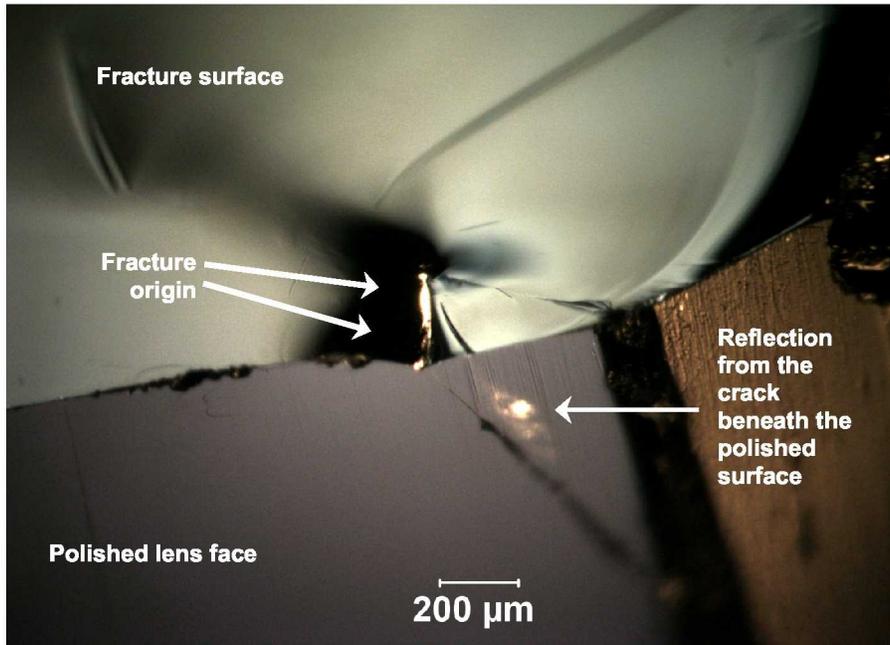
Figure 19.—Stereo optical microscope views of half B of RSC no. 2. The piece has been tilted so that both the fracture surface and the polished curved lens face can be seen. (b) is a close up of (a).

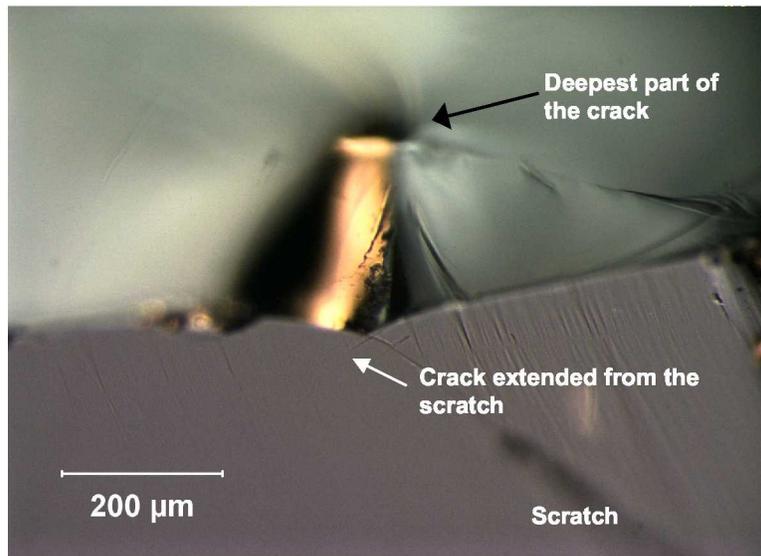
Figure 20.—Detail of the fracture origin of RSC no. 2, in half B. A crack extends from the scratch region (out of focus in this view) which is characterized by tell tale short lateral spall cracks. The crack created underneath the scratch extended upwards and curved to the left in this view (small arrow). The crack penetrates at least 250 μm deep beneath the polished surface into the lens body. Lens fracture started from the deepest point of the crack indicated by the black arrow. In this view, light reflections from the subsurface curved crack face cause shadows and bright reflections.

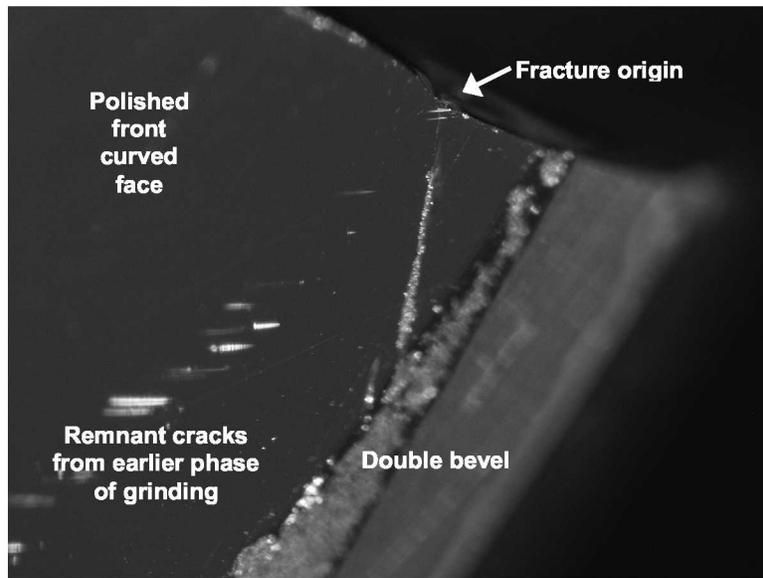
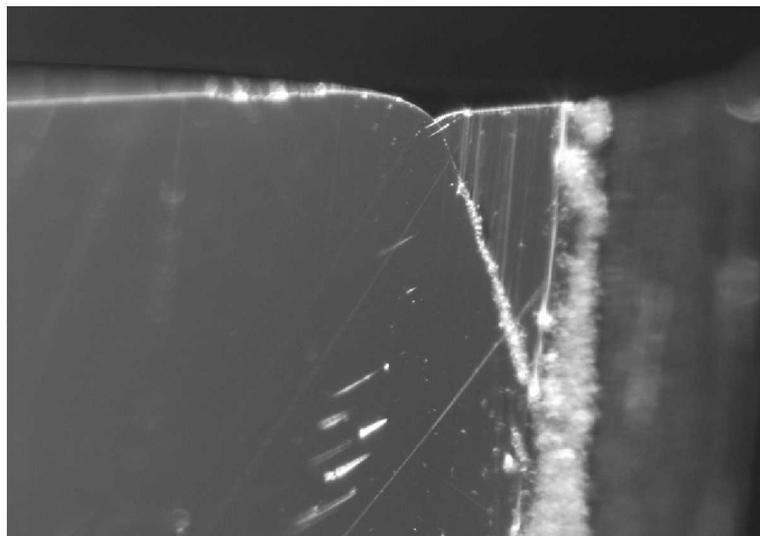
Figure 21.—Two views of the same area of the polished face and edge bevel of half B of RSC no. 2 revealing additional irregularities besides the curved scratch. Notice how adjusting the lighting in (b) can bring out some scratches that are not visible in (a).

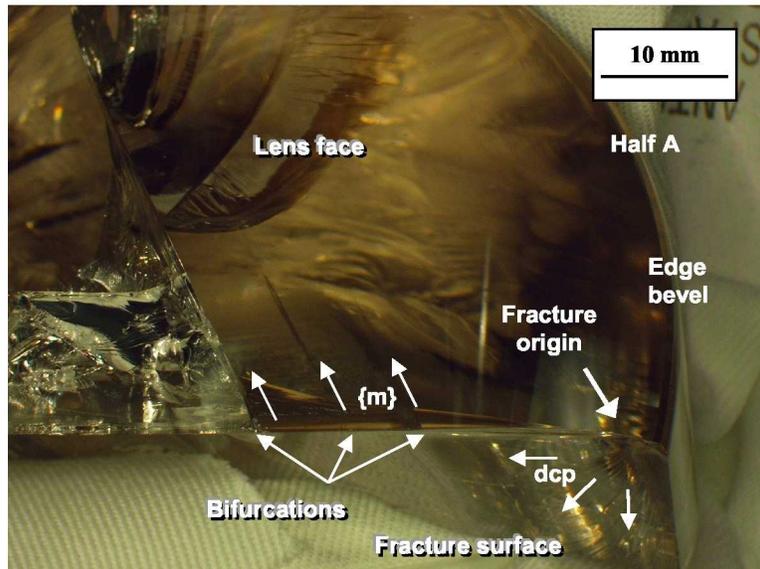
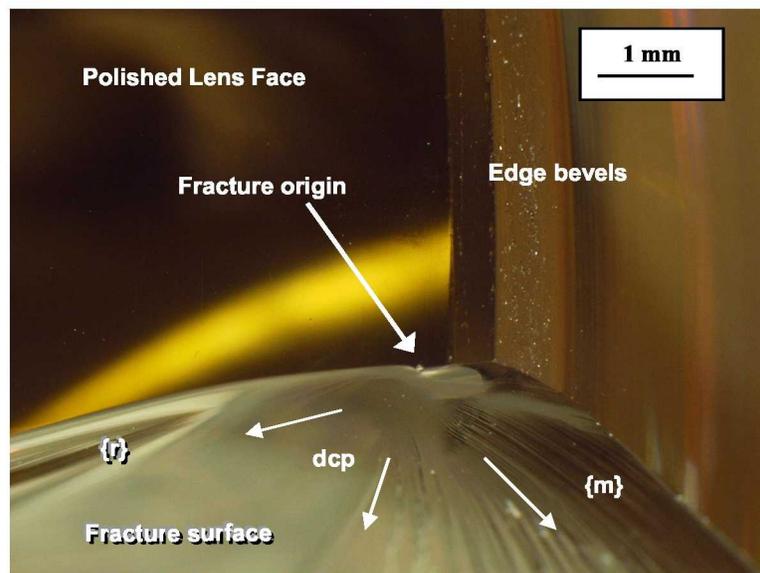
Figure 22.—Views of the fracture origin area in half A of RSC no. 2 showing both the fracture surface and the polished front surfaces. Bifurcations onto the $\{m\}$ plane are evident in (a). The first two do not extend very far into the body, but the third causes a main crack to form all the way through the body. (b) shows radiating hackle lines on the fracture surface that point back to the origin site. “dcp” is direction of crack propagation.

Both of the crack fronts running along the *m*-plane (Fig. 22(b)) and *r*-plane (Fig. 22(a)) bifurcate at ~17 mm. Figure 22(a) shows several short bifurcations that are in a row, but these all arrested after a short propagation into the cone. The first significant bifurcation occurred at 30 mm from the origin. The bifurcation distance of ~17 mm combined with $A_b = 7.0 \text{ MPa}\sqrt{\text{m}}$ and equation 3 implies a fracture stress of ~65 MPa. The larger distance (30 mm) gives a stress estimate of 51 MPa using equation 3. This also is a very low stress, but again, these estimates are supported by the observation that the flaw at the fracture origin was rather large and deep.

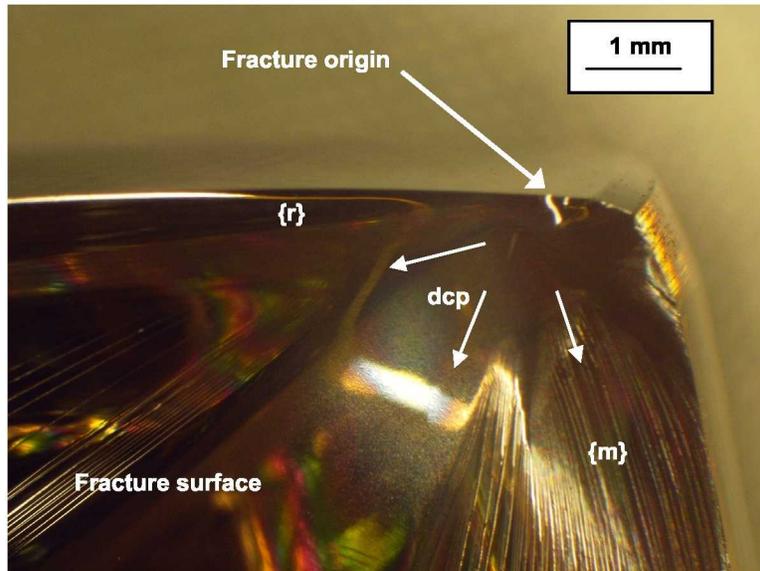
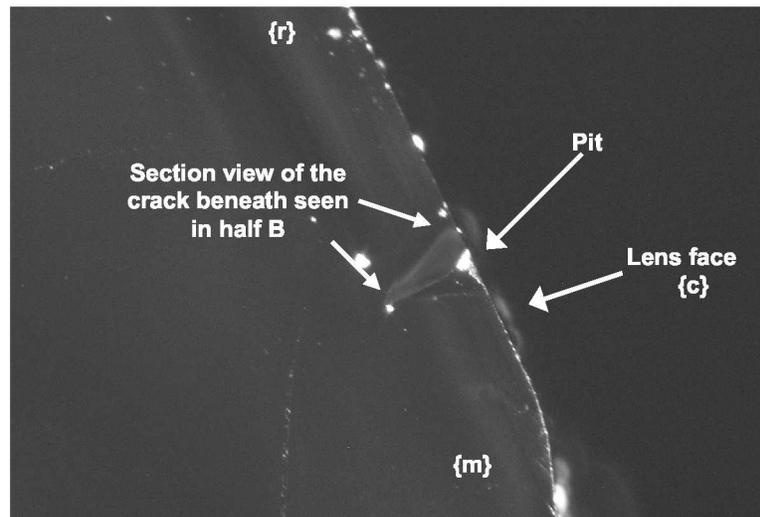
Figure 23.—View of fracture surface of half A of RSC no. 2 showing hackle lines that formed on $\{r\}$ and $\{m\}$ planes on either side of the origin.

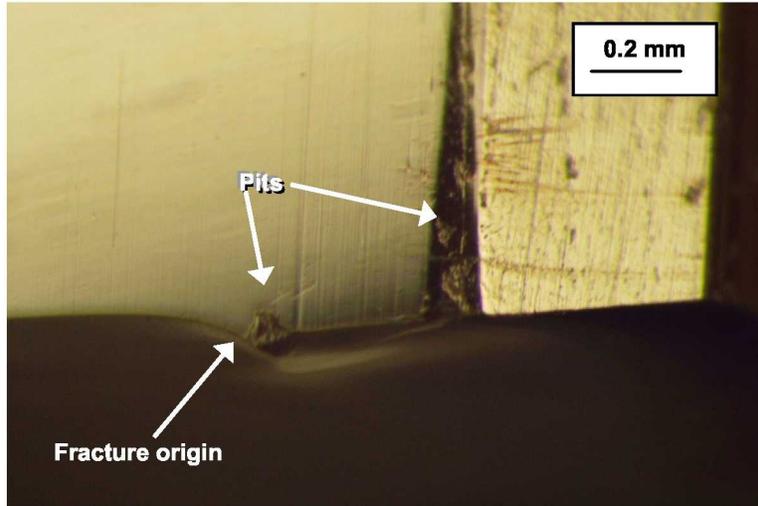
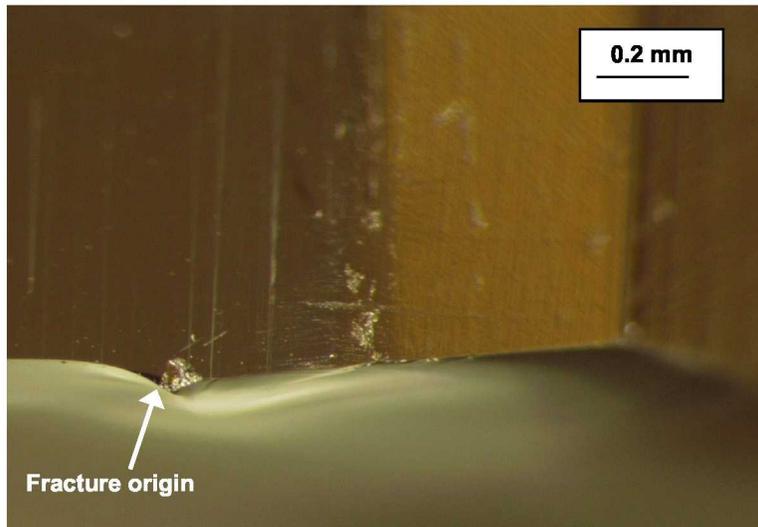
Figure 24.—Two views with different illuminations of lens face of half A of RSC no. 2 showing surface scratches, pits, and the fracture origin site.

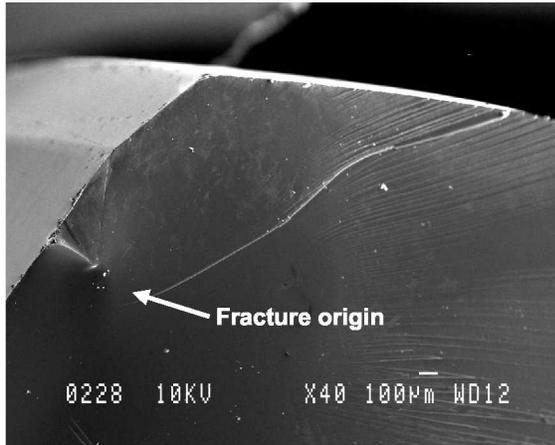
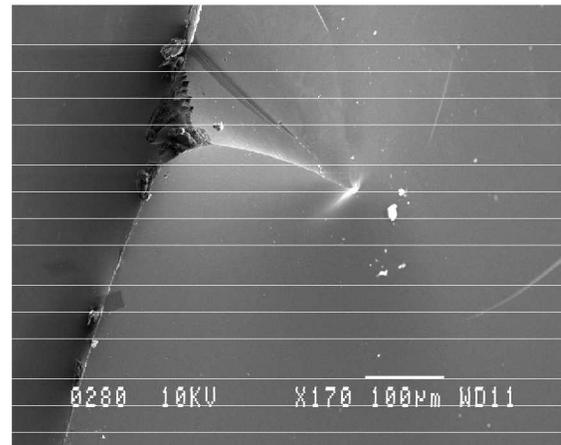
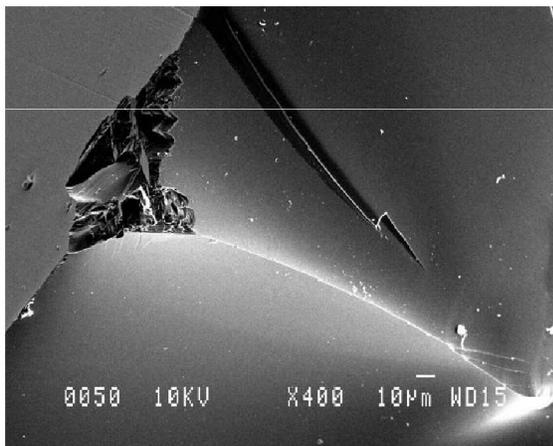
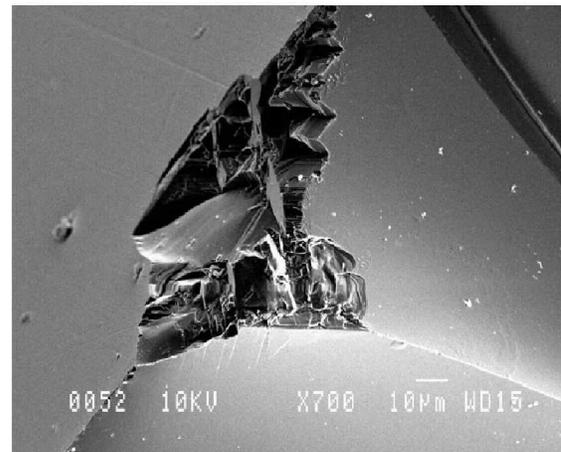
The matching half A of concentrator 2 is shown in Figures 22 to 25. The crack from the scratch is less clearly evident and attention is drawn to what appears to be a pit at the origin site. No trace of the apparent pit existed on half B. The “pit” is probably secondary chipping after the main fracture occurred or it may have been a small initial pit that was enlarged by secondary chipping. The scratch is the primary flaw.

Figure 25—SEM close-up views of the origin in half A of RSC no. 2. (b) to (d) are close up views. The origin is the crack that penetrated beneath the polished surface. The "pit" is probably secondary chipping although genuine pits were noted elsewhere in the vicinity.

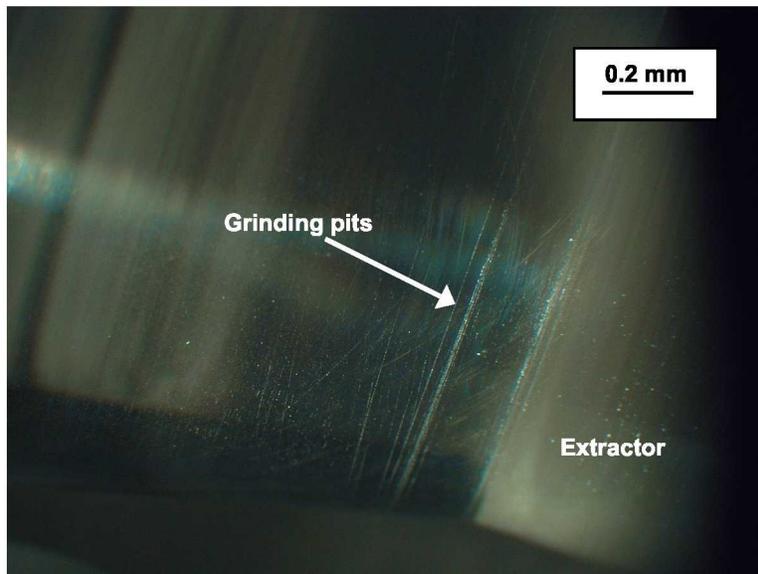
In addition, occasional, large remnant scratches from the initial rough machining stages can be noted on the lens, rod and cone, as shown in Figures 26 and 27. Several other features in the vicinity of the origin were also detected as shown in Figure 28, but they appeared to be incidental micro twins.

Figure 26.—View of lens cone and rod of RSC no. 2 showing surface scratches (grinding damage) prior to testing.

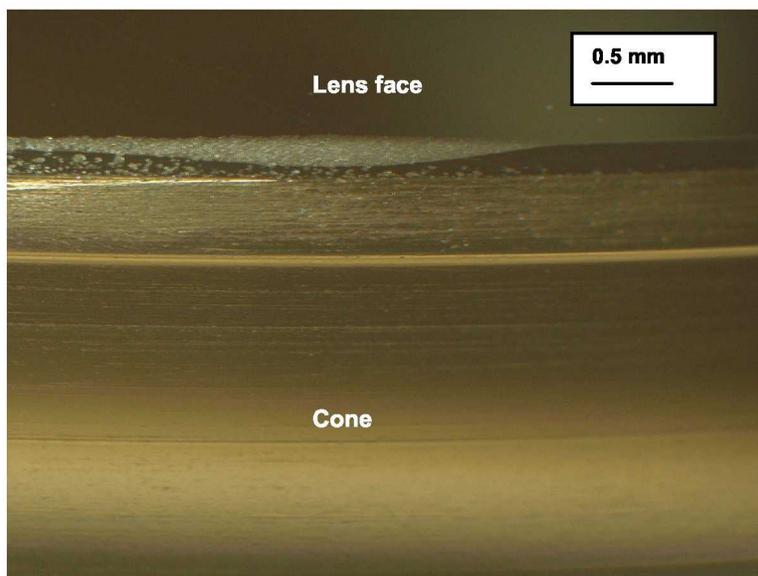
Figure 27.—View of RSC no. 2 cone and bevel showing heavy pitting and surface scratches (grinding damage) prior to testing. Notice the two step uneven bevel.

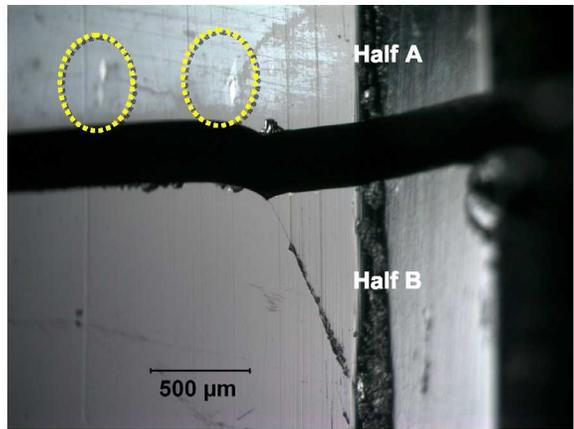
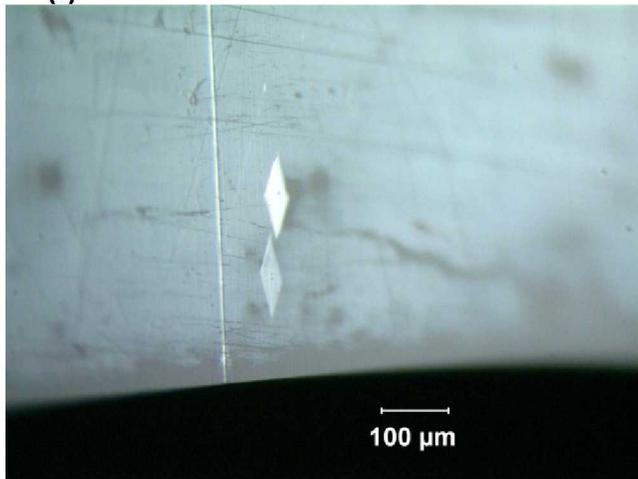
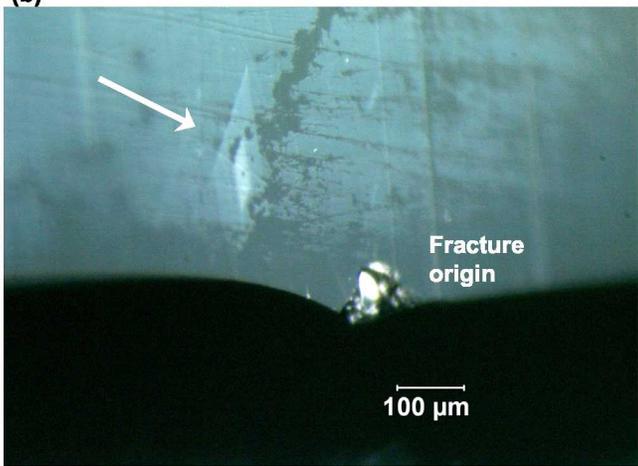
Figure 28.—Odd features detected on or just underneath the surface in half A of RSC no. 2 near but not actually at the fracture origin site. (a) shows the overall origin area with arrows marking the strange features. (b) and (c) are close up views.

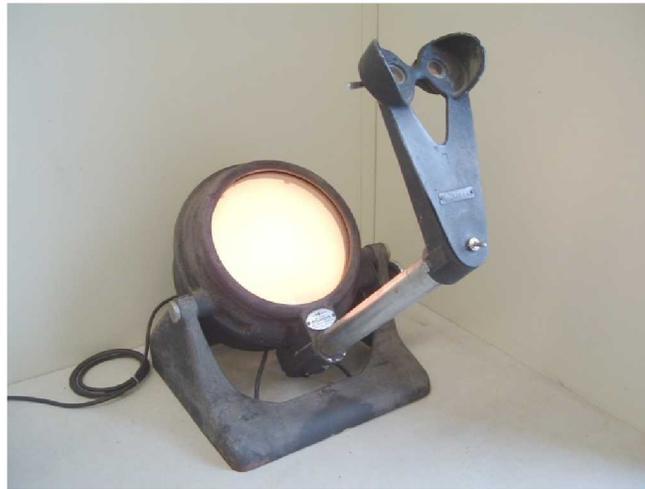
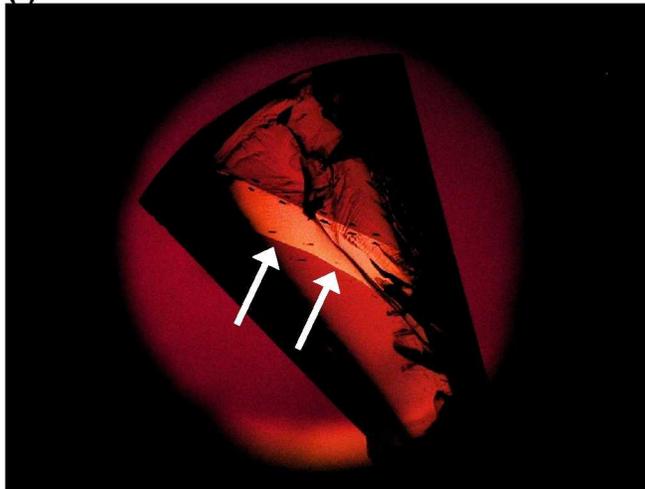
Figure A1.—Classic style Polariscope. (a) The component is placed between the polarizer eyepieces and the illuminated polarizing screen. (b) is a picture of piece 1 of concentrator 1. The photo was taken by a digital camera focused through one eyepiece. The very large twin appears as a light colored band running diagonally through the piece (white arrows). It is not a fracture plane.
