NASA/TM—2009-215802

Failure Analysis of Sapphire Refractive Secondary Concentrators

Jonathan A. Salem
Glenn Research Center, Cleveland, Ohio

George D. Quinn
National Institute of Standards and Testing, Gaithersburg, Maryland

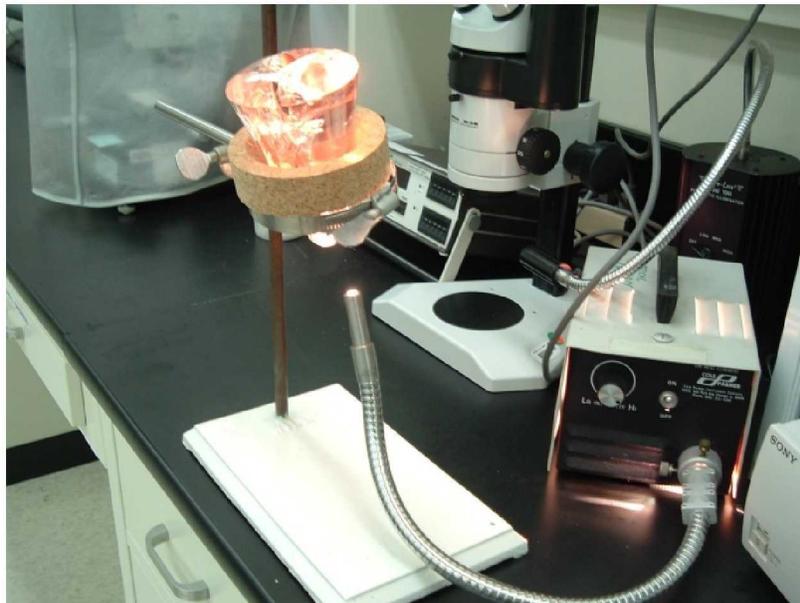
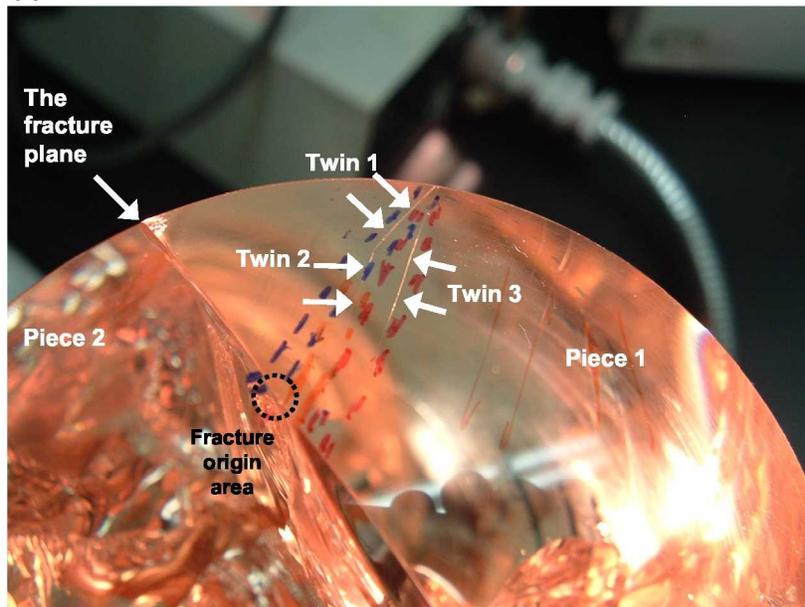
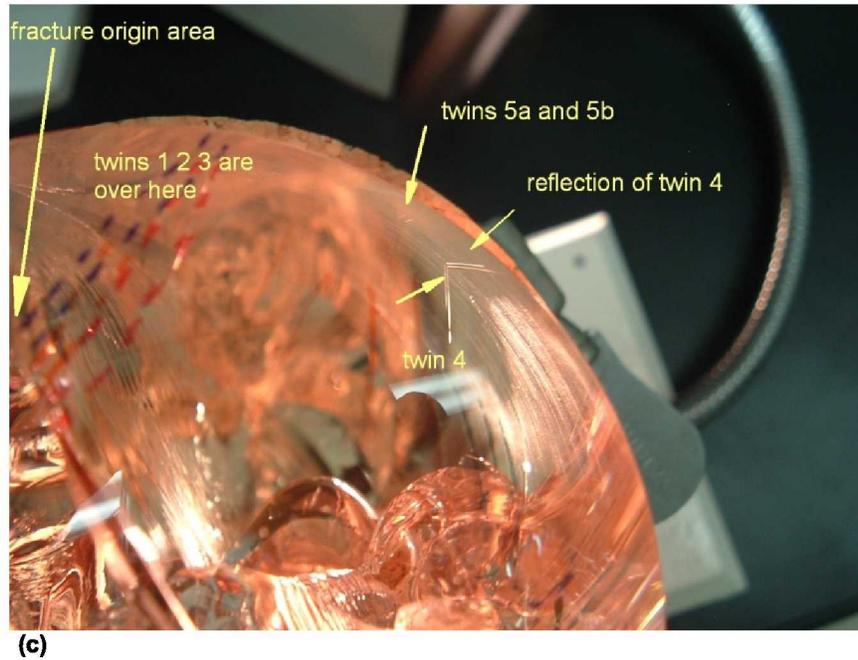
Figure A3.—Transmitted illumination was used to detect small twins. (a) shows the two pieces of concentrator 1 mounted in a soft cork ring on a common ring stand. A fiber optic light source was directed up through the body. (b) shows a digital camera photograph of the front face of RSC no. 1. Color felt tip dashed marker lines were marked on the surface to bracket two twins, which are the very thin white lines marked by the white arrows. (c) shows other twins on the same surface. The lighting and component orientation has to be changed to accentuate each twin set since it is difficult to get all twins visible at the same time. Twins 5a and b are tiny short segments. Twin 4 is longer.
