Investigation of Cracks Found in Helicopter Longerons

Abstract: Four cracked longerons, containing a total of eight cracks, were provided for study. Cracked regions were cut from the longerons. Load was applied to open the cracks, enabling crack surface examination. Examination revealed that crack propagation was driven by fatigue loading in all eight cases. Fatigue crack initiation appears to have occurred on the top edge of the longerons near geometric changes that affect component bending stiffness. Additionally, metallurgical analysis has revealed a local depletion in alloying elements in the crack initiation regions that may be a contributing factor. Fatigue crack propagation appeared to be initially driven by opening-mode loading, but at a crack length of approximately 0.5 inches (12.7 mm), there is evidence of mixed-mode crack loading. For the longest cracks studied, shear-mode displacements destroyed crack-surface features of interest over significant portions of the crack surfaces.

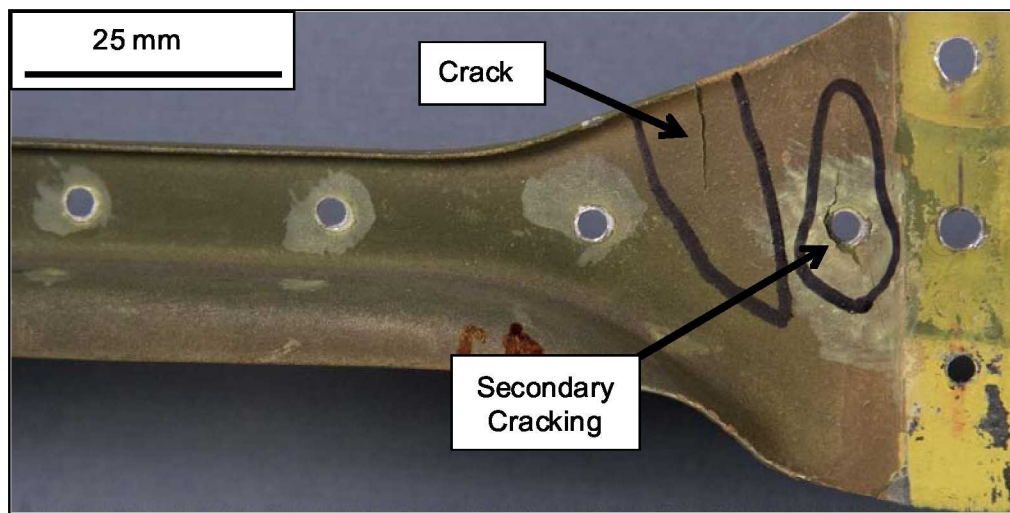
(a) Photograph of typical longeron crack with secondary cracking (Longeron #2, Crack #2).

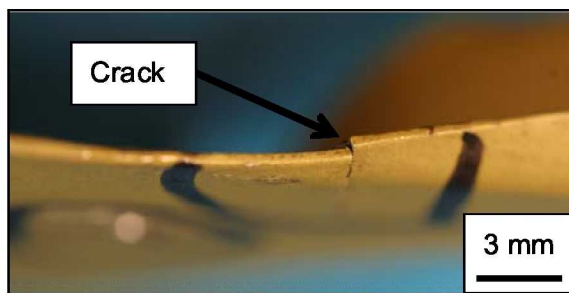
Several of the crack surfaces examined appeared to contain regions of mechanical damage where crack surface features were obliterated, presumably by crack surfaces coming into contact with each other (Longeron #1, Crack #1; Longeron #2, Crack #1; Longeron #2, Crack #2; Longeron #4, Crack #1). These were the longest cracks examined and were the same cracks that exhibited residual shear displacements. (Recall, an example of residual shear deformation was shown in Figure 3b.) It seems highly likely that the surface damage observed was a result of crack surface contact from shear (or mode III) displacements. Without knowledge of the load transfer within the structure, it is difficult to determine if the crack propagated under mixed-mode loading from the onset of crack growth, or if the crack growth caused local load redistribution and produced mixed-mode crack-tip loading only as the crack grew to a significant length (perhaps something like 0.5 inches (12.7 mm)). The most severe damage was observed on the crack surfaces nearest the top edge of the longeron, corresponding to the likely location of crack initiation. During the later stages of crack propagation, this region is the furthest from the crack-tip where crack opening and sliding displacements are expected to be largest, which is more damaging in terms of mechanical crack-face contact damage.

(b) Photograph of crack with residual shear displacement (Longeron #4, Crack #1).

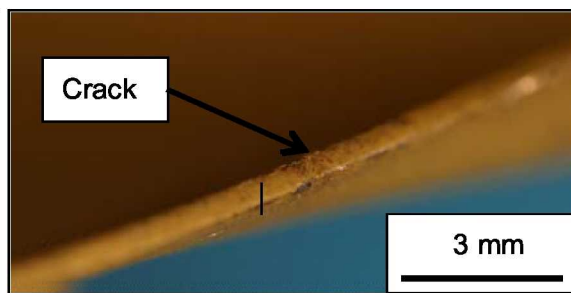
Finally, it is possible that residual shear displacements were not a product of service loading, but were imparted on the structure during component removal. The two smallest cracks (Longeron #1, Crack #3 and Longeron #4, Crack #2) were only discovered during examination at NASA (not found during Army inspections), and these cracks were considered to be “tight,” meaning that these cracks appeared as a fine linear indication without obvious residual shear deformation. Therefore, it seems likely that the visual inspection performed as routine maintenance, was only able to detect highly-visible cracks with significant shear displacements. Specifically, cracks with significant residual shear displacements expose a portion of the crack face, providing visual contrast with the painted (green) longeron surface, enhancing crack detection.

(c) Photograph of crack without residual shear displacement (Longeron #4, Crack #2).

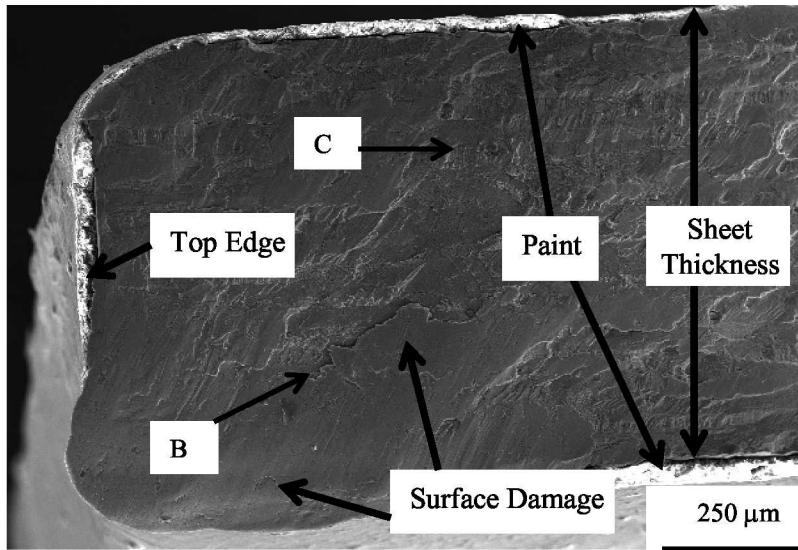
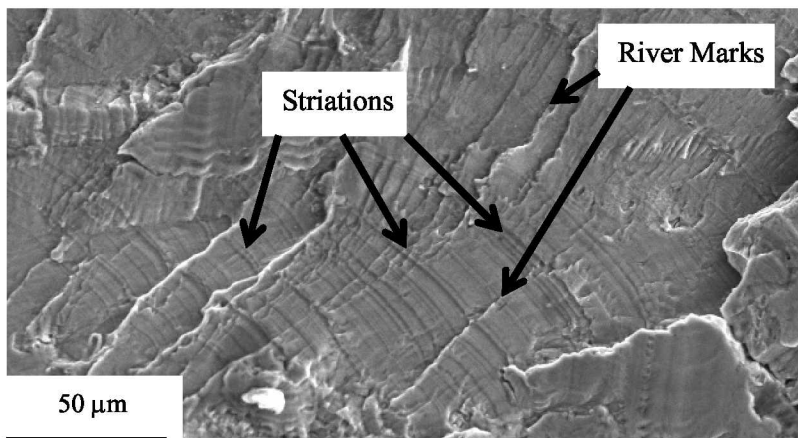
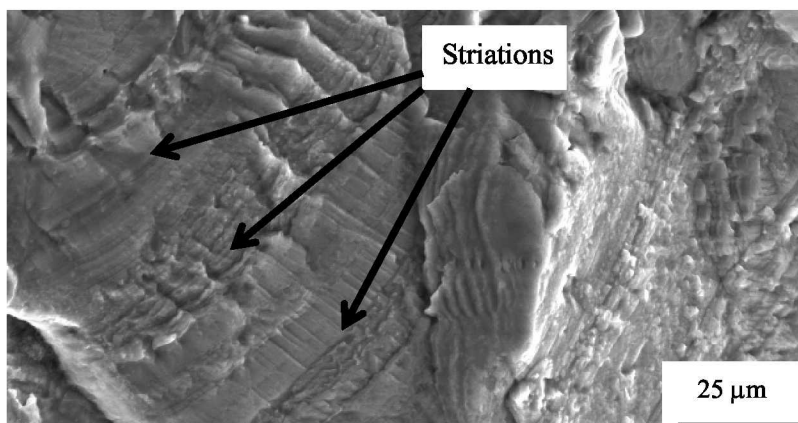
Figure 4. SEM crack-surface micrographs for Longeron #1, Crack #1.

SEM crack-surface micrographs for Longeron #1, Crack #1 (a crack approximately 0.85 inches long (21.59 mm) that initiated at Station 164.87) are shown in Figure 4. In Figure 4a, the sheet thickness direction is oriented vertically with the top edge of the longeron on the left side of the figure. Bright white regions seen on the outer surfaces of the sheet are paint. Large portions of the crack surface appear to be damaged or smeared, likely a result of the crack surfaces coming into contact with each other. Crack-surface features that may have been in these damaged regions have been destroyed; however, there are undamaged regions of the crack surface where striations have been found, and are shown at higher magnification in Figures 4b and 4c. These striations are compelling evidence that crack growth was driven by fatigue loading (ref. 1). Additionally, river marks (fatigue crack surface features that are typically perpendicular to striations, oriented parallel to the direction of crack growth) are labeled in Figure 4b.

(a) Lower-magnification image showing the entire sheet thickness.

(b) Higher-magnification image of fatigue striations, region B.

(c) Higher-magnification image of fatigue striations, region C.

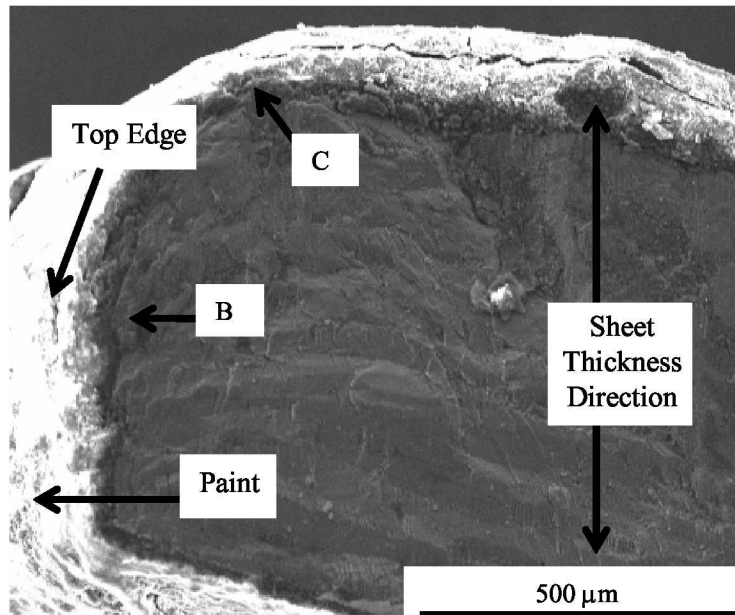
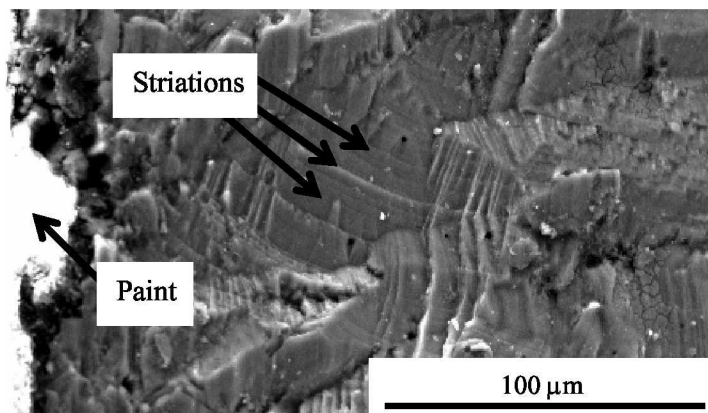
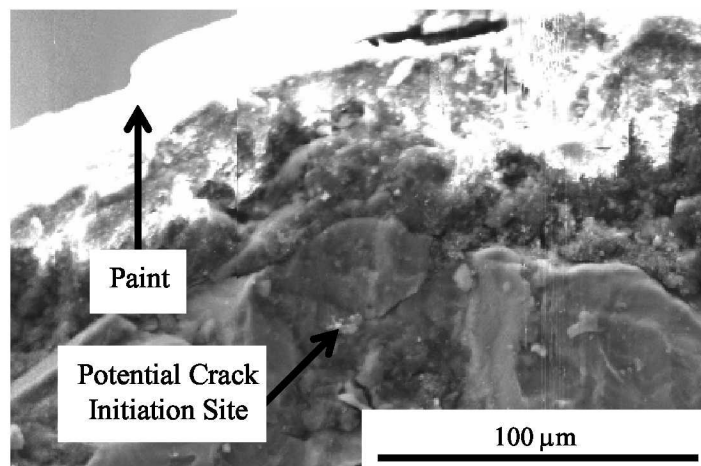
Figure 5. SEM crack-surface micrographs for Longeron #1, Crack #2.

Crack-surface examinations of Longeron #1, Crack #2 (a crack approximately 0.38 inches long (9.65 mm) occurring at Station 155.75), reveals the presence of fatigue striations, microscopic features consistent with fatigue crack growth (see Figure 5). A lower-magnification image of the crack surface is shown in Figure 5a corresponding to the top side of the longeron in the region where crack initiation appears to occur. The sheet thickness (0.025-inch-thick) direction is oriented vertically in this image. Two regions of interest are denoted, which are shown at higher-magnification in Figures 5b and 5c. Fatigue striations are easily identified in Figure 5b and at multiple other locations on the crack surface (ref. 1). The slight curvature of these striations (indications of the crack front at some previous point in time) can be traced back to determine the crack initiation site, which is shown at higher-magnification in

Figure 5c. Crack-surface features suggest that the location of crack initiation was near the surface of the sheet material. No obvious defect in the region of crack initiation was noted (e.g., corrosion pit, scratch, tool mark, etc.). The bright region near the outer surface of the sheet (extreme right side of Figure 5c) is a result of the paint covering the longeron.

(a) Lower-magnification image showing the entire sheet thickness.

(b) Higher-magnification image of fatigue striations, region B.

(c) Higher-magnification image of apparent crack initiation site, region C.

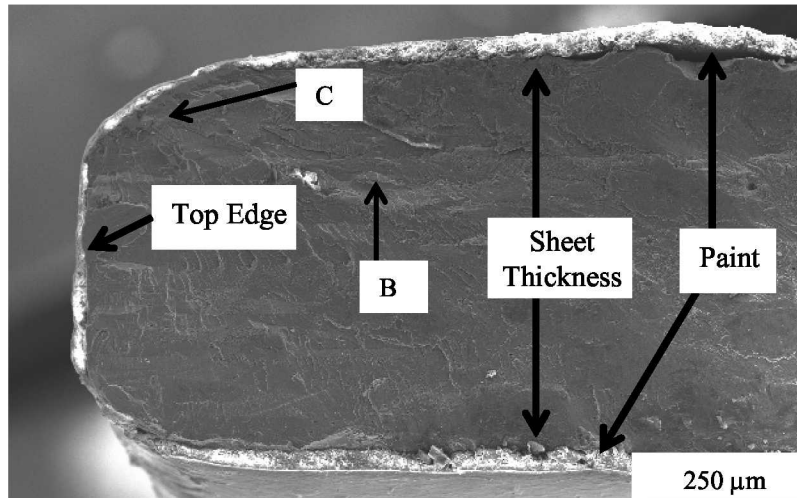
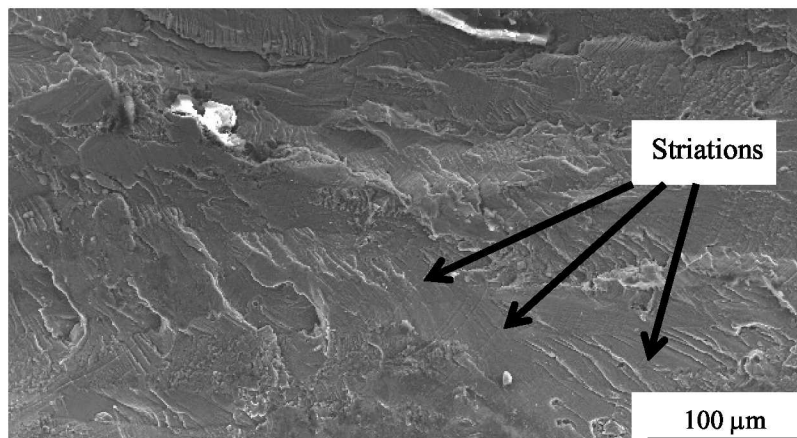
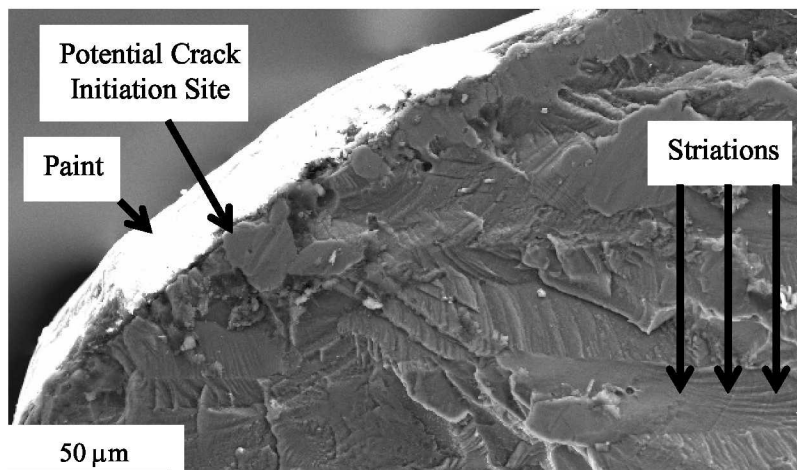
Figure 6. SEM crack-surface micrographs for Longeron #1, Crack #3.

SEM crack-surface micrographs for Longeron #1, Crack #3 (a crack approximately 0.15 inches long (3.81 mm) that initiated at Station 185.89) are shown in Figure 6. The crack surface corresponding to the top edge of the longeron is shown in Figure 6a, where the top edge of the longeron is on the left side of the figure and the sheet thickness direction is vertical. Paint on the surface of the longeron is seen as the bright white regions near the top and bottom of the figure. The crack surface is nearly free of mechanical contact damage and striations can be readily observed over nearly the entire surface (ref. 1). A typical striated region is shown in Figure 6b. Striations can be traced back to an apparent origin, which is located near the top left corner of the sheet, with respect to the orientation presented in Figure 6a, and is shown at higher magnification in Figure 6c.

(a) Lower-magnification image showing the entire sheet thickness.

(b) Higher-magnification image of fatigue striations, region B.

(c) Higher-magnification image of apparent crack initiation site, region C.

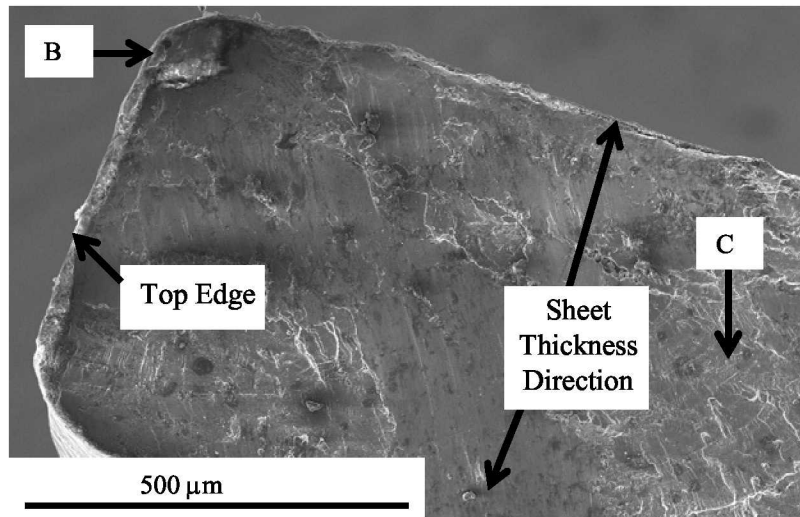
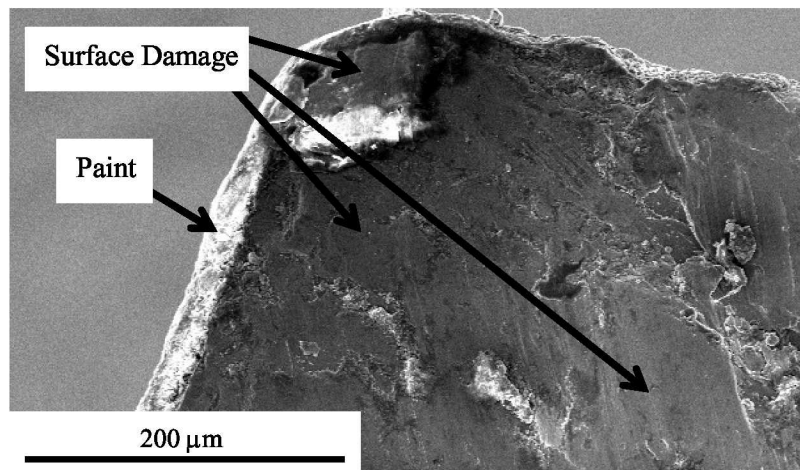
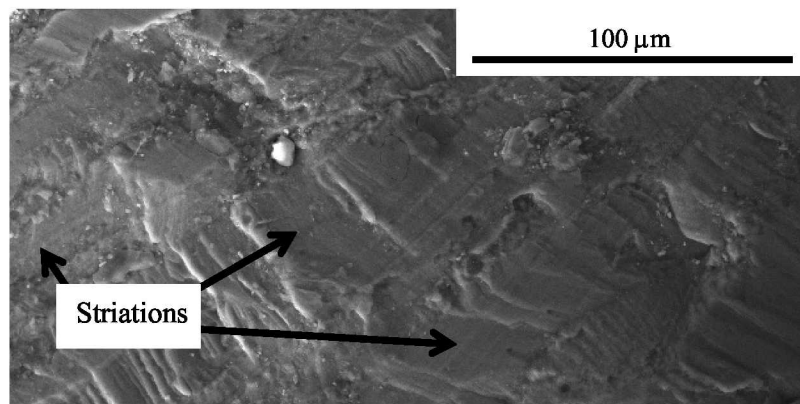
Figure 7. SEM crack-surface micrographs for Longeron #2, Crack #1.

SEM crack-surface micrographs for Longeron #2, Crack #1 (a crack approximately 0.62 inches long (15.75 mm) that initiated at Station 146.62) are shown in Figure 7. A lower-magnification image of the crack surface corresponding to the top edge of the longeron (apparent crack initiation region) is shown in Figure 7a. A higher-magnification image of the crack surface, corresponding to the upper left corner of Figure 7a, is shown in Figure 7b. Here, the crack surface appears to be smeared (contact damage) such that most of the crack-surface features (e.g., fatigue striations) have been destroyed. However, further from the top edge of the longeron (crack surface regions corresponding to the left side of Figure 7a), fatigue striations are observed (ref. 1). A typical region of fatigue striations is shown at high magnification in Figure 7c.

(a) Lower-magnification image showing the entire sheet thickness.

(b) Higher-magnification image of crack-surface damage, region B.

(c) Higher-magnification image of fatigue striations, region C.

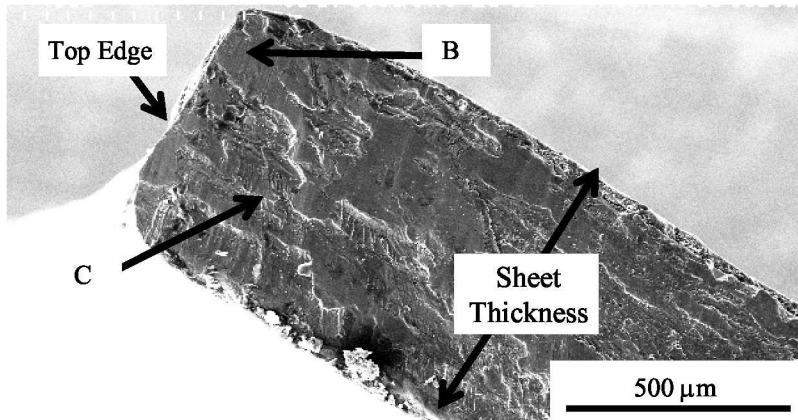
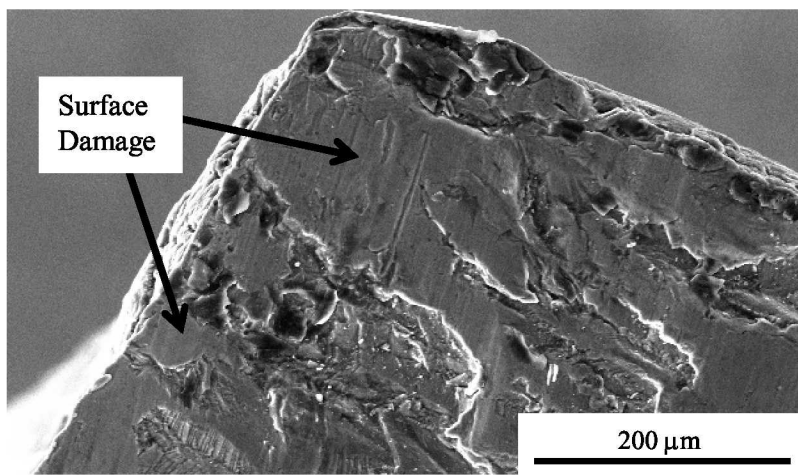
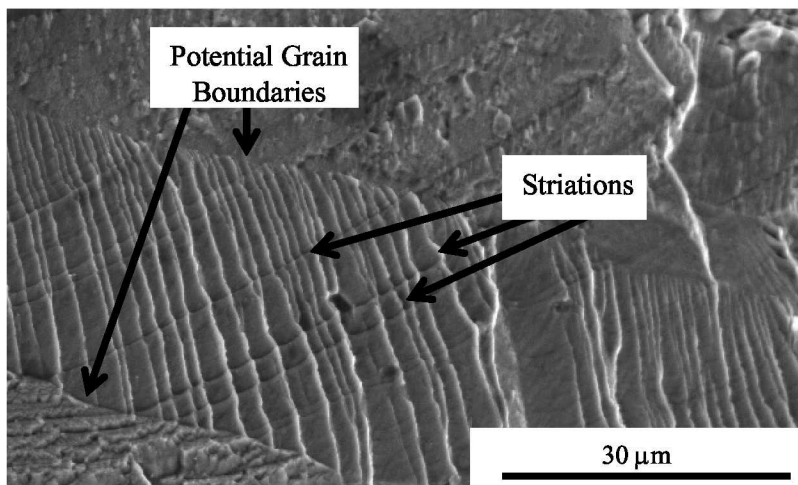
Figure 8. SEM crack-surface micrographs for Longeron #2, Crack #2.

SEM crack-surface micrographs for Longeron #2, Crack #2 (a crack approximately 0.44 inches long (11.18 mm) that initiated at Station 164.87) are shown in Figure 8. The crack surface near the top edge of the longeron is shown at lower-magnification in Figure 8a. A higher-magnification image of the crack surface, corresponding to the upper left corner of Figure 8a, is shown as Figure 8b. Similar to the results previously shown in Figure 7 (Longeron #2, Crack #1), the crack surface appears to be smeared (contact

damage) such that most of the crack-surface features, like fatigue striations (if they did exist), have been destroyed. However, there are a few islands of undamaged crack surface that contain striations (ref. 1). An example of these striations is shown in Figure 8c. Here, “river marks” (fatigue crack surface features that are typically perpendicular to striations, oriented parallel to the direction of crack growth) can be seen oriented vertically and striations are seen arcing across the image, as the crack appeared to grow from the upper left corner of the figure to the lower right. In this image, a third set of interesting linear features can be seen that are believed to be grain boundaries (ref. 1). Here, it is believed that the region containing the clear striations is within a grain oriented in a manner to promote striations while the regions above and below are grains having different orientations such that striations are less pronounced. If these features are indeed grain boundaries, the grains in this sheet product are elongated in the sheet directions and thin in the direction of the sheet thickness. Further work is needed to characterize the microstructure of this sheet product.

(a) Lower-magnification image showing the entire sheet thickness.

(b) Higher-magnification image surface damage, region B.

(c) Higher-magnification of fatigue crack striations, region C.

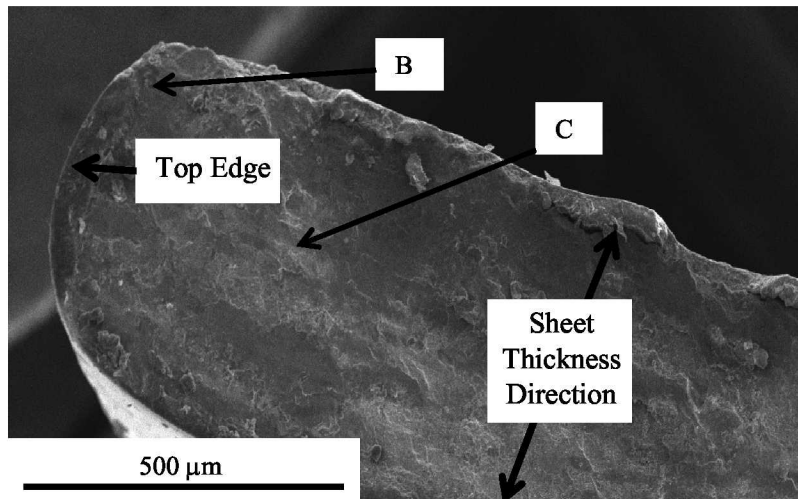
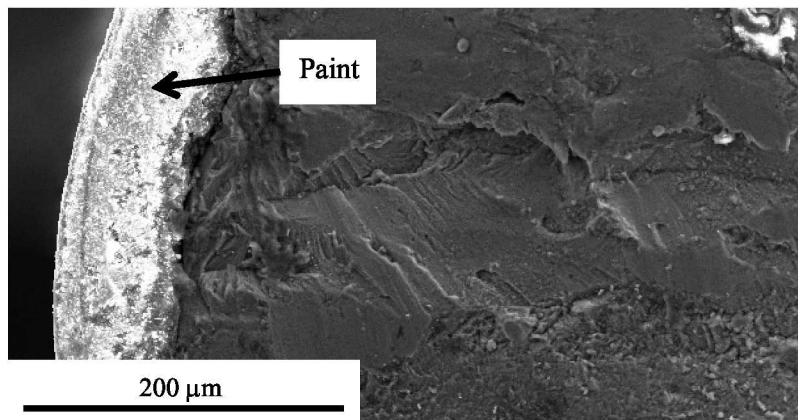
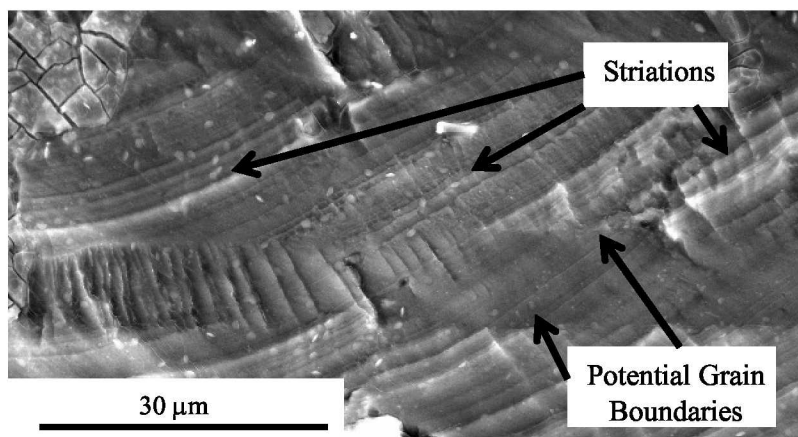
Figure 9. SEM crack-surface micrographs for Longeron #3, Crack #1.

SEM crack-surface micrographs for Longerons #3, Crack #1 (a crack approximately 0.31 inches long (7.87 mm) that initiated at Station 164.87) are shown in Figure 9. The crack surface region near the top edge of the longeron is shown at lower-magnification in Figure 9a. A higher-magnification image of the surface near the edge is shown in Figure 9b. Here, the top edge of the longeron sheet is on the left side of Figure 9b; the bright area corresponds to the paint on the outer surface. Similar to the results for the cracks found in Longerons #2, portions of the crack surface appear to be smeared or damaged. However, islands of undamaged surface can be seen near the center of Figure 9b. Some of these undamaged regions are striated, as shown in Figure 9c, indicating that the crack propagation was driven by cyclic loading (ref. 1).

(a) Lower-magnification image showing entire sheet thickness.

(b) Higher-magnification image of surface damage, region B.

(c) Higher-magnification image of fatigue striations, region C.

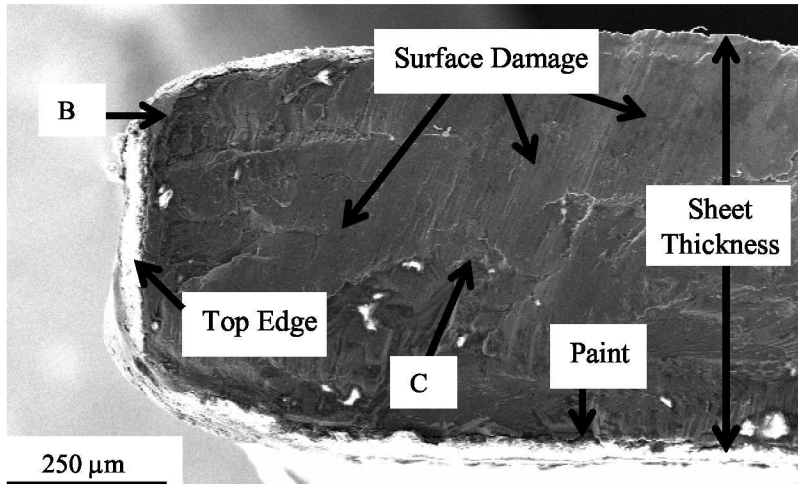
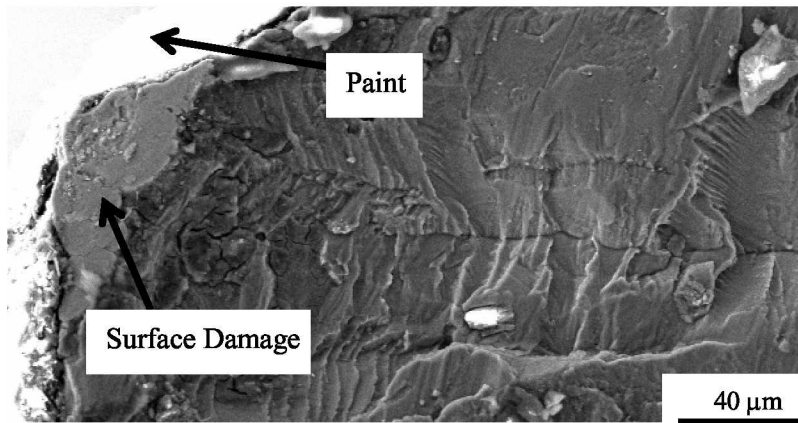
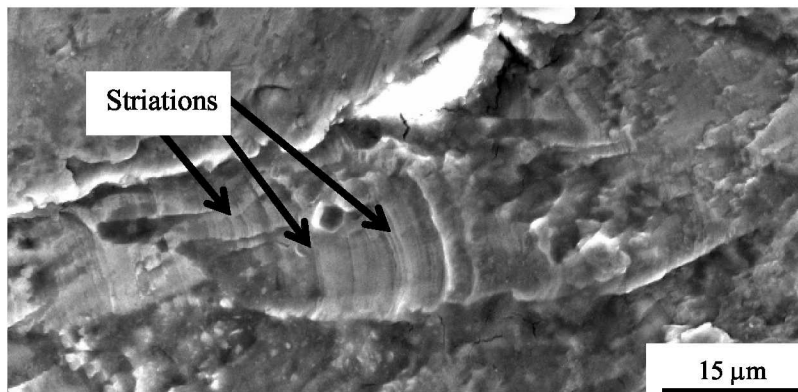
Figure 10. SEM crack-surface micrographs for Longeron #4, Crack #1.

SEM crack-surface micrographs for Longerons #4, Crack #1 (a crack approximately 0.49 inches long (12.45 mm) that initiated at Station 155.75) are shown in Figure 10. A relatively low-magnification image of the entire sheet thickness is shown as Figure 10a; here, the top edge of the longeron corresponds to the left side of the figure. Large portions of the crack surface appear to be damaged, presumably smeared as crack faces came into sliding contact, as observed in Figure 3b. In these damaged regions, crack-surface features of interest have been destroyed. A higher-magnification image of the damaged corner region is shown as Figure 10b. However, there are crack-surface regions that escaped mechanical

damage and in these regions fatigue striations were observed (ref. 1). A typical example of striations in these undamaged regions is shown as Figure 10c.

(a) Lower-magnification image showing the entire sheet thickness.

(b) Higher-magnification image of surface damage, region B.

(c) Higher-magnification image of fatigue striations, region C.

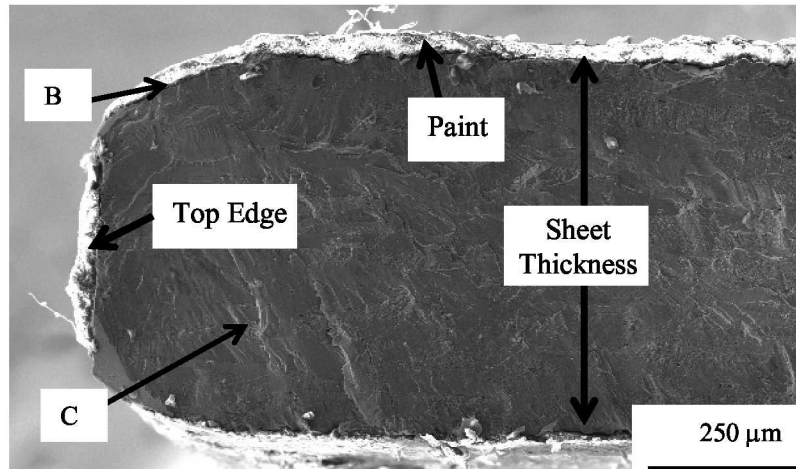
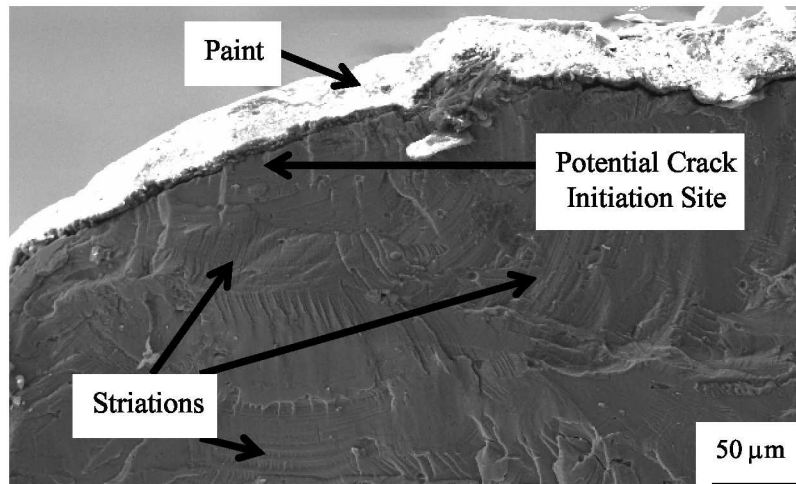
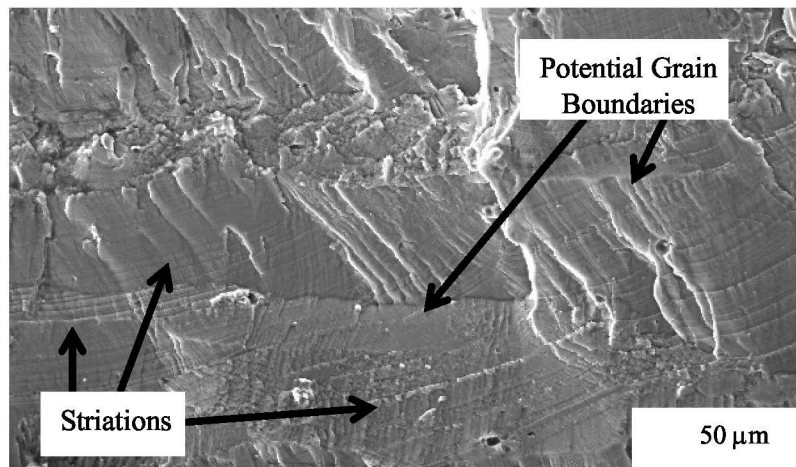
Figure 11. SEM crack-surface micrographs for Longeron #4, Crack #2.

SEM crack-surface micrographs for Longerons #4, Crack #2 (a crack approximately 0.18 inches long (4.57 mm) that initiated at Station 164.87) are shown in Figure 11. A relatively low-magnification image of the entire sheet thickness is shown as Figure 11a; here, the top edge of the longeron corresponds to the right side of the figure. Recall from Figure 3b that this relatively short crack exhibited no residual shear displacement. It is likely not coincidental that these crack surfaces are nearly free of contact or smearing damage. Nearly the entire crack surface contains fatigue striations (ref. 1). These fatigue striations can be traced back to an apparent crack initiation site, which is shown at higher magnification as Figure 11b. No obvious crack initiation feature (e.g., scratch, pit, or other defect) was observed near the crack initiation site, which suggests that surface defects were not a contributing factor in crack initiation. Fatigue striations are shown at high magnification in Figure 11c. In this image, the crack surface appears similar to that of Longerons #2, Crack #2 (Figure 8c) and Longerons #3, Crack #1 (Figure 9c), where features that are believed to be grain boundaries can be identified in the image.

(a) Lower-magnification image showing the entire sheet thickness.

(b) Higher-magnification image of apparent crack initiation site, region B.

(c) Higher-magnification image of fatigue striations, region C.

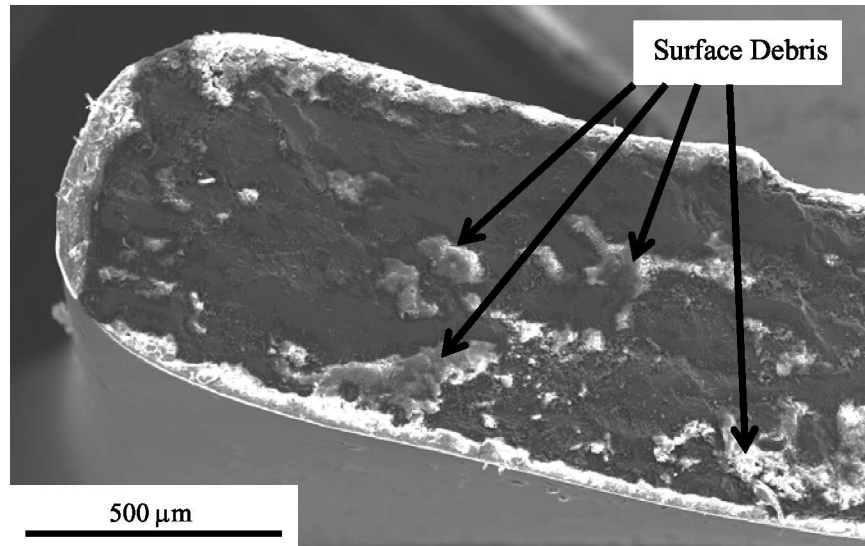
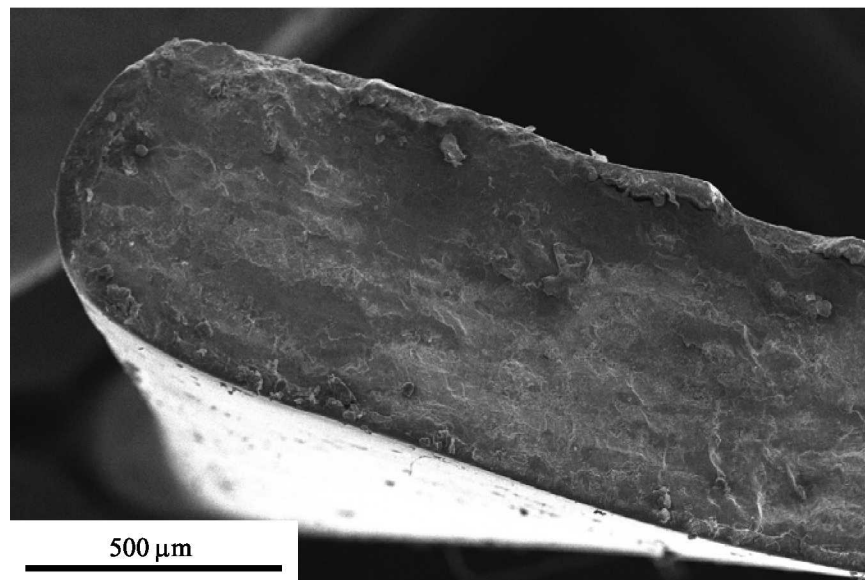
Figure 12. Images of typical crack surface (Longeron #3, Crack #1).

Typically, the crack surfaces were covered with debris that obscured the microscopic features of interest. To examine these features, the crack surfaces were ultrasonically cleaned in acetone, which successfully removed most of the debris without damaging the crack surfaces or the paint on the external surfaces of the longerons. The SEM images shown in Figures 4-11 were taken from clean surfaces. However, before cleaning, the dirty surfaces were examined in the SEM and chemically analyzed using Energy Dispersive X-ray (EDX) Spectroscopy (ref. 2). Crack surfaces of Longerons #3, Crack #1 are shown in Figure 12 both before cleaning the crack surfaces (Figure 12a) and after cleaning (Figure 12b). The crack surface debris is readily seen as the bright white regions in Figure 12a (absent in Figure 12b), a result of surface charging in the electron beam of the SEM. An EDX analysis taken of the debris (white regions in Figure 12a) indicates the presence of chlorine (25.3% weight), oxygen (16.6%), silicon (15.7%), sulfur (11.3%), sodium (9.0%), potassium (7.4%), phosphorus (6.0%), calcium (5.4%), and aluminum (3.3%). Similar chemical signatures have been obtained from other crack surfaces.

(a) Crack surface with debris before cleaning.

(b) Crack surface after cleaning.

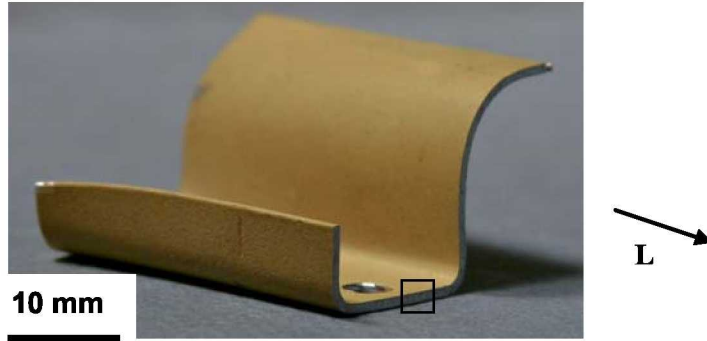
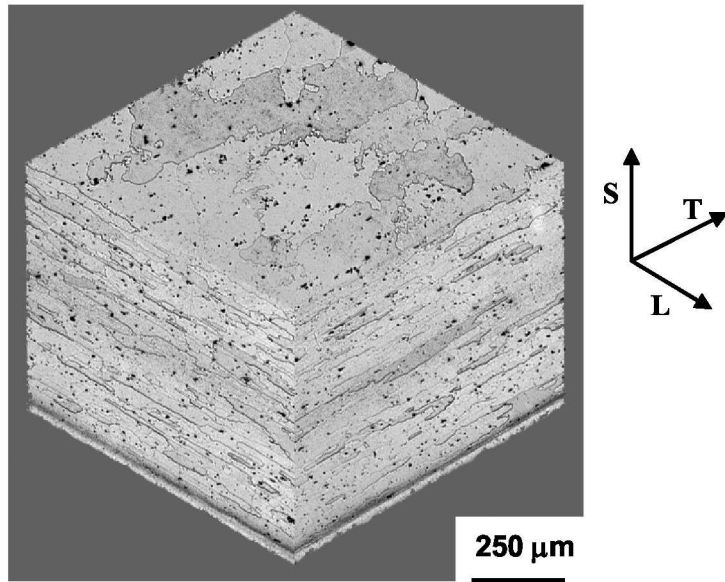
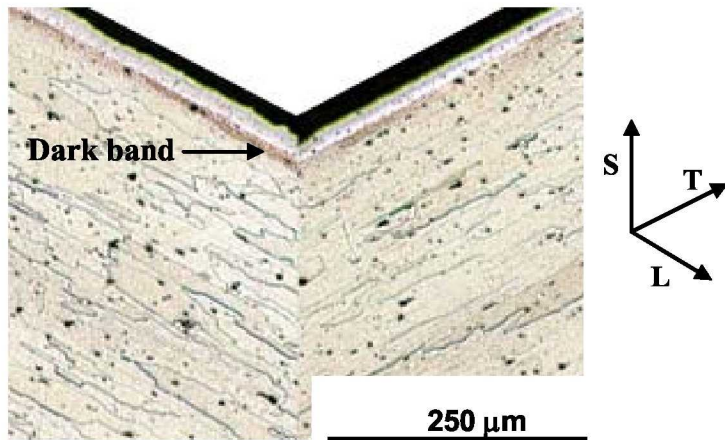
Figure 13. Results of metallurgical analysis of aluminum alloy 7075 longeron sheet material.

The microstructure of the aluminum alloy 7075 sheet is shown in Figure 13. For this microstructural analysis, a sample of material was cut from Longerons #1, immediately aft of Station 155.75. As indicated by the boxed region in Figure 13a, the material analyzed corresponded to the portion of the longeron that was fastened to the tail-boom fairing skin. Surfaces normal to the sheet directions were cut, mounted, etched[†] and polished for metallurgical analysis, and the corresponding images were arranged to appear as a three-dimensional cube of the material, herein termed “orthogonal metallurgical cube.” See Figure 13b for an orthogonal metallurgical cube of the longeron sheet material; here, the bottom edge of Figure 13b corresponds to the outer edge of the longeron sheet. The orthogonal surfaces used were termed “L” (perpendicular to the length of the longeron), “T” (perpendicular to the vertical longeron direction as described in Figure 1), and “S” (perpendicular to the 0.025-inch sheet thickness direction). Examination of the dark lines in Figure 13b (presumably grain boundaries) indicates large grain areas on the S-surface with long and flat grain areas along both the L-surfaces and T-surfaces. These observations are typical of aluminum sheet material and a flattened pancake-shape grain structure. A portion of Figure 13b is shown at higher magnification in Figure 13c to better show microstructural boundaries. Here, the typical spacing between linear indications on both the L-surfaces and T-surfaces is nearly 20 μm , consistent with the hypothesis that the features observed in Figures 8c and 9c are grain boundaries.

Examination of the orthogonal metallurgical cube of Figure 13b reveals the presence of what appears to be a dark band near the outer surface of the sheet material (see bottom of Figure 13b). This discoloration occurred in the same near-surface region where small grain sizes were observed (recall Figure 14). A chemical analysis (EDX) was performed on near-surface and interior regions of the polished surfaces. SEM images of regions examined are shown in Figure 15. In these images, the sheet material is seen at the bottom with the paint layer near the top. The near surface region selected for analysis is shown with a box in Figure 15a and the interior region (approximately 60 μm from the surface) is indicated by a box in Figure 15b. The chemical analysis results, which are summarized in Table 2, indicate that the near surface region contains less alloying elements (zinc, copper, and magnesium) than the interior region, which has a composition typical of aluminum alloy 7075 (ref. 4). This depletion of alloying elements at the surface may result in a degradation of mechanical properties, such as poor resistance to crack initiation. In all cases where crack surface observations permitted (recall Figures 5, 6, and 11), crack initiation sites were always located on the corner of the longeron cross-section near the intersection of sheet surface (where a depletion of alloying elements was observed) and the top edge of the longeron where bending stresses are likely greatest. Further study is needed to determine if the chemical depletion contributed to the cracking.

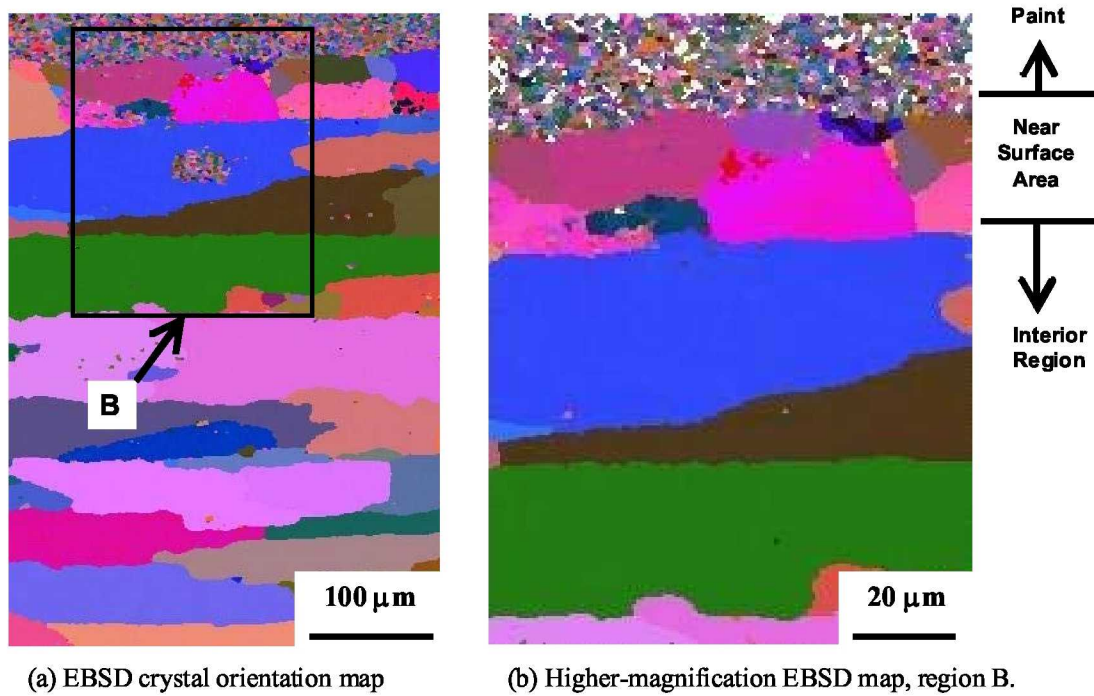
Figure 14. Near-surface crystal orientation maps generated by EBSD.

To confirm that the linear indications observed in Figure 13 are indeed grain boundaries, the physical metallurgy of the sheet material was analyzed using an SEM equipped with Electron Back-Scatter Diffraction (EBSD) to generate crystal orientation maps (ref. 2). A section of the longeron material (cut from Longerons #1, immediately aft of Station 155.75) was mounted and prepared for EBSD analysis, exposing a surface normal to the L-direction as defined in Figure 13, and having the same nominal

orientation as the crack faces. The sample was mounted in an epoxy material to preserve the integrity of the edges (prevent rounding during polishing) and polishing was performed with care to eliminate surface residual stresses. EBSD data were collected across the sample, and then analyzed to produce crystal orientation maps of the near-sheet-surface material, which are presented in Figure 14. Figure 14b is a higher-magnification crystal orientation map of region B, which is indicated in Figure 14a. The paint, near surface area, and interior regions are indicated in Figure 14b. The crystal orientation map consists of thousands of points, each assigned a color based on its crystal orientation. In this image, grains appear as continuous regions having the same color. The grains seen in the interior region appear to be elongated and approximately 25 μm thick (in the sheet thickness direction, seen in Figure 14 as the vertical direction), which is consistent with the grain size estimates obtained from SEM observations of Figures 8c, 9c, and 11c. The grains within 25 μm of the sheet surface have a significantly smaller grain size compared with the interior region.

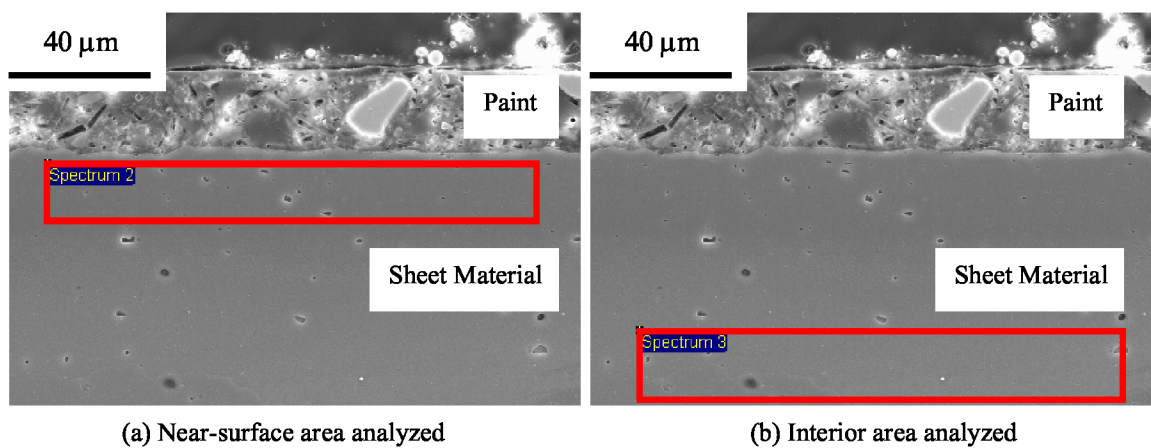
Figure 15. Near-surface and interior regions used for chemical analysis.

During metallurgical analysis of the longeron sheet material, an unusual feature was observed on polished surfaces of near-surface samples. (Recall, this layer appeared as a dark band near the bottom of Figure 13b.) Chemical analysis of near-surface region (Figure 14a) revealed that, in comparison to both the interior chemistry and typical aluminum alloy 7075 chemistry (ref. 4), it was relatively poor in the alloying elements copper, zinc, and magnesium, and appeared to contain traces of iron. This alloying element depletion may result in a local degradation in mechanical performance, including resistance to cracking. In the examples where crack-surface features were used to determine an apparent crack initiation site (Longeron #1, Crack #2; Longeron #1, Crack #3), these crack initiation sites occurred near the longeron sheet surface (where alloying element depletion was observed). EBSD results (Figure 15) revealed that the typical grain sizes within this near-surface alloying-element-depletion region were significantly finer than those within the longeron sheet interior. Additionally, the absence of corrosion pits, scratches, dents, or tool marks, suggests that corrosion and handling (e.g., installation and maintenance) were not contributing factors on crack initiation.
