## **Large Scale Shearography Inspection of the Space Shuttle External Fuel Tank**

# ET-122 Background - Hurricane Katrina

## ET-122 Restoration Thermal Protection System Assessment

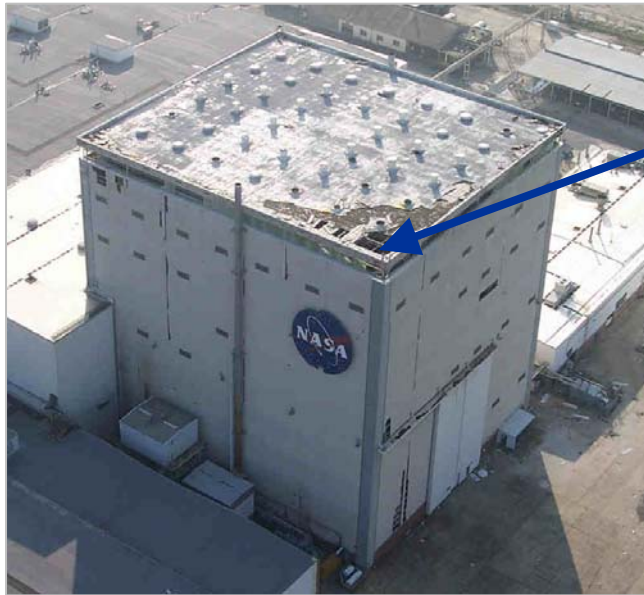
Hole in Roof  
(not directly over ET-122)

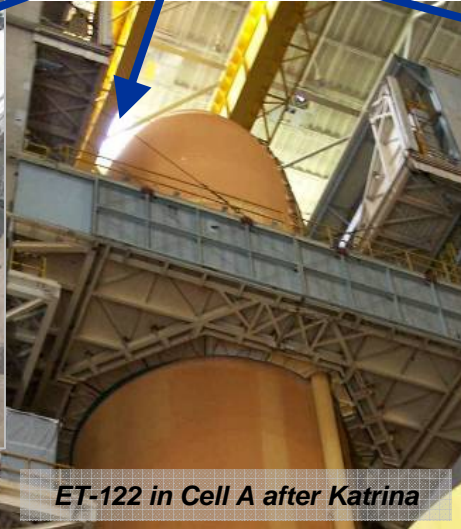
ET-122 in Cell A after Katrina

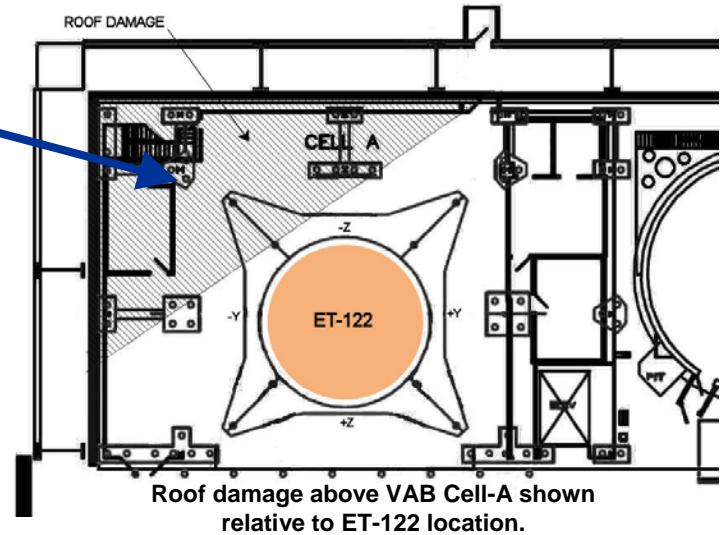
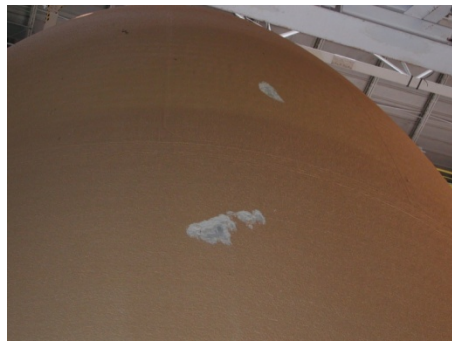
LO2 Tank Ogive Damage

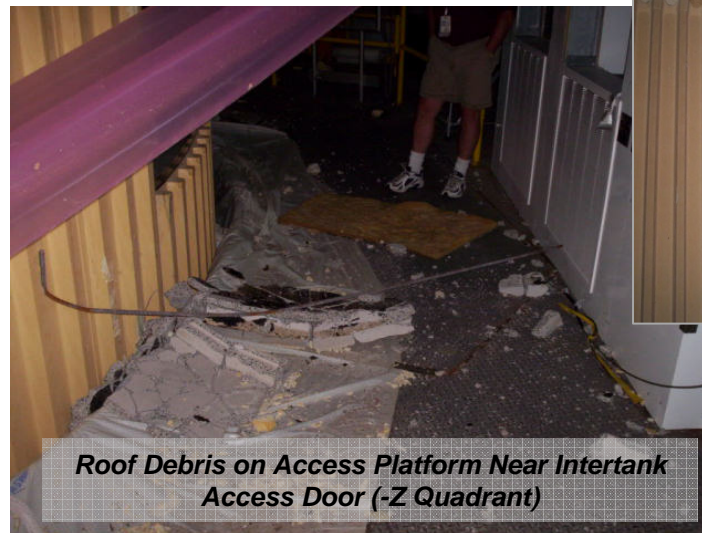
Roof Debris on Access Platform Near Intertank Access Door (-Z Quadrant)

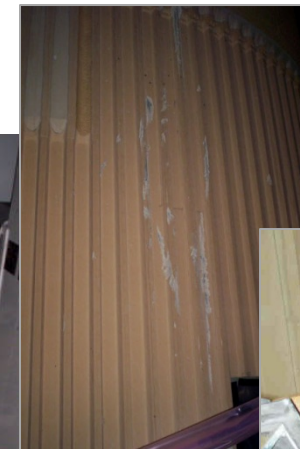
Intertank Damage

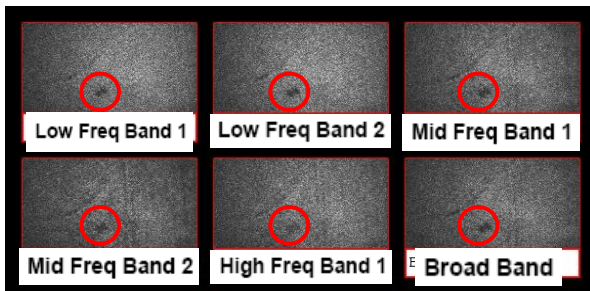
### **Visible Indication**

Strong Shearography response and damage was visibly evident

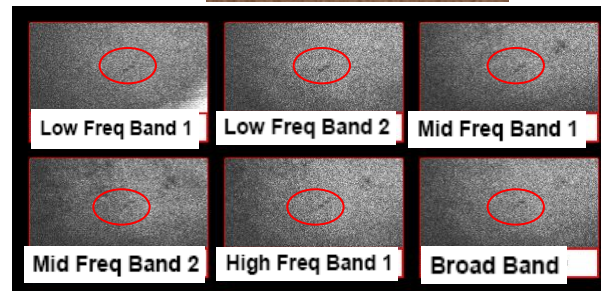
### **Non-visible Indication**

Strong Shearography response but no visible damage on tank

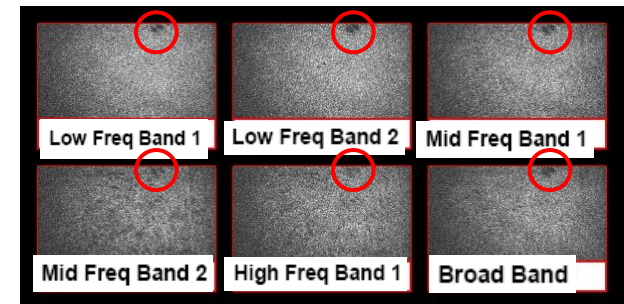
### **Embedded Concrete Chip**

Strong Shearography response, small but visible damage on tank

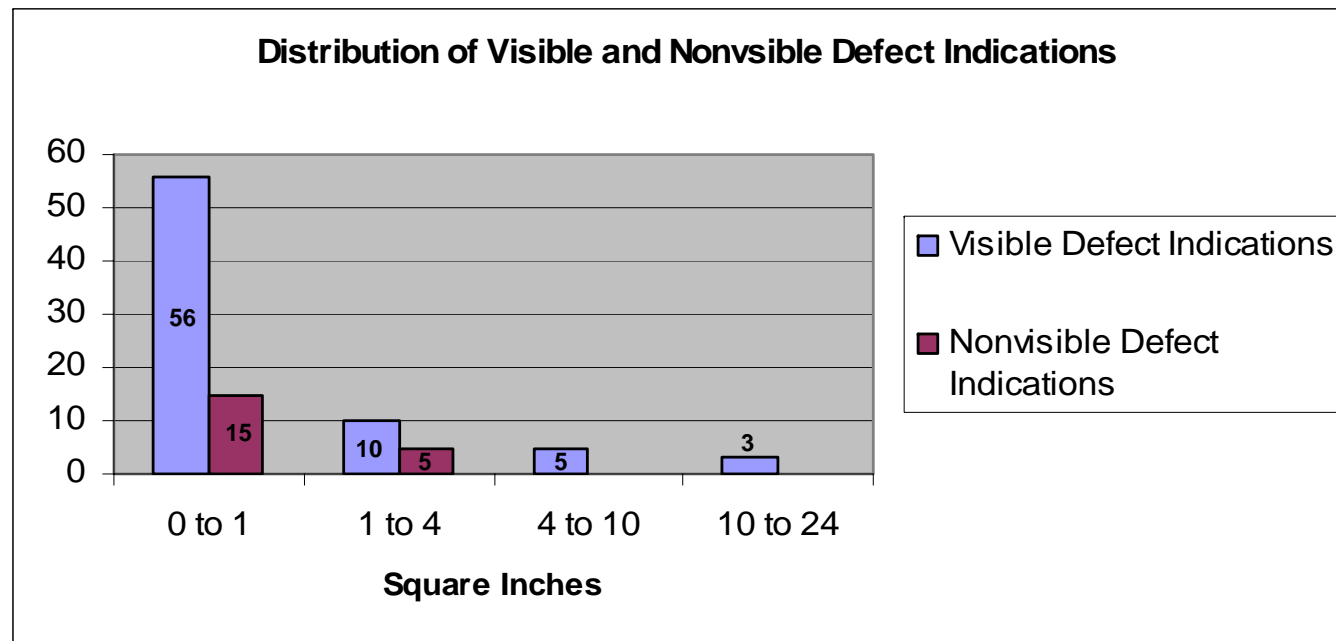
**Distribution of Defect Indications by Size**

- 95 total defect indications
- 74 indications involved visible TPS damage
- 21 indications exhibited no visible damage
- Two occurrences of embedded concrete chips were detected

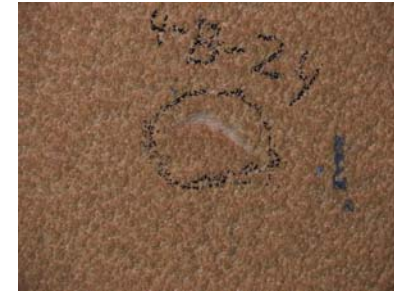
Contamination adjacent to visible impact damage was determined by shearography not to be actual foam damage

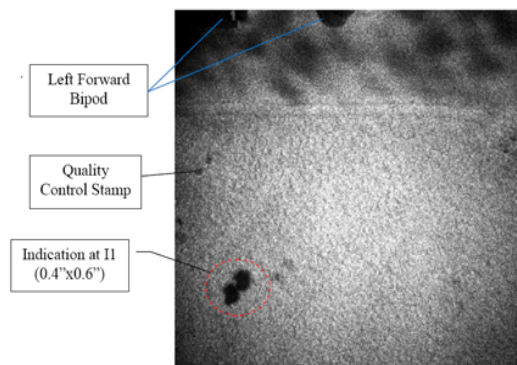
Distinct crush damage indication from recent ET135 inspection

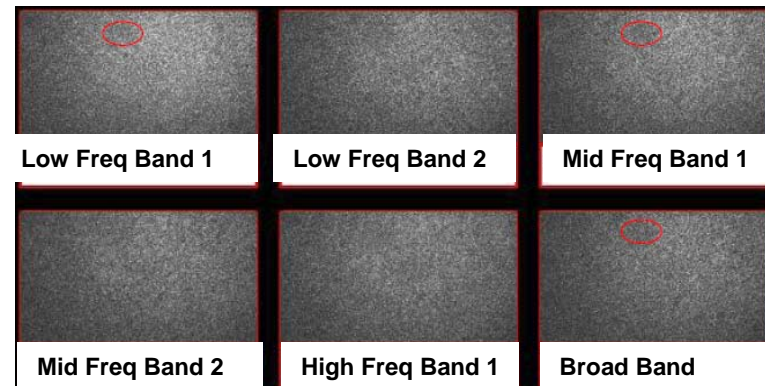
Many ET122 indications were faint and not distinct in all frequency bands
