# Lessons Learned From The EMU Fire And How It Impacts CxP Suit Element Development & Testing

**Presenter: Terry Hill**

**15 Sep 08**

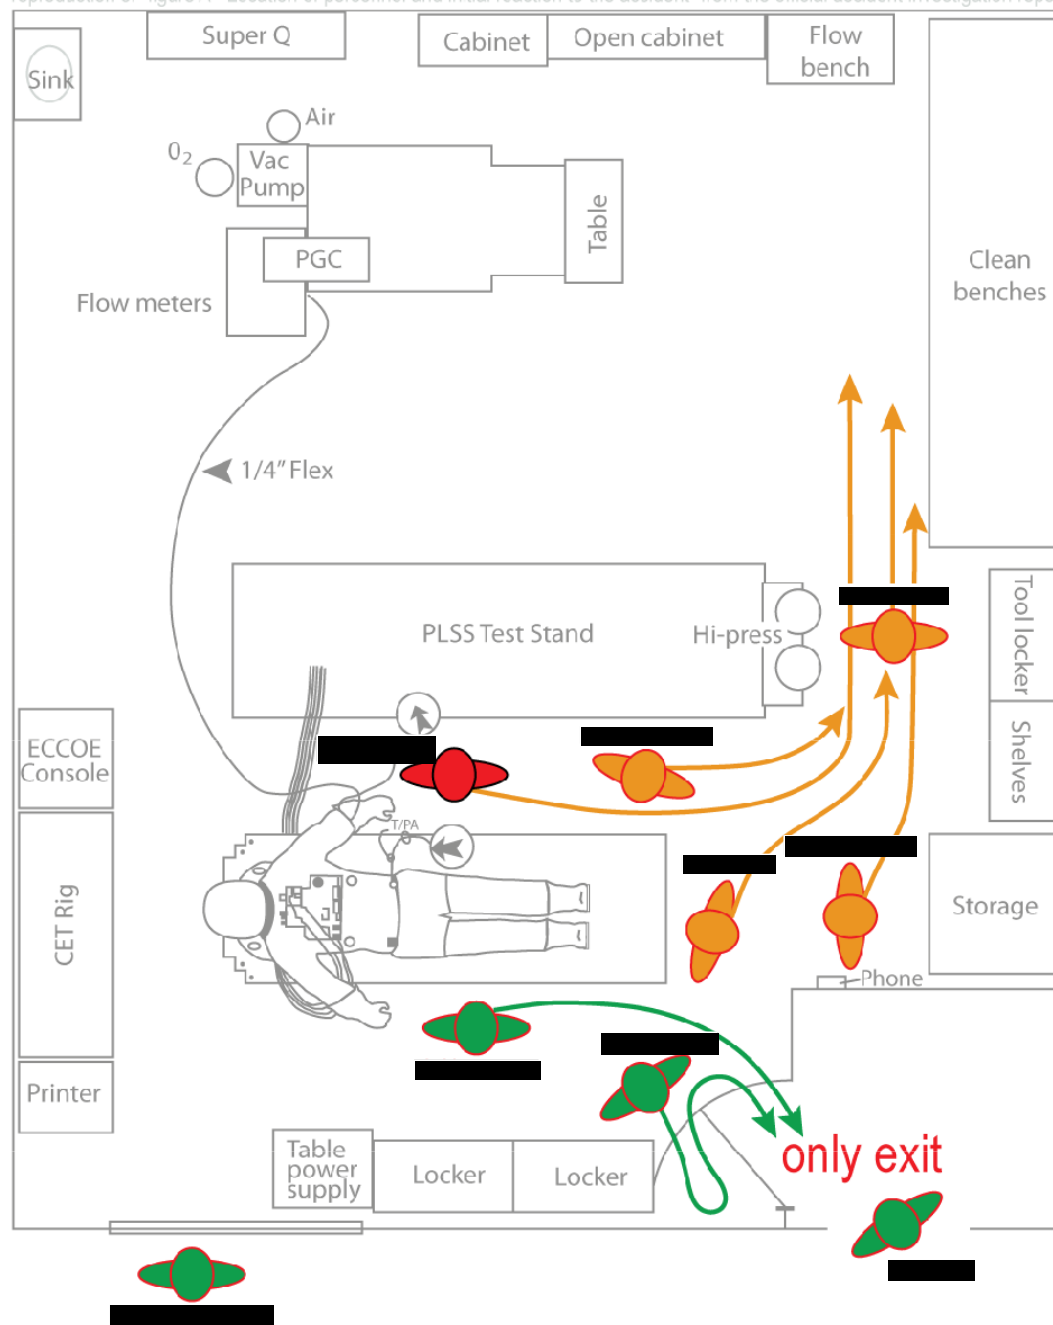
reproduction of "figure A - Location of personnel and initial reaction to the accident" from the official accident investigation report

Suffered severe injuries - hospitalized
-

Improper reaction – could have resulted in injury or death
-

Proper reaction – individuals exited the room to safety

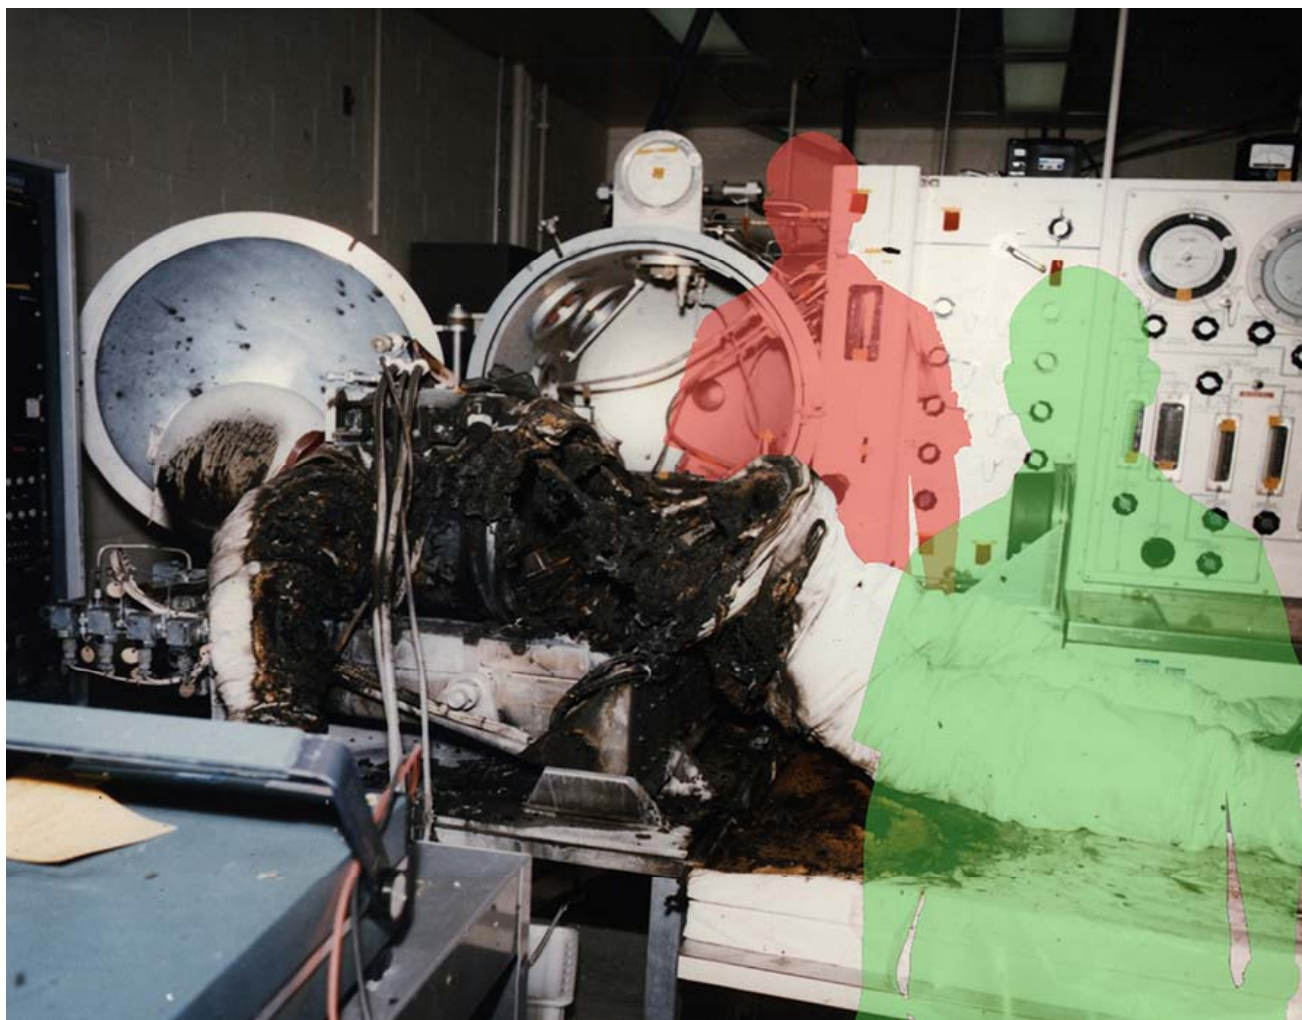
A technician was standing between the suit and test stand

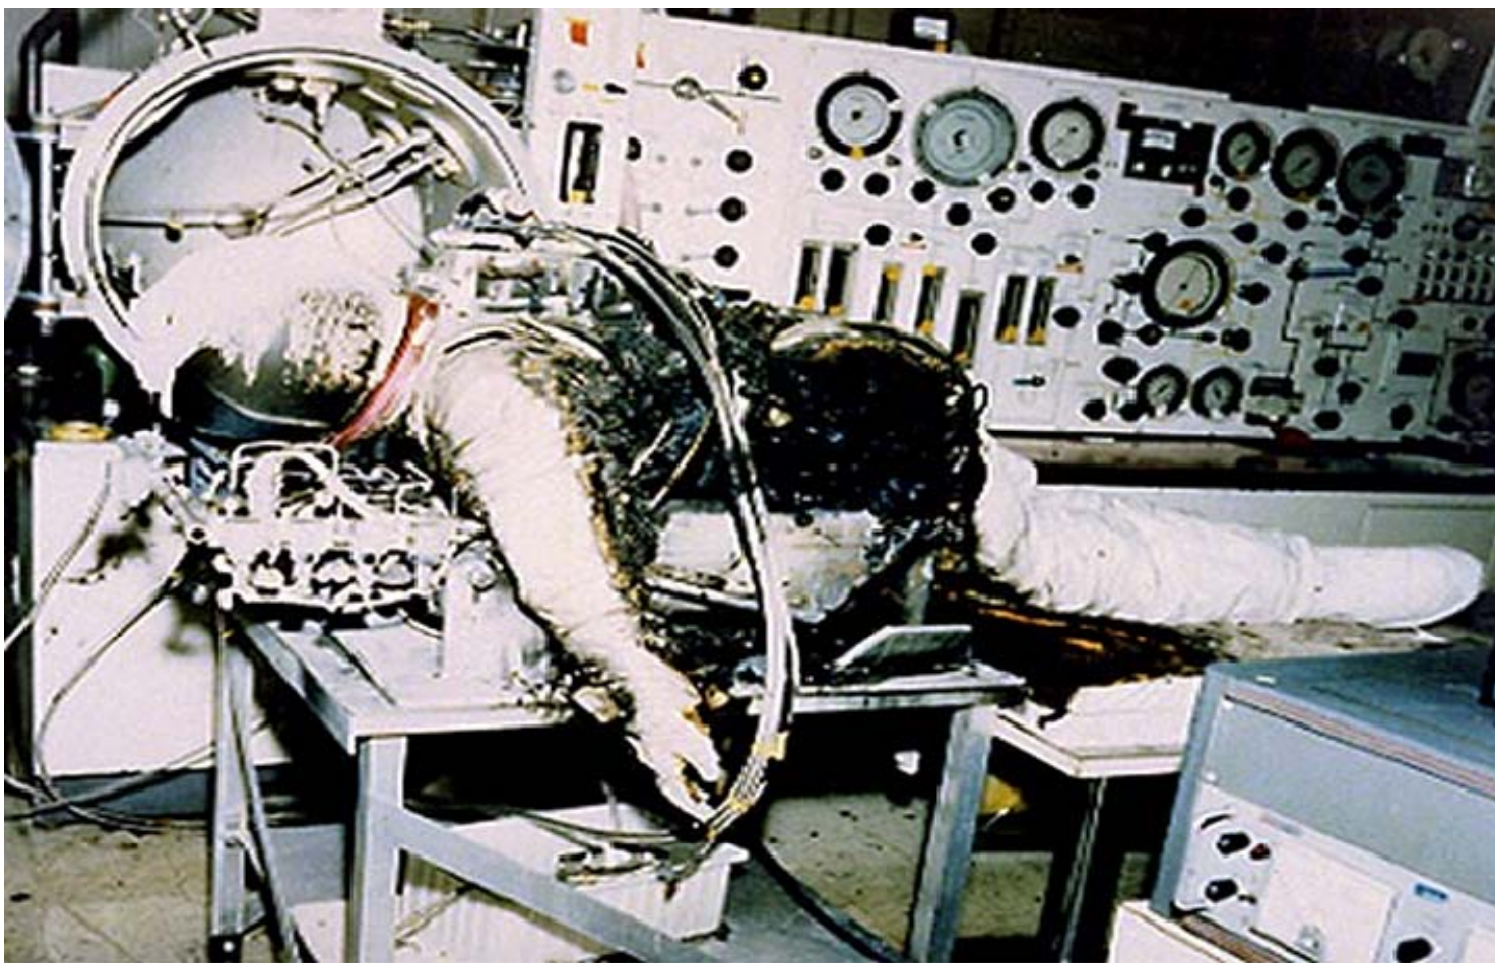
~2 million dollars worth of damage

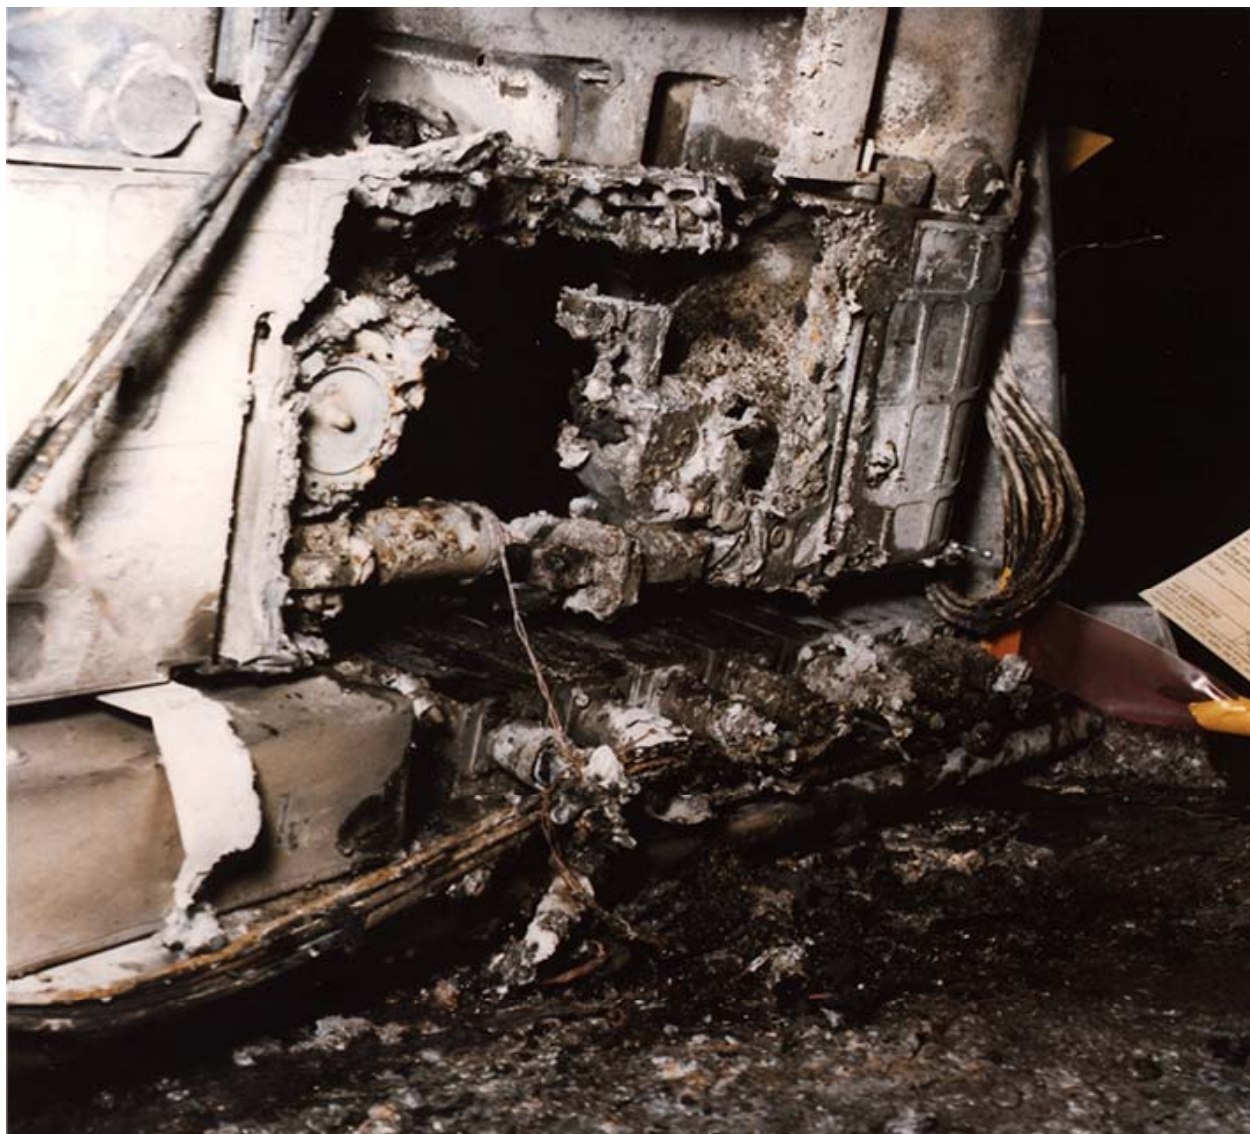
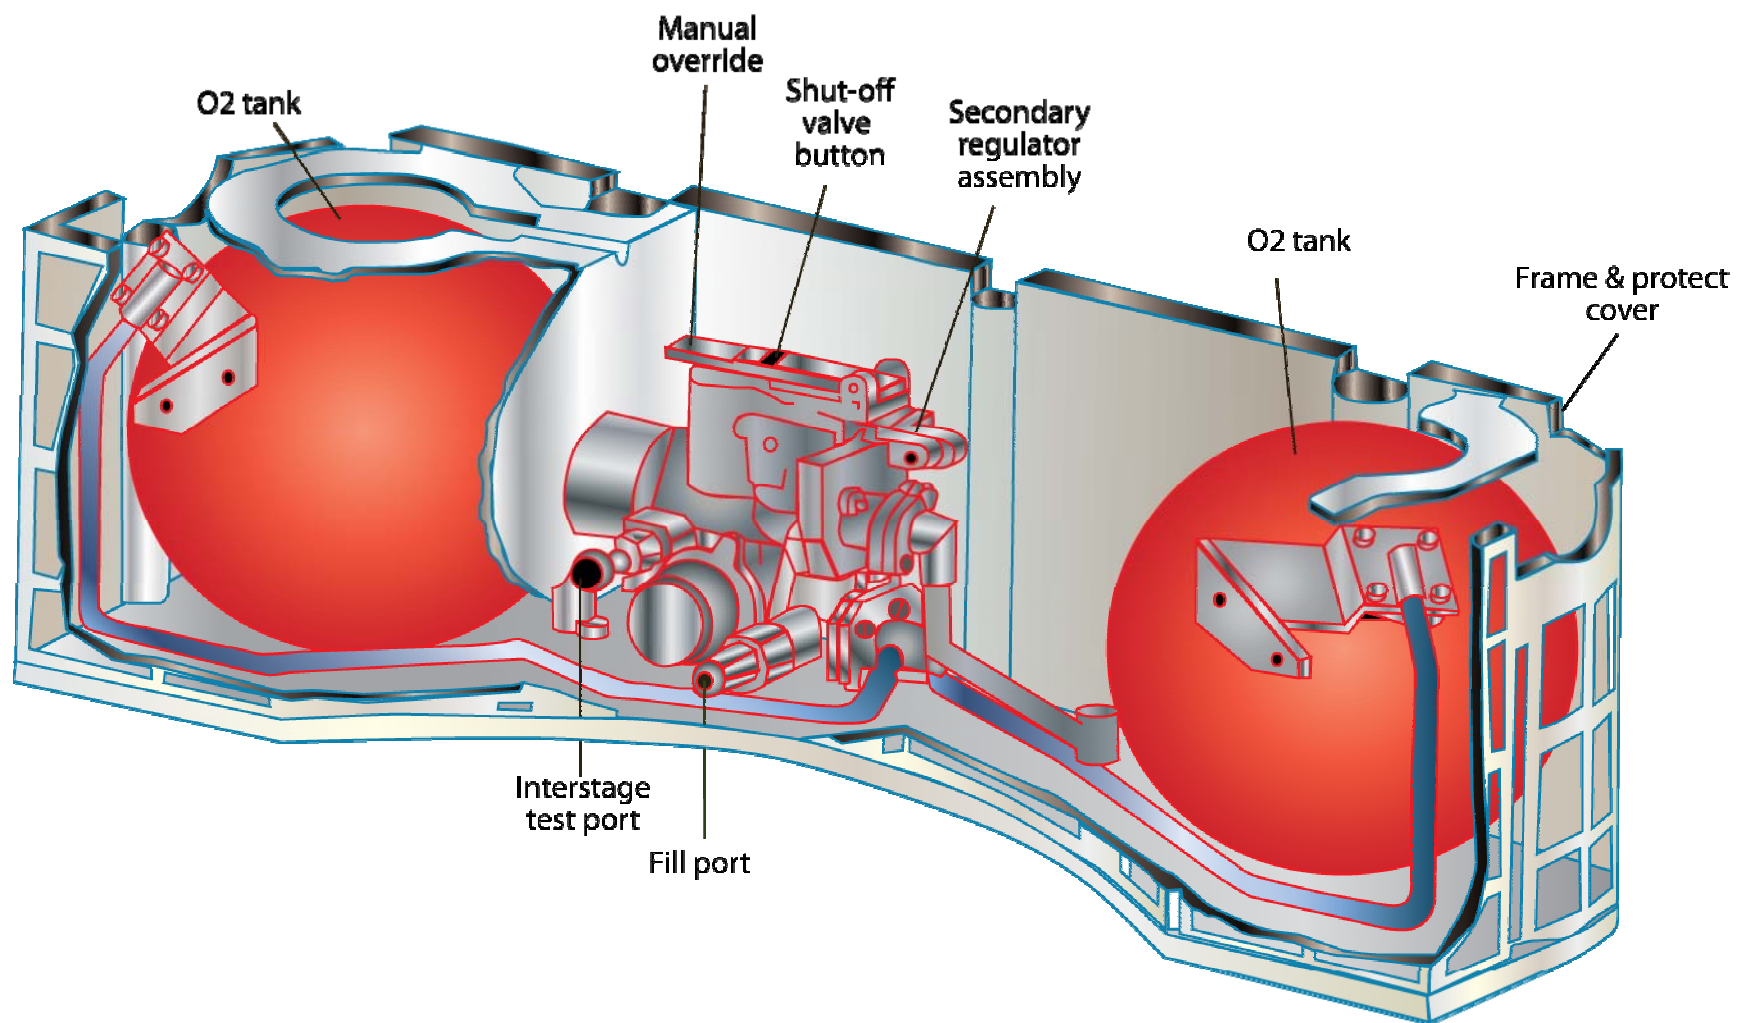
# Rear View of SOP/PLSS Regulators

- The fire originated in an aluminum bodied regulator and valve assembly when 6000-psi oxygen was released through the valve into the regulator. It was postulated that the fire was probably caused by one or combination of the following:
  - the rupture of a thin, internal section of the aluminum body
  - the ignition of a silicone O-ring by compression heating of the oxygen, or
  - particle impact

As a result of the post fire investigation, the regulator and valve assembly was redesigned, and the aluminum in this assembly was replaced with Monel®
